**FIFTH FIVE-YEAR REVIEW REPORT  
FOR  
PHOENIX-GOODYEAR AIRPORT (NORTH AND SOUTH AREAS) SUPERFUND SITE  
MARICOPA COUNTY, ARIZONA**

EA Engineering, Science, and Technology, Inc.

**United States Environmental Protection Agency  
Region 9**

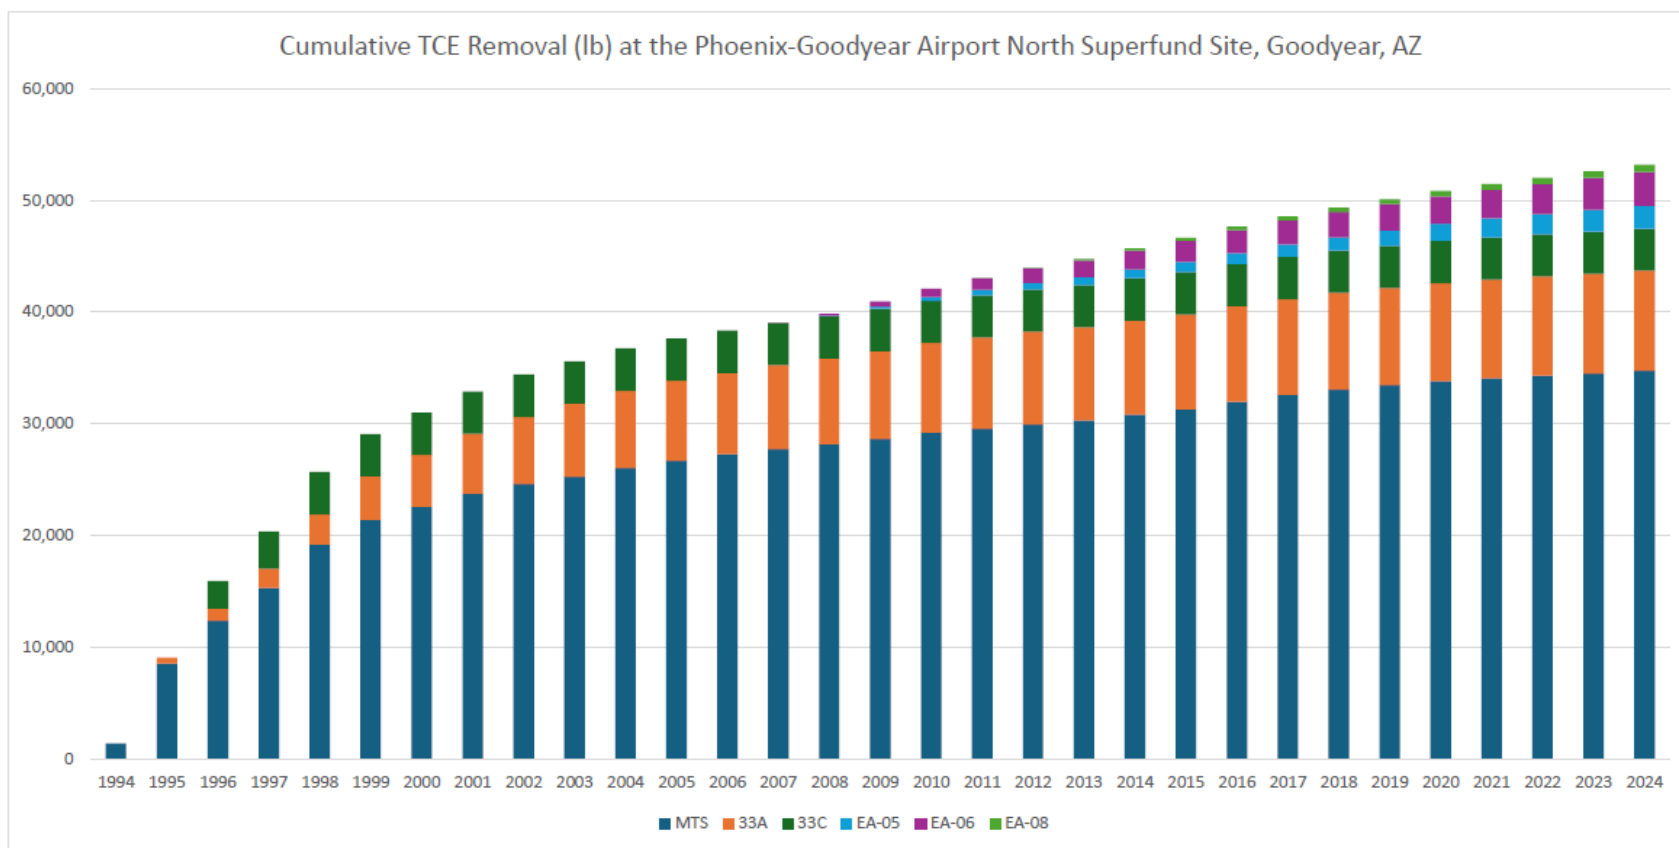
**Figure 4. PGA North Cumulative Groundwater Treatment System TCE Mass Removal**

The TCE mass removal data for Subunit A (Figure 4) shows an asymptotic trend for the cumulative amount of TCE removed and decreasing mass of TCE removed each year for the older treatment systems, the Main Treatment System and 33A which both began operation in 1994. The extraction wells associated with the Main Treatment System are sited in areas with higher concentrations of TCE, and these concentrations have been declining over time. Extraction wells EA-15, EA-16, and EA-17 were installed in in 2021/2022 for the EA-06 system may be contributing to less mass treatment at the 33A system. The newer systems, EA-06 began operation in 2007, EA-05 began operation in 2008, and EA-08 began operation in 2011, have not been operating long enough to reach the asymptotic trend.

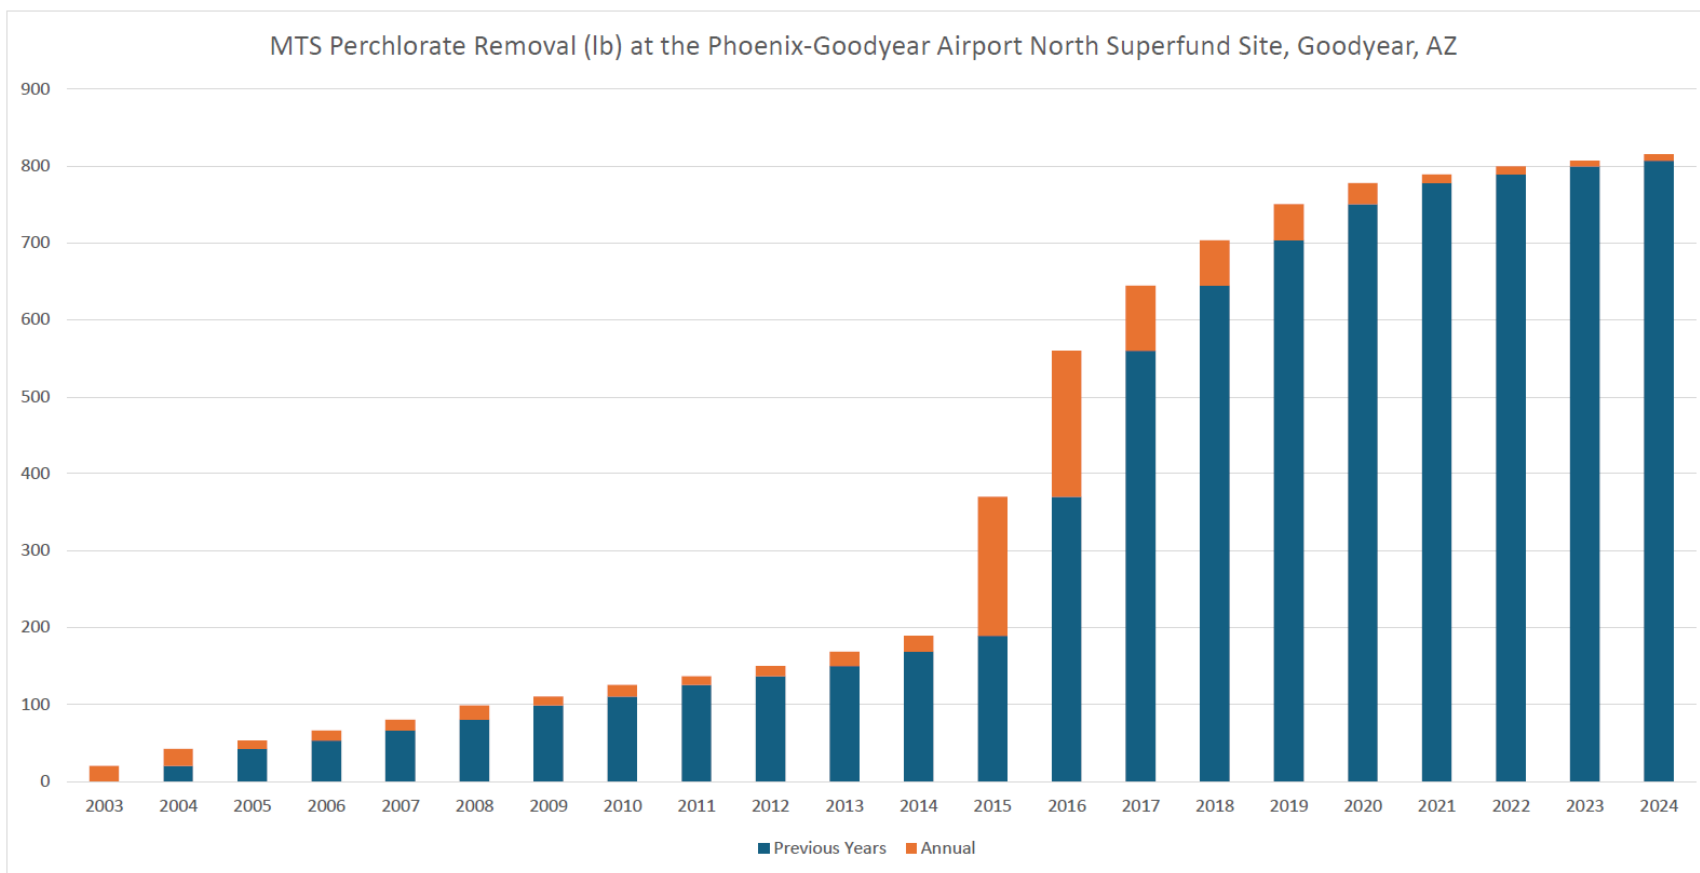
**Figure 5. PGA North Main Treatment System Cumulative Perchlorate Mass Removal**

Perchlorate removal began as a pilot study in 2003 and the Crane Company added it to the Main Treatment System in 2005 and increases in mass removal are seen annually on the graph (Figure 5). Following the implementation of the 2014 ROD Amendment, the perchlorate mass removal percentage noticeably increased likely due to enhanced treatments selected by the remedy described in Section 2.2.8. Since 2014, the cumulative mass removal has been trending towards an asymptotic level. Given the conservative fate and transport properties of perchlorate, this trend indicates that extraction pumping is containing the target perchlorate source zone.

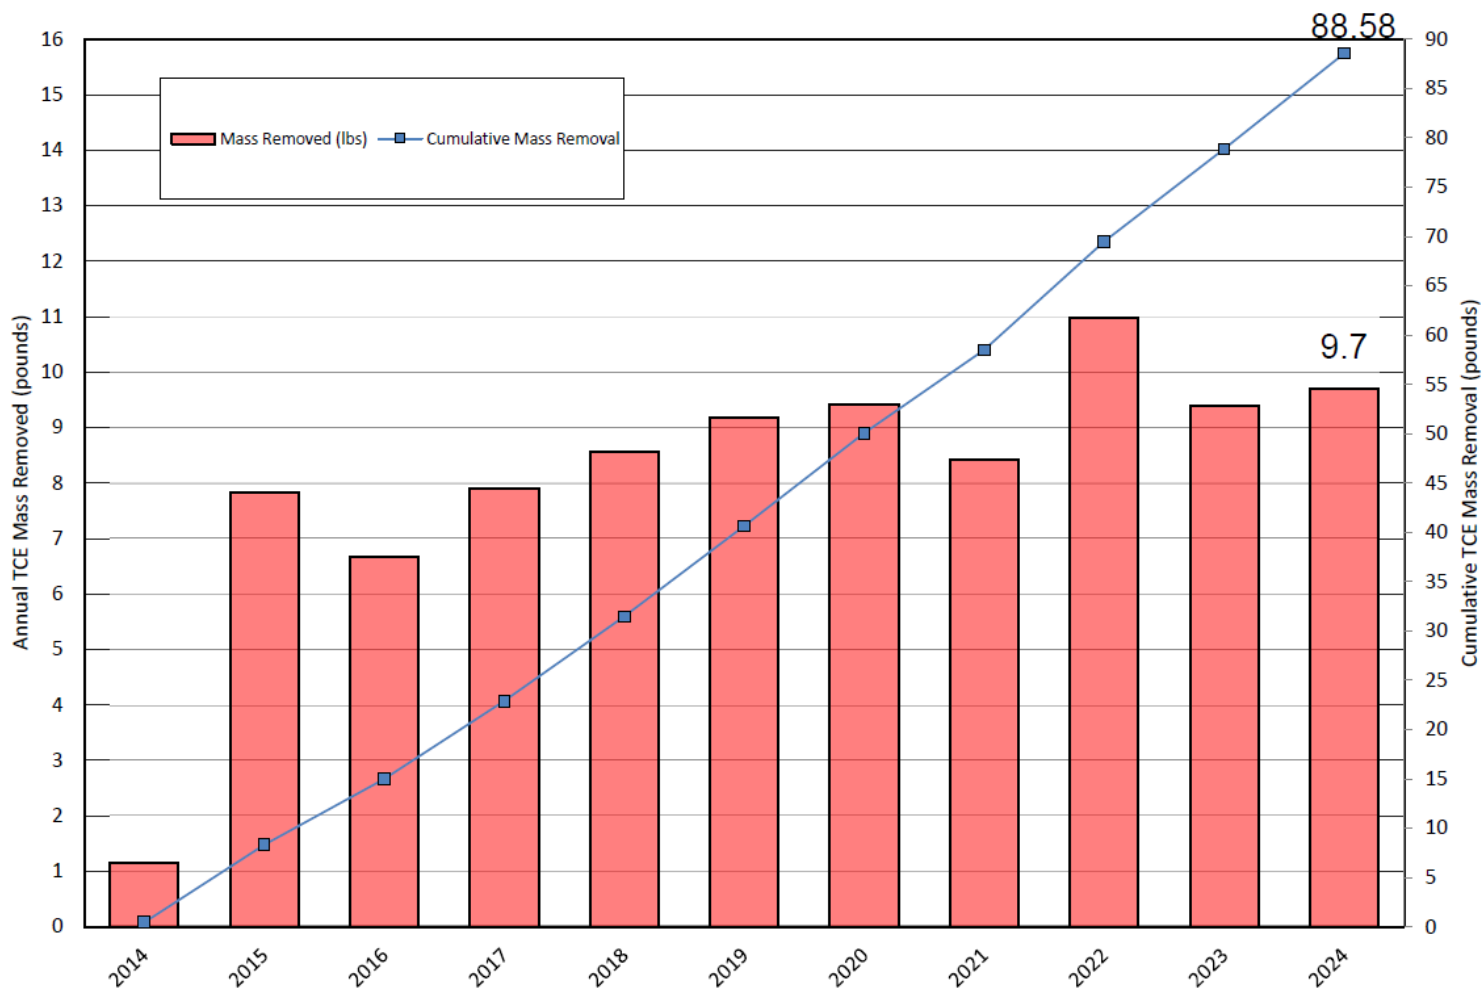
**Figure 7. PGA South Subunit C Annual and Cumulative TCE Mass Removal**

The TCE mass removal data for Subunit A (Figure 6) show an asymptotic trend for the cumulative amount of TCE removed and decreasing trends for TCE removed each year. Both the data sets and graphs indicate continued removal of TCE from the groundwater. Subunit C TCE Mass Removal (Figure 7) has not yet reached asymptotic trends yet even though mass removal has decreased. Subunit C treatment systems are younger and began operation in 2014 or 2025, and have not yet reached asymptotic conditions.

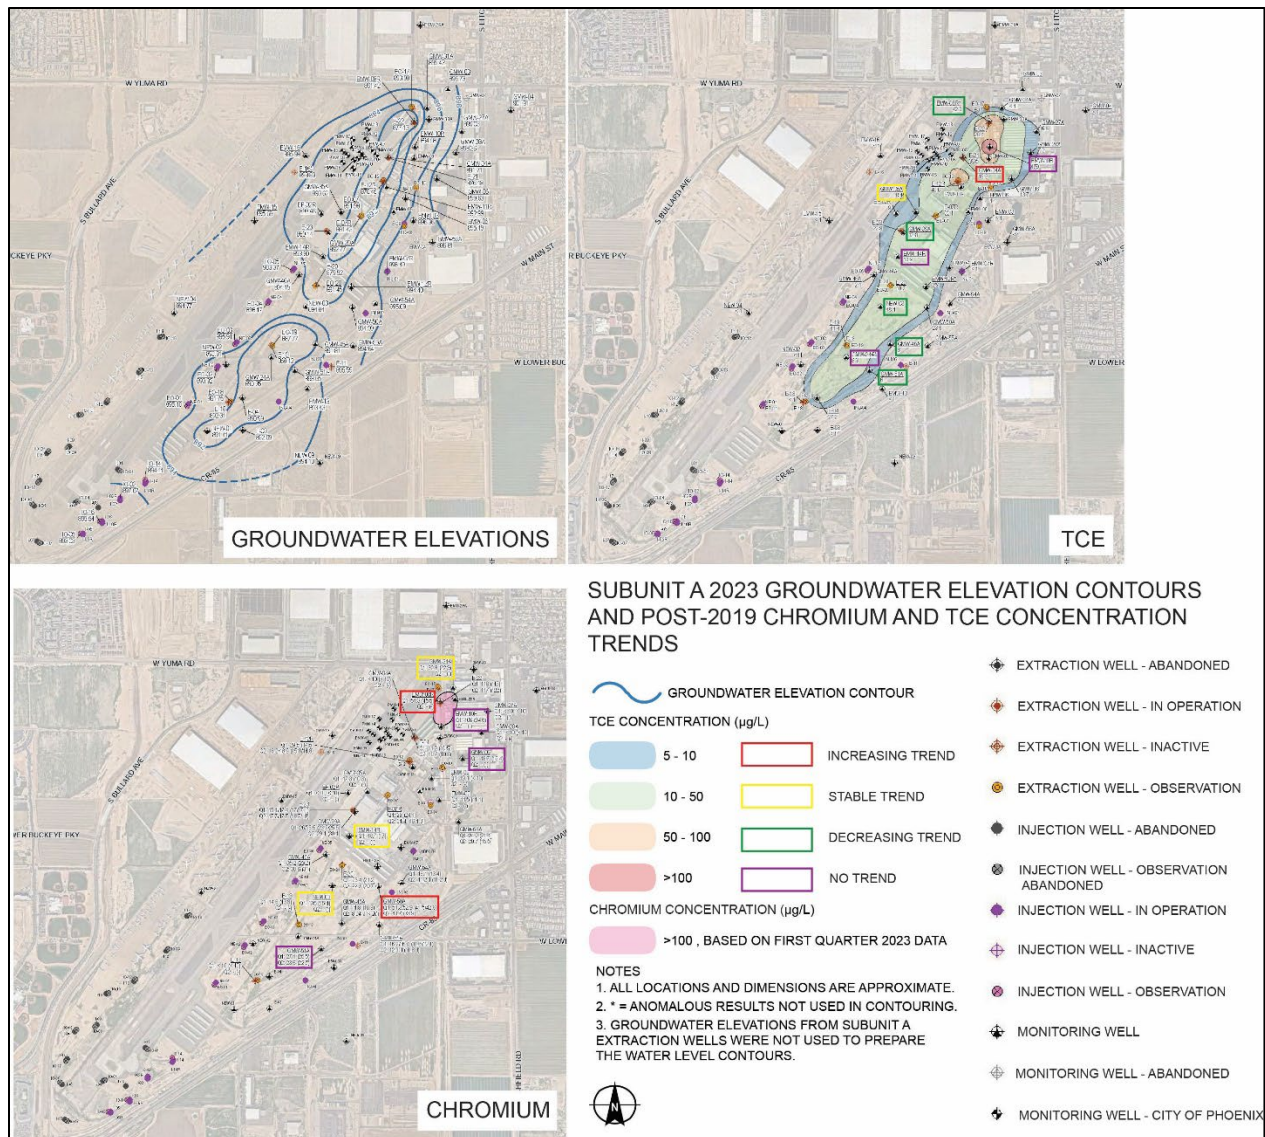
Monitoring well GMW-52UC is located between the northwestern edges of the northern plume and the central plume, and did not exhibit a monotonic trend during either the current or historical time periods. The groundwater flow model presented in the 2023 First Semiannual Groundwater Monitoring Report depicts groundwater from GMW-52UC to flow towards extraction well E-103. Plume capture by E-103 cannot be confirmed due to a lack of a clear decreasing TCE concentration trend.

In the central plume, the four monitoring wells evaluated had TCE concentrations that exceeded the cleanup level during the review period. Monitoring wells GMW-49UC, GMW-47UC, and GMW-53UC had decreasing TCE trends during the review period, which could indicate that the plume is being captured by the downgradient extraction wells. Groundwater elevation data suggests that contaminated groundwater in GMW-53UC is expected to flow towards extraction well E-102R. The groundwater flow model presented in the 2023 First Semiannual Groundwater Monitoring Report states that groundwater from GMW-53UC that is outside of the capture zone of extraction well E-102R flows north towards extraction well E-103. Cleanup level exceedances have not been found in groundwater samples collected downgradient at GMW-57UC and GMW-58UC, further supporting groundwater flow from GMW-53UC to E 102R and E-103. Monitoring well GMW-64UC had a stable concentration greater than the cleanup level during the review period, and groundwater from GMW-64UC is likely flowing downgradient to extraction well E-102R.

**Figure C-4.** PGA South Subunit A aquifer groundwater elevations from 2023 and current review period chromium and TCE concentration trends.

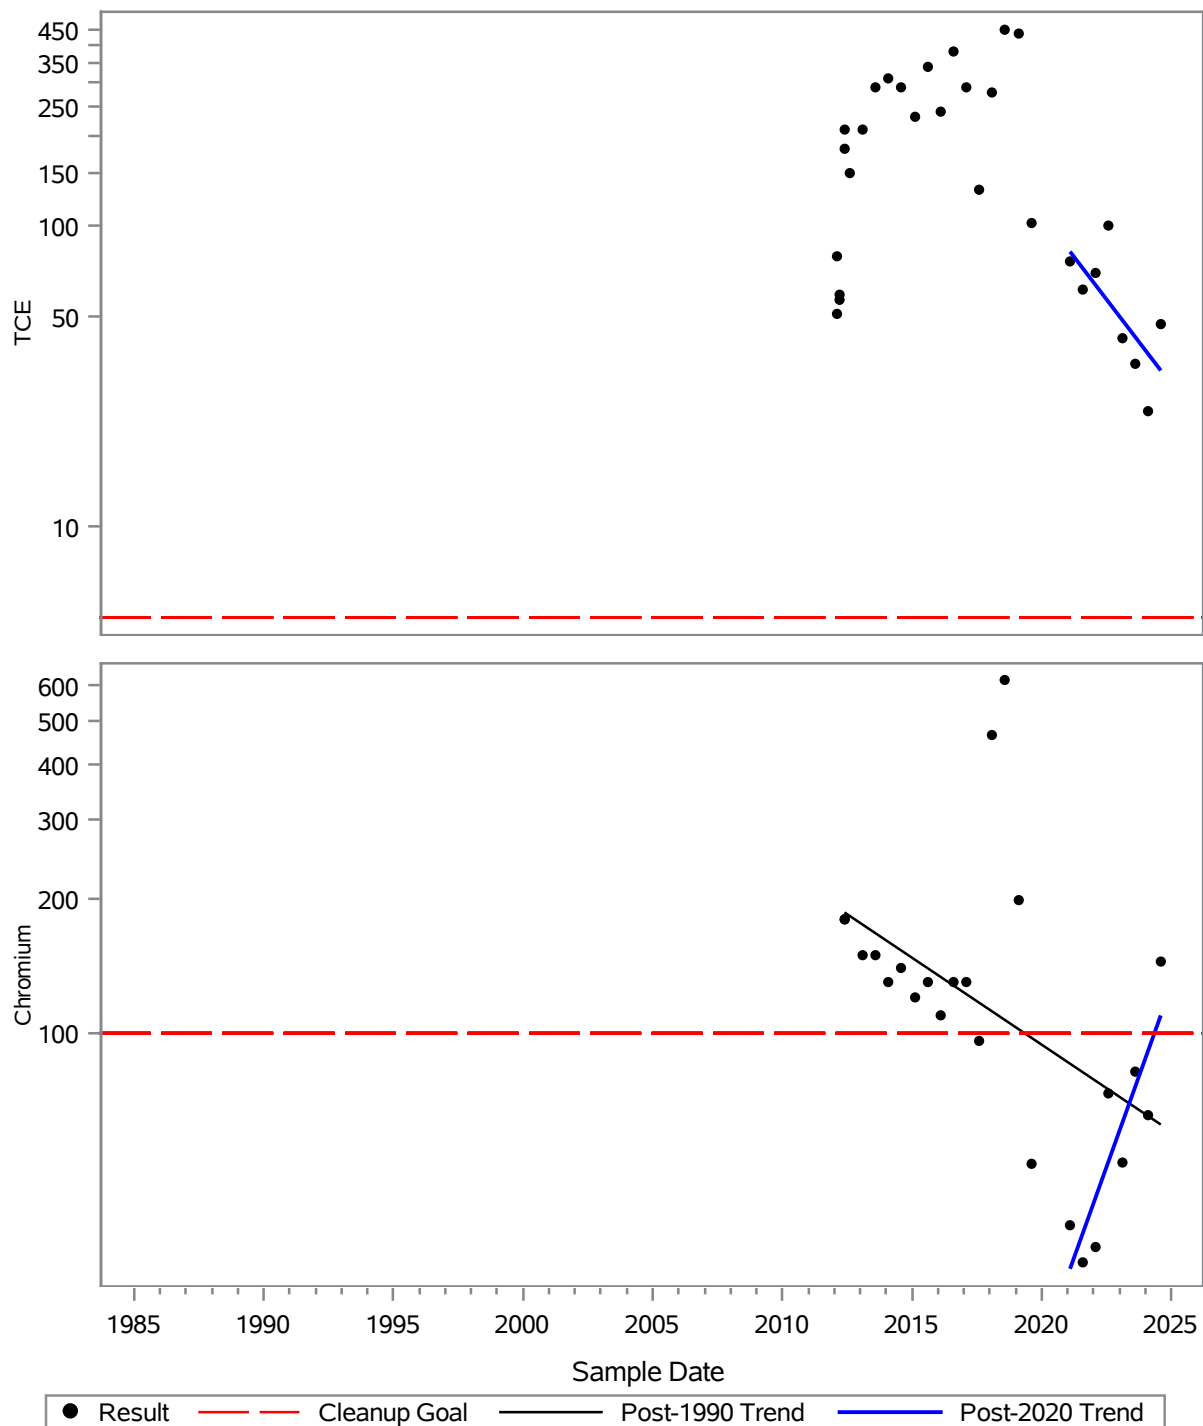
## Concentration Trend Plots: Subunit A EMW-08R

EMW-08R, EMW-10R, and NEW-03 had chromium concentrations greater than the cleanup level during the review period. Monitoring wells EMW-10R did not exhibit a monotonic chromium trend and NEW-03 had a stable trend. Groundwater from these wells should be flowing downgradient towards nearby extraction wells based on recent (2023) groundwater elevations. Monitoring wells EMW-08R and GMW-50A have a currently increasing trend, which is likely attributed to nearby extraction wells drawing in contaminated groundwater. Based on observed chromium trends and groundwater elevations during the review period, the extraction and injection wells appear to contain the chromium plume.

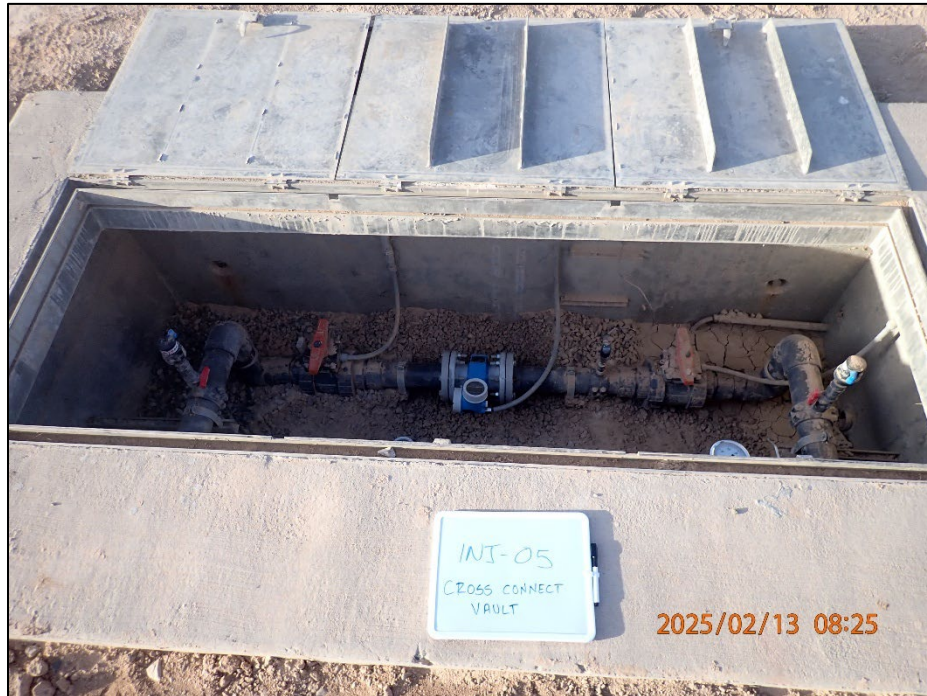
**Photograph 1.** February 13, 2025, 08:25 AM  
PGA South injection well INJ-05 cross connect vault. Facing west.

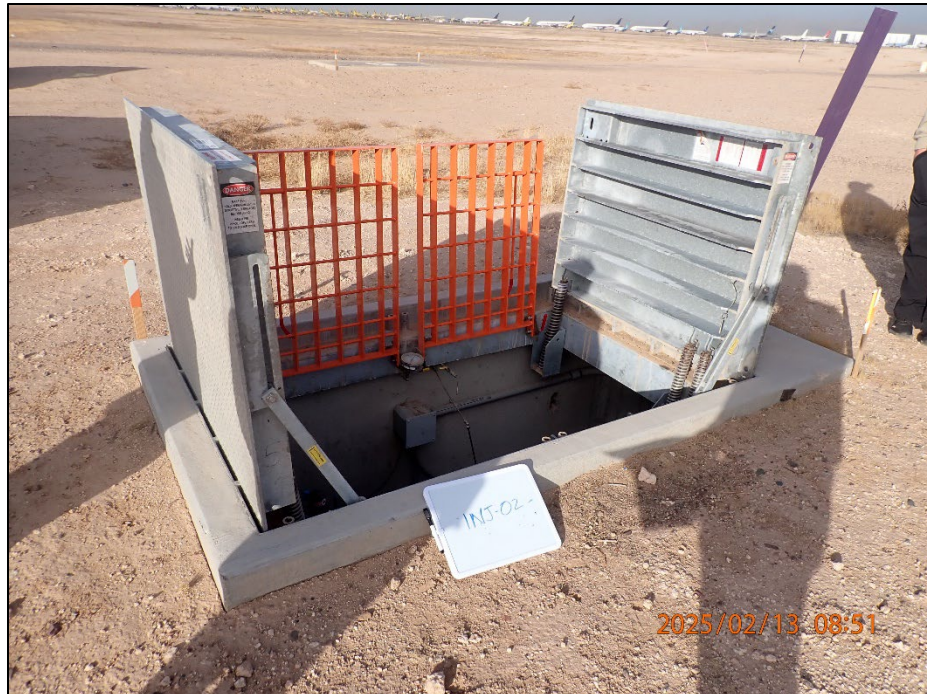
**Photograph 2.** February 13, 2025, 08:51 AM  
PGA South injection well INJ-02 vault. Facing northwest.

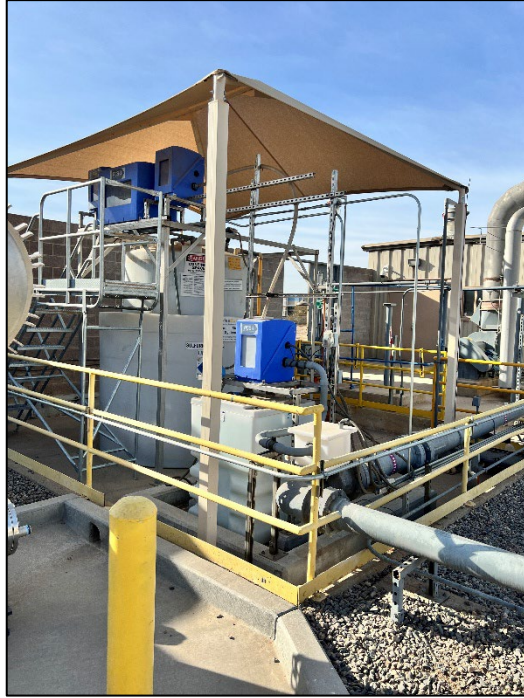
**Photograph 3.** February 13, 2025, 09:23 AM  
PGA South Subunit A acid storage tank within secondary containment. Facing south.

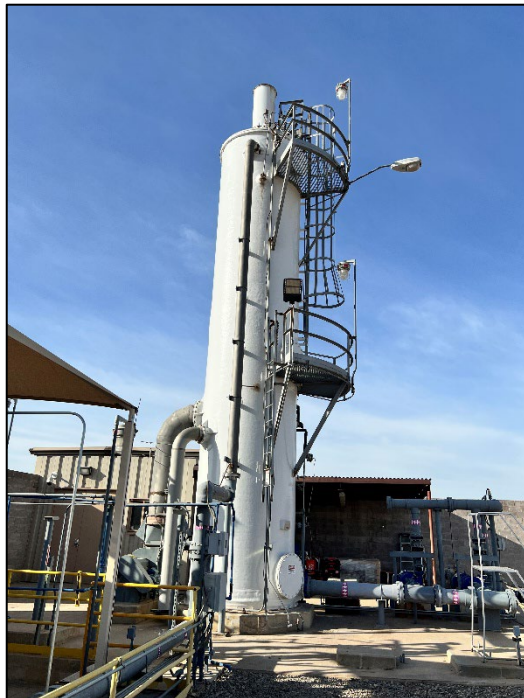
**Photograph 4.** February 13, 2025, 09:23 AM  
PGA South Subunit A air stripper. Facing southwest.

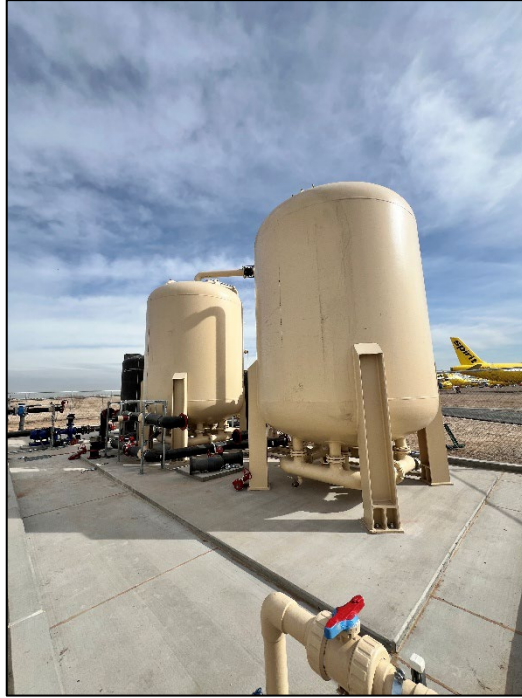
**Photograph 5.** February 13, 2025, 10:22 AM

PGA South Subunit C Southwest treatment system under construction. Facing northwest.

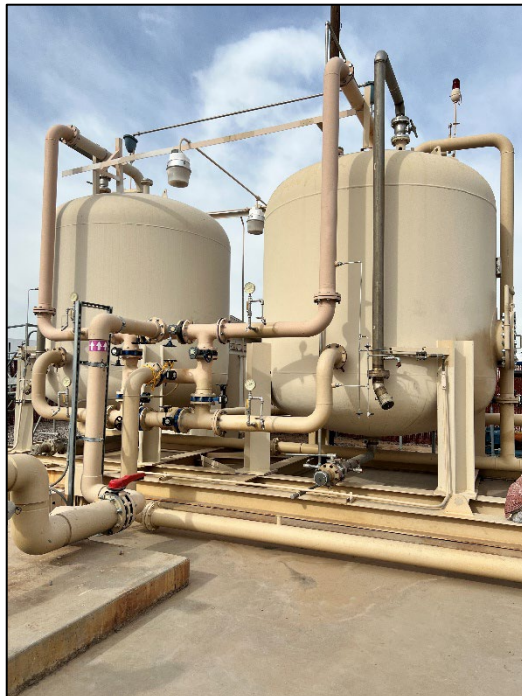
**Photograph 6.** February 13, 2025, 10:33 AM

PGA South Subunit C LGAC vessels. Facing northeast.

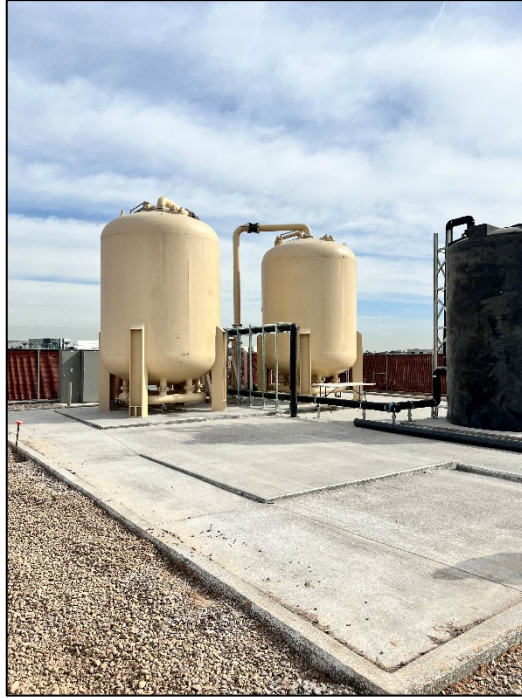
**Photograph 7.** February 13, 2025, 10:42 AM  
PGA South Subunit C LGAC vessels. Facing north.

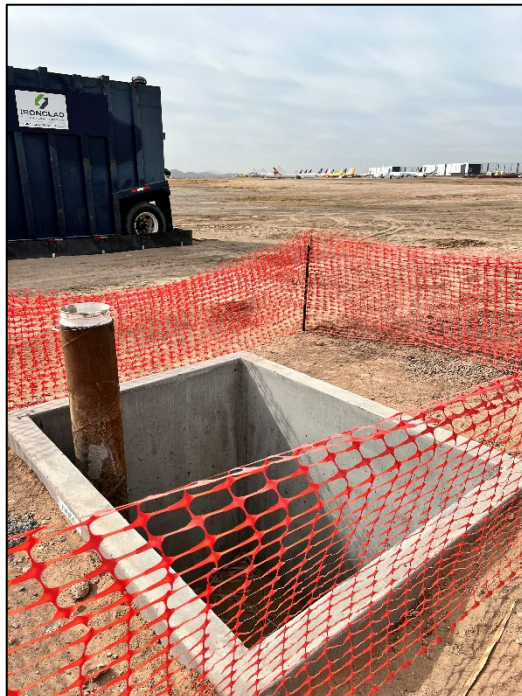
**Photograph 8.** February 13, 2025, 10:57 AM  
PGA South extraction well E-104 under construction. Facing south.

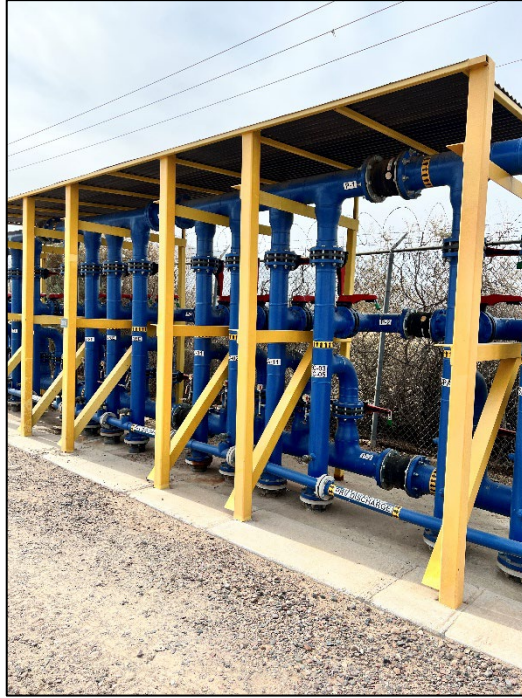
**Photograph 9.** February 13, 2025, 12:34 PM  
PGA North main treatment system process lines. Facing southwest.

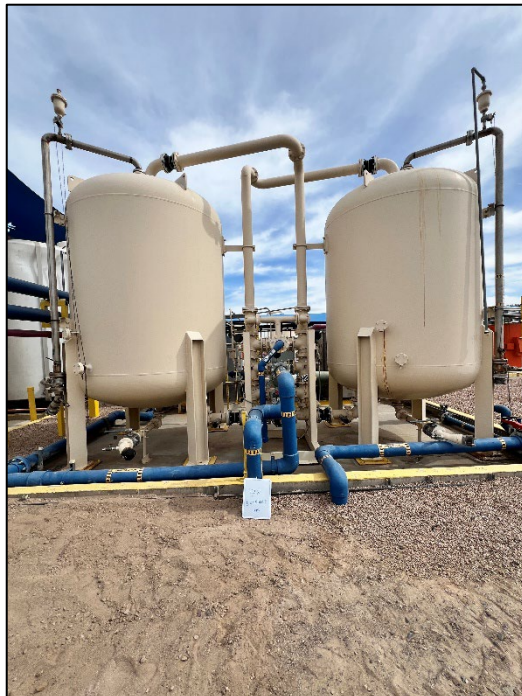
**Photograph 10.** February 13, 2025, 12:42 PM  
PGA North main treatment system ion exchange vessels. Facing east.

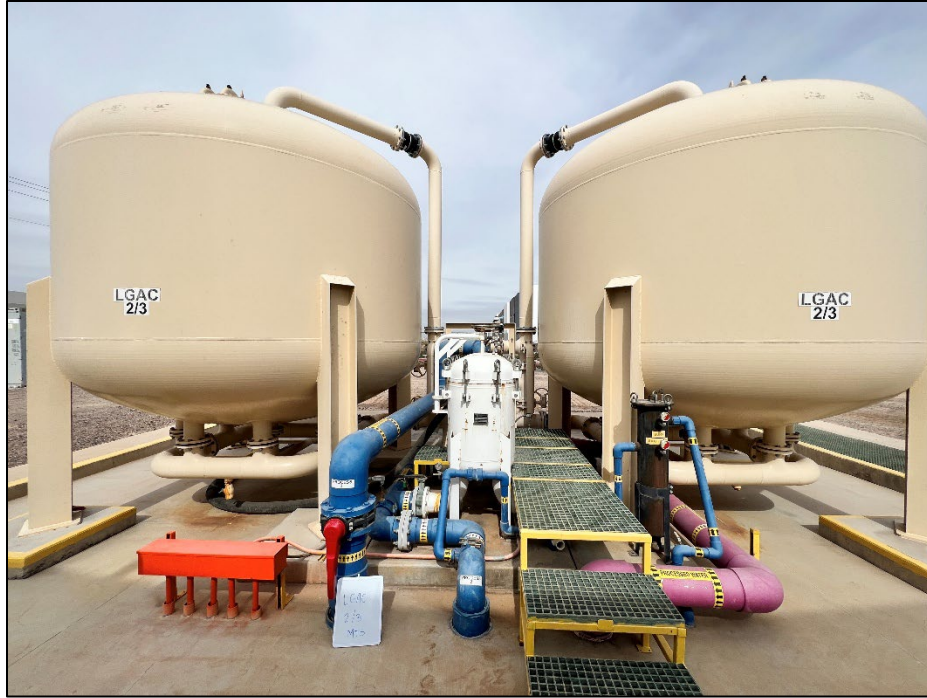
**Photograph 11.** February 13, 2025, 12:48 PM  
PGA North main treatment system LGAC vessels (LGAC 2/3). Facing north.

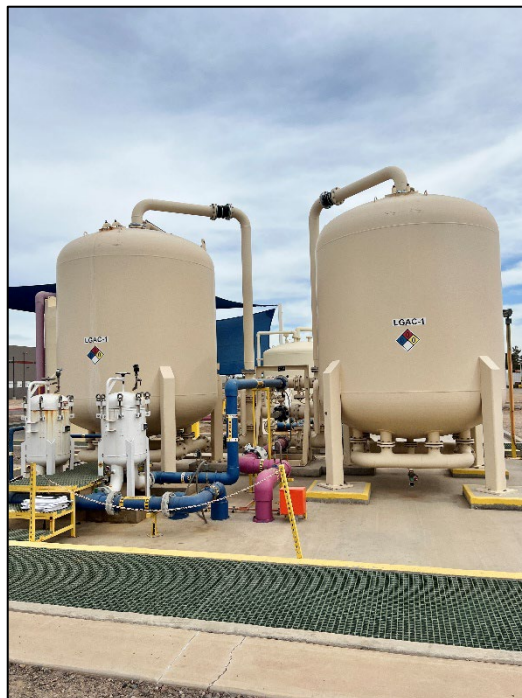
**Photograph 12.** February 13, 2025, 01:00 PM  
PGA North main treatment system LGAC vessels (LGAC 1). Facing west.

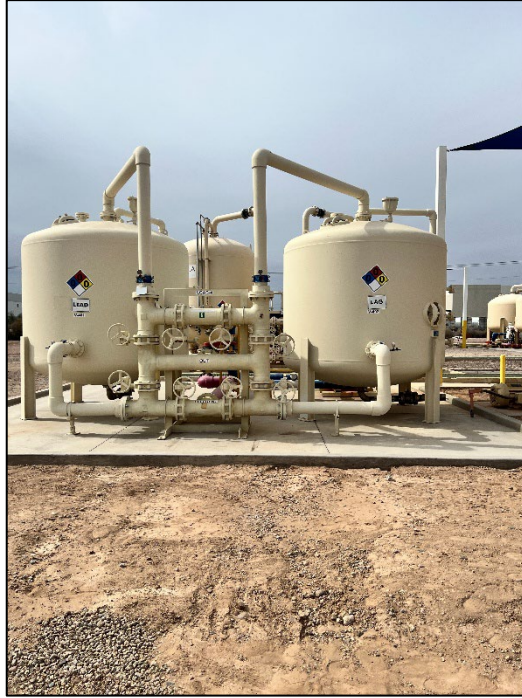
**Photograph 13.** February 13, 2025, 01:22 PM  
PGA North main treatment system LGAC vessels (LGAC 4). Facing east.

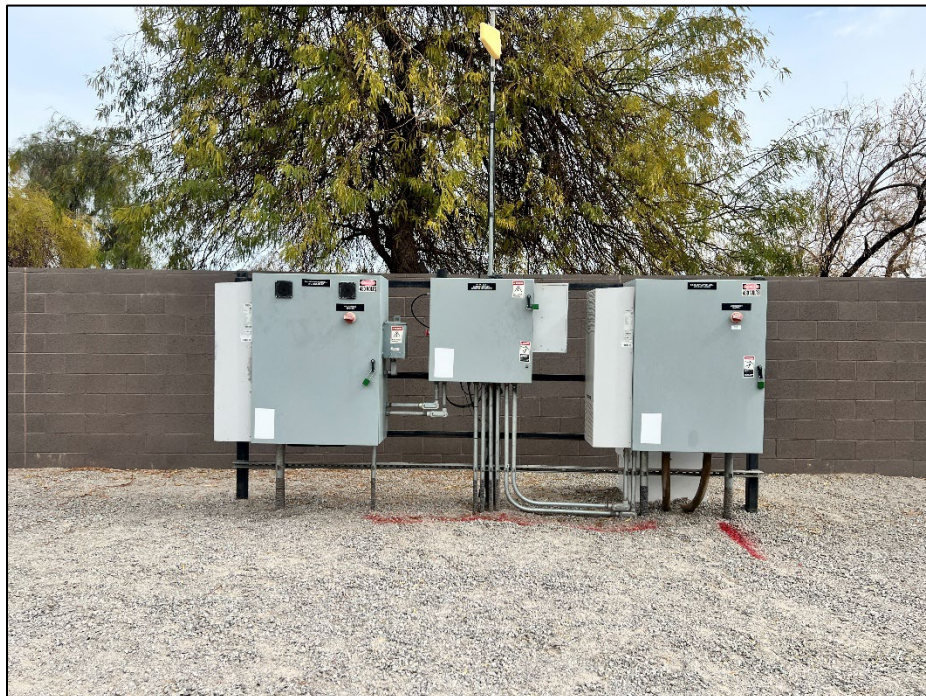
**Photograph 14.** February 13, 2025, 01:29 PM  
PGA North extraction well EA-14 control panels. Facing east.

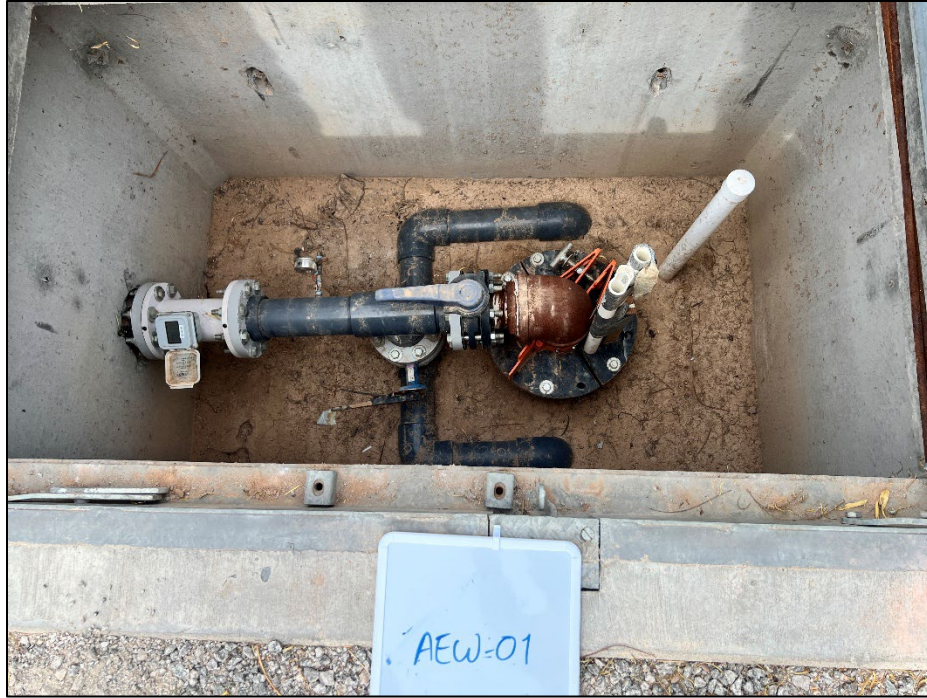
**Photograph 15.** February 13, 2025, 01:31 PM  
PGA North injection well AEW-01 (potential use for additive emplacement). Top view.

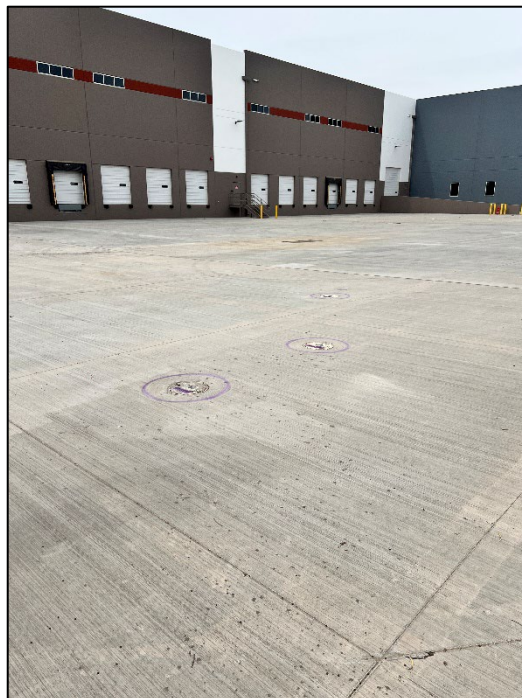
**Photograph 16.** February 13, 2025, 01:34 PM  
PGA North groundwaters monitoring wells MW-5B, SAC MW-04A. Facing northwest.

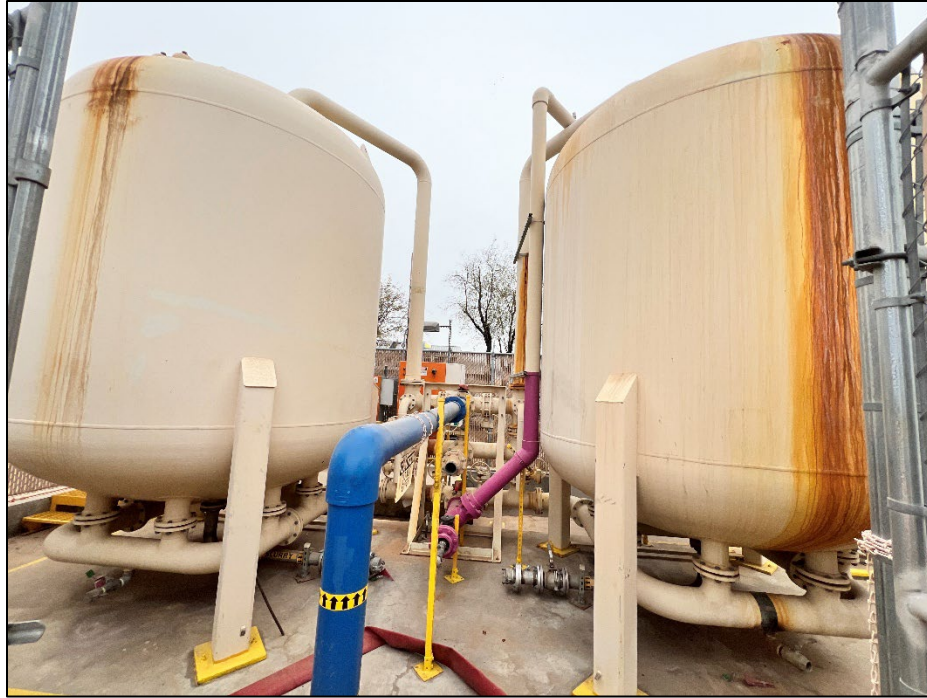
**Photograph 17.** February 13, 2025, 01:48 PM  
PGA North groundwater treatment system EA-05 LGAC vessels. Facing north.

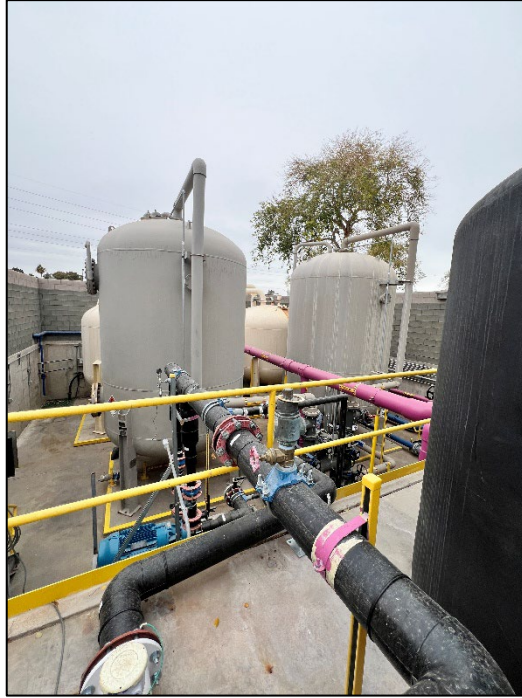
**Photograph 19.** February 13, 2025, 02:11 PM  
PGA North groundwater treatment system EA-06 LGAC vessels. Facing north.

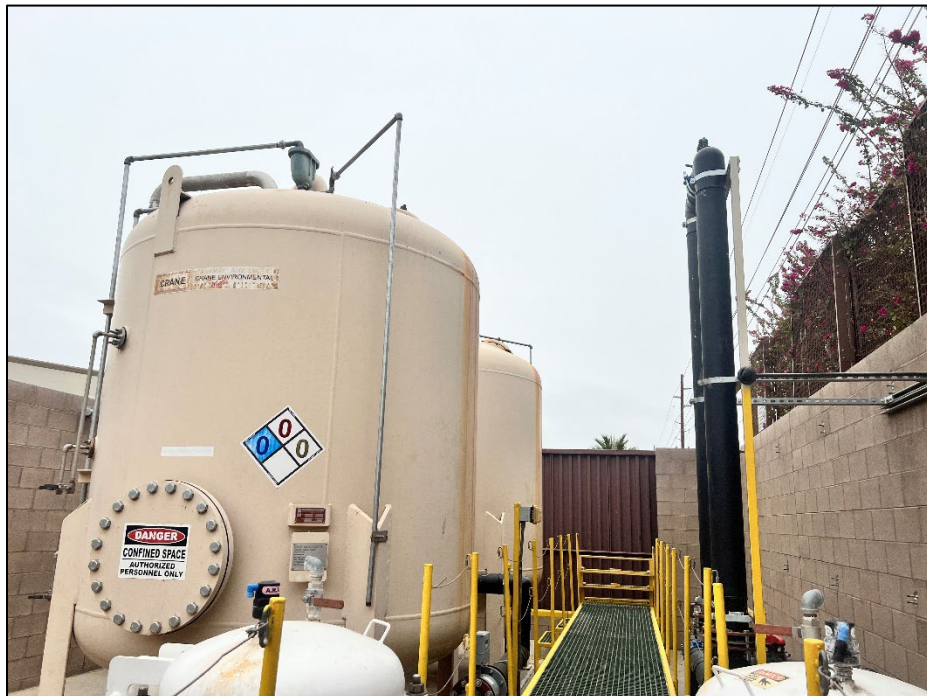
**Photograph 20.** February 13, 2025, 02:27  
PGA North groundwater treatment system EA-08 LGAC vessels. Facing northeast.

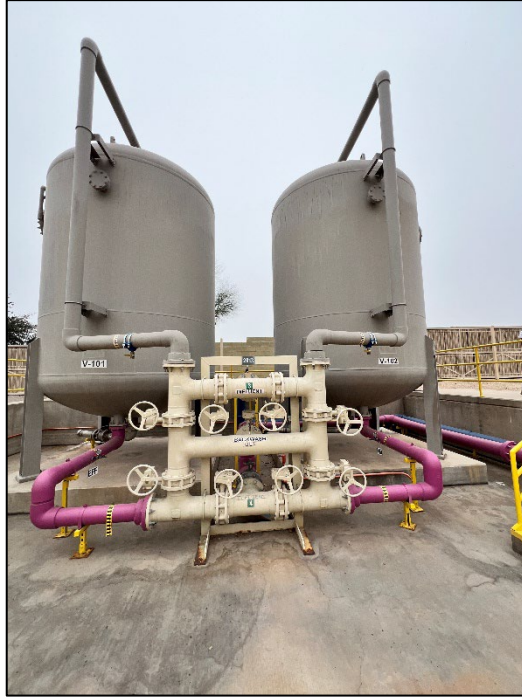
**Photograph 21.** February 13, 2025, 02:43  
PGA North groundwater treatment system 33A LGAC vessels. Facing west.

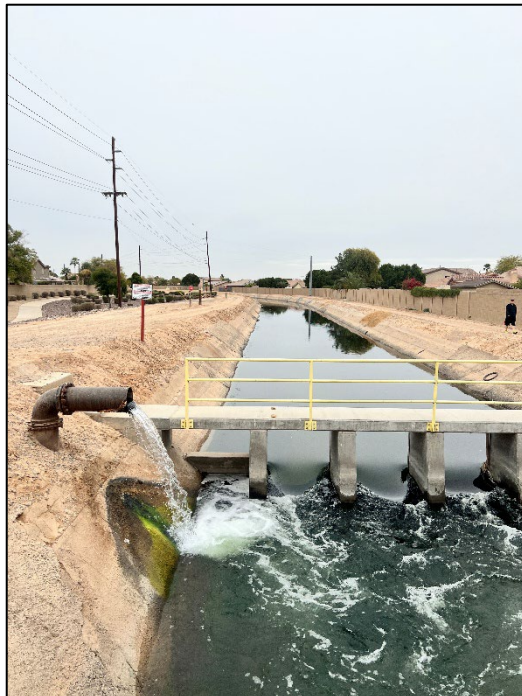
**Photograph 22.** February 13, 2025, 02:53  
PGA North Treated groundwater discharge into the Roosevelt Canal. Facing east.

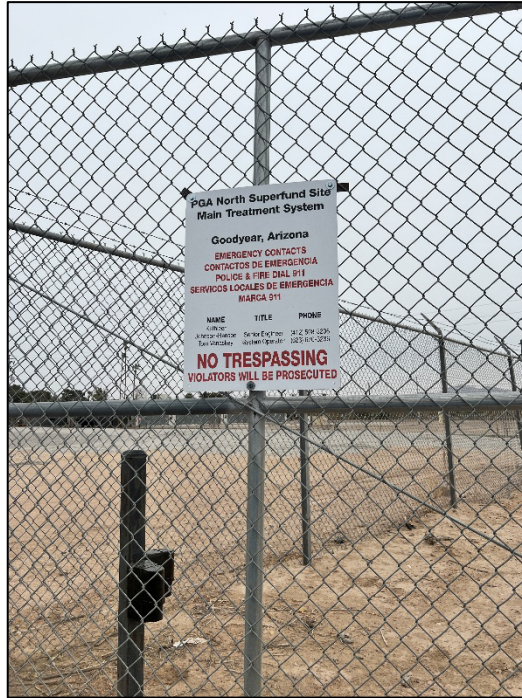
**Photograph 23.** February 13, 2025, 03:28

PGA North sign at entrance to the main treatment system. Facing south.
