New Idria Mercury Mine Superfund Site Idria, San Benito County, California Removal Action Final Report

April 2012

Prepared for: U.S. Environmental Protection Agency Region 9

> Prepared by: Weston Solutions, Inc.

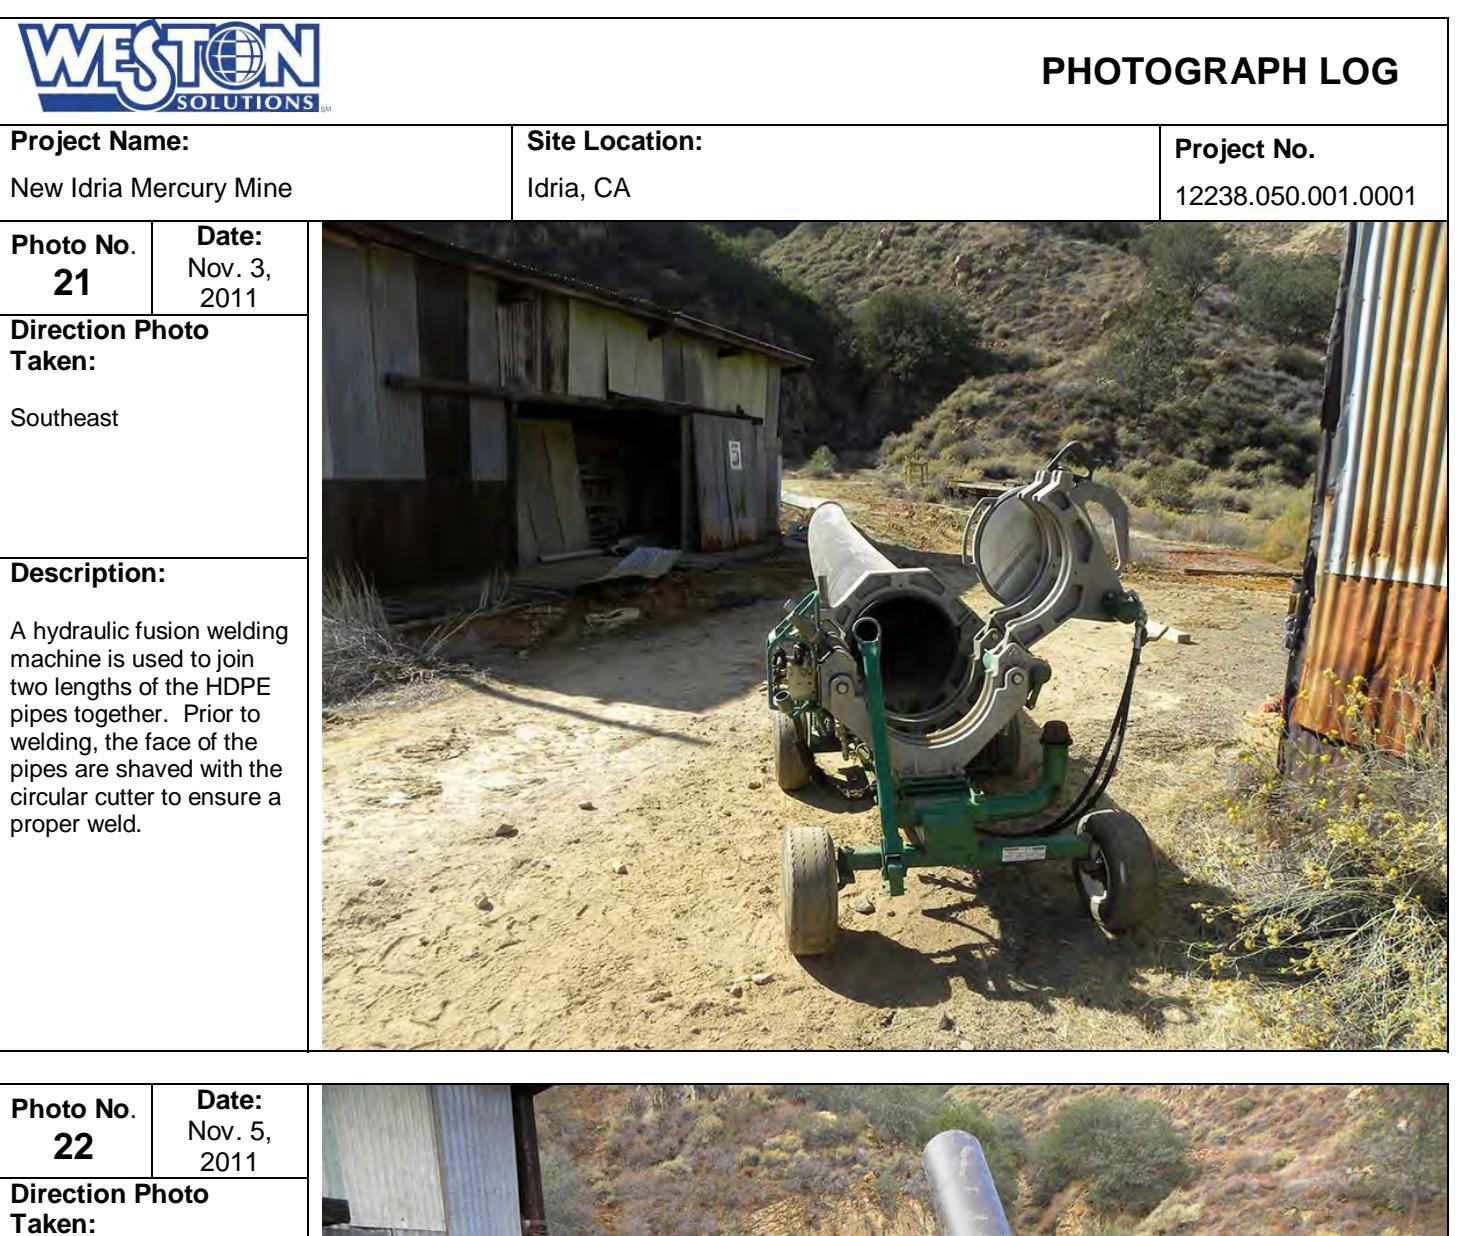
View of the HDPE pipes being welded near the junction of the second clean out location.

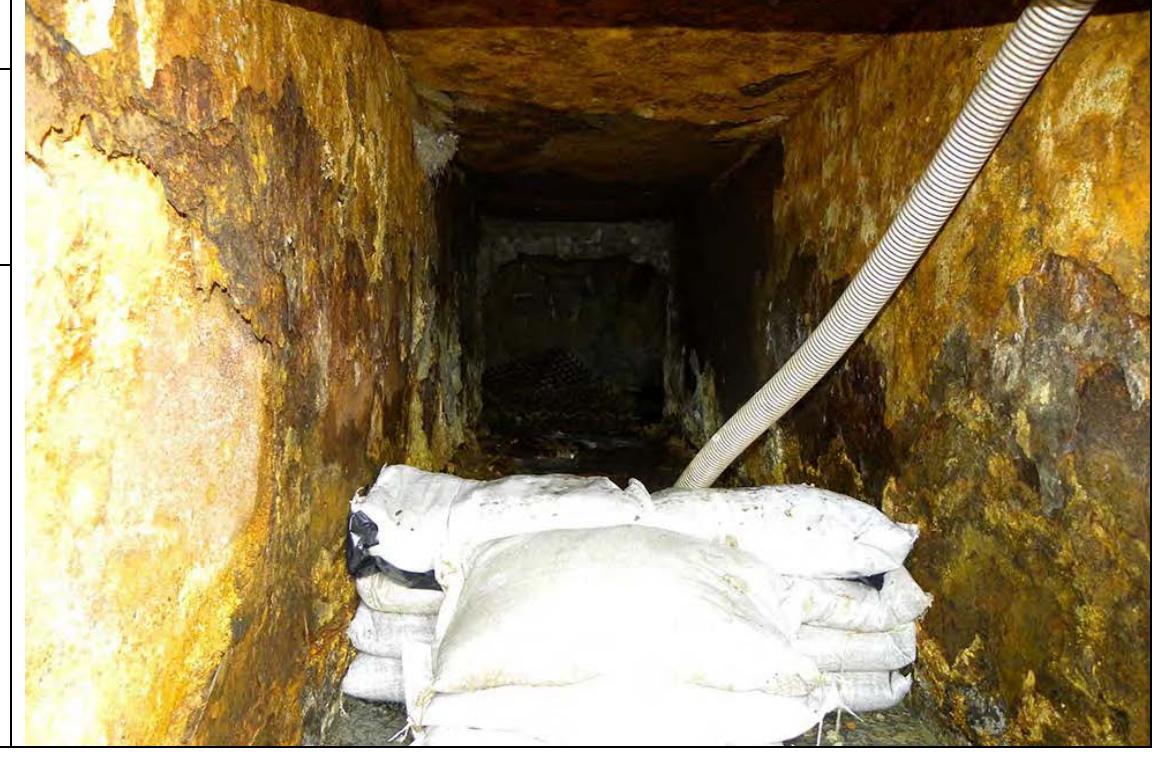
Prior to connecting the HDPE pipe to the entrance of the Level 10 Adit, a sand bag dam was installed and the AMD was pumped out.

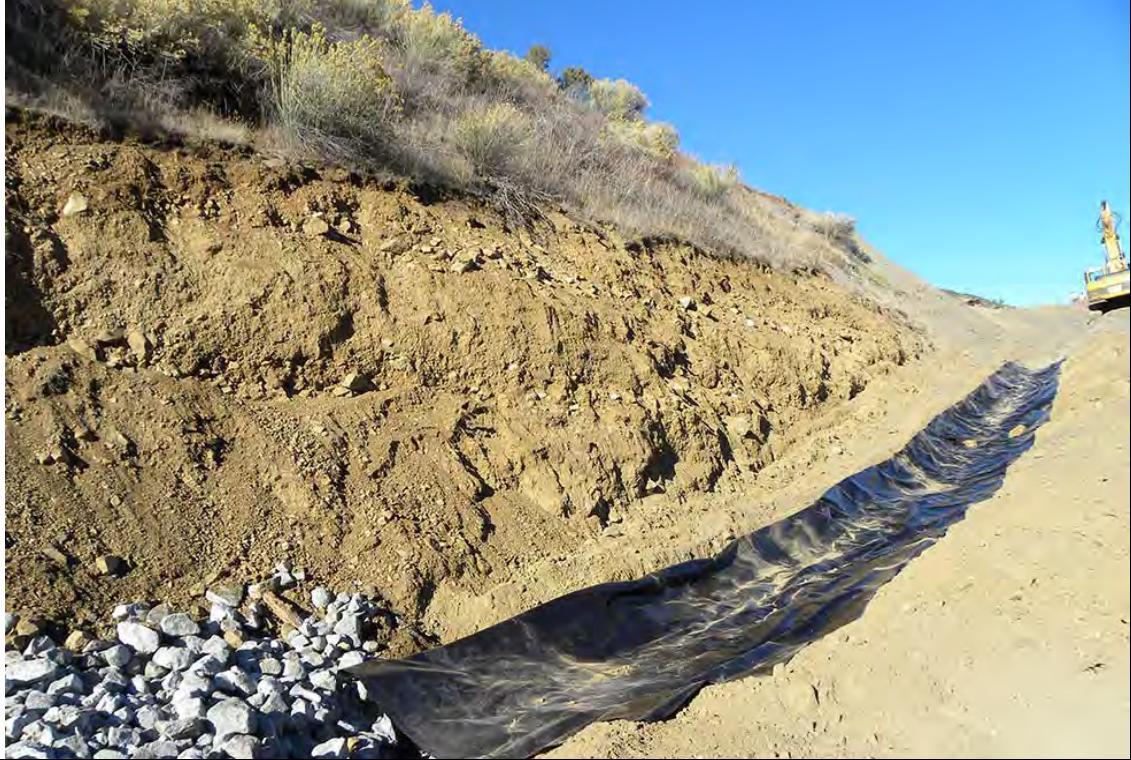
The lined Surface Water Diversion Channel is connected to a rip rap stilling basin. Water flowing through the channel will be slowed down by the rip rap prior to entering a 40-foot culvert pipe that empties to San Carlos Creek.

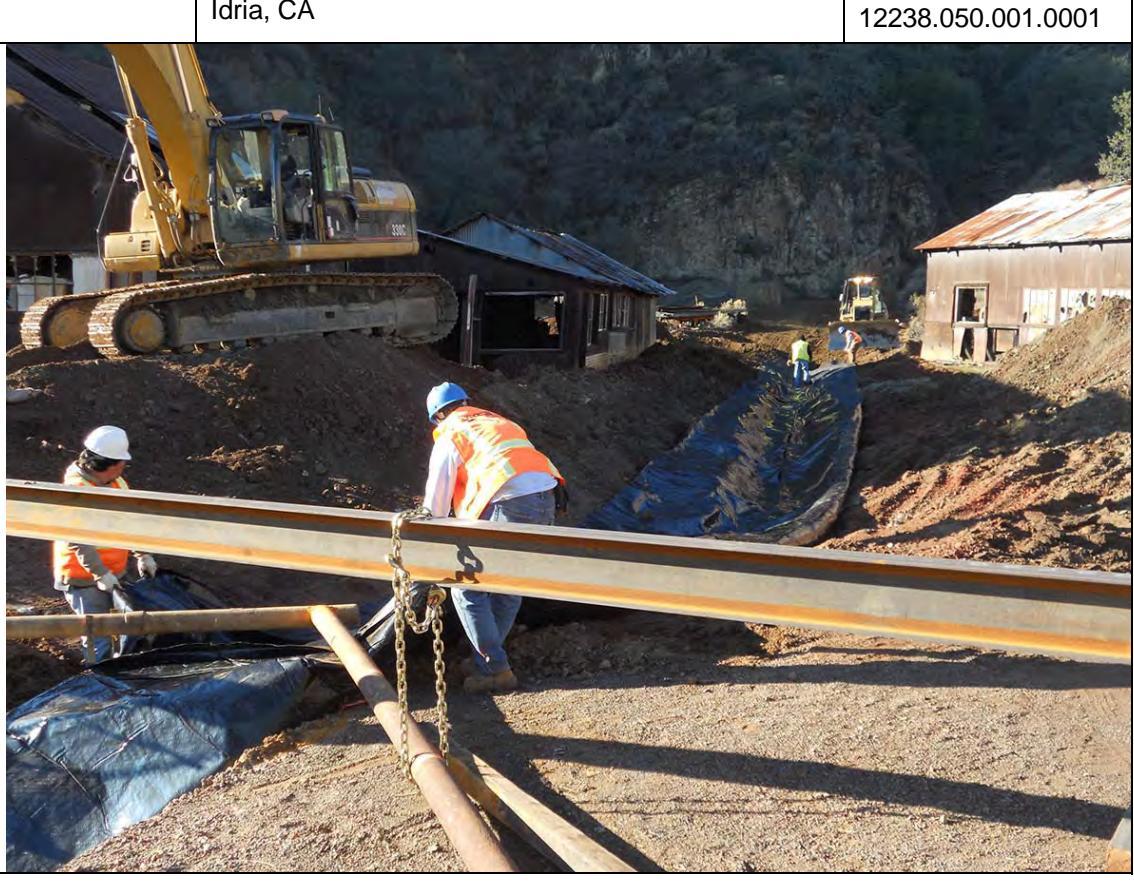
View of WESTON crew members installing the 12mil liner for the Intermittent Stream Diversion Channel.

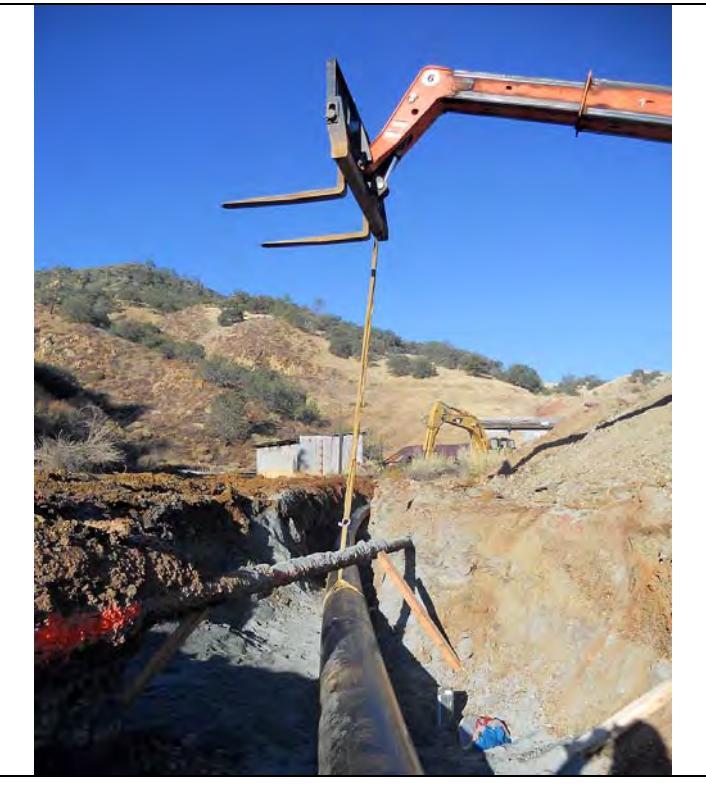
Immediately prior to construction activities at the NIMM site, WESTON was notified that an active underground water line existed in an unknown location along the upper bench of the Level 10 Adit dump. It was suspected that the water line crossed the path of the planned AMD Conveyance alignment; therefore, it needed to be located prior to excavation of the alignment to ensure that it was not damaged. WESTON rented and underground utility locator and was able to identify the water line location by excavating test pits with a shovel along its path. The AMD Conveyance alignment was successfully excavated with no damage to the aging water line. The location of the water line required the HDPE pipe to be installed underneath line, and WESTON was required to purchase an electro-fusion coupler to join two sections of the HDPE pipe together.

Photo No. 34	Date: Nov. 9, 2011	
Direction Photo Taken:		
West		
Description:		
View of the exposed active water line crossing the AMD Conveyance pipe alignment. Additional efforts were required to install the HDPE pipe beneath the water line.

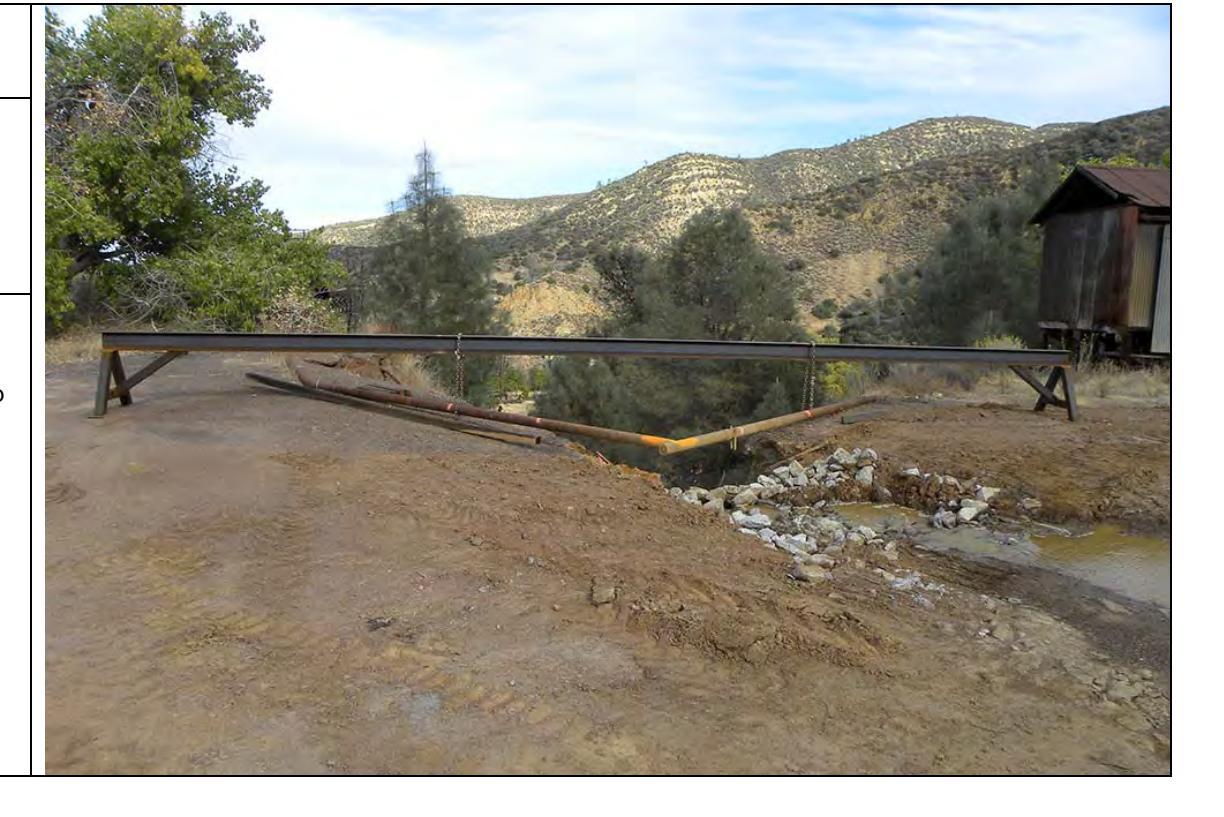
The active water line was also identified above ground at location that crossed the termination point of the Intermittent Stream Diversion Channel. Due to the excavation activities required for the channel installation, it was determined that the water line needed to be secured to prevent damage to the line. WESTON had a steal beam horse fabricated and delivered to the Site. The water line was secured to the steal horse with chains.

View of the water line stabilization above the rip rap portion of the Intermittent Stream Diversion Channel.

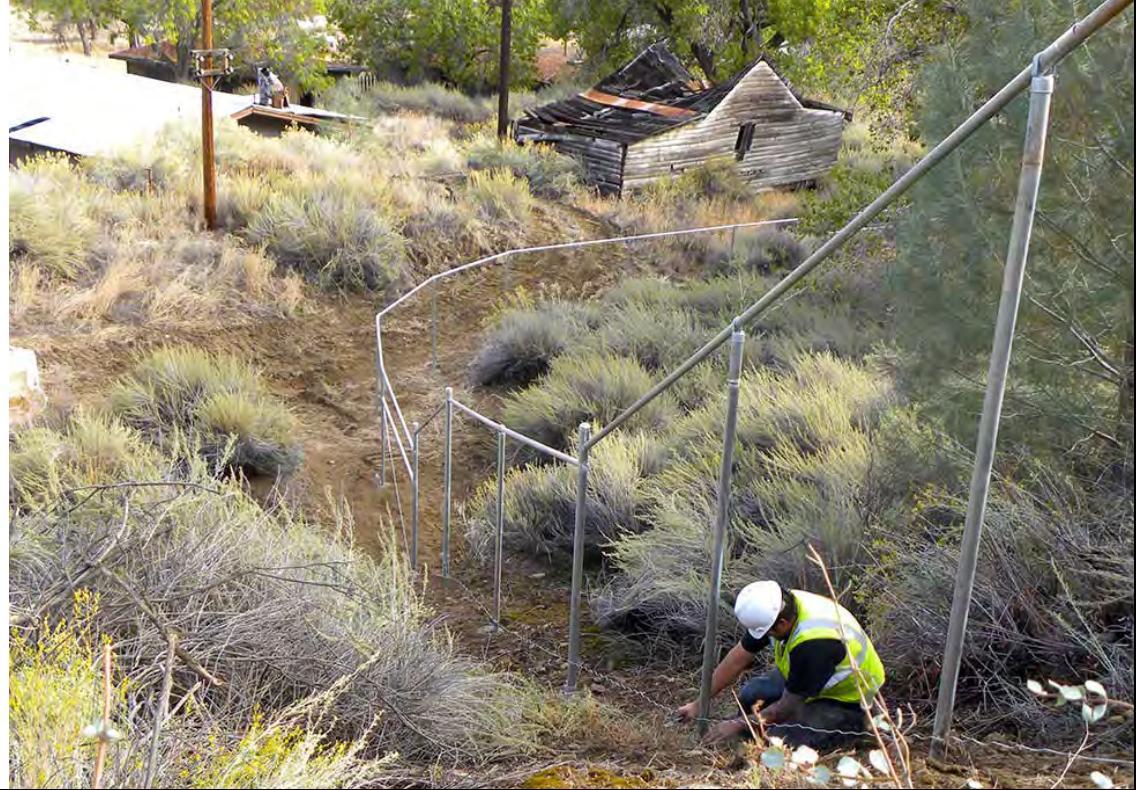
View of the 6-foot high chain link fence being installed near the 14-foot wide single swing gate along the upper access road.
