Fourth Five-Year Review Report

FMC Corporation Yakima

Superfund Site

SEPTEMBER 2013

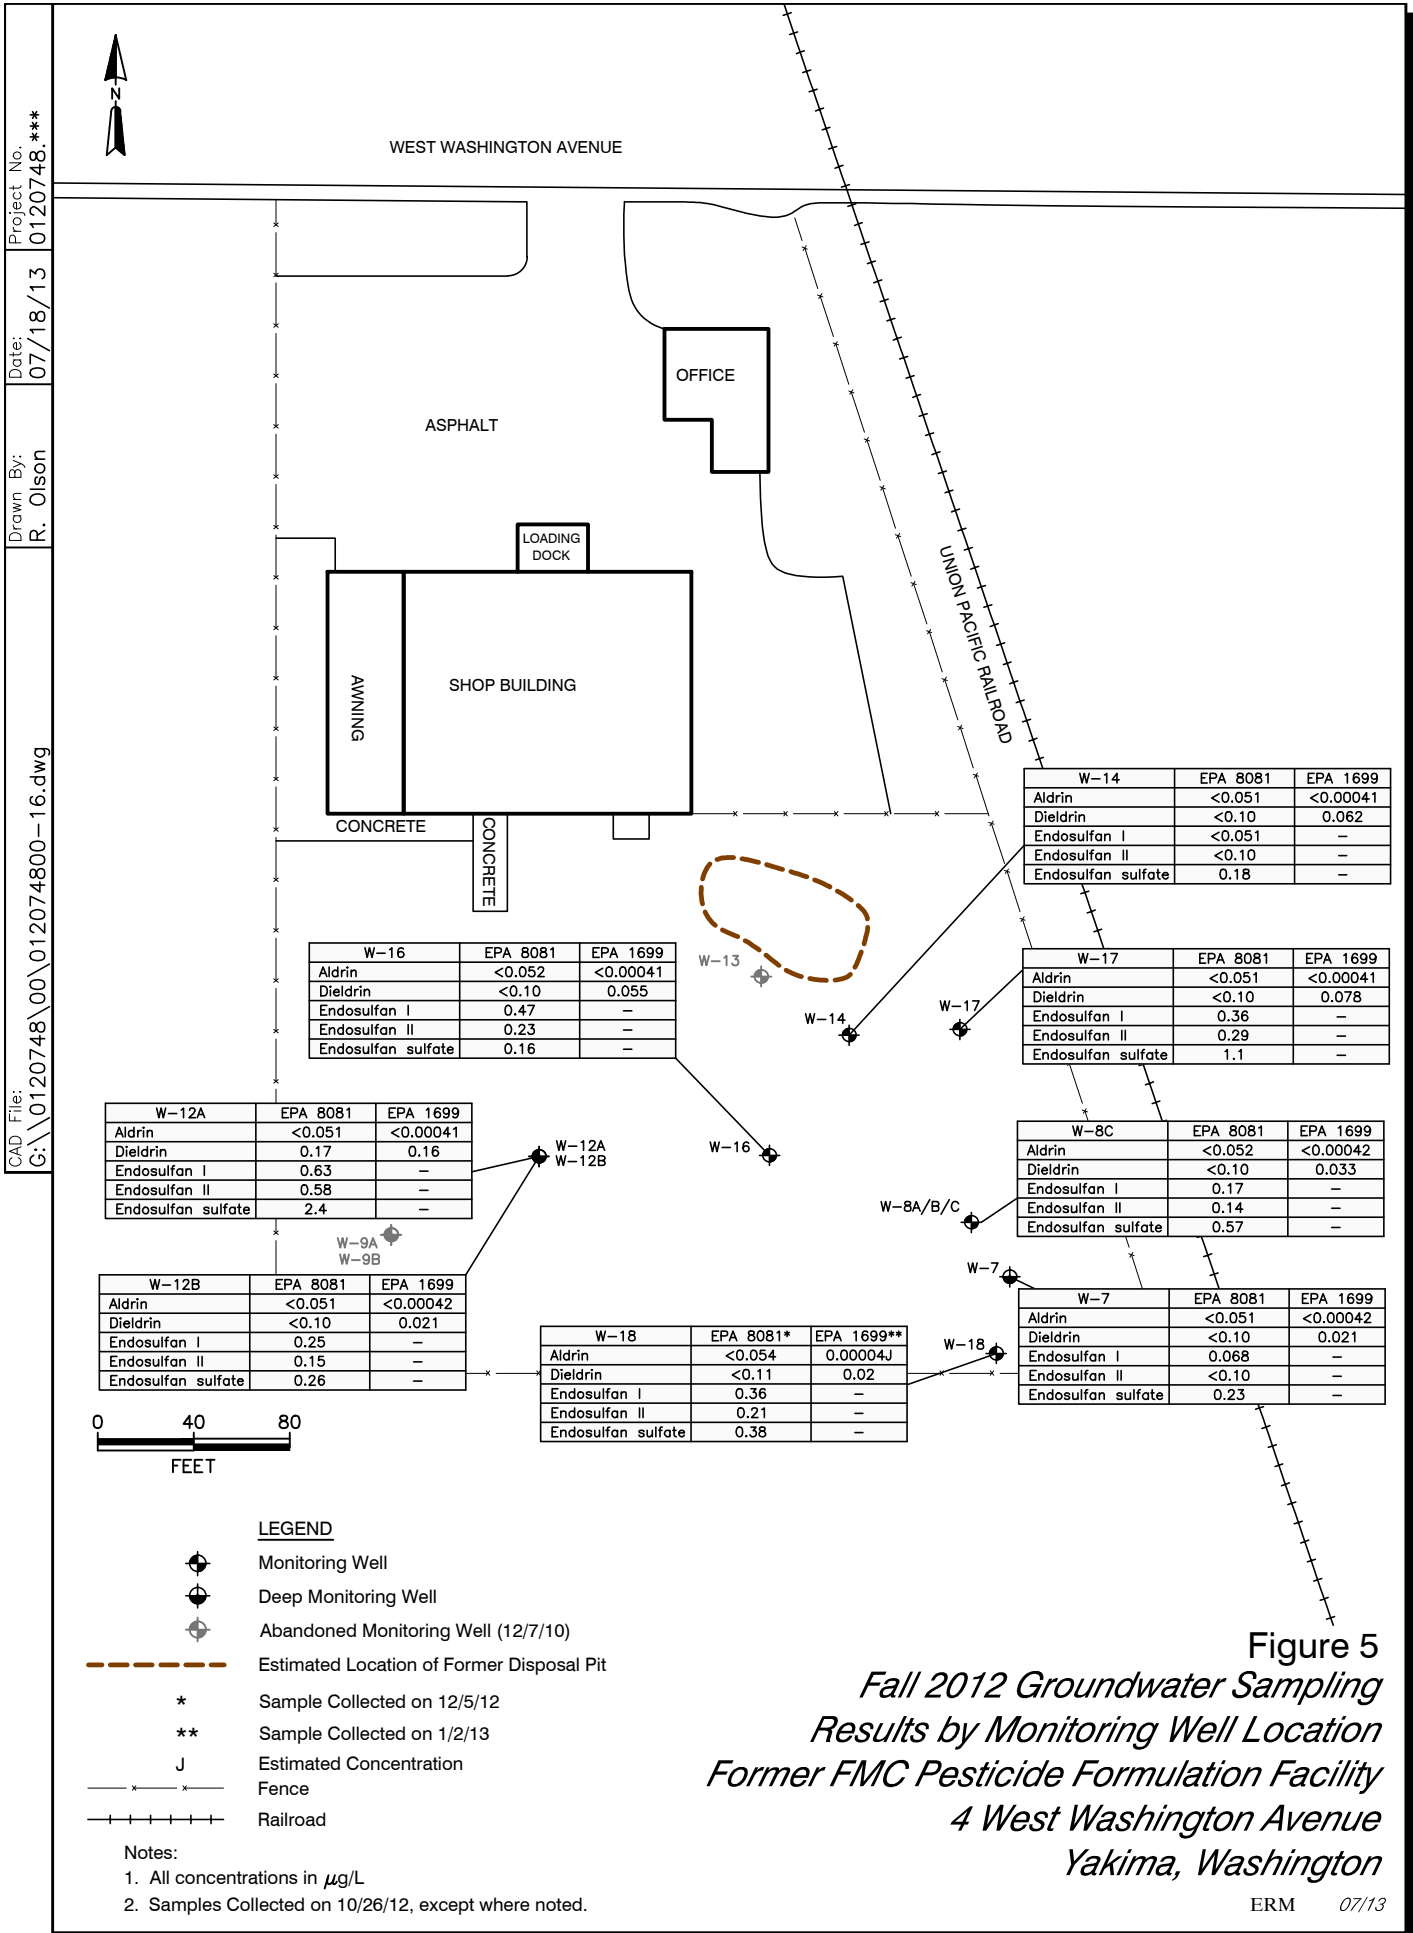
Figure 5
Fall 2012 Groundwater Sampling Results by Monitoring Well Location Former FMC Pesticide Formulation Facility 4 West Washington Avenue Yakima, Washington

The screened cobble backfill is much more permeable since the fines (silt and sand) were removed. As a result, groundwater flows through this area more easily than before the excavation and at a faster rate than the surrounding areas, especially when the groundwater levels are elevated during the summer and fall irrigation season. Since the cobbles are more permeable than the surrounding soils, groundwater elevations are slightly lower within this area immediately adjacent to and above soil with residual organochlorine compound contamination. Excess groundwater is pulled through those residually contaminated soils into the cobble backfill and drawn in a cross-gradient direction toward the former disposal pit area. As a result, maximum concentrations of organochlorine compounds are typically detected in monitoring wells immediately down gradient after the seasonal high water table occurs. Figures 3 and 4 in the Appendix show the groundwater table elevations across the site for the fall 2012 and spring 2013 sampling campaigns (respectively). Figures 5 and 6 in the Appendix show the 2012 and 2013 contaminant concentrations (respectively) by well.

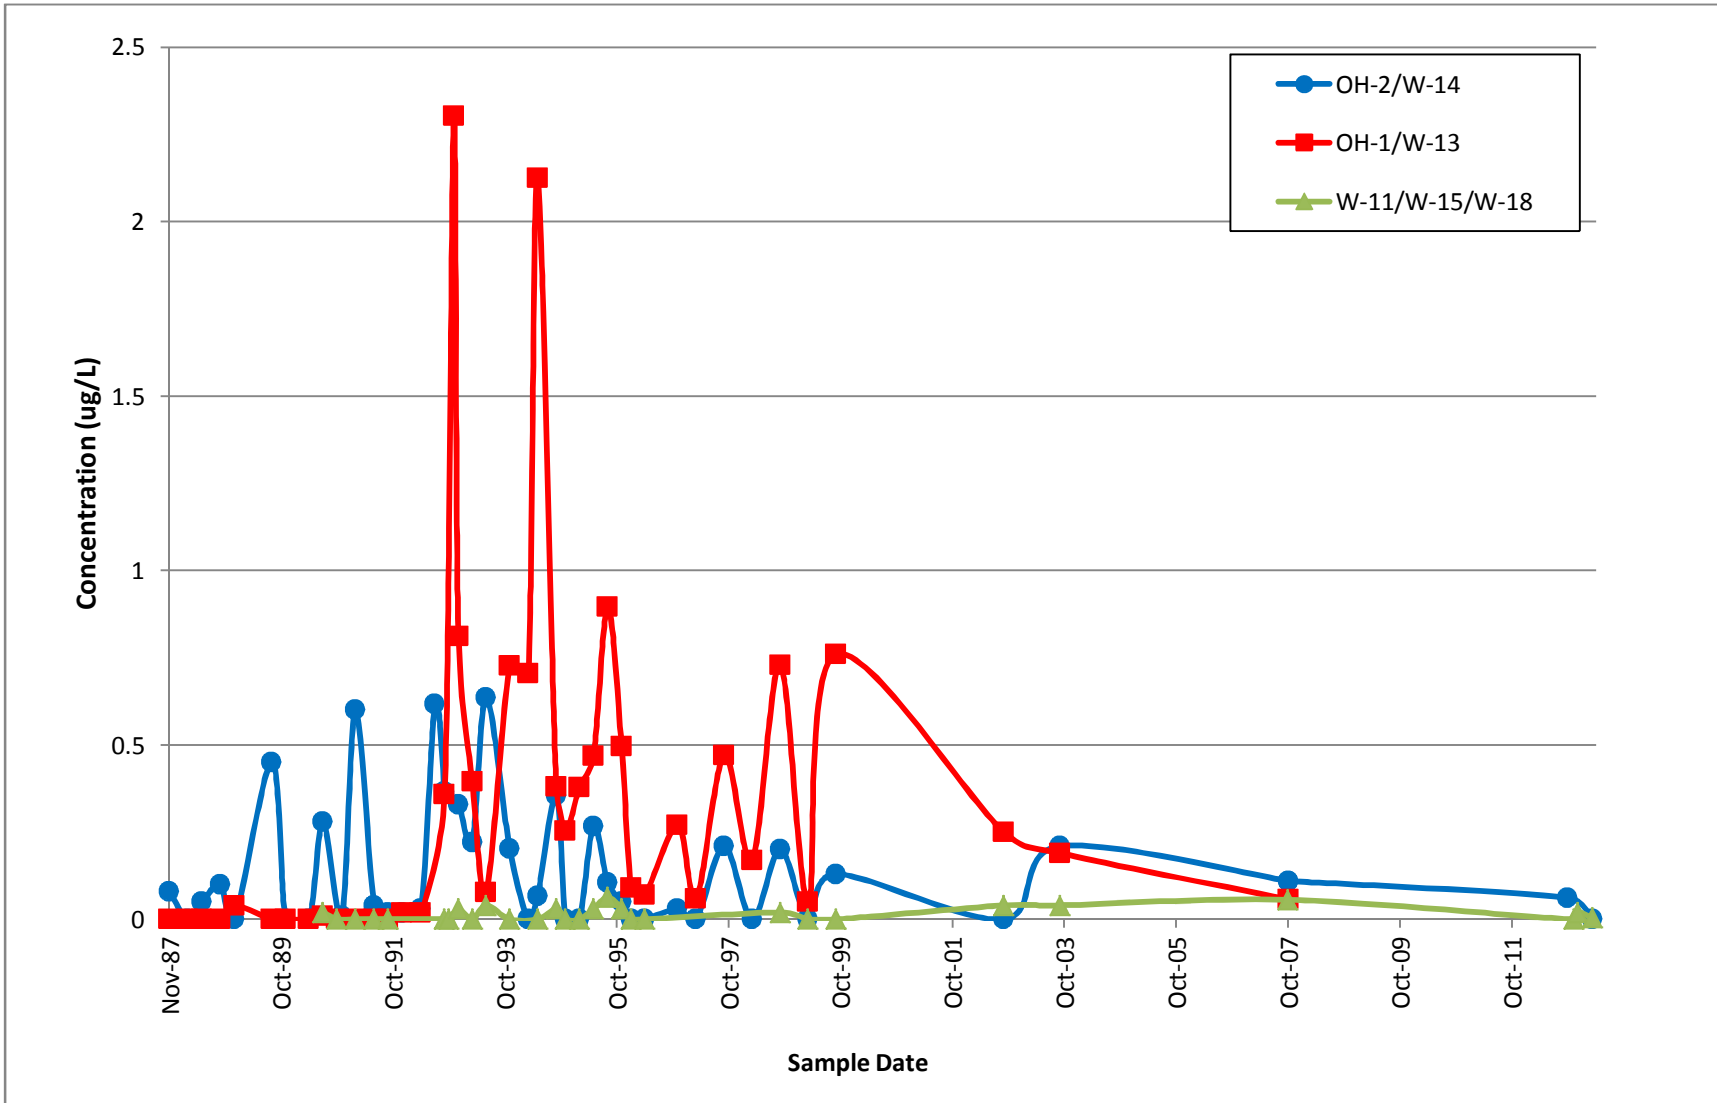
Figure 7
 Long-term Trend of Dieldrin Plus Aldrin in Groundwater
 Former FMC Pesticide Formulation Facility
 Yakima, Washington

The long-term trends for aldrin plus dieldrin and for total endosulfans are provided in figures 7 and 8 in the Appendix. Generally, the trends for these contaminants have decreased over the life of the monitoring program and are at low levels compared with peak concentrations detected immediately following active remediation.

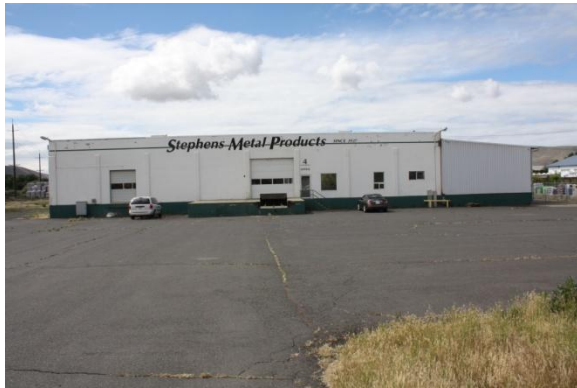
Front of Stephens Metal Products warehouse – parcel address is 4 W. Washington Avenue in Yakima, Washington (business has moved but is about to lease to another light industrial business).

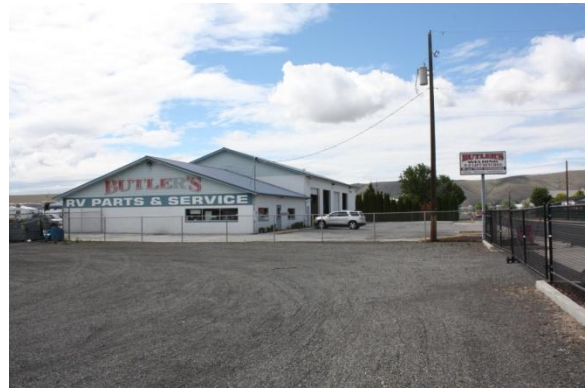
Butler's Welding and RV Accessories – parcel address is 1909 Longfibre Road in Yakima, Washington (another long time business on the former FMC facility site).

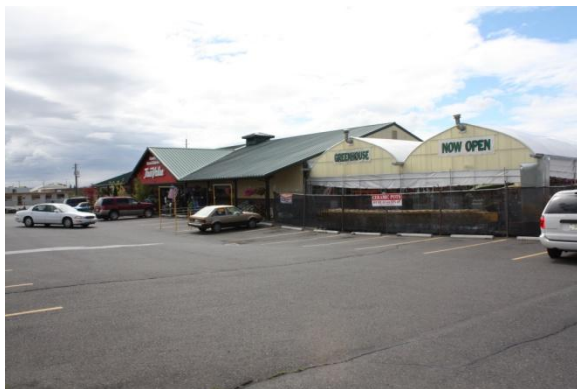
TrueValue Country Farm and Garden – parcel address is 6 W. Washington Avenue in Yakima, Washington (another long time business at the site).

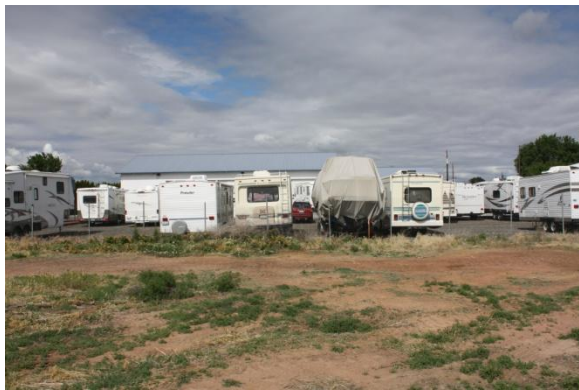
Looking west toward the back of the Butler property from the Stephens Metal Products yard.

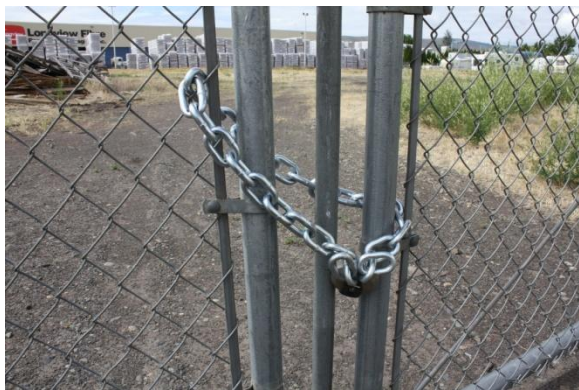
Locked gate at Stephens Metal Products property. Longview Fibre facility is visible in distance.
