FOURTH FIVE-YEAR REVIEW REPORT FOR **KERR-McGEE SUPERFUND SITE** CARIBOU COUNTY, IDAHO

Prepared for: U.S. Environmental Protection Agency **Region 10** Seattle, Washington

This is the fourth FYR for the Kerr-McGee Chemical Corporation Superfund Site (Site). This statutory review was prompted by the completion date of the previous FYR. The FYR was prepared because hazardous substances, pollutants, or contaminants remain at the Site above levels that allow for unlimited use and unrestricted exposure.

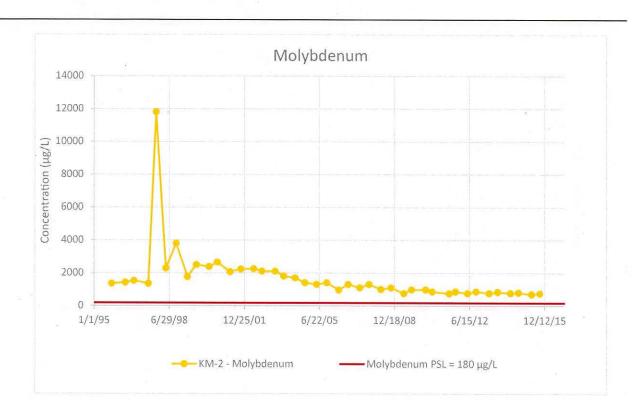
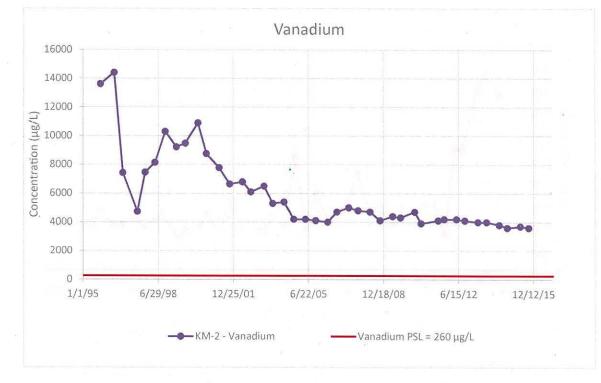
Figure 8. KM-2 COC Data Trends Kerr-McGee 2017 Five Year Review

Vanadium concentrations in all monitoring wells near and downgradient from the former Scrubber Pond and Calcine Cap, with the exception of wells KM-11 and KM-17, remain above the risk-based groundwater performance standards of 260 μ g/L. Since 2012, KM-2 has displayed a slight decreasing trend (Figure 8) and KM-3 has exhibited slightly variable concentrations (Figure 9); in the same time period, KM-4 (Figure 10) has had a decreasing trend; but concentrations are above the PSL.

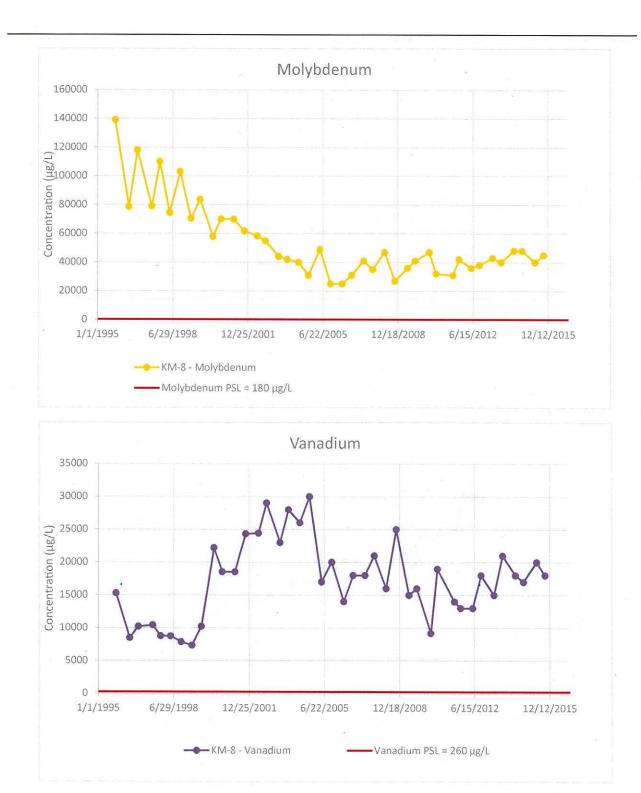
Figure 16. KM-8 COC Data Trends Kerr-McGee 2017 Five Year Review

Well KM-8 continues to contain the highest level of molybdenum at the Site (currently 45,000 µg/L). Concentrations at KM-8 display an increasing trend from 2012 to present (Figure 16). KM-12, located near KM-8, also continues to exceed the PSL. Concentrations at KM-12 have shown a decreasing trend from 2012 to 2014, but recent sampling in 2015 indicates an increase (Figure 17) and concentrations are above the PSL. Concentrations at KM-13 have been stable from 2012 to 2015 and have remained just below the PSL (Figure 18).

Well KM-8 continues to contain the highest level of vanadium at the Site (18,000 μ g/L). Concentrations at KM-8 display an increasing trend during the period of the study (Figure 16). Concentrations at KM-12 have shown a stable trend from 2012 to 2015 (Figure 17). Concentrations at KM-13 have been stable from 2012 to 2015 and

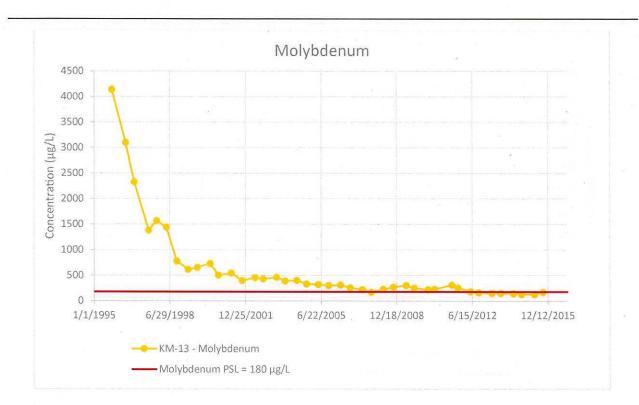
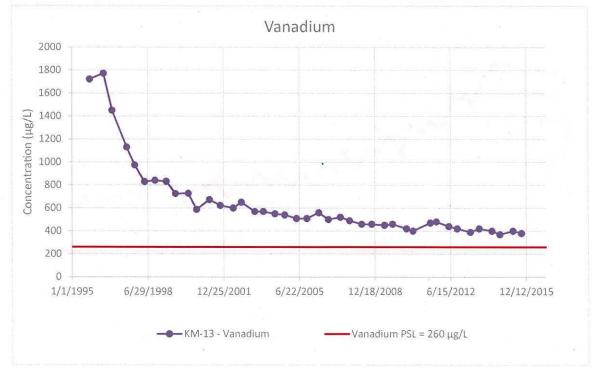
Figure 18. KM-13 COC Data Trends Kerr-McGee 2017 Five Year Review

have remained above the PSL (Figure 18).

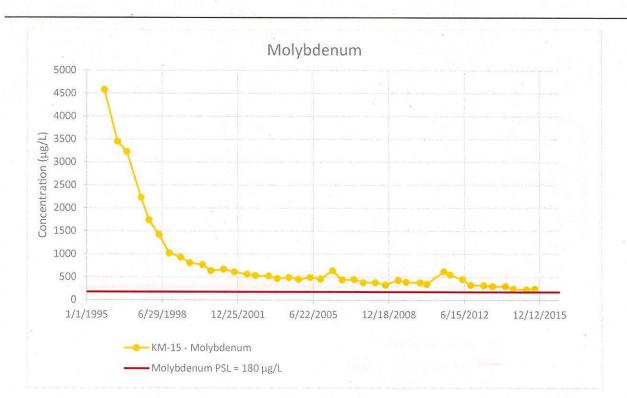
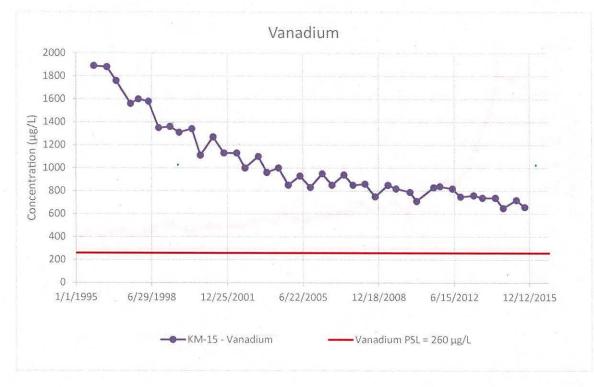
Figure 19. KM-15 COC Data Trends Kerr-McGee 2017 Five Year Review

Molybdenum concentrations in wells downgradient of the wells located near the S-X Pond Area (KM-15, KM-16, and KM-18) remain above the PSL. Data trends for molybdenum at Wells KM-15 (Figure 19) and KM-18 (Figure 21) have been stable during the FYR period. Concentrations at KM-16 have a decreasing trend from 2012 to present (Figure 20). Of the Evergreen Facility wells located downgradient of the property boundary, only EV-2 had concentrations below the PSL during all three sampling rounds.

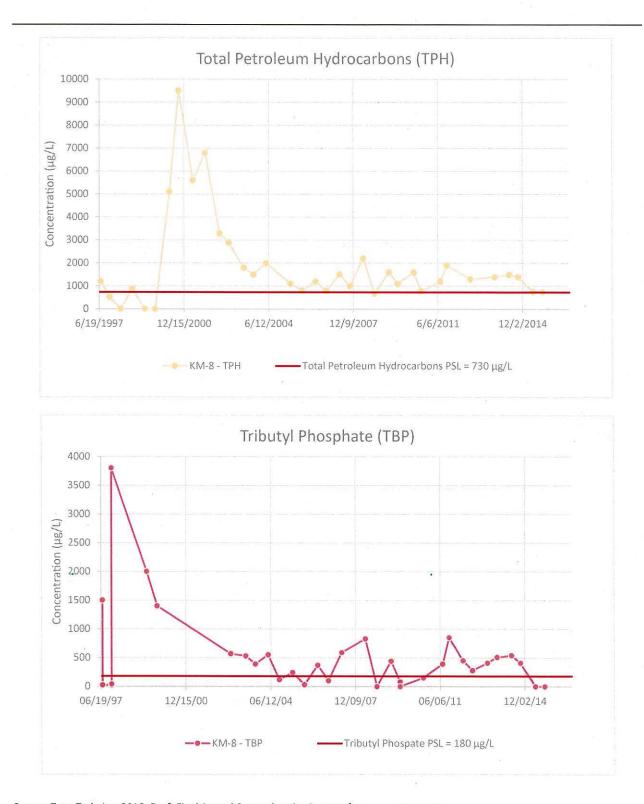
Figure 22. KM-8 COC Data Trends Kerr-McGee 2017 Five Year Review

Well KM-8 is the only well that is routinely sampled for TPH. Concentrations remained relatively stable above the PSL of 730 μ g/L from 2012 to 2014 and then a decrease in 2015, but still above the PSL (Figure 22).

Similar to TPH, Well KM-8 is the only well that is routinely sampled for tributyl phosphate. Concentrations of tributyl phosphate in Well KM-8 increased from 2012 to 2014, remaining above the PSL of 180 μ g/L. In 2015 the concentrations decreased to below the PSL with a nondetection result (Figure 22).

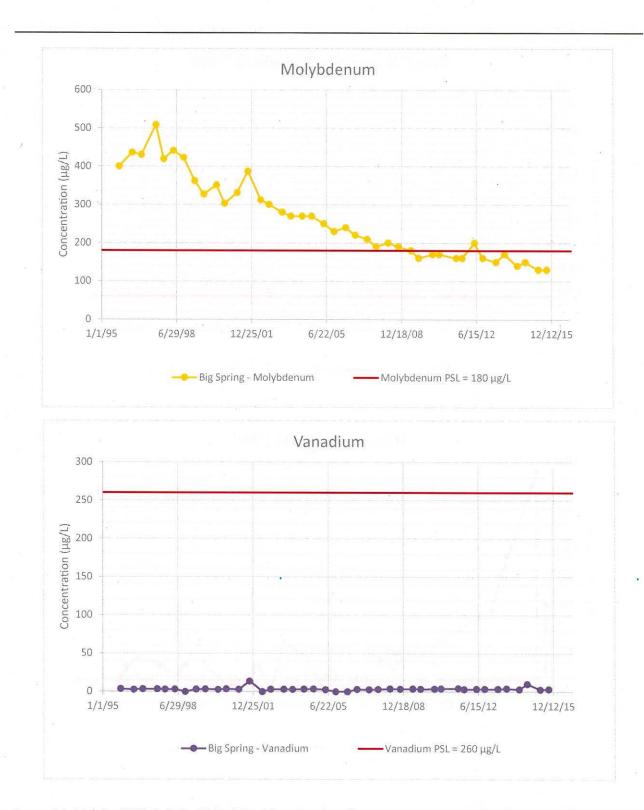
Figure 23. Big Springs COC Data Trends Kerr-McGee 2017 Five Year Review

Of the four offsite springs (Big Spring, Finch Springs, Upper Ledger, and Lower Ledger) sampled, Big Spring and Finch Spring have only shown historical exceedances of the risk-based groundwater performance standard for molybdenum. Concentrations of molybdenum in both Big Spring (located in the southern part of Soda Springs) and Finch Spring (north of Soda Springs) have shown a steady decline since 1998 (Figures 23 and 24). Over the FYR period, concentrations of molybdenum in these two springs continued to decline and remain below the PSL of 180 μ g/L, while vanadium remained flat significantly below the PSL. All other COCs measured at Upper and Lower Ledger springs have consistently been well below risk-based groundwater performance standards.
