FOURTH FIVE-YEAR REVIEW REPORT FOR MONSANTO CHEMICAL CO. (SODA SPRINGS PHOSPHOROUS PLANT) SUPERFUND SITE CARIBOU COUNTY, IDAHO

Prepared for: U.S. Environmental Protection Agency Region 10 Seattle, Washington

9/12/2018

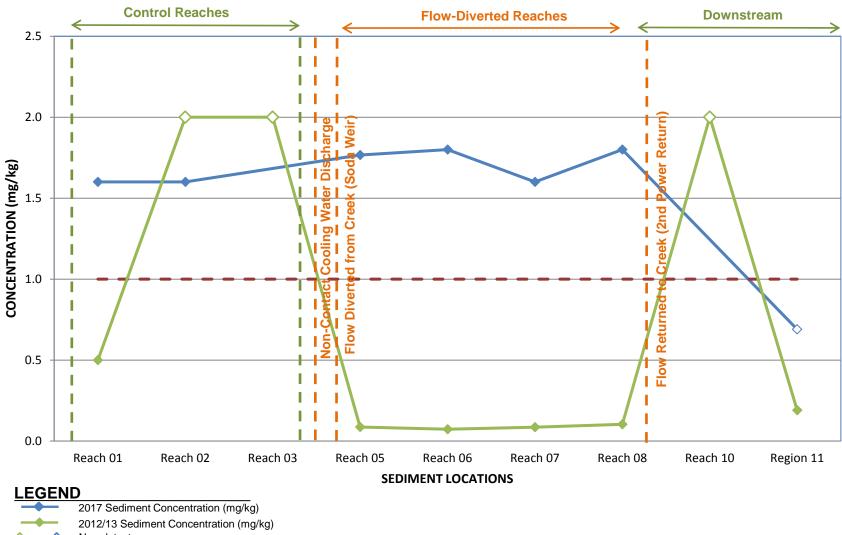
FIGURE 24 **Silver Concentrations in Soda Creek Sediment** Monsanto Site 2018 Fourth Five-Year Review Caribou County, Idaho

- Selenium: Slightly higher than 2011 in Reaches 02, 05 and 07, but same as 2011 in Soda Creek Arm (Figure 23).
- Silver: Higher than 2012 in the flow-diverted reaches (05 through 08), but similar to upstream reaches and non-detect in the Soda Creek Arm (Figure 24).
