# **Third Five-Year Review Report**

**FMC YAKIMA**

**Superfund Site**

**SEPTEMBER 2008**

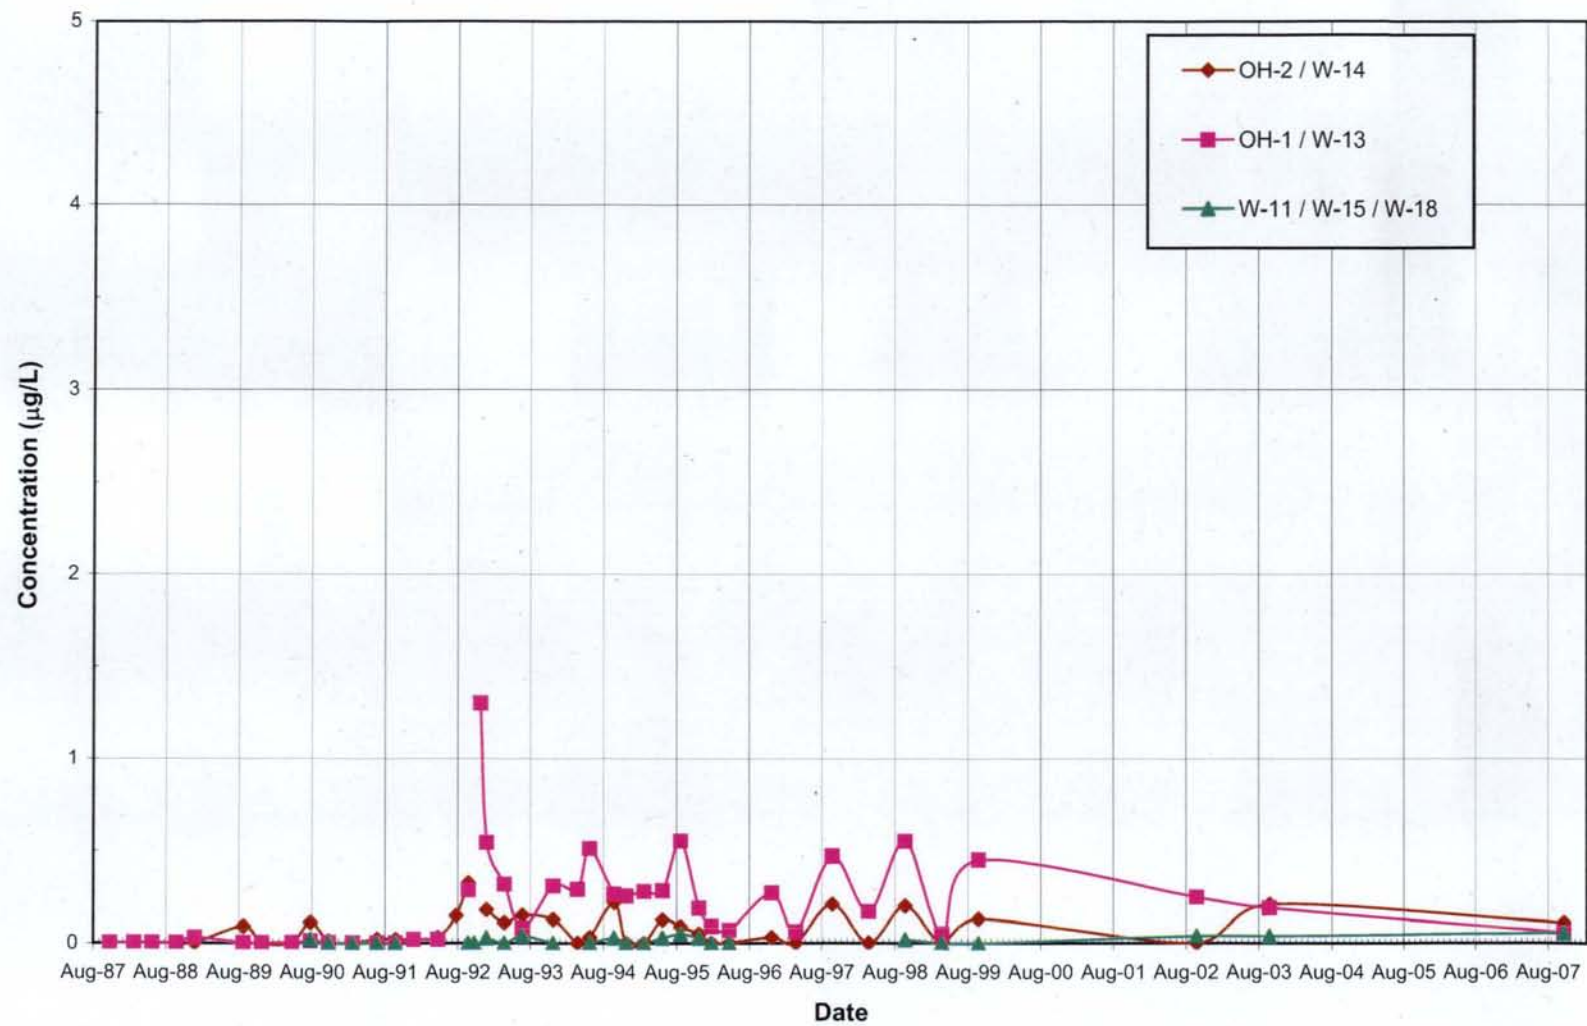
Figure 5 - Dieldrin plus Aldrin in Groundwater

The 2007 groundwater samples contained low levels of pesticides (see Table 2 or Figure 3 in Appendix A.1). The highest detected level for dieldrin (0.14 µg/L) occurred at well W-12A (see Table 2 or Figure 3). The highest detected level of endosulfans (4.27 µg/L) was also found at well W-12A. When this data is plotted with data from previous monitoring events, an overall decreasing trend can be observed (see Figures 4 and 5 from Appendix A.1) since the completion of soil remedial action, although dieldrin concentrations remain above pre-excavation levels.

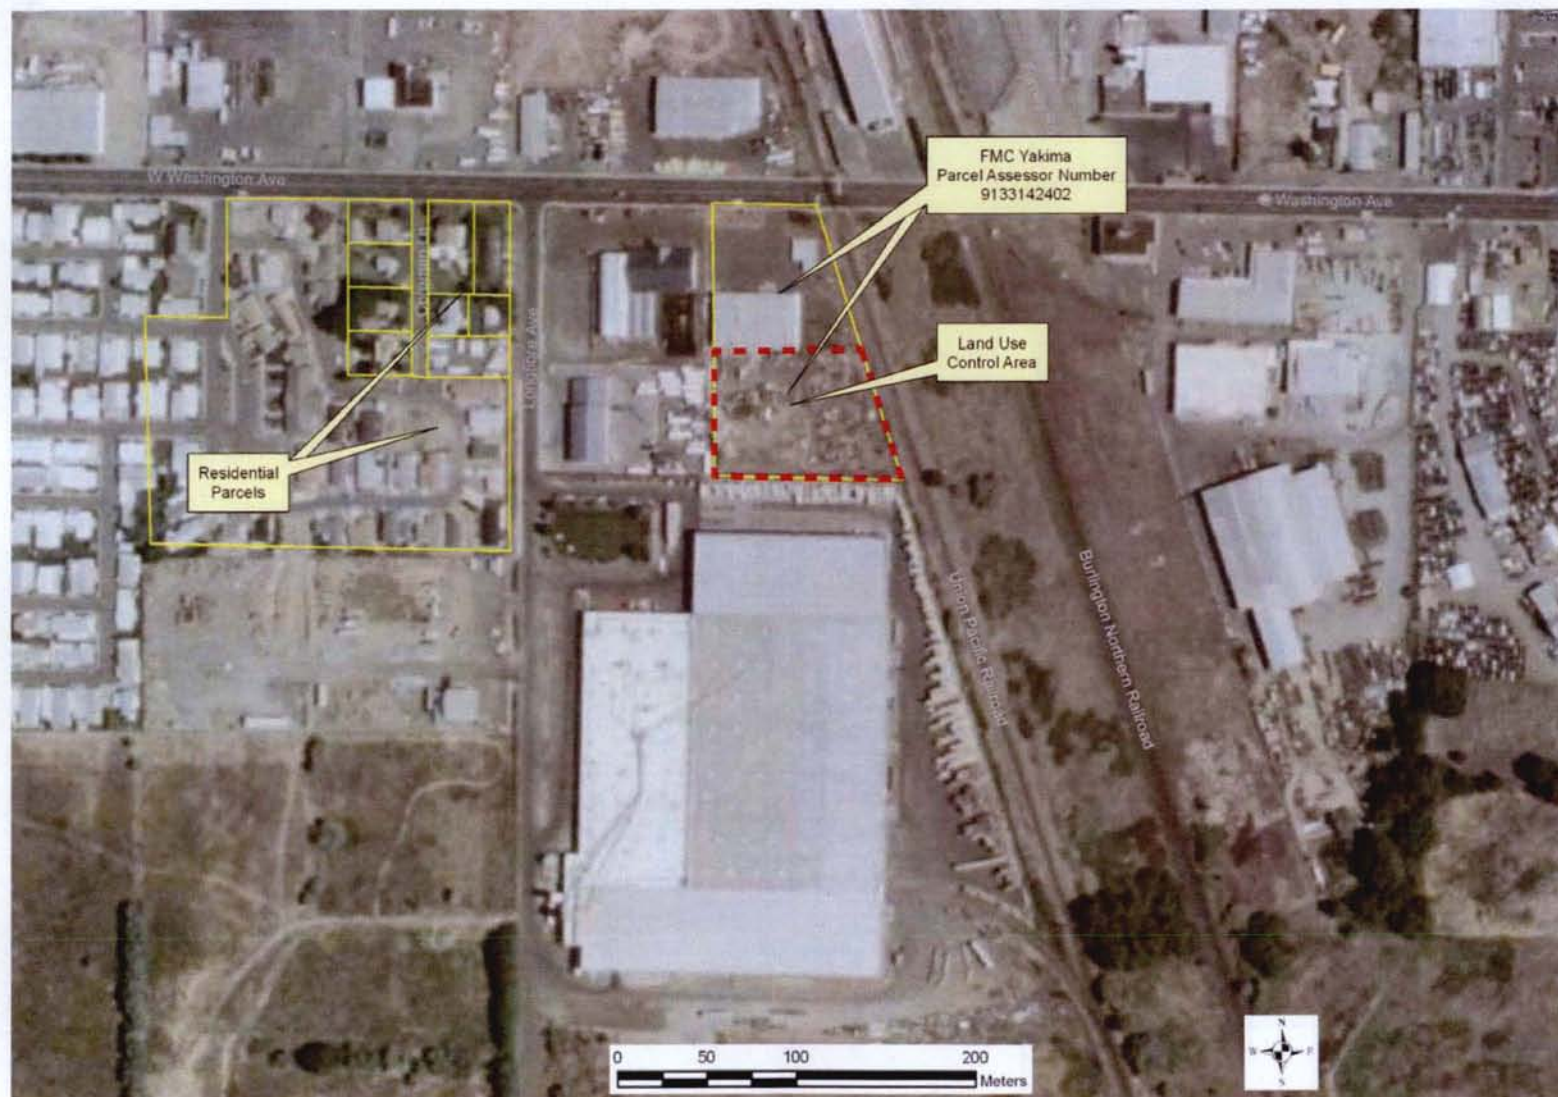
Figure 6 - Projected Land Use Control Area for the FMC Yakima Site and Proximity to Residentially Zoned Parcels

No institutional controls are required by the ROD, even though hazardous substances remain on site below 7 feet and in the groundwater. To remain protective in the long term, institutional controls should be developed and implemented. EPA intends to incorporate institutional controls into the remedy in a ROD Amendment following public comment, specifically in the form of enforceable land use restrictions in a covenant pursuant to the recently enacted Washington Uniform Environmental Covenant Act or an equivalent easement to prevent or appropriately restrict groundwater use and intrusion into subsurface contamination. A Proposed Amendment for public comment is anticipated in early 2009, with later FY 2009 ROD Amendment issuance. See Figure 6 in Appendix A.1 for the land use control area where institutional controls are projected to be implemented within the site.
