FIVE YEAR REVIEW
PESSES CHEMICAL COMPANY
SUPERFUND SITE
FORT WORTH, TEXAS
JUNE 2000

**PESSES CHEMICAL COMPANY
SUPERFUND SITE
FIVE YEAR REVIEW
JUNE, 2000**

Subject: Pesses Chemical Company - Fort Worth, Texas
SW Registration No. None; EPA Identification No. None
Biannual Operations & Maintenance (O&M) Inspection

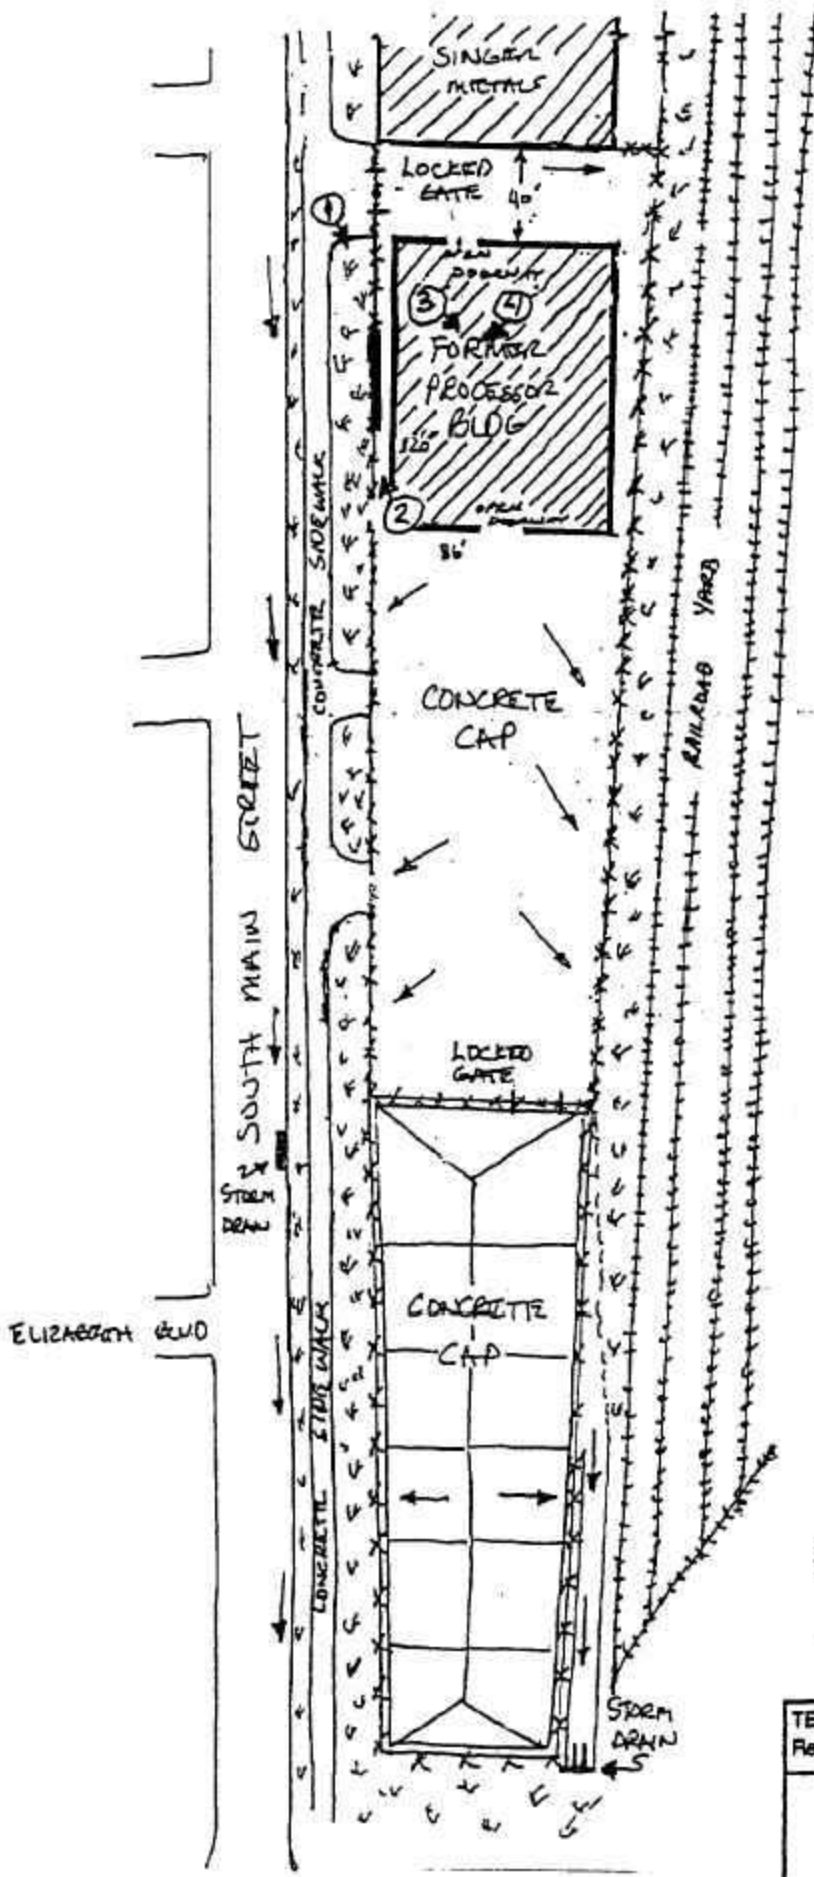
During the inspection, the 20' portion of the perimeter chain link fence and three posts located along South Main Street (adjacent to the non-hazardous area of the site) first reported damaged from a vehicle impact during the January 27, 1999 inspection were noted still needing repairs. The extent of damage remains the same. It appears vagrants are still entering the site under the collapsed portion of the fenceline and seeking overnite refuge in the on-site building.

During the inspection, it was noted that the spalled areas along the top center seam of the southern sloped concrete cap previously identified for minor maintenance had been repaired. The two areas are marked on the attached sketch and photographs. The site was left locked and secured.

During interviews with the staff of the adjacent facility (Singer Metals), the writer was informed that their staff would be able to maintain the grassy areas along the site boundaries. It is recommended that weed control measures be implemented this spring as windblown seeds have established weed pockets within the concrete seam areas throughout the site.

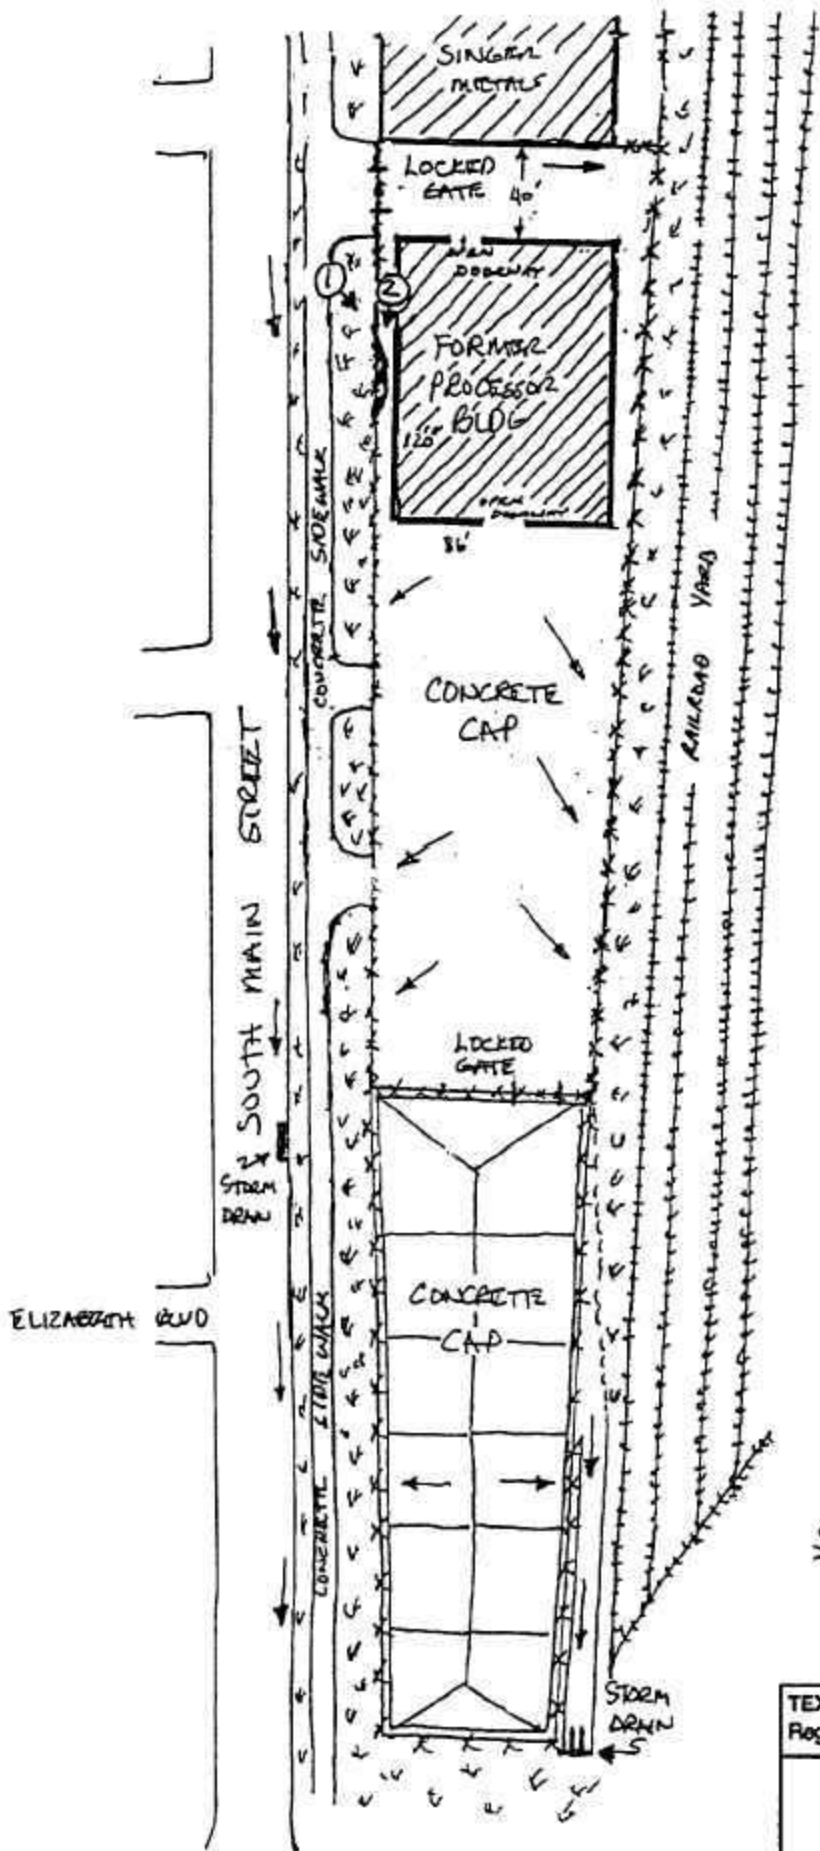
During the inspection, a 20' portion of the perimeter chain link fence and two posts located along the west portion of the site along South Main Street had been damaged from a vehicle impact. The extent of damage and location is shown on the attached site sketch and photographs. The damage had occurred several weeks ago, apparently from a hit and run accident. The adjacent facility manager was instructed to notify the TNRCC immediately when such incidents occur so that appropriate action could be taken in a timely manner. The site was left locked and secured.

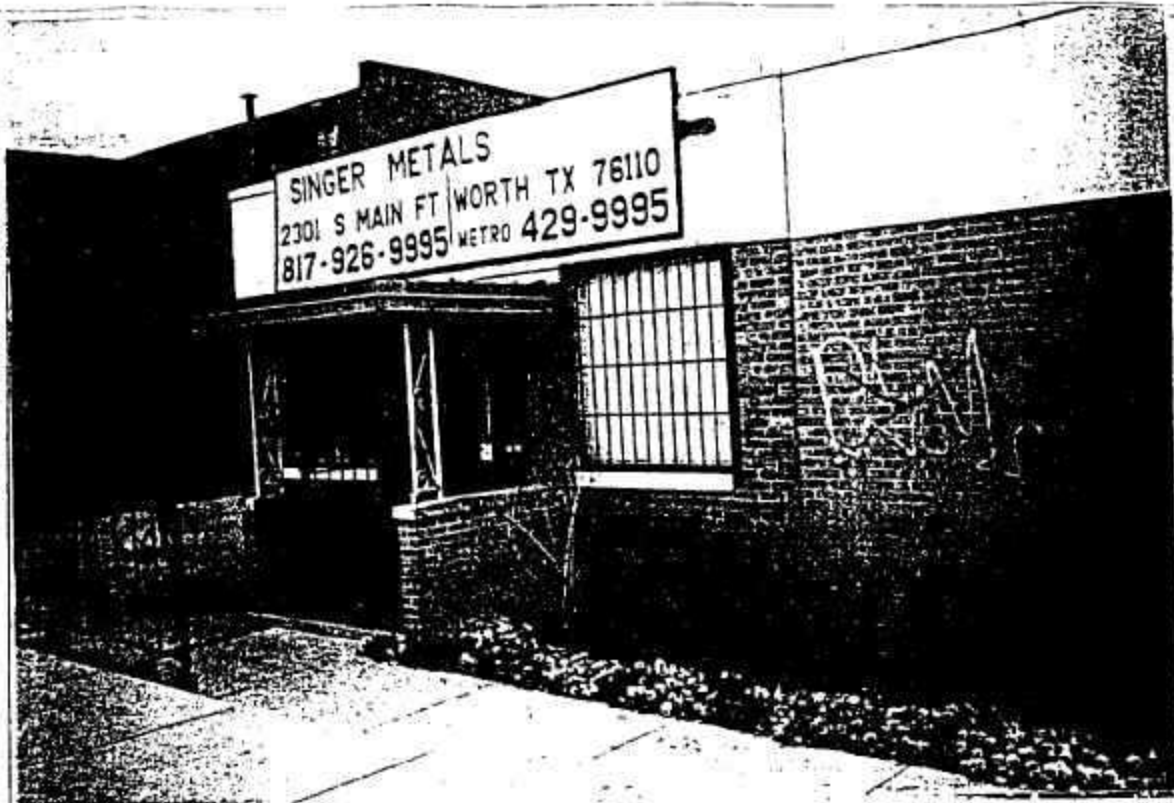
Photo #1 - The adjacent business located north of the site shown above. The owner maintains a set of keys to the outside gates. Photo taken facing east.

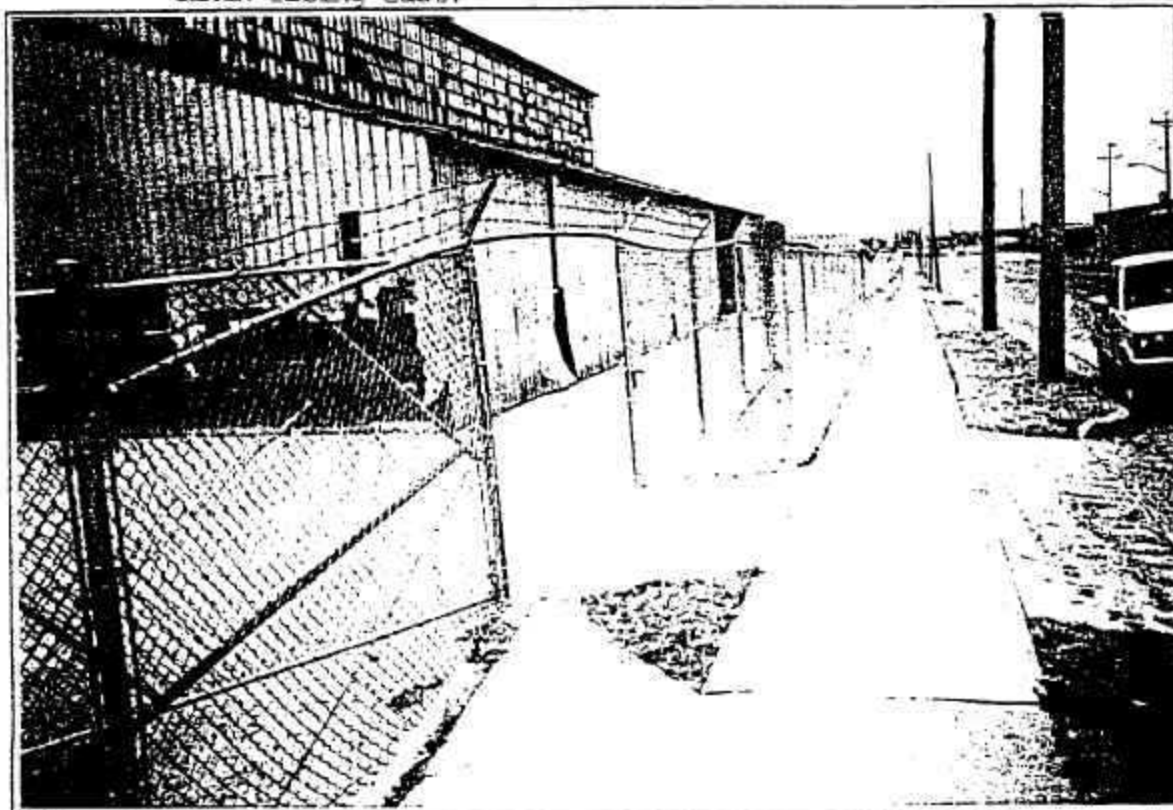
Photo #2 - Photo of the site entrance from South Main St. showing entrance gate shown above. Photo taken facing south.

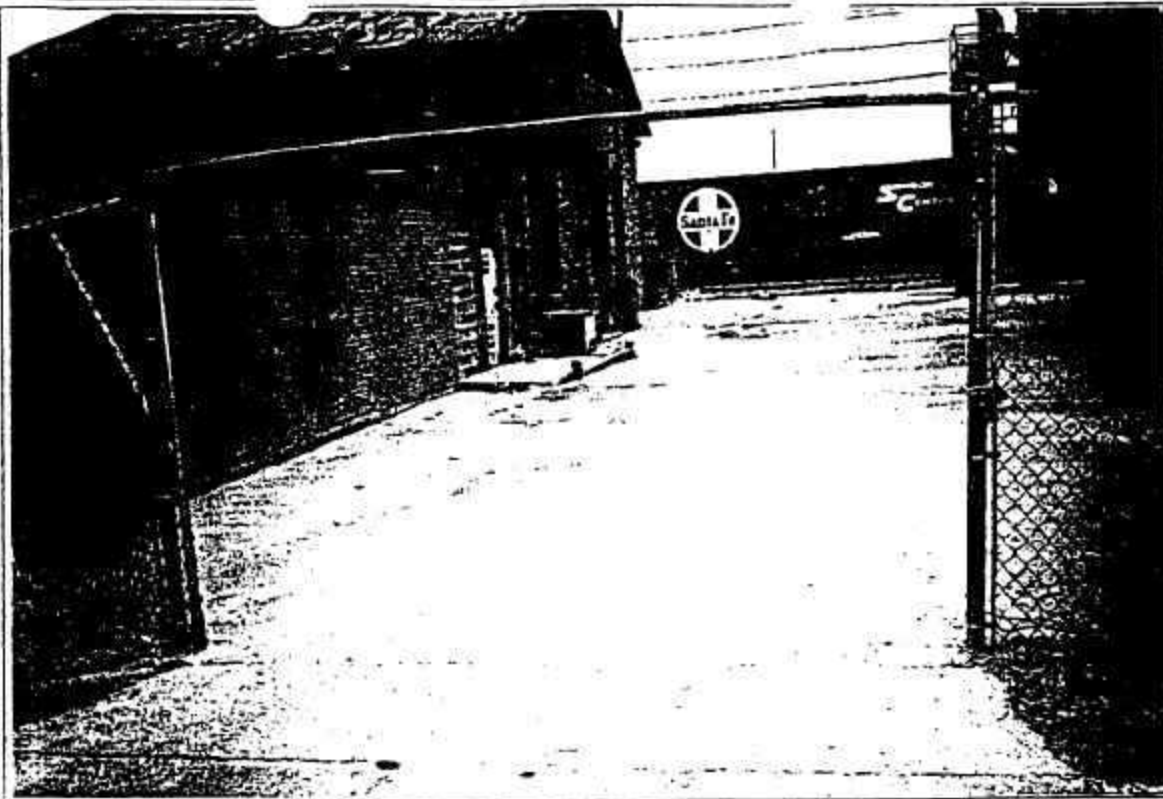
Photo #3 - Entrance to site from South Main St. and north portion of site shown above. The adjacent business (Singer Metals) is shown on left. Railroad track (background) bound the site on the east side.
