SUPERFUND FIVE YEAR REVIEW REPORT

LEE'S LANE LANDFILL

LOUISVILLE, JEFFERSON COUNTY, KY

JUNE 2003

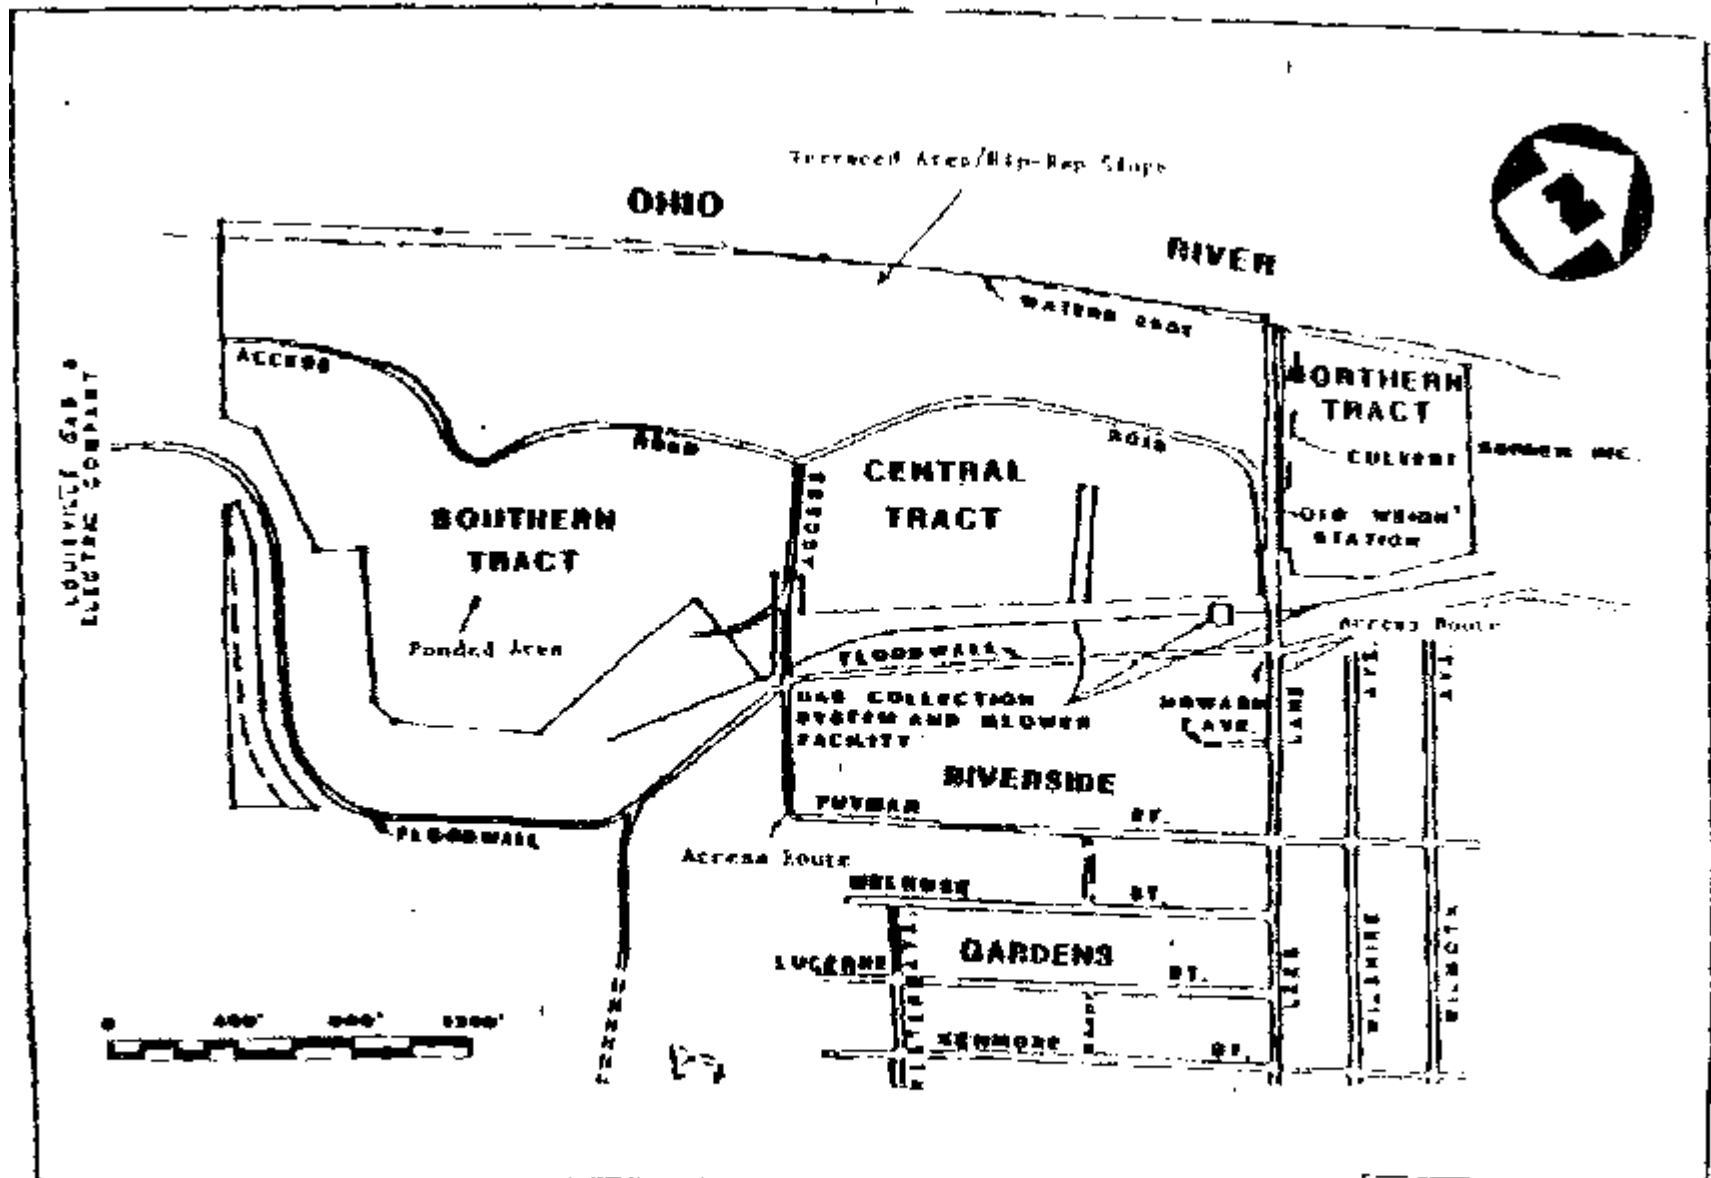
Figure 2
 Site Layout
 Lee's Lane Landfill

north of the ditch appeared stable and little or no rubbish was present on the surface, see Photograph 8 and Figure 2.

12. The access road to the South Tract has only a thin cover of gravel and is severely rutted, due mostly to the uncontrolled trespasser quad-runner ATV traffic, see Photograph 14 and Figure 2.

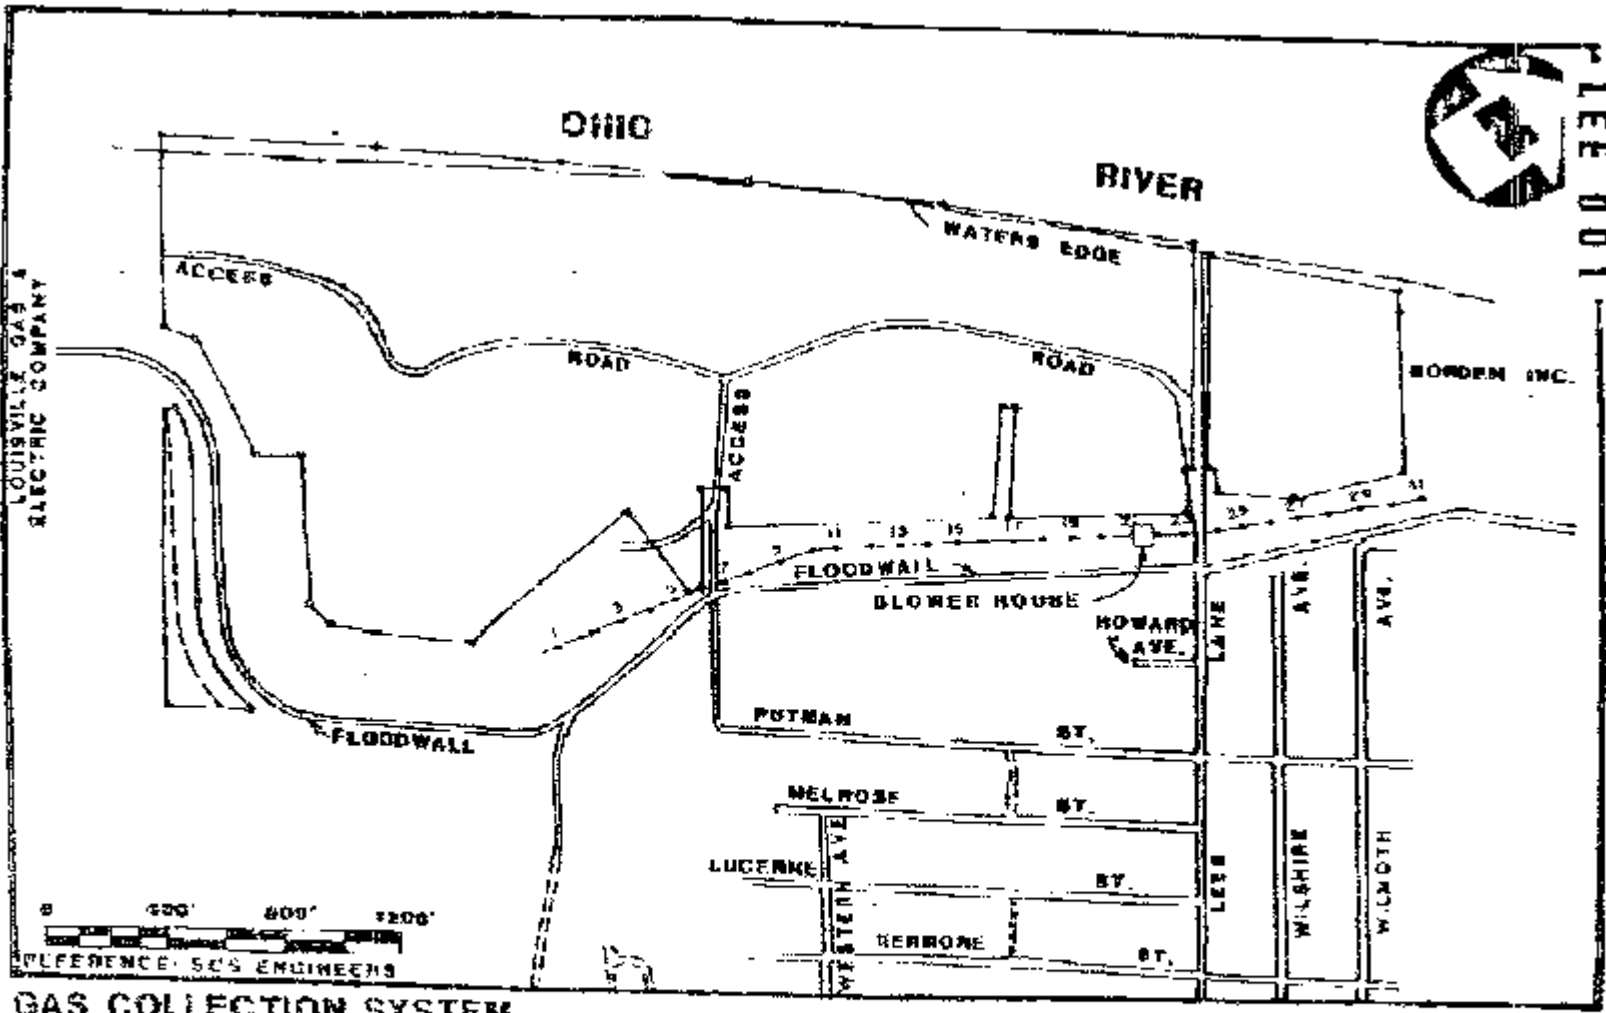
Figure 5
Subsurface Gas Collection System
Lee's Lane Landfill

16. The blower house for the subsurface gas collection system has many pipes and controls. Mr. Mike Humphrey of MSD indicated that the only maintenance that MSD performs is to replace burnt-out motors. The system runs continuously. He said MSD has no operations and maintenance manual for the system, no as-built drawings, and generally has no way of adequately monitoring the performance of the system, see Photographs 4 and 17, and Figure 5.
