United States Air Force

FIVE-YEAR REVIEW REPORT

Homestead Air Reserve Base, Florida

December 2004

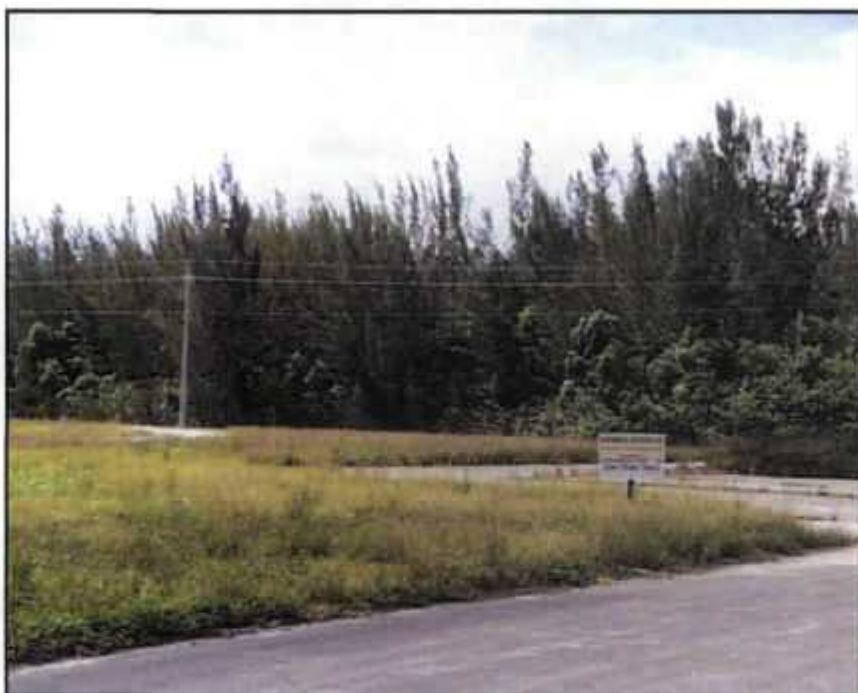
Photograph 10: Operable Unit 25 – Hush House Area

Photograph 10 of OU-25 appears to be the same as in photograph 11 of OU-27.
