BPMO NE/BH
Ser 09-170
June 10, 2009

FIVE YEAR REVIEW
for
Girard Point Management Area
at
Philadelphia Naval Business Center
Philadelphia, Pennsylvania

June 2009

**Naval Facilities Engineering Command
Second Five-Year Review (June 2004 to June 2009)
Girard Point Management Area
Philadelphia, Pennsylvania**

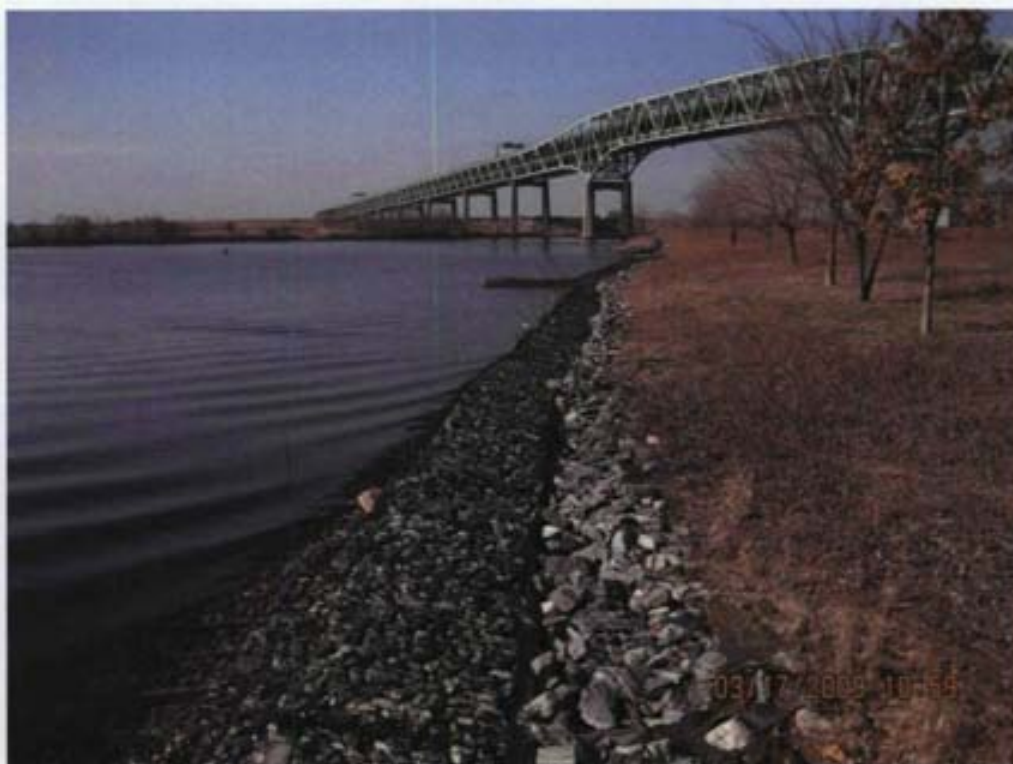
VIEW OF SHORELINE STABILIZATION FROM LIFT BRIDGE

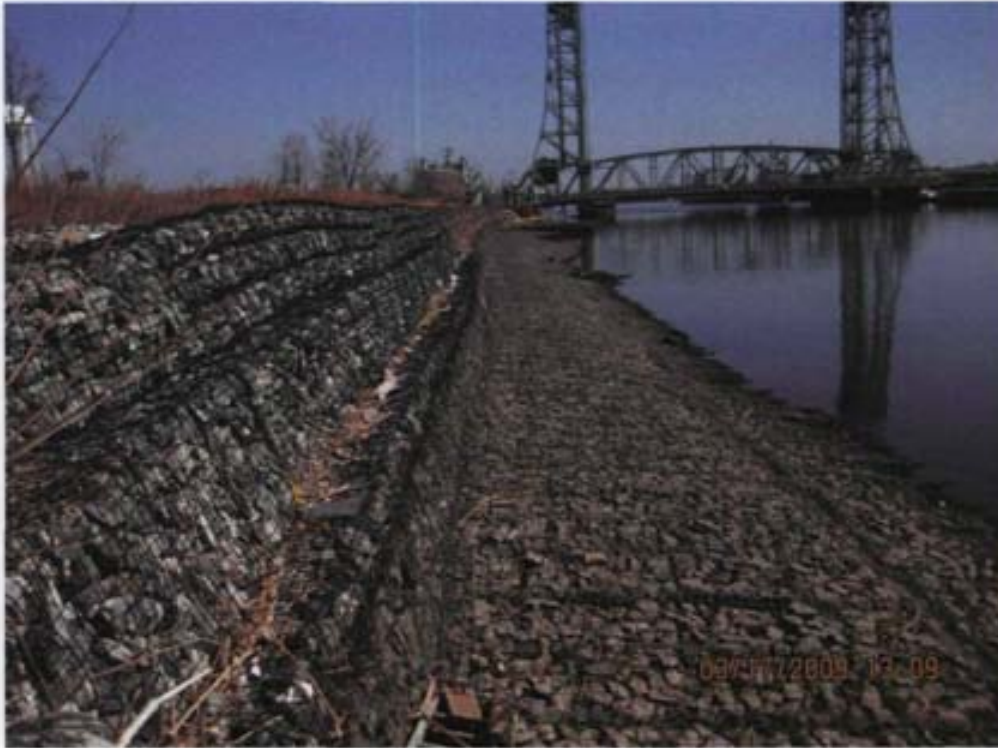
VIEW OF GABION BASKETS TOWARD LIFT BRIDGE

- It is recommended that the burrow hole from small animals in the Zone A cap be repaired during the next round of O&M activities.
- The excavation Area in Zone A related to the water line capping conducted by PIDC should be re-graded and reseeded.
- The Zone B asphalt cap should be inspected after PIDC storm sewer construction activities on adjacent parcels is completed. The entire cap should undergo inspection due to the heavy equipment movement on portions of the cap. The area under the soil stockpiles that could not be observed during this Five-Year Review inspection should also be observed and any necessary repairs should be performed.
- It is recommended that the missing gabion baskets be replaced and that the basket with the torn mesh be repaired.
