**FINAL  
FIRST FIVE-YEAR REVIEW  
FOR THE  
ROCKWOOL INDUSTRIES, INC. SUPERFUND SITE  
BELTON, BELL COUNTY, TEXAS**

September 2012

REGION 6  
UNITED STATES ENVIRONMENTAL PROTECTION AGENCY  
1445 Ross Avenue  
Dallas, TX 75202-2733

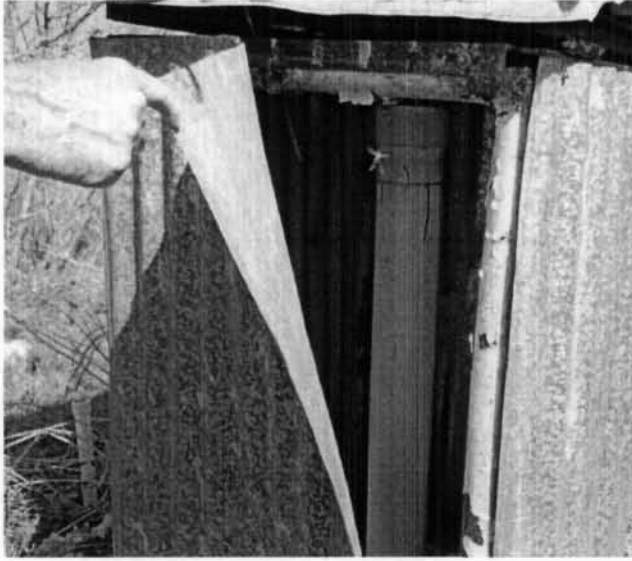
Photo 1. MW-07, no identification marker, enclosed in a corrugated metal housing.

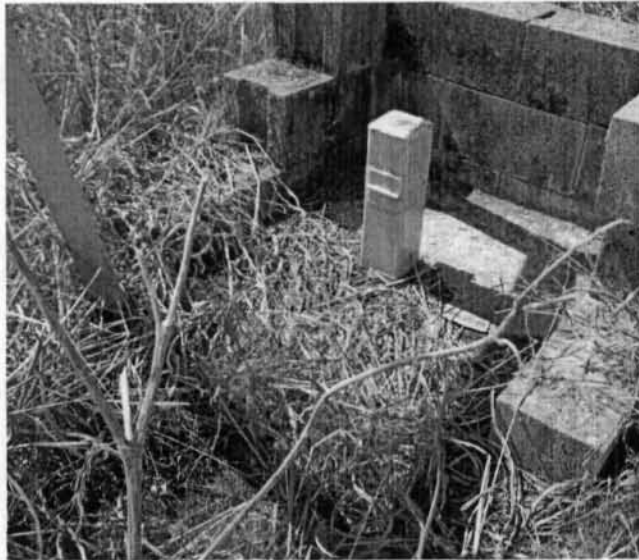
The 23 monitoring wells designated for use in the groundwater monitoring plan at the site were found during the inspection. Two additional wells, MW-18 near the northern edge of the Central Property, and MW-25-90 near the eastern edge of the landfill in the northeast section of the Central Property (**Photos 9 and 15**), were also found on the site. The O&M Plan (**CH2M HILL, 2006**) states that MW-25-90 was abandoned in 1990, and that MW-18 could not be located during the RA. The other wells not designated for groundwater monitoring were plugged and abandoned during the RA. These two wells are not part of the site groundwater monitoring plan and should be considered for plugging and abandonment. Wells MW-7, MW-14, MW-15, MW-17, and MW-25-90 were either missing identification, or the identification tag had fallen off and was laying on the well pad or ground nearby. The identification on these wells should be replaced to avoid possible confusion and errors during groundwater sampling and measurements. There was erosion under the well pad at well MW-28-90 (**Photo 18**). The soil should be built back up around this well pad. The lock was missing on well MW-33-90 (**Photo 21**), and should be replaced. Wells MW-17 and MW-20 are overgrown (**Photos 8 and 11**), and the vegetation needs to be cleared away to allow continued access.

Photo 15. MW-25-90, identification marker has fallen off

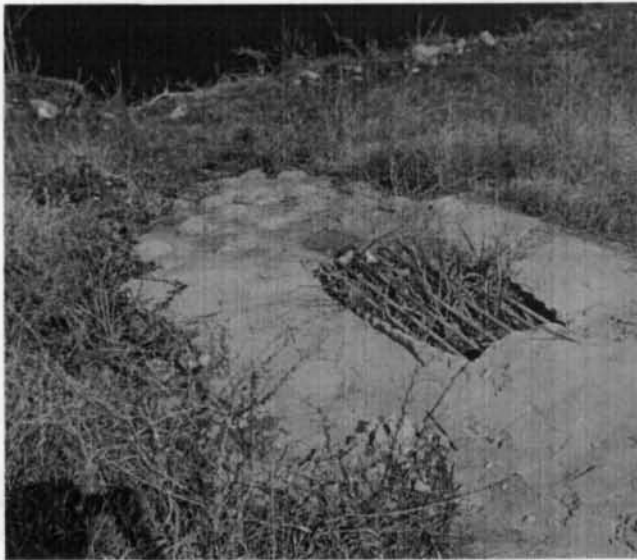
Photo 31. Clogged CMP outfall in stabilized Leon River bank.

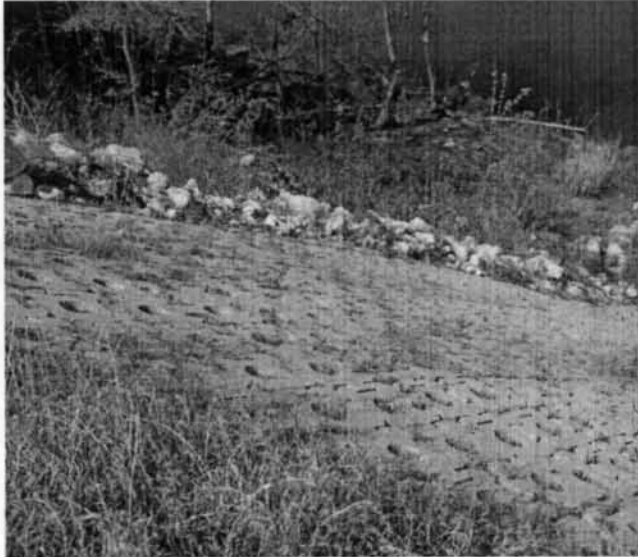
Photo 35. Western edge of the stabilized Leon River bank.

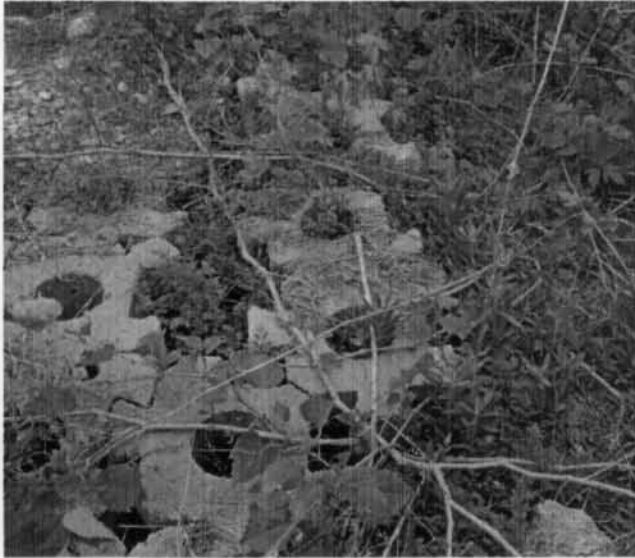
Photo 39. Instability and loss of continuity in the ACB at the toe of the LRB.

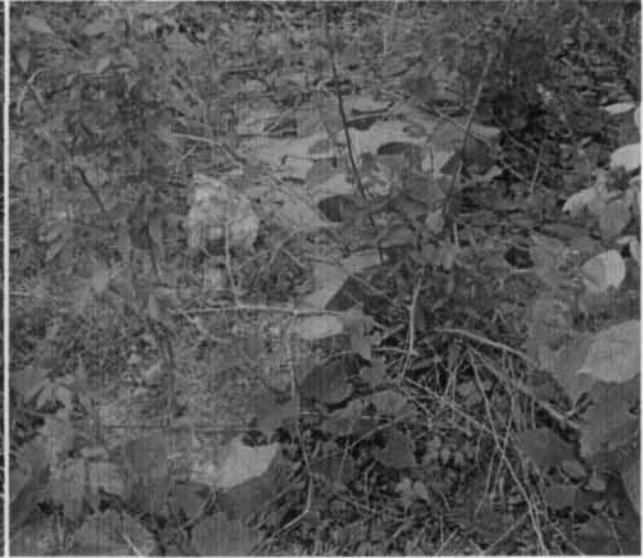
Photo 40. Instability and loss of continuity in the ACB at the toe of the LRB.

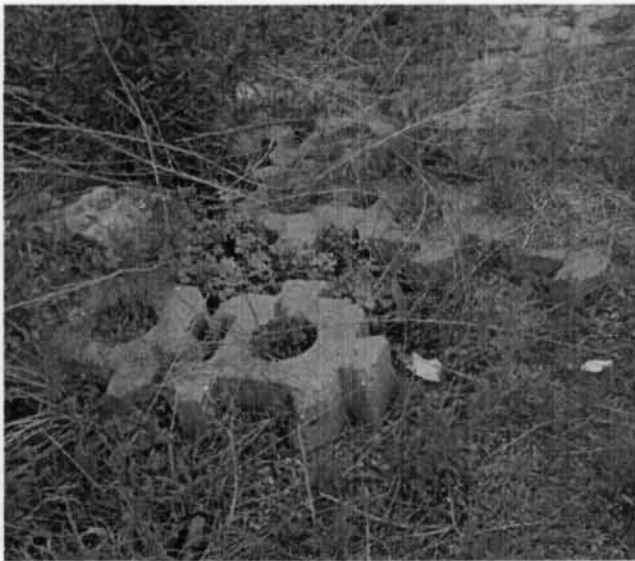
Photo 41. Instability and loss of continuity in the ACB at the toe of the LRB.

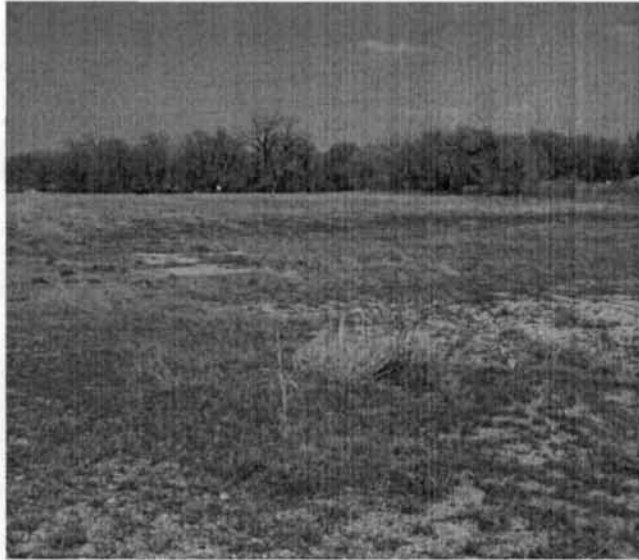
Photo 43. Looking northeast over the EVL area from between wells MW-21 and MW-22.

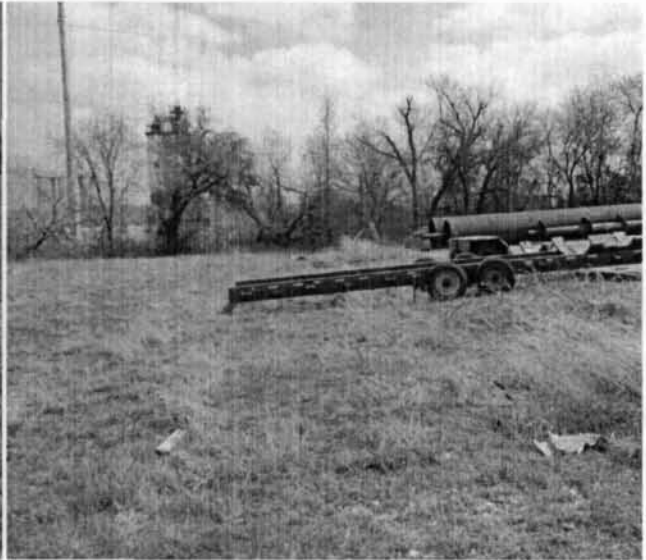
The southern boundary of the Central Property along FM 93 has a barbed wire fence which is in good condition, and a locked gate. The southern boundary of the North Property along Taylor's Valley Road has a chain link fence and a locked gate. The fencing is partially missing and damaged around the paved asphalt parking area (**Photos 44 and 46**). There are no fencing requirements in the ROD.

Photo 44. Equipment encroaching on the site on the north side of the paved parking area.

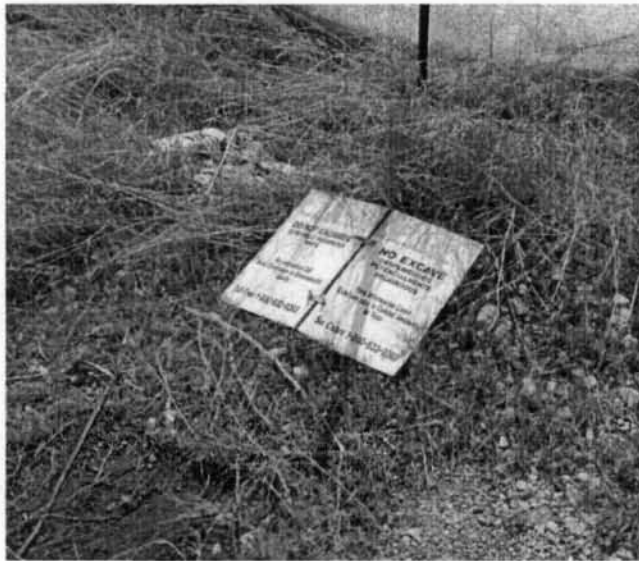
Photo 45. Fallen warning sign adjacent to the paved parking area.

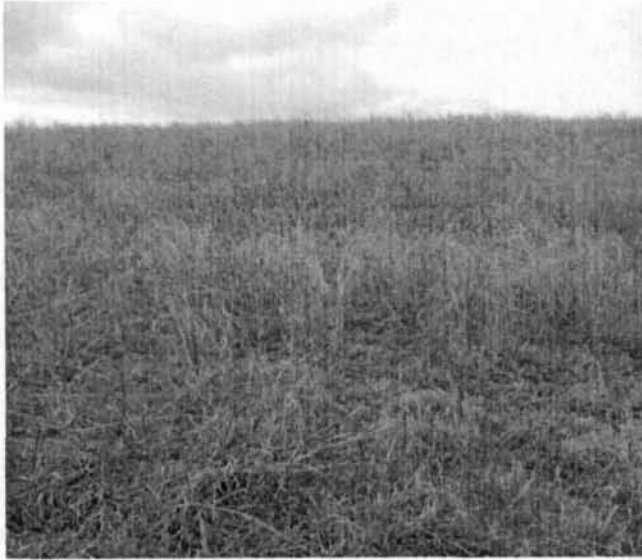
Photo 50. Northern slope of the NSP.

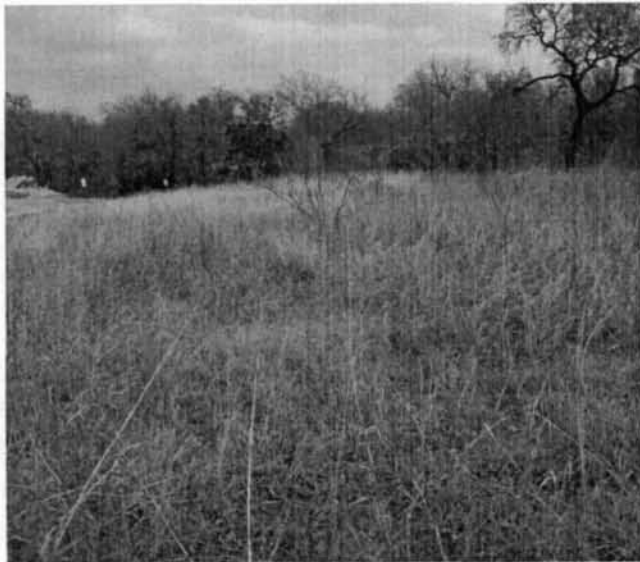
Photo 53. Grass cover on the top of the CSP.

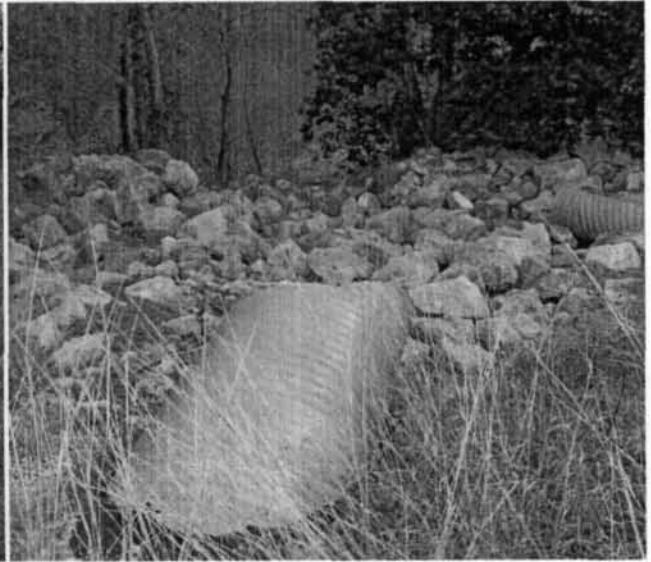
Photo 54. CMP outfalls at the northern edge of the CSP.

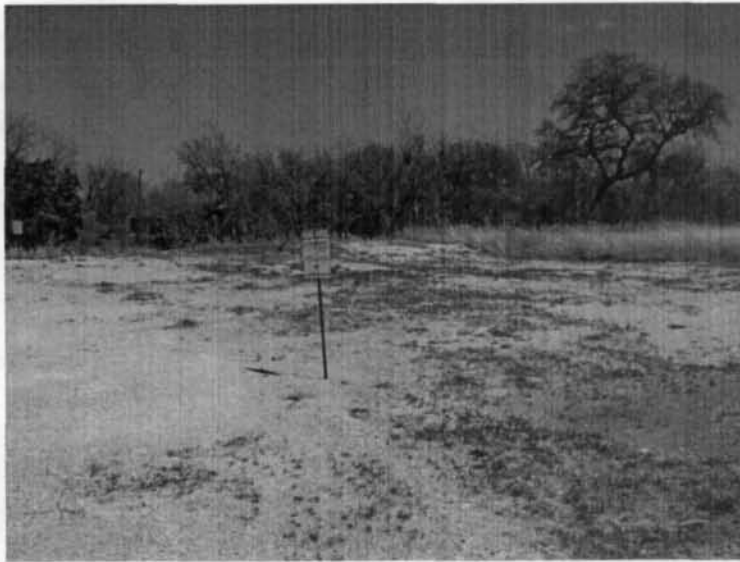
Photo 57. Area of past encroachment on the western edge of the CSP at the concrete plant.

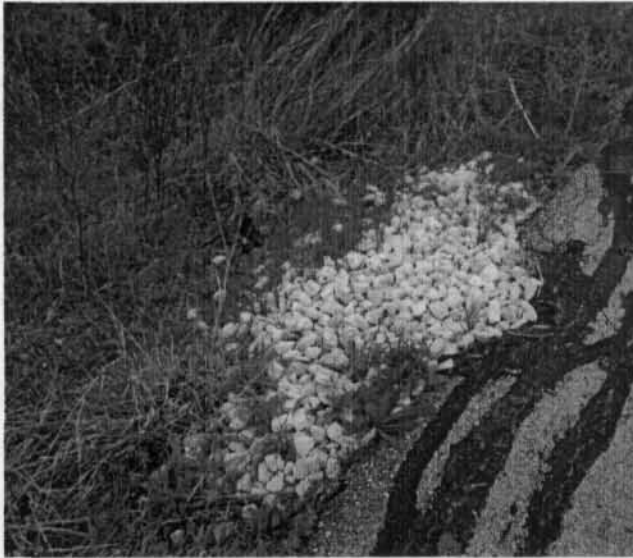
Photo 62. Rip rap along the southern edge of the CC.

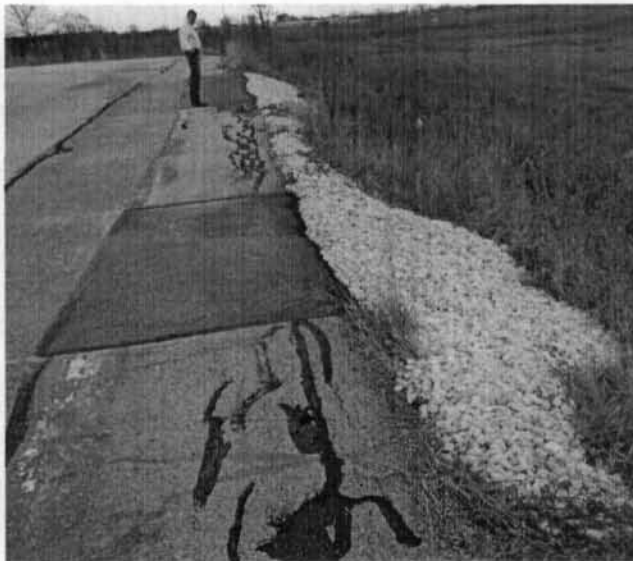
Photo 64. Rip rap and repaired cap along the southern edge of the CC.

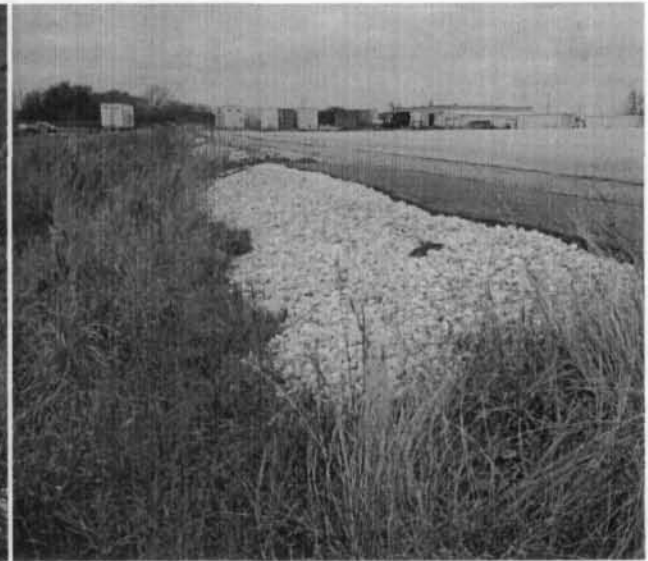
Photo 65. Rip rap and repaired cap along the southern edge of the CC.

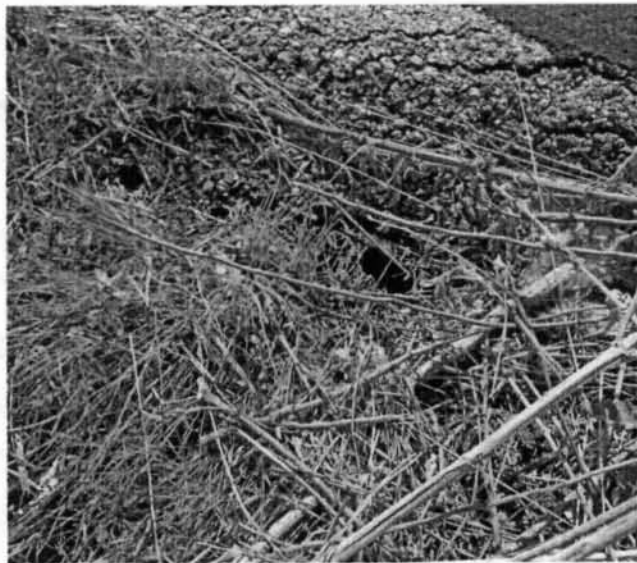
Photo 68. Possible minor erosion at the southern edge of the CC cap.

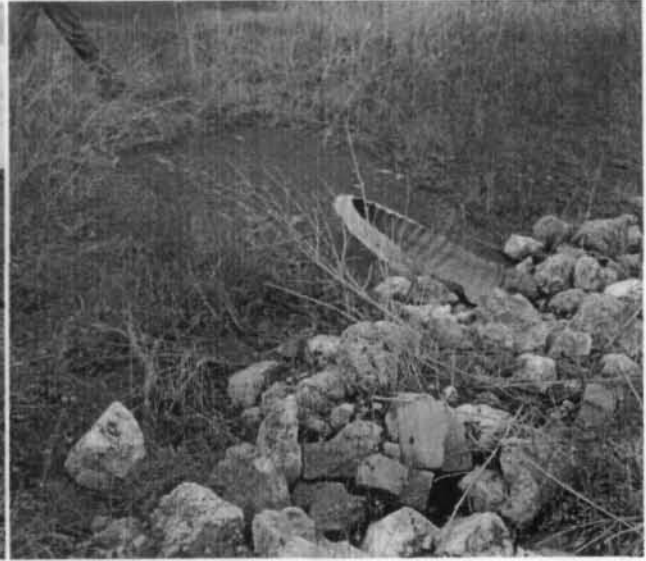
Photo 71. Detention basin outlet pipe.
