**THIRD FIVE-YEAR REVIEW REPORT FOR
BUCKINGHAM COUNTY LANDFILL SUPERFUND SITE
BUCKINGHAM COUNTY, VIRGINIA**

August 2013

**U.S. Environmental Protection Agency
Region 3
Philadelphia, Pennsylvania**

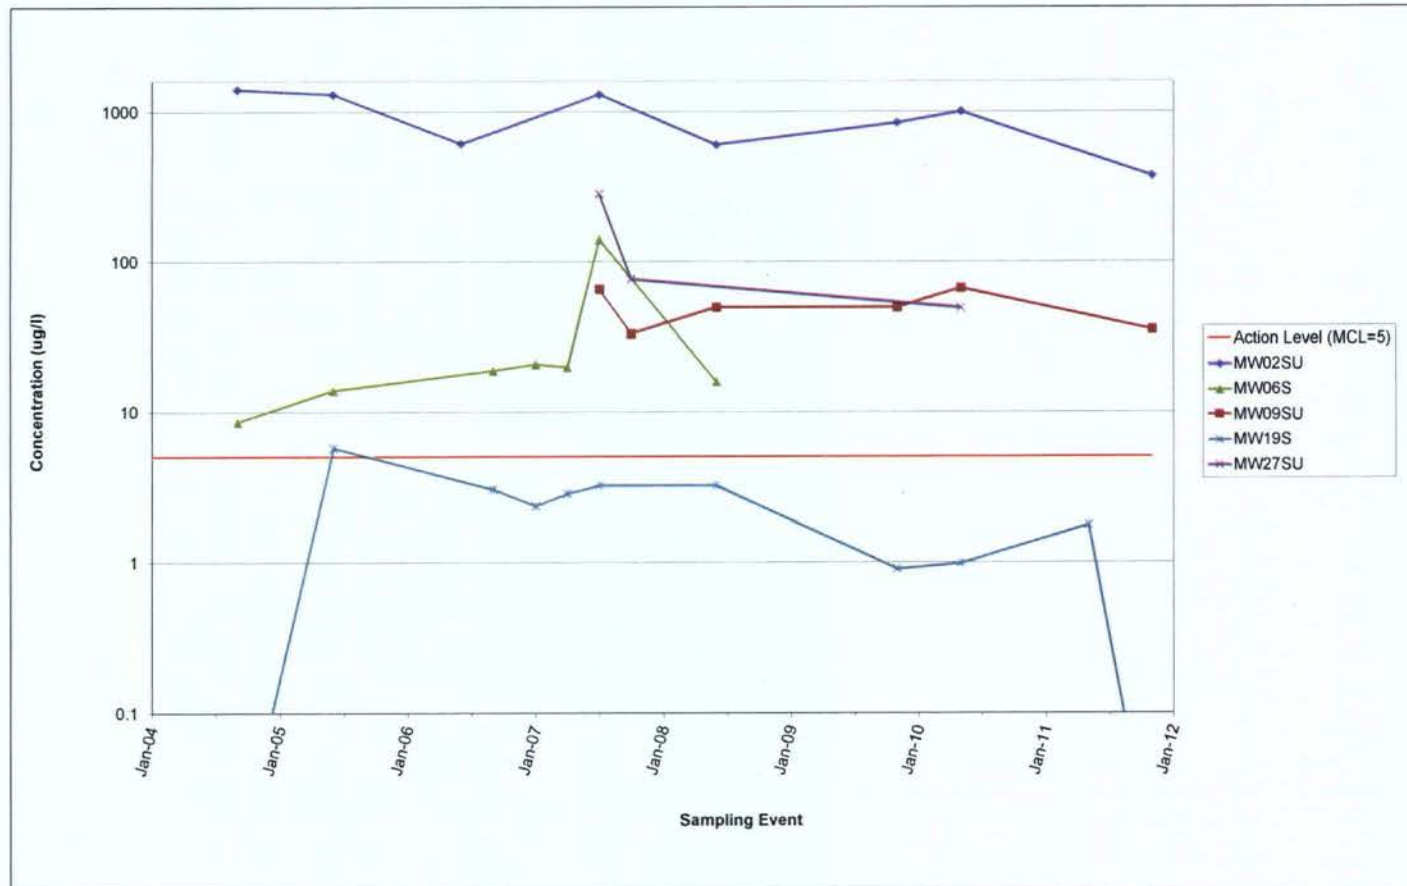
Figure 4-1
Tetrachloroethene Concentration Trends
Shallow Hydrologic Zone

Figure 4-1 presents PCE concentration trends for Shallow Hydrologic Zone wells in which PCE has been detected above the screening level of 5 µg/l. To provide spatial reference, these charts are also shown on the map on Figure 3-1. Source area well MW-2SU still has the highest levels of PCE on the Site. PCE levels at this well increased since the 2008 Hydrogeological Analysis, from 600 µg/l in June 2008 to approximately 1,000 µg/l in May 2010, before decreasing again to 370 µg/l in November 2011. The overall PCE concentration at MW-2SU is decreasing, but changes are irregular. Locations MW-9SU and MW-6S do not exhibit a consistent PCE concentration trend, while the PCE concentration at MW-27SU has dropped significantly since the well was first sampled in July 2007. All three of these wells still have PCE levels several times above the screening level in November 2011. Location MW-19S has only had one PCE result above 5 µg/l since 2005, and it appears to be decreasing in concentration. As shown on Figure 3-1, a slice through the plume at the center elevation of this hydrologic zone (570 ft msl) reveals PCE in groundwater within Upper and Lower Saprolite primarily, with some extending into the Residium.

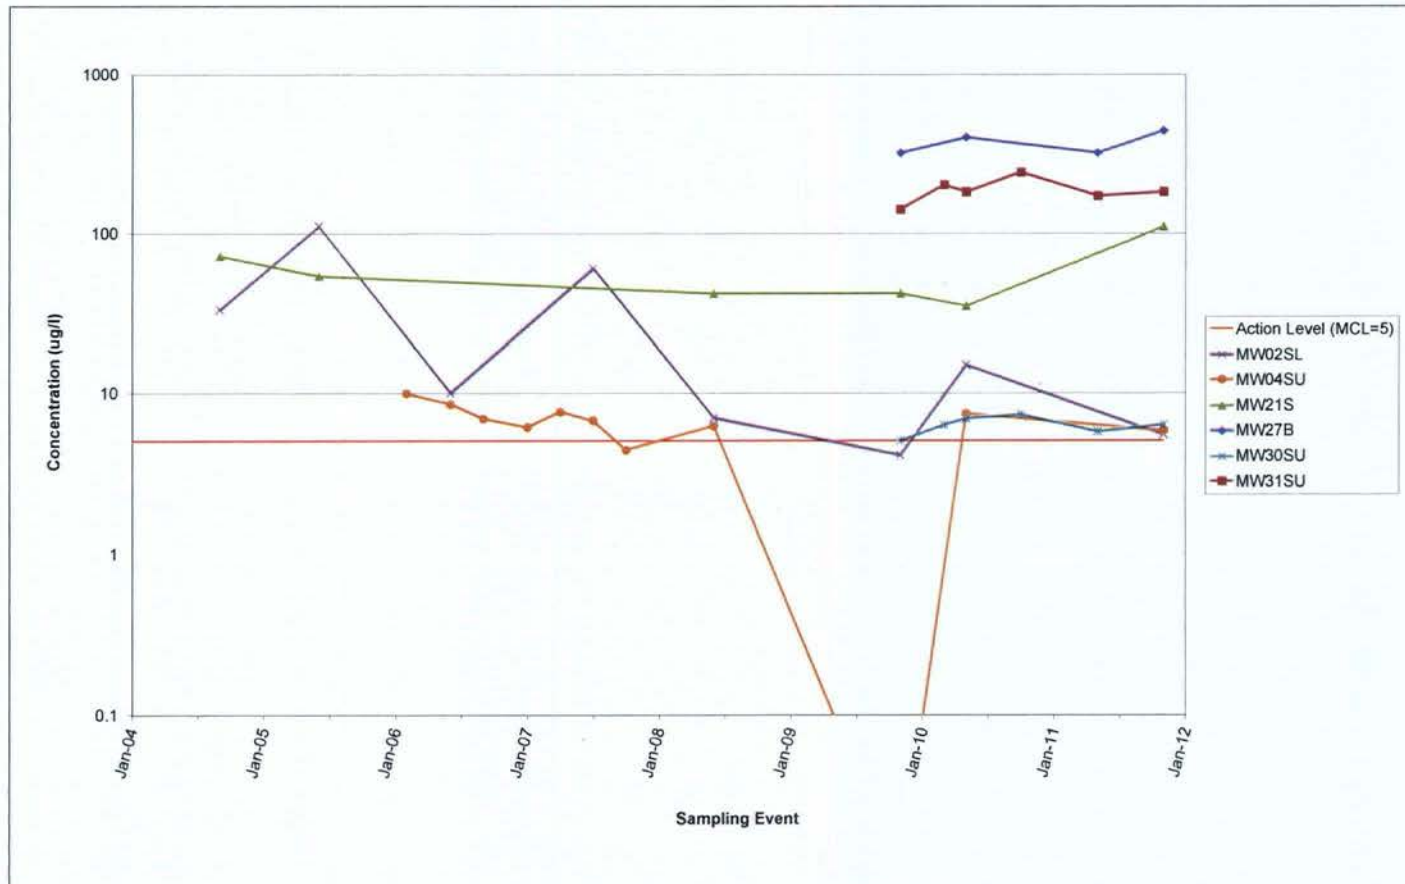
Figure 4-2
Tetrachloroethene Concentration Trends
Upper Intermediate Hydrologic Zone

Figure 4-2 presents PCE concentration trends for Upper Intermediate Hydrologic Zone wells in which PCE has been detected above the screening level of 5 µg/l. These charts are also shown on the map on Figure 3-2. The only well in this group that exhibits a clear decreasing trend is MW-2SL. The other wells exhibit relatively steady concentrations or slight overall increasing trends. The highest PCE concentration detected in this zone is in MW-27B, with a slight overall increasing trend based on four sampling events leading up to a PCE level of 440 µg/l in November 2011. MW-31SU which, like MW-27B, is located downgradient from the Site in the central axis of the plume leading to Cooper Creek, is showing a slight overall increasing PCE trend since it was first sampled in November 2009. The third well in this zone with PCE levels well above the screening level is MW-21S. PCE levels at MW-21S were decreasing steadily from September 2004 (72 µg/l) until May 2010 (35 µg/l), before increasing

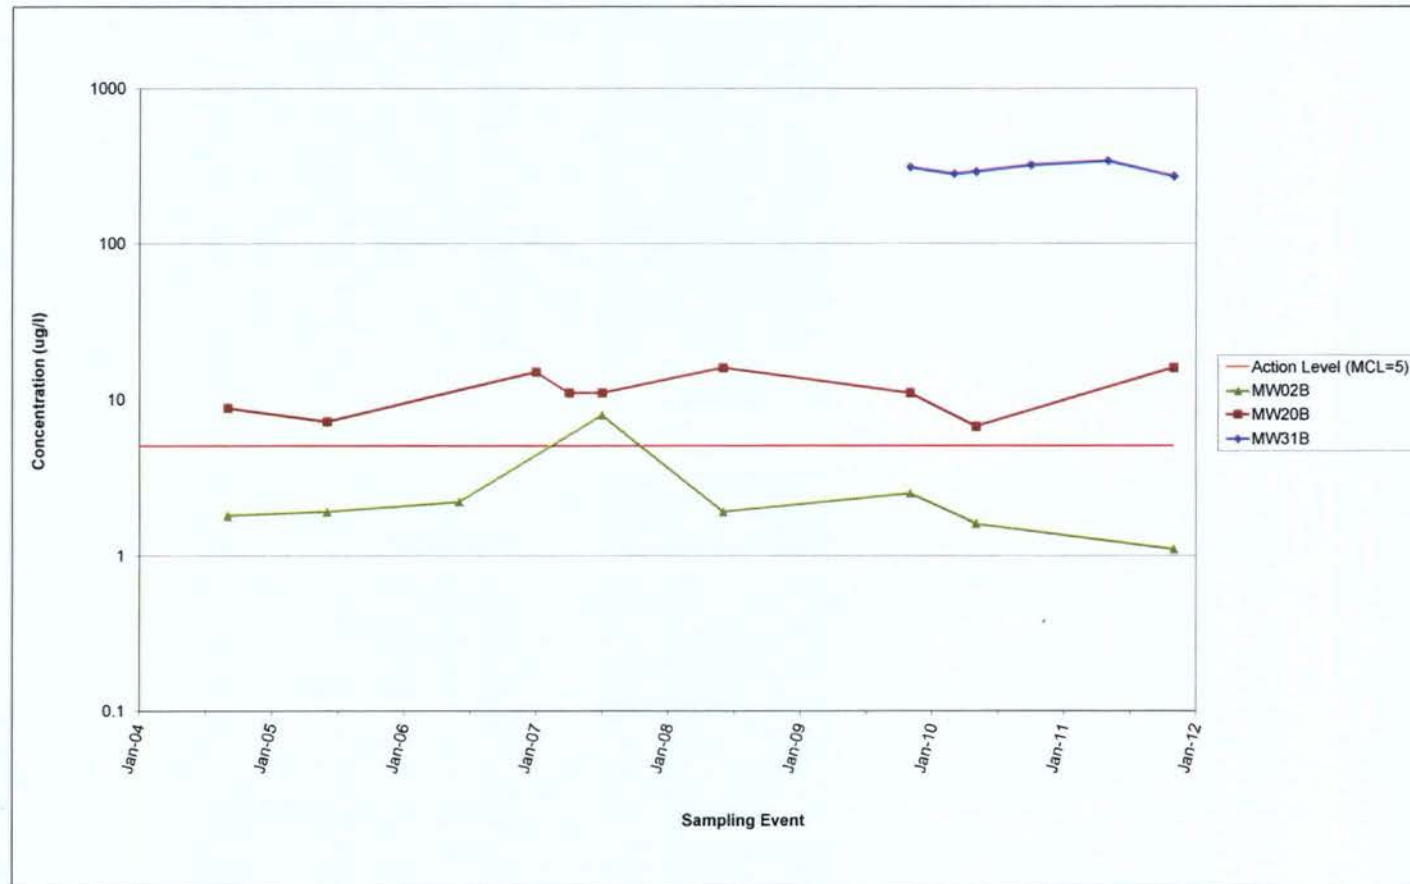
Figure 4-3
Tetrachloroethene Concentration Trends
Lower Intermediate Hydrologic Zone

Figure 4-3 presents PCE concentration trends for Lower Intermediate Hydrologic Zone wells in which PCE has been detected above the screening level of 5 µg/l. These charts are also shown on the map on Figure 3-3. PCE levels in MW-2B, MW-20B, and MW-31B have remained relatively consistent since monitoring began. PCE levels at MW-31B have vacillated between approximately 250 µg/l and 350 µg/l since this well was installed. PCE was detected at 270 µg/l in November 2011 in MW-31B. The other two wells in this zone have much lower concentrations, with PCE in MW-20B ranging from 5 to 15 µg/l (just above the screening level). PCE levels in MW-2B remain around 2.5 µg/l (just below the screening level). In November 2011, PCE was detected at MW-20B at 16 µg/l and at MW-2B at 1.1 µg/l. As shown on Figure 3-3, a slice through the plume at the center elevation of this hydrologic zone (515 ft msl) reveals PCE in groundwater within Bedrock and Weathered Bedrock primarily, with some extending into the Lower Saprolite.

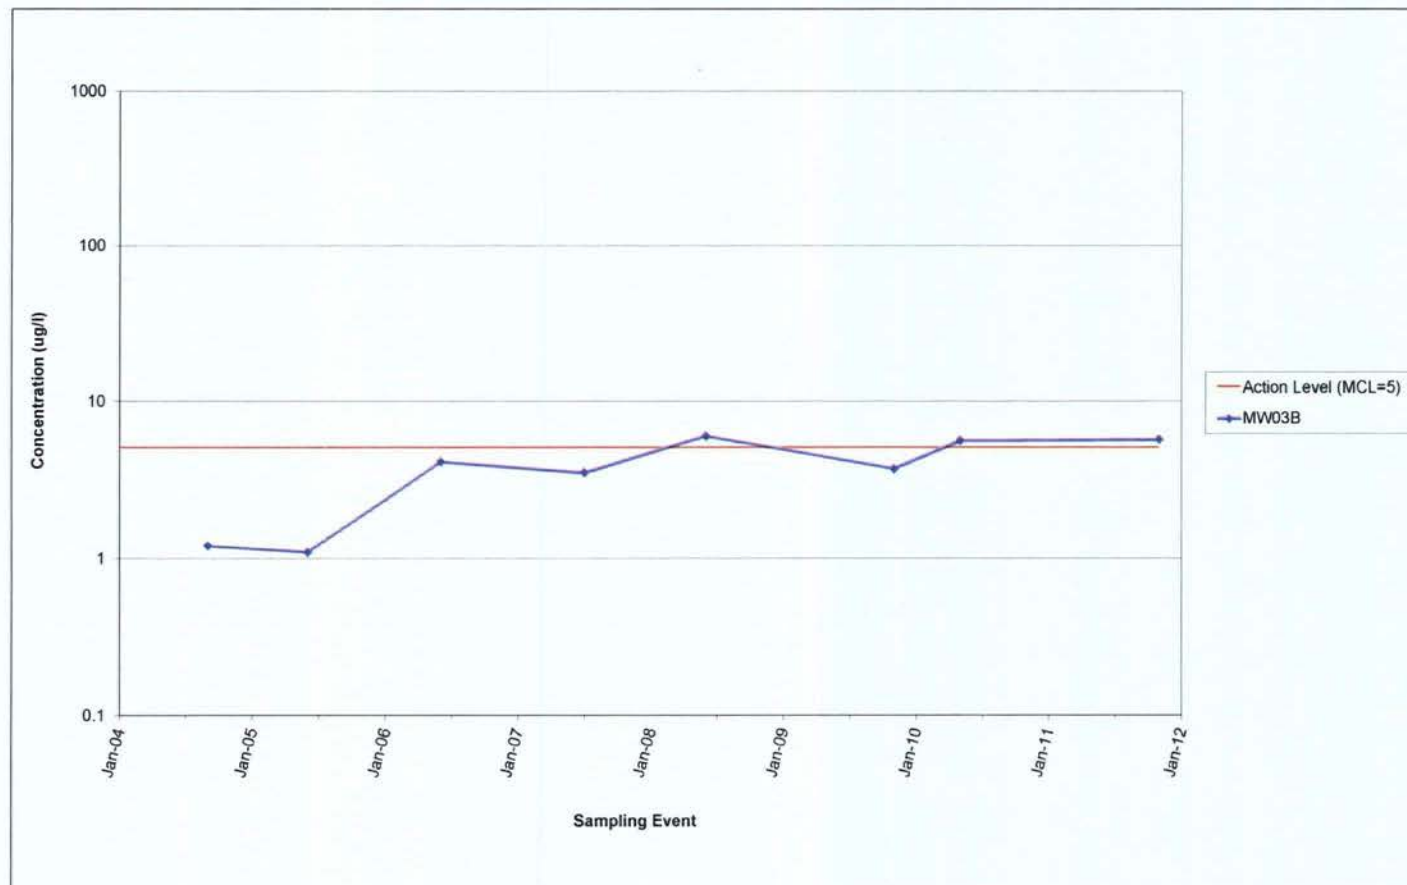
Figure 4-4
Tetrachloroethene Concentration Trends
Upper Bedrock Hydrologic Zone

Figure 4-4 presents PCE concentration trends for the single Upper Bedrock Hydrologic Zone well in which PCE has been detected above the screening level of 5 µg/l. This chart is also shown on the map on Figure 3-4. MW-3B shows relatively low levels of PCE, with an increasing trend from 2005 (1.2 µg/l) until November 2011 (5.7 µg/l).

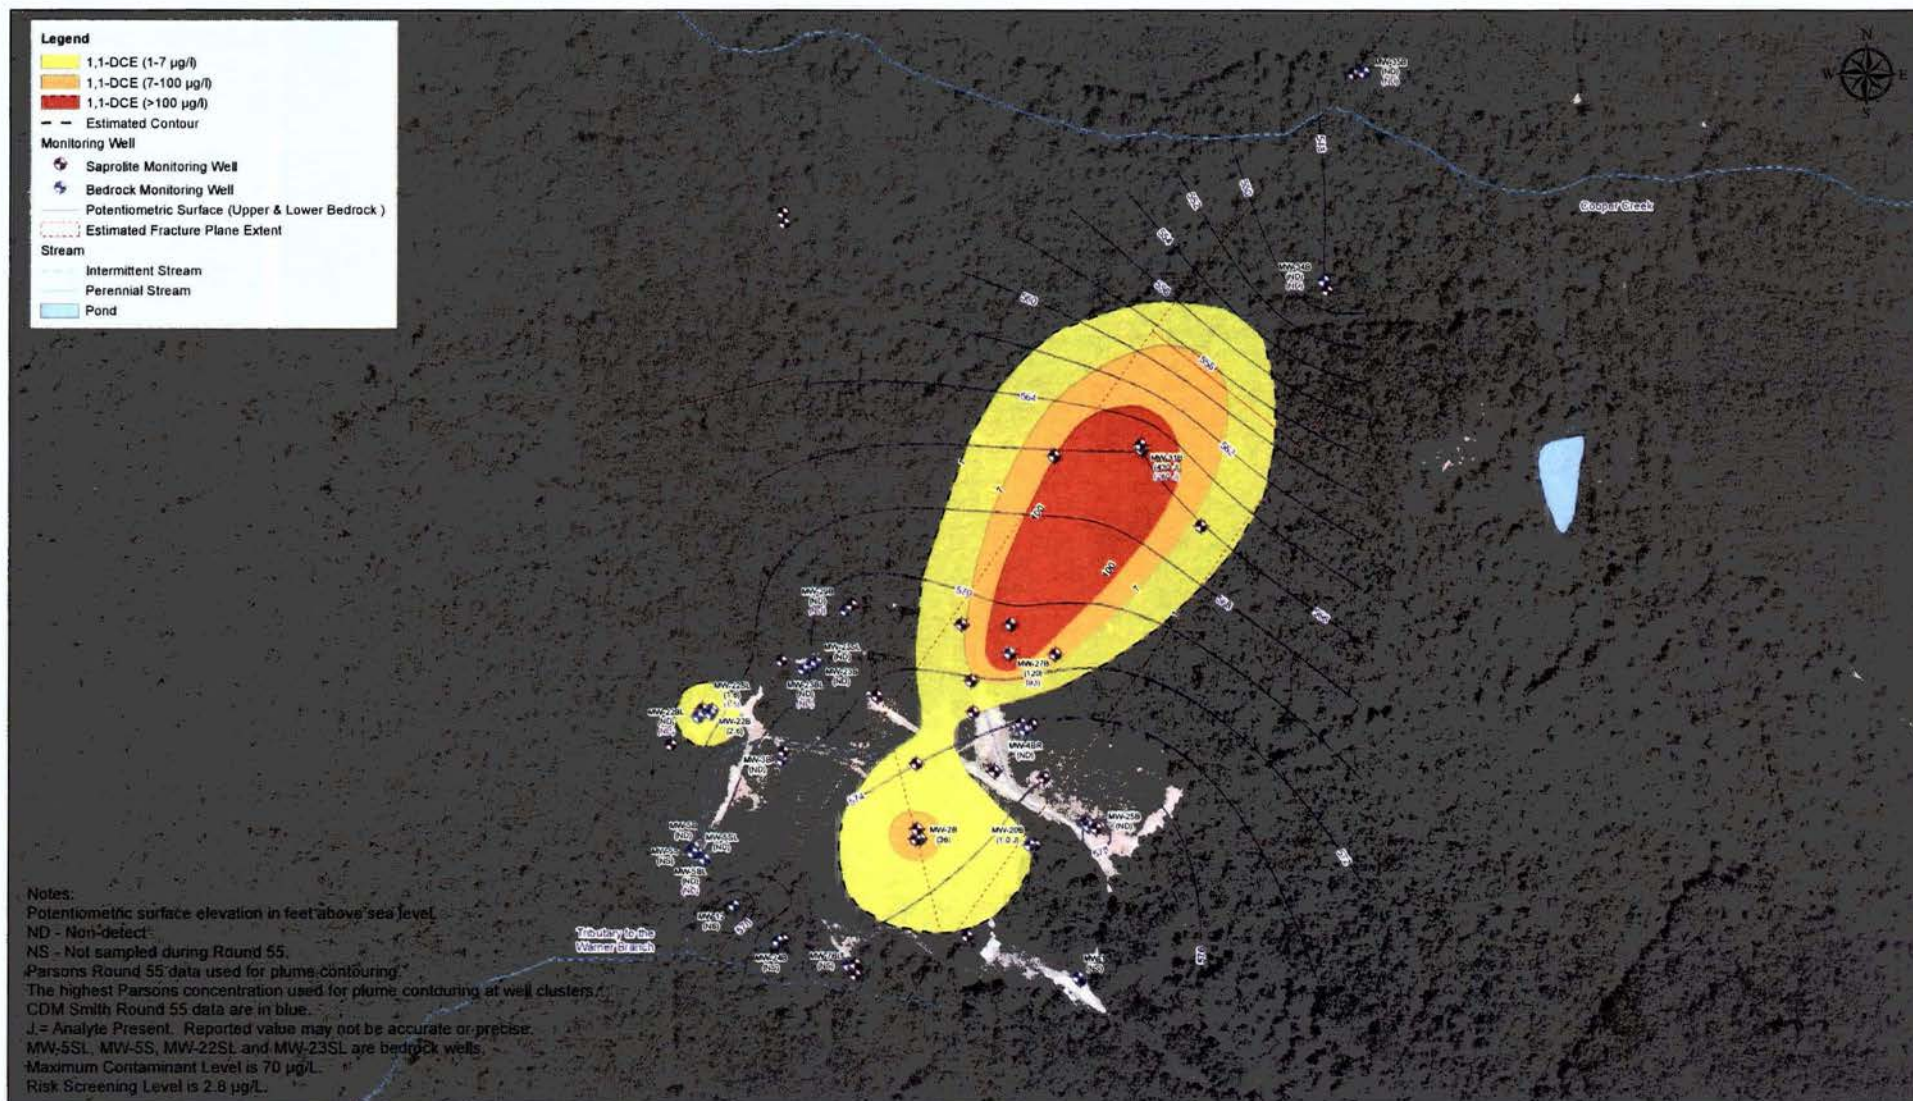
Figure 4-20
 1,1-Dichloroethene in Upper and Lower Saprolite Groundwater
 Round 55 (November and December 2012)

As presented on Figure 4-20, 1,1-DCE in Upper and Lower Saprolite Stratigraphic Zone groundwater is present above 1 µg/L in a plume that follows groundwater contours and extends from an elevated concentration area centered at MW-2SU and generally follows the horizontal gradient to the northeast before terminating in another elevated concentration area at MW-31SU.

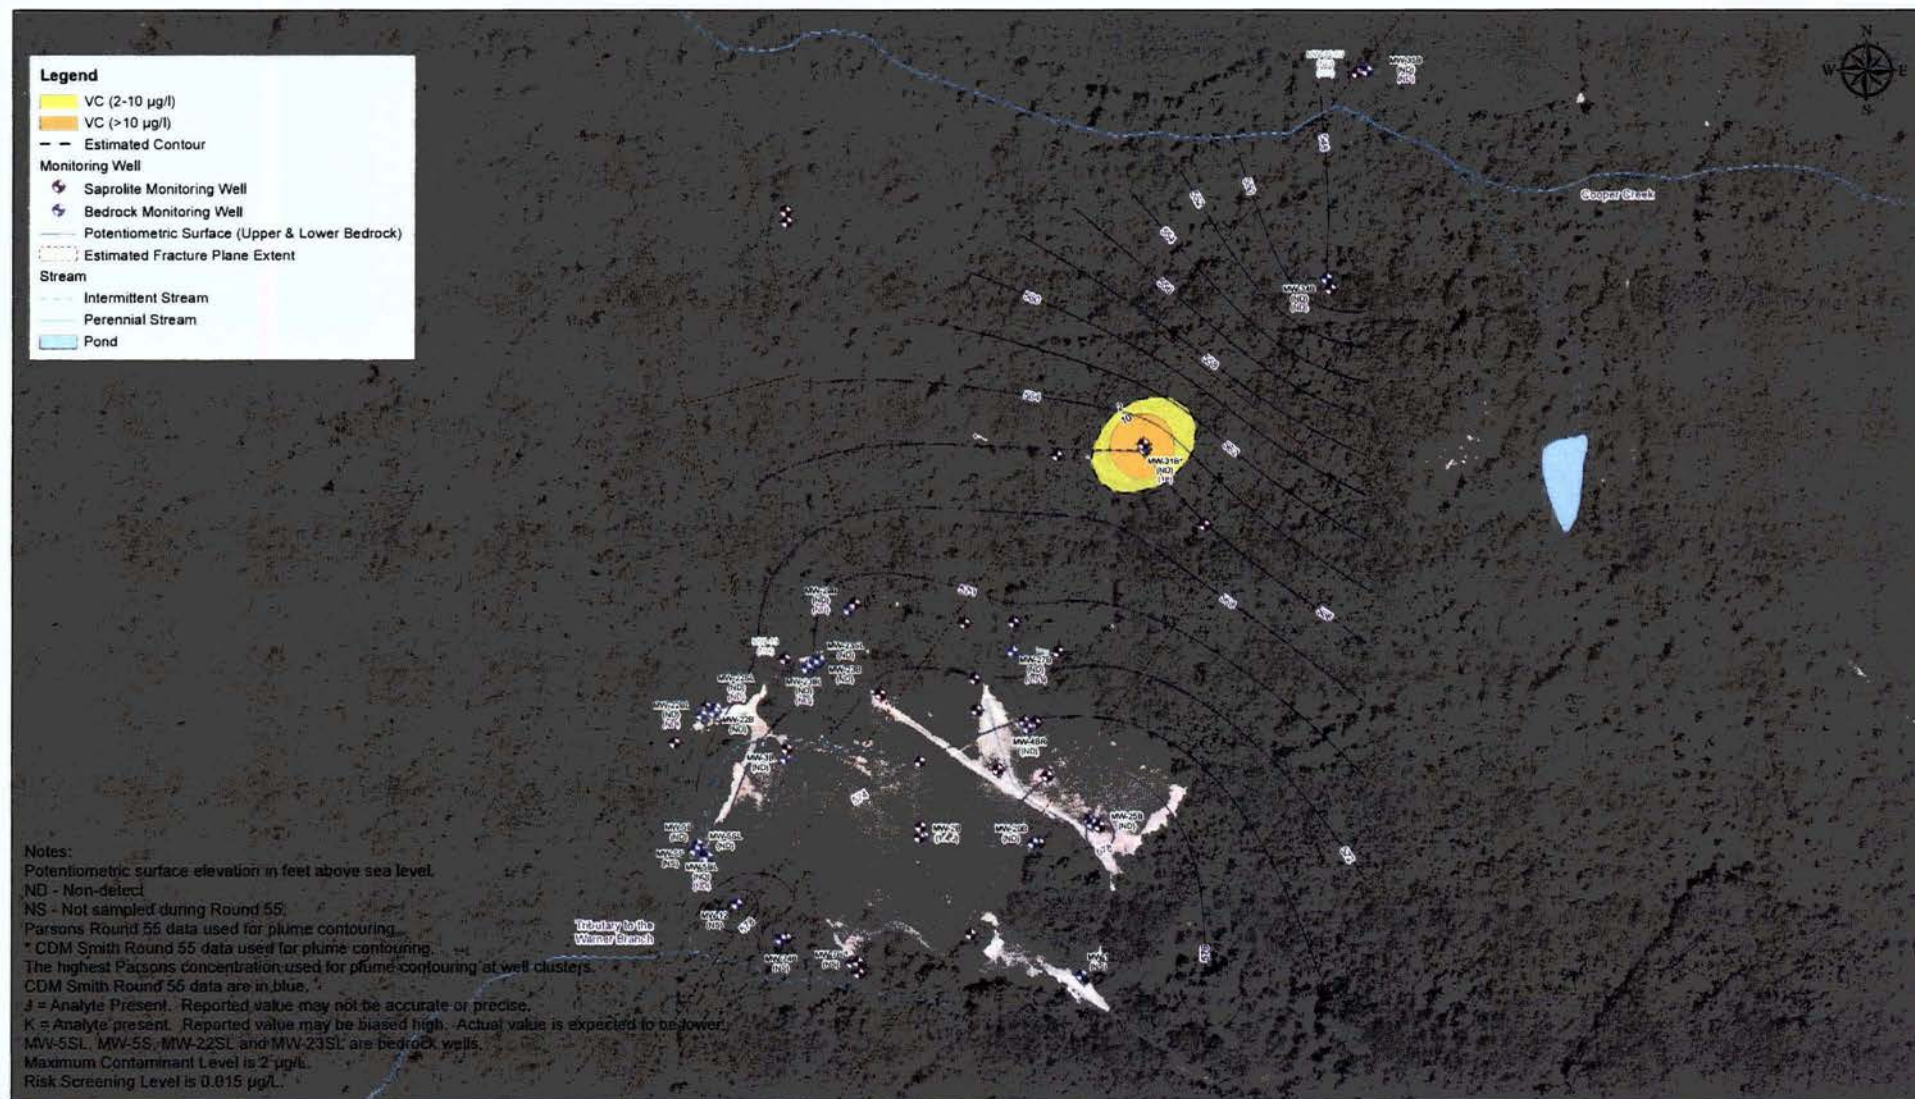
Figure 4-22
Vinyl Chloride in Upper and Lower Saprolite Groundwater
Round 55 (November and December 2012)

As presented on Figure 4-22, vinyl chloride in Upper and Lower Saprolite Stratigraphic Zone groundwater is present above 2 µg/L in a plume that follows groundwater contours and extends from MW-4SU to MW-31SU, with an isolated elevated concentration area centered at MW-2SU.

Is this getting worse or are we just finding out about the plume? Was an existing plume, but cap had slowed its migration. Historical data is showing that levels are increasing and moving in different directions. In some areas it is going down CDM map fig. 4-22

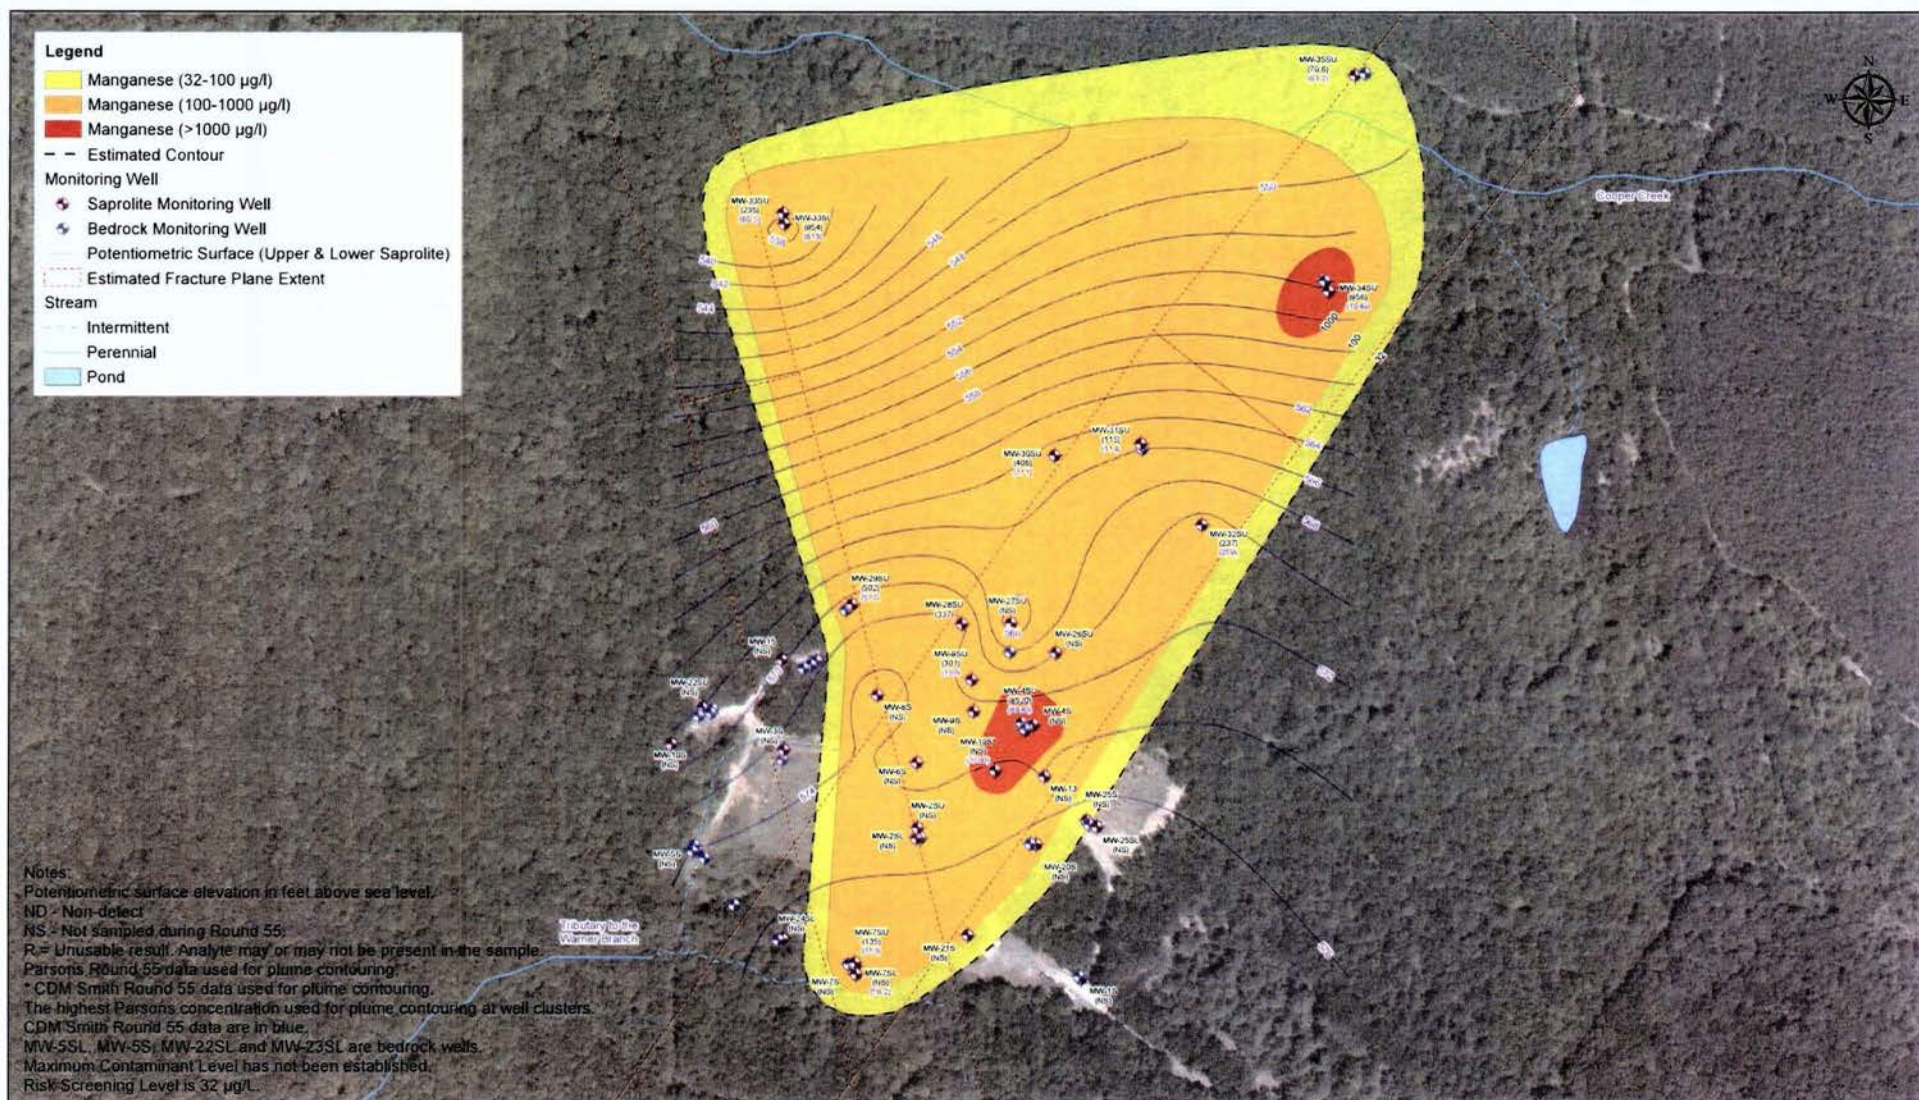
Figure 4-23
Vinyl Chloride in Upper and Lower Bedrock Groundwater
Round 55 (November and December 2012)

As presented on Figure 4-23, vinyl chloride in Upper and Lower Bedrock Stratigraphic Zone groundwater is only present in MW-31B.

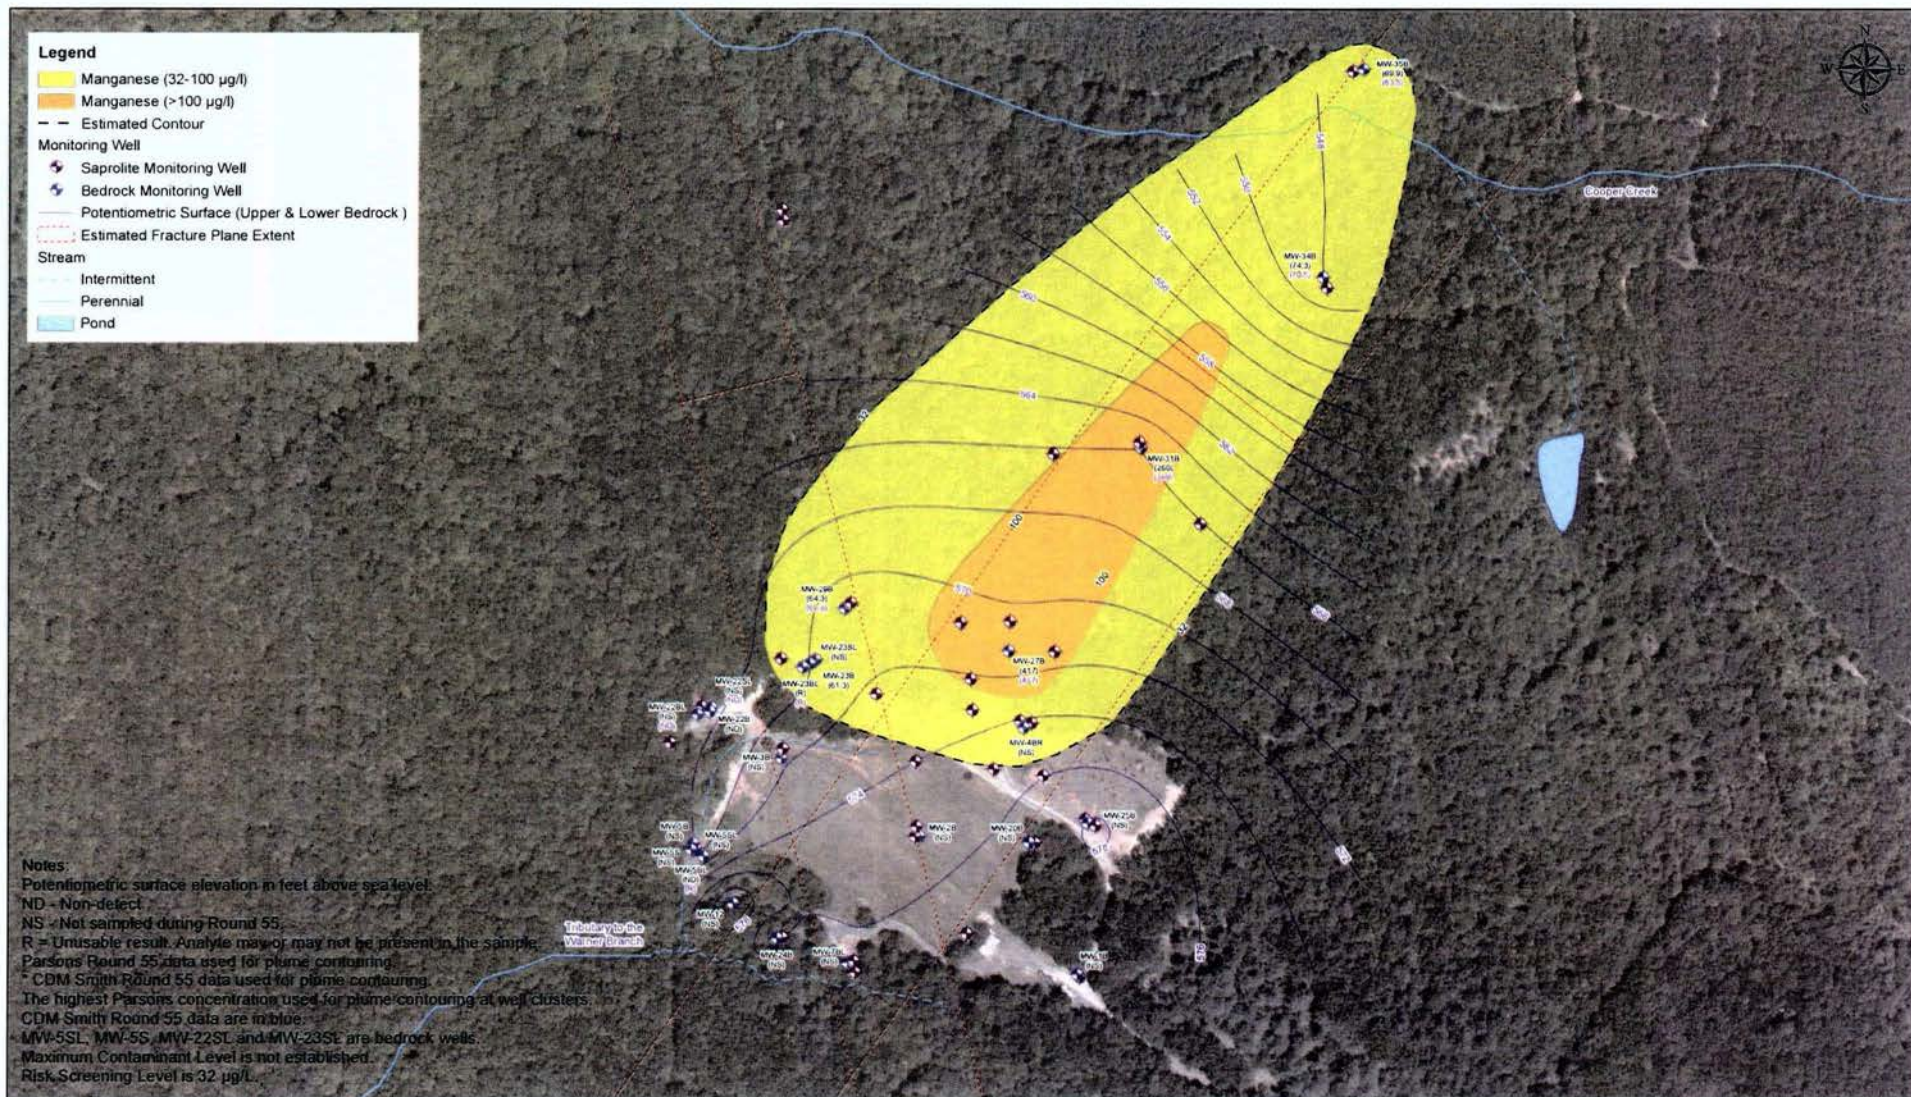
Figure 4-24
Total Manganese in Upper and Lower Saprolite Groundwater
Round 55 (November and December 2012)

As presented on Figure 4-24, manganese in Upper and Lower Saprolite Stratigraphic Zone groundwater is present above 32 µg/L in a pervasive plume that extends from the source area downgradient to elevated concentration areas at MW-4SU and MW-34SU. Untypically, compared to other COCs, manganese was also detected at elevated concentrations at MW-33SU, which is located downgradient and to the northwest of the landfill approximately 300 feet south of Cooper Creek.

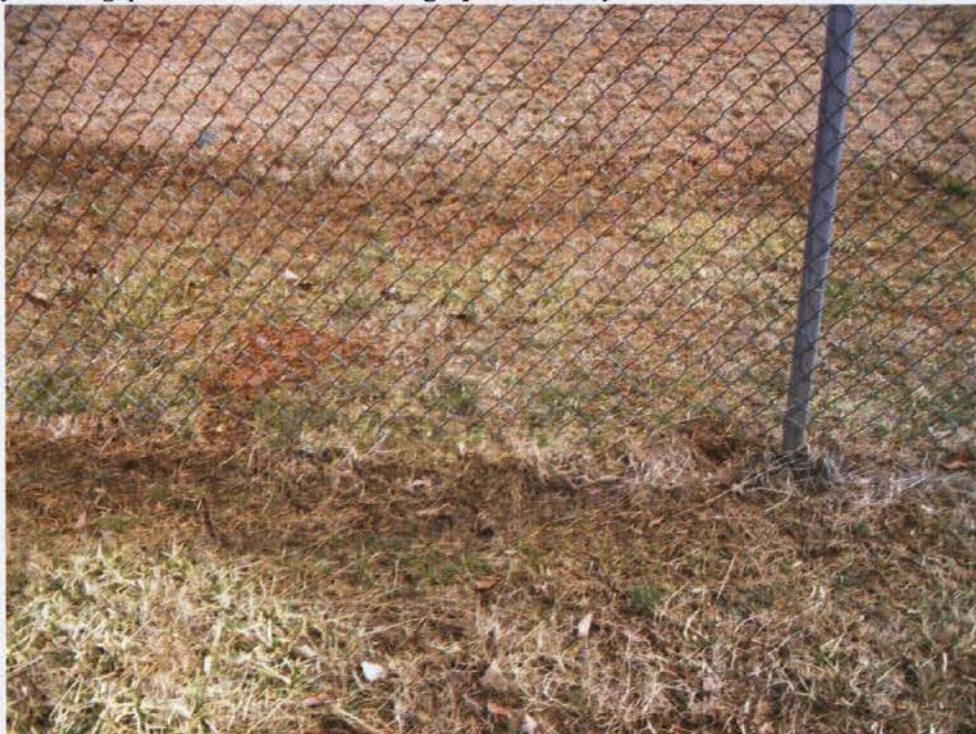
Photo: 183 Date: 02/28/13 Description: Facing east near back Landfill gate and fence. Gap at bottom of fence. **Photographer:** Rich Opem

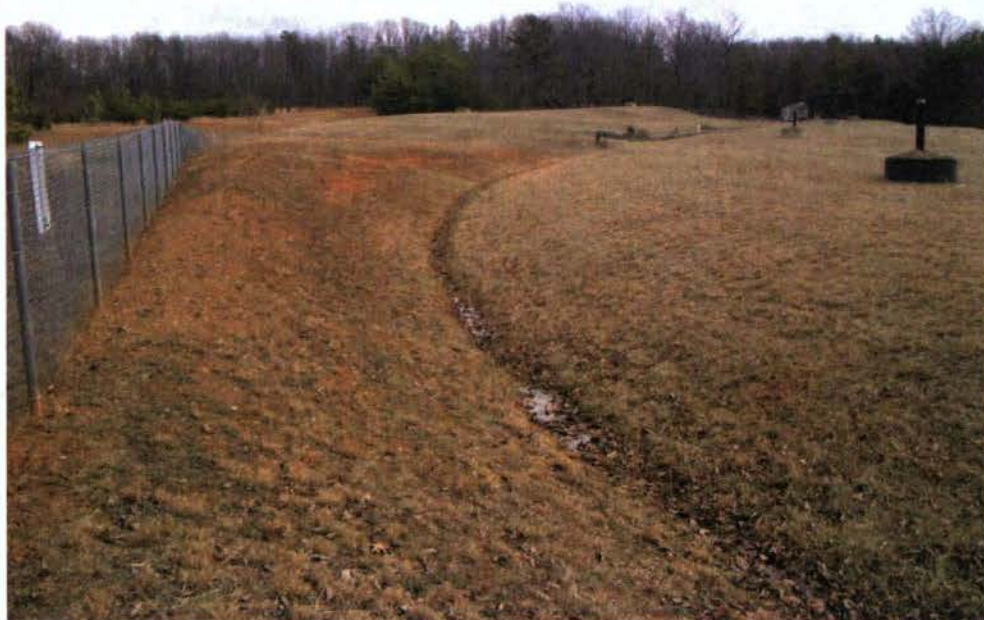
Photo: 190 Date: 02/28/13 Description: Facing east at Landfill. Landfill with bare grass spots near north fence line. Standing water, drainage swale and gas vents (GV-1 and GV-2) in the background. **Photographer:** Rich Opem

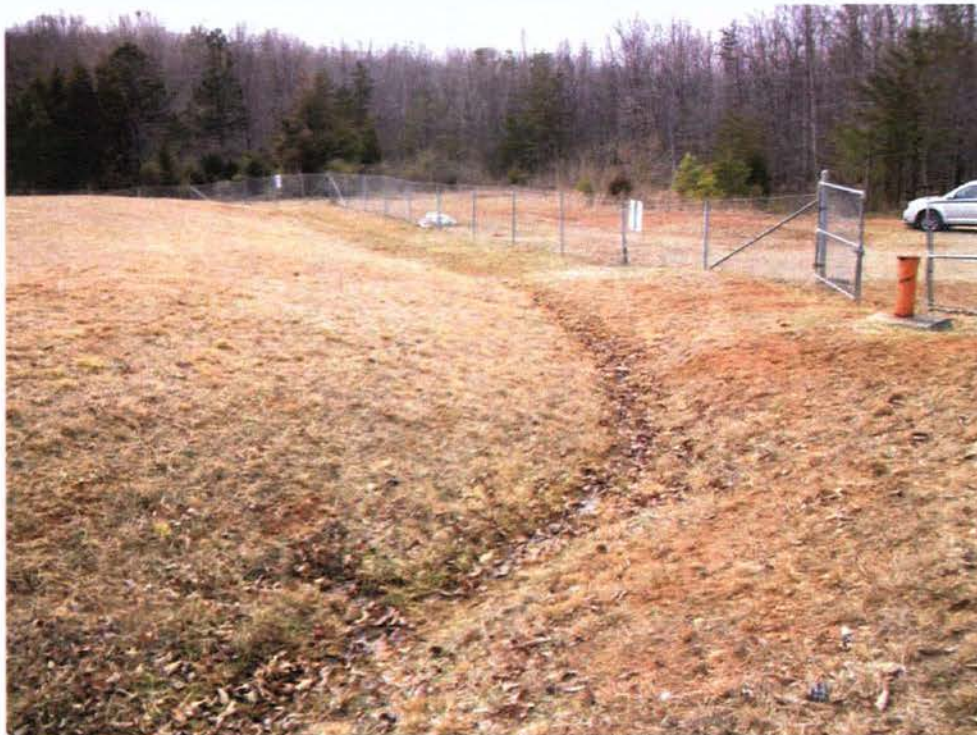
Photo: 191 **Date:** 02/28/13 **Description:** Facing west at Landfill. Back Landfill gate and fence. Monitoring well MW-3B, standing water and left over bags of sand. **Photographer:** Rich Opem

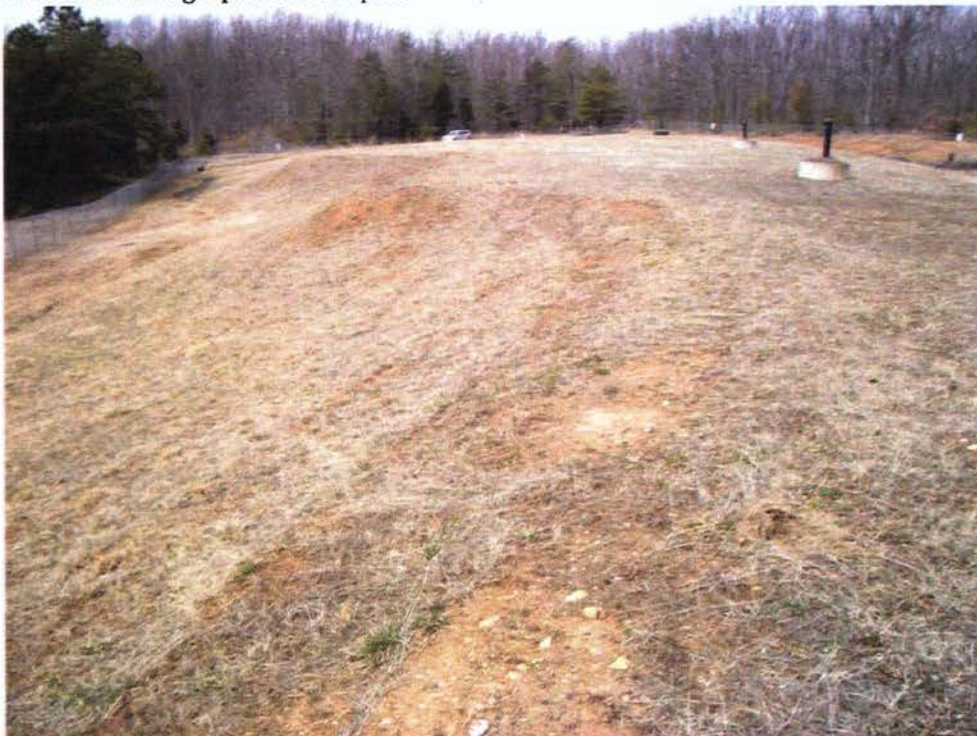
Photo: 203 Date: 02/28/13 Description: Facing west at Landfill near south of Landfill fence line. Several bare grass spots on landfill cover in need of reseeding. Standing water near southwest corner of fence line. **Photographer:** Rich Opem
