**SECOND FIVE-YEAR REVIEW REPORT FOR
Moyer's Landfill Superfund Site
Montgomery County, Pennsylvania**

United States Environmental Protection Agency
Region III
Philadelphia, Pennsylvania

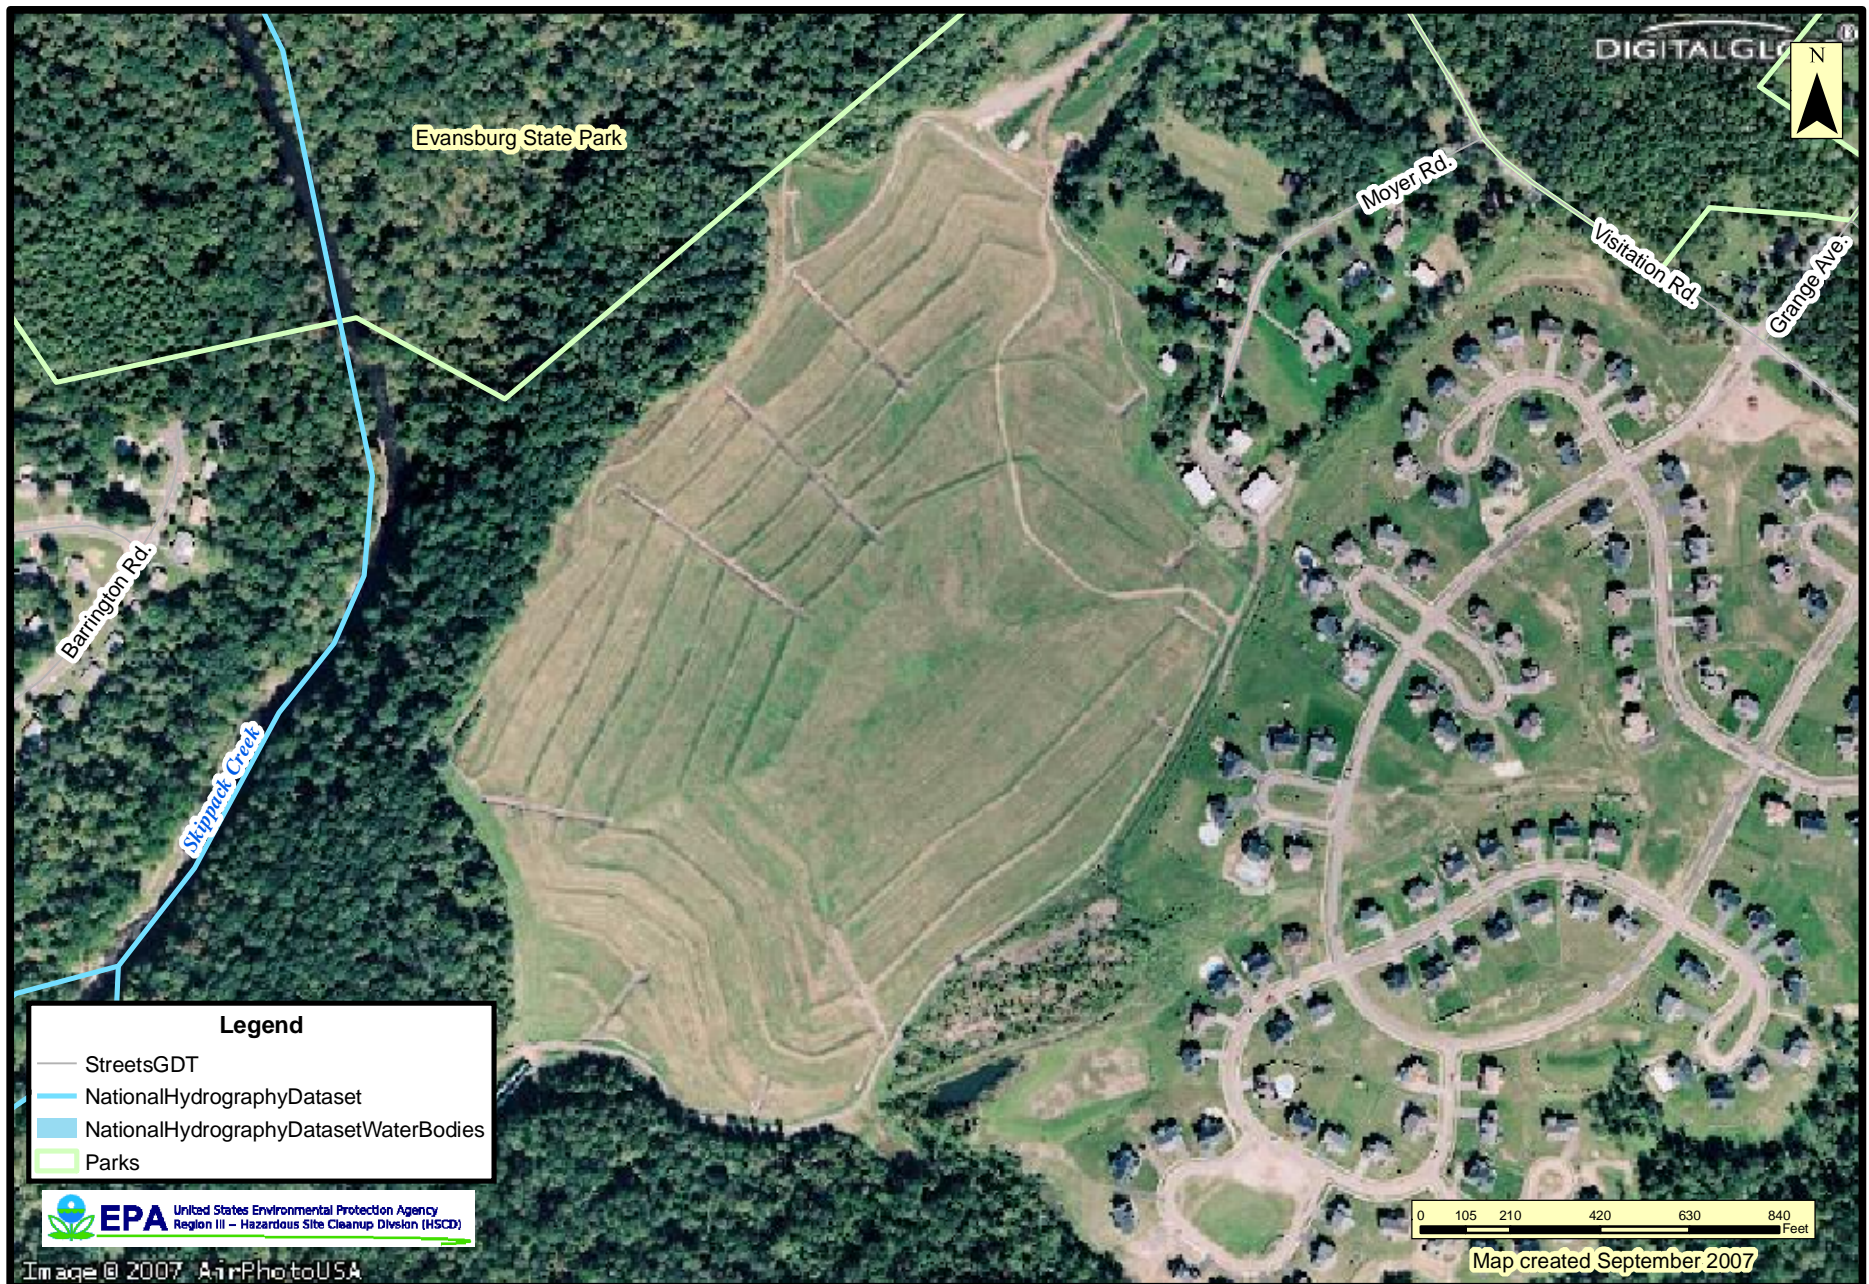
Figure 2

Moyers Landfill Superfund Site, Site Layout

The site area consists of open land surrounded by wooded areas on steep slopes. Located on the site are leachate collection tanks and a wooden storage shed in the south valley. Runoff from the landfill slopes flowed westerly into Skippack Creek, until the remedy was built. Now runoff is directed towards stormwater basins around the perimeter of the landfill and routed off the landfill cap. The Skippack Creek is located about 350 feet north-west of the landfill. The Skippack Creek then discharges into the Perkiomen Creek which eventually discharges into the Schuylkill River (Figure 2, Site Layout Map).

The landfill is bounded on the north and west by Evansburg State Park, on the east by a single original home and a new housing development (Valley High Estates) and on the south by the new housing development and undeveloped land (Figure 2, Site Layout Map). The area immediately surrounding the landfill is residential. The nearby Skippack Creek flows through Evansburg State Park and has, in the past, been stocked with trout.

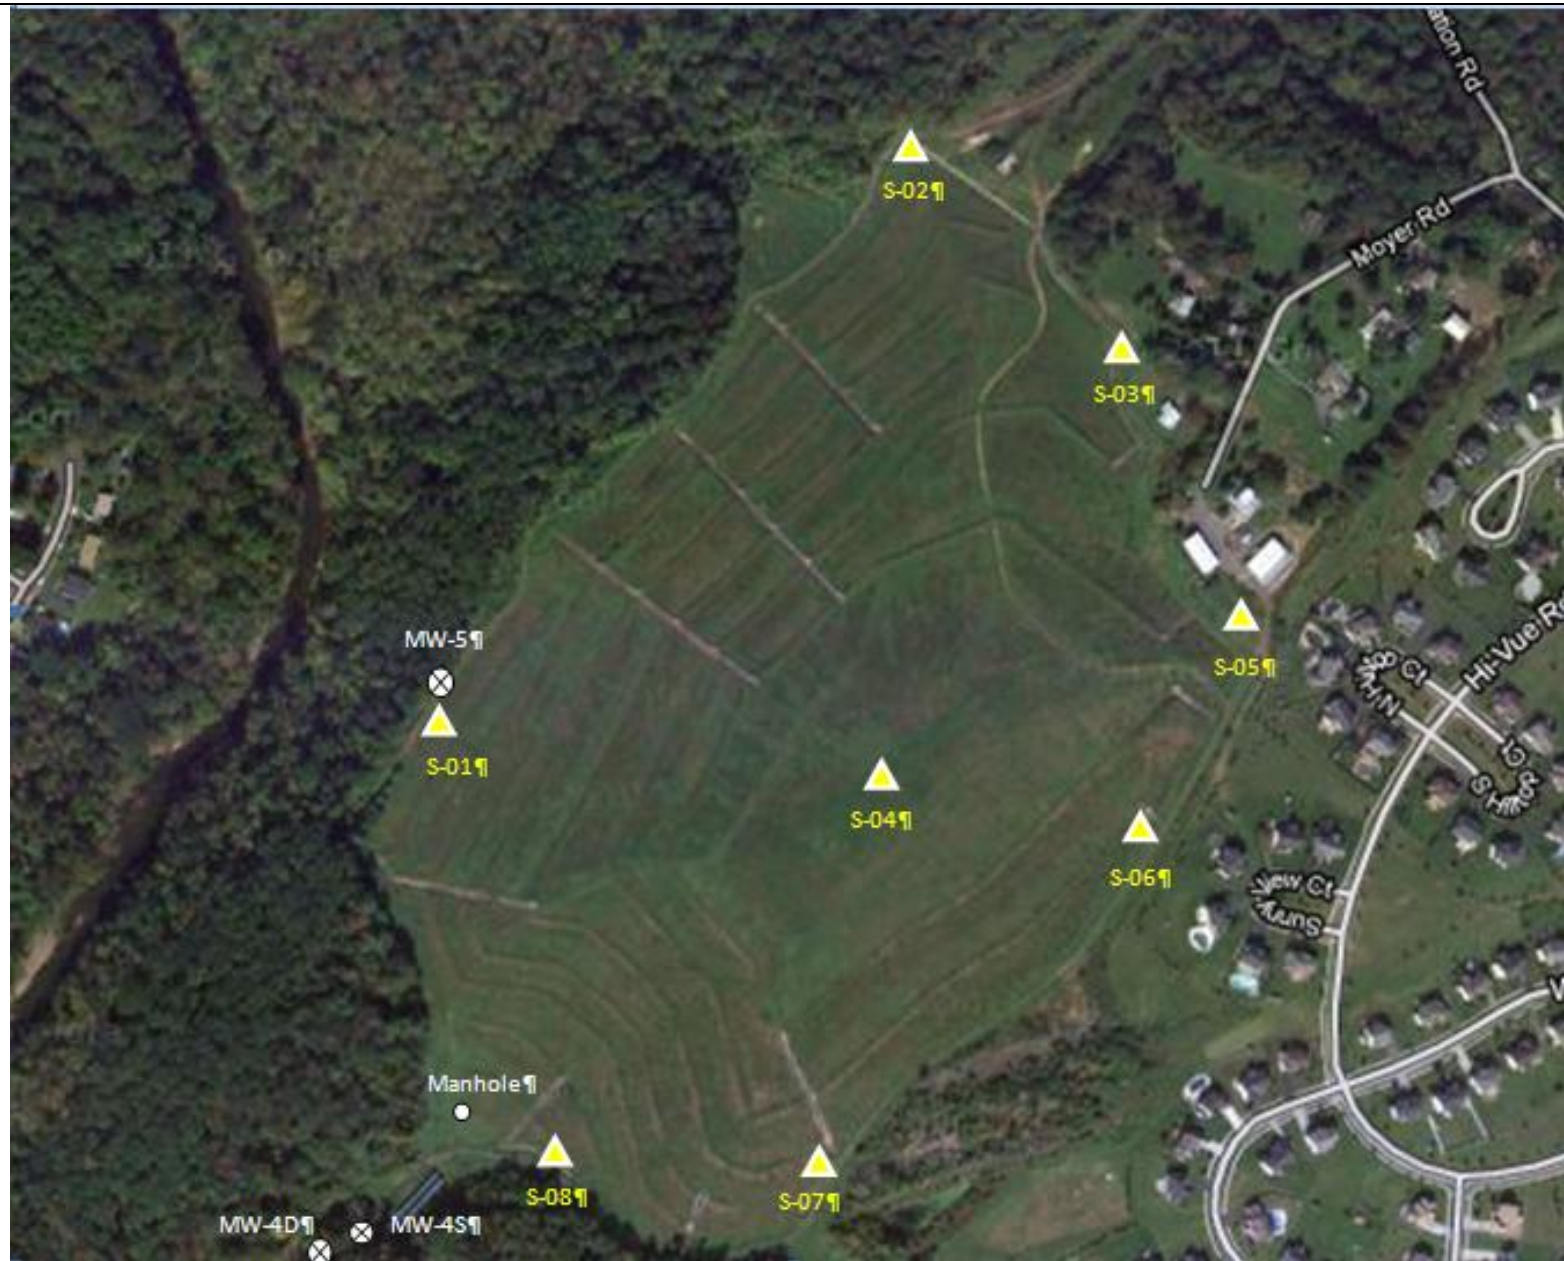
Figure 4 Moyer Landfill - Summa Canister and Well Locations

February 21, 2012 and February 28, 2012

In 2010 and 2012, ambient air sampling was performed at seven locations around the perimeter of the landfill (Summa 1 - Summa 3, Summa 5 - Summa 8) and one location at the apex of the landfill (Summa 4). See Figure 4 for 2012 locations. All ambient air samples were taken with standard Summa canisters fitted with 8- hour regulators.
