Barton 3 (#220)

Removal Site Evaluation Report

Final | October 9, 2018

NAVAJO NATION
AUM Environmental Response Trust-First Phase

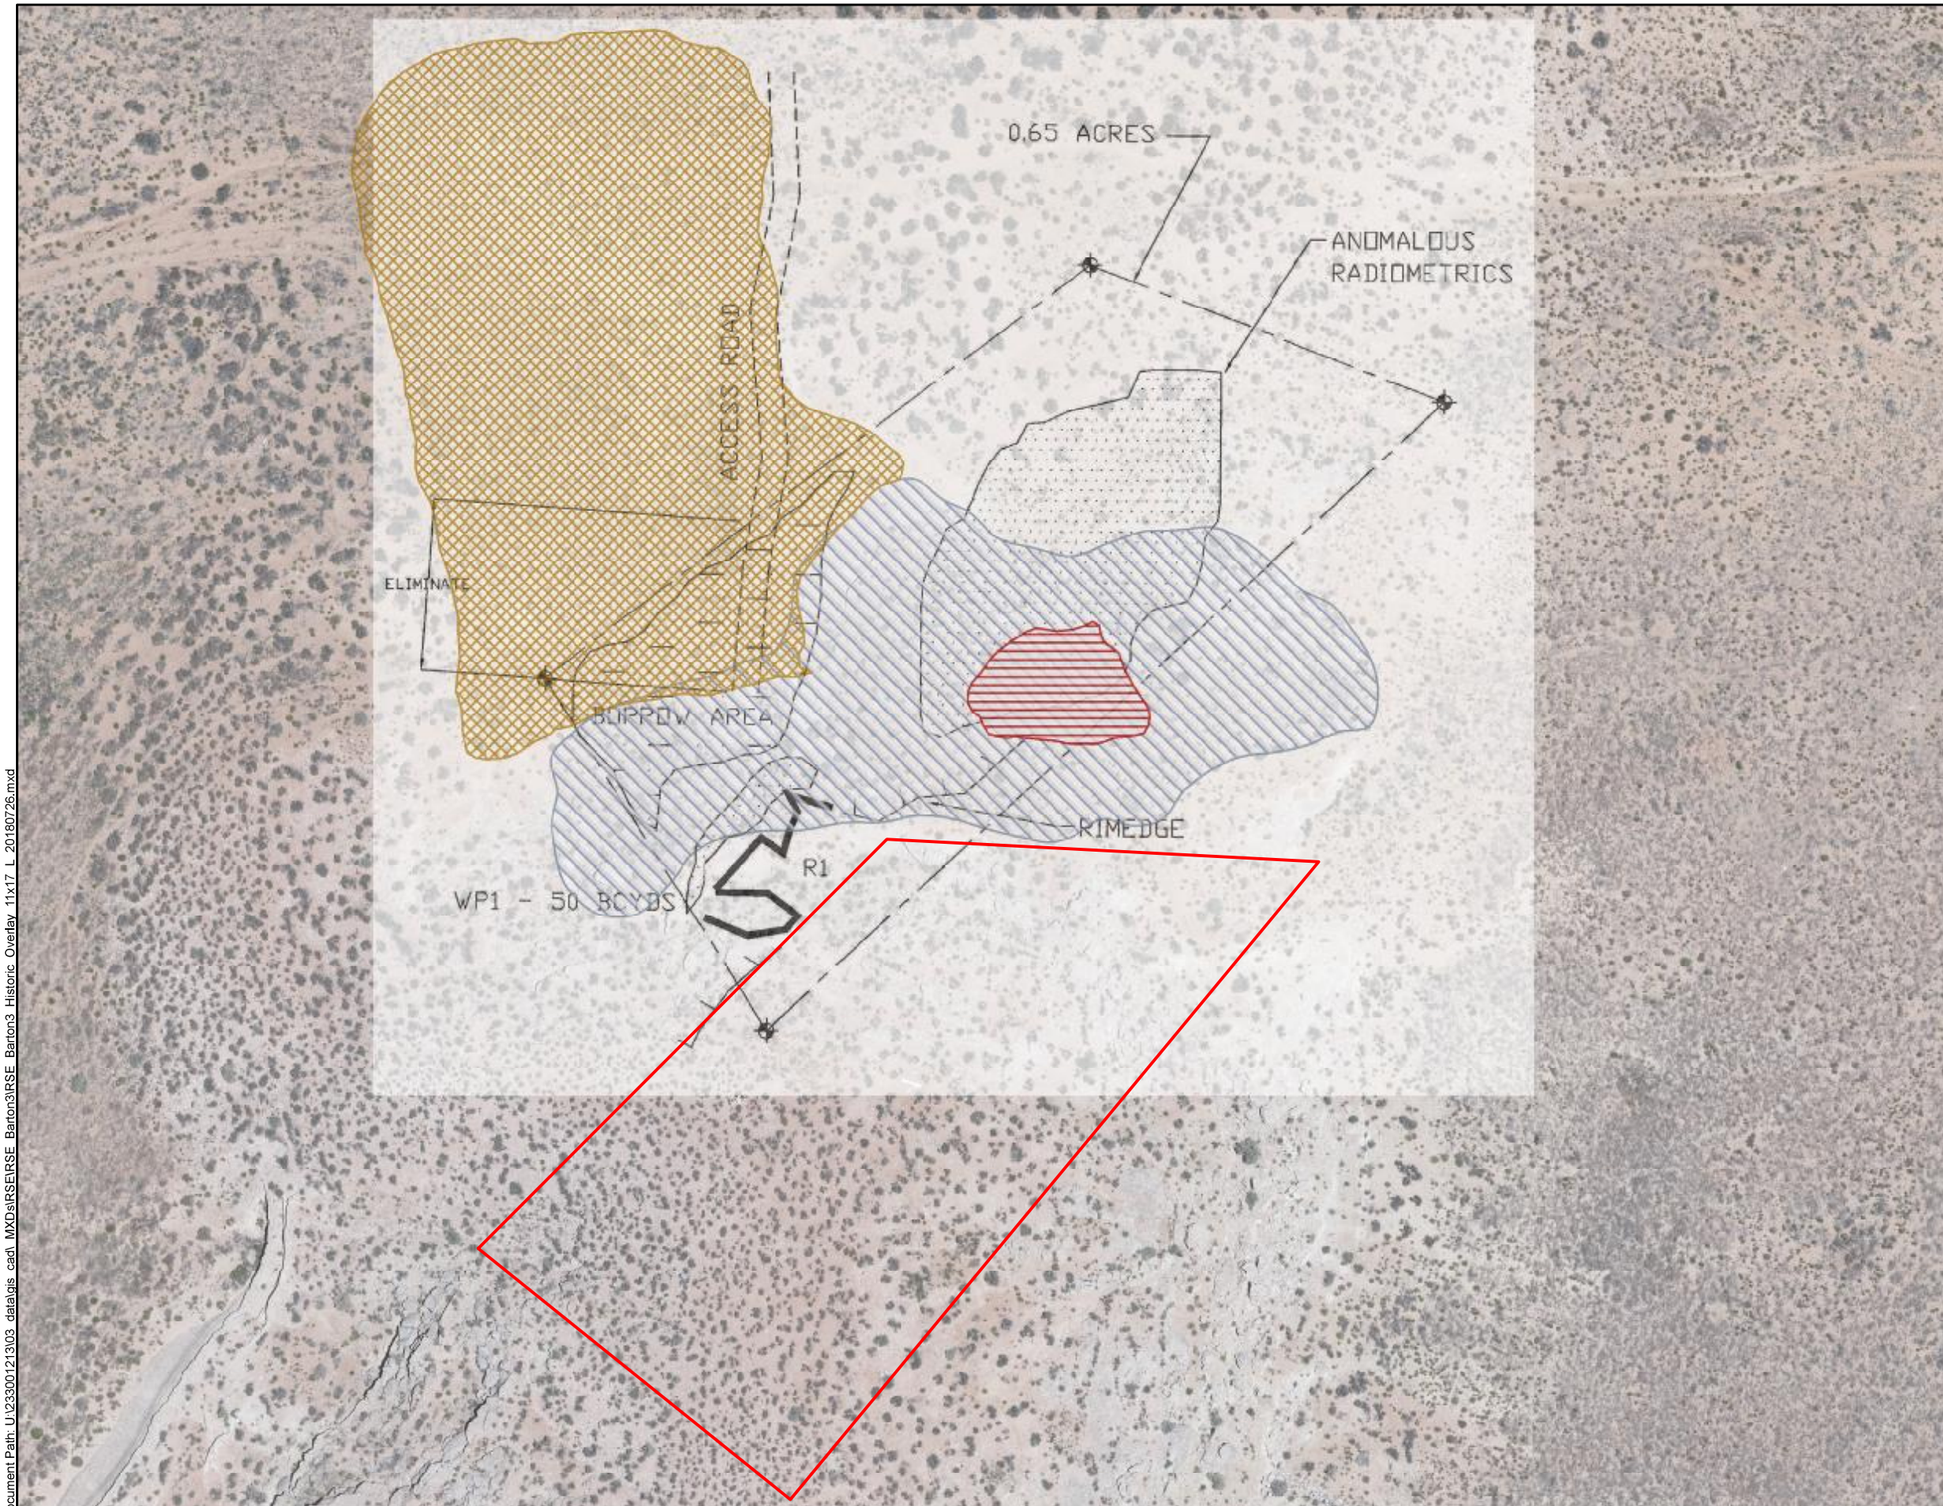
FIGURE: 2-2

- Borehole location S220-SCX-006 and surface sample location S220-CX-007 are potentially located in the area of the historical rim strip and waste pile WP1 shown in Figure 2-2. The elevated Ra-226 concentration (56.30 pCi/L) and subsurface static gamma measurements collected between 2.0 and 2.5 ft bgs in S220-SCX-006 may be indicative of either residual soils from weathered bedrock near the bedrock contact, or from waste rock that was present in either WP1 or the rim strip that was then covered during reclamation at the Site. While the area of these samples is included in the TENORM area,

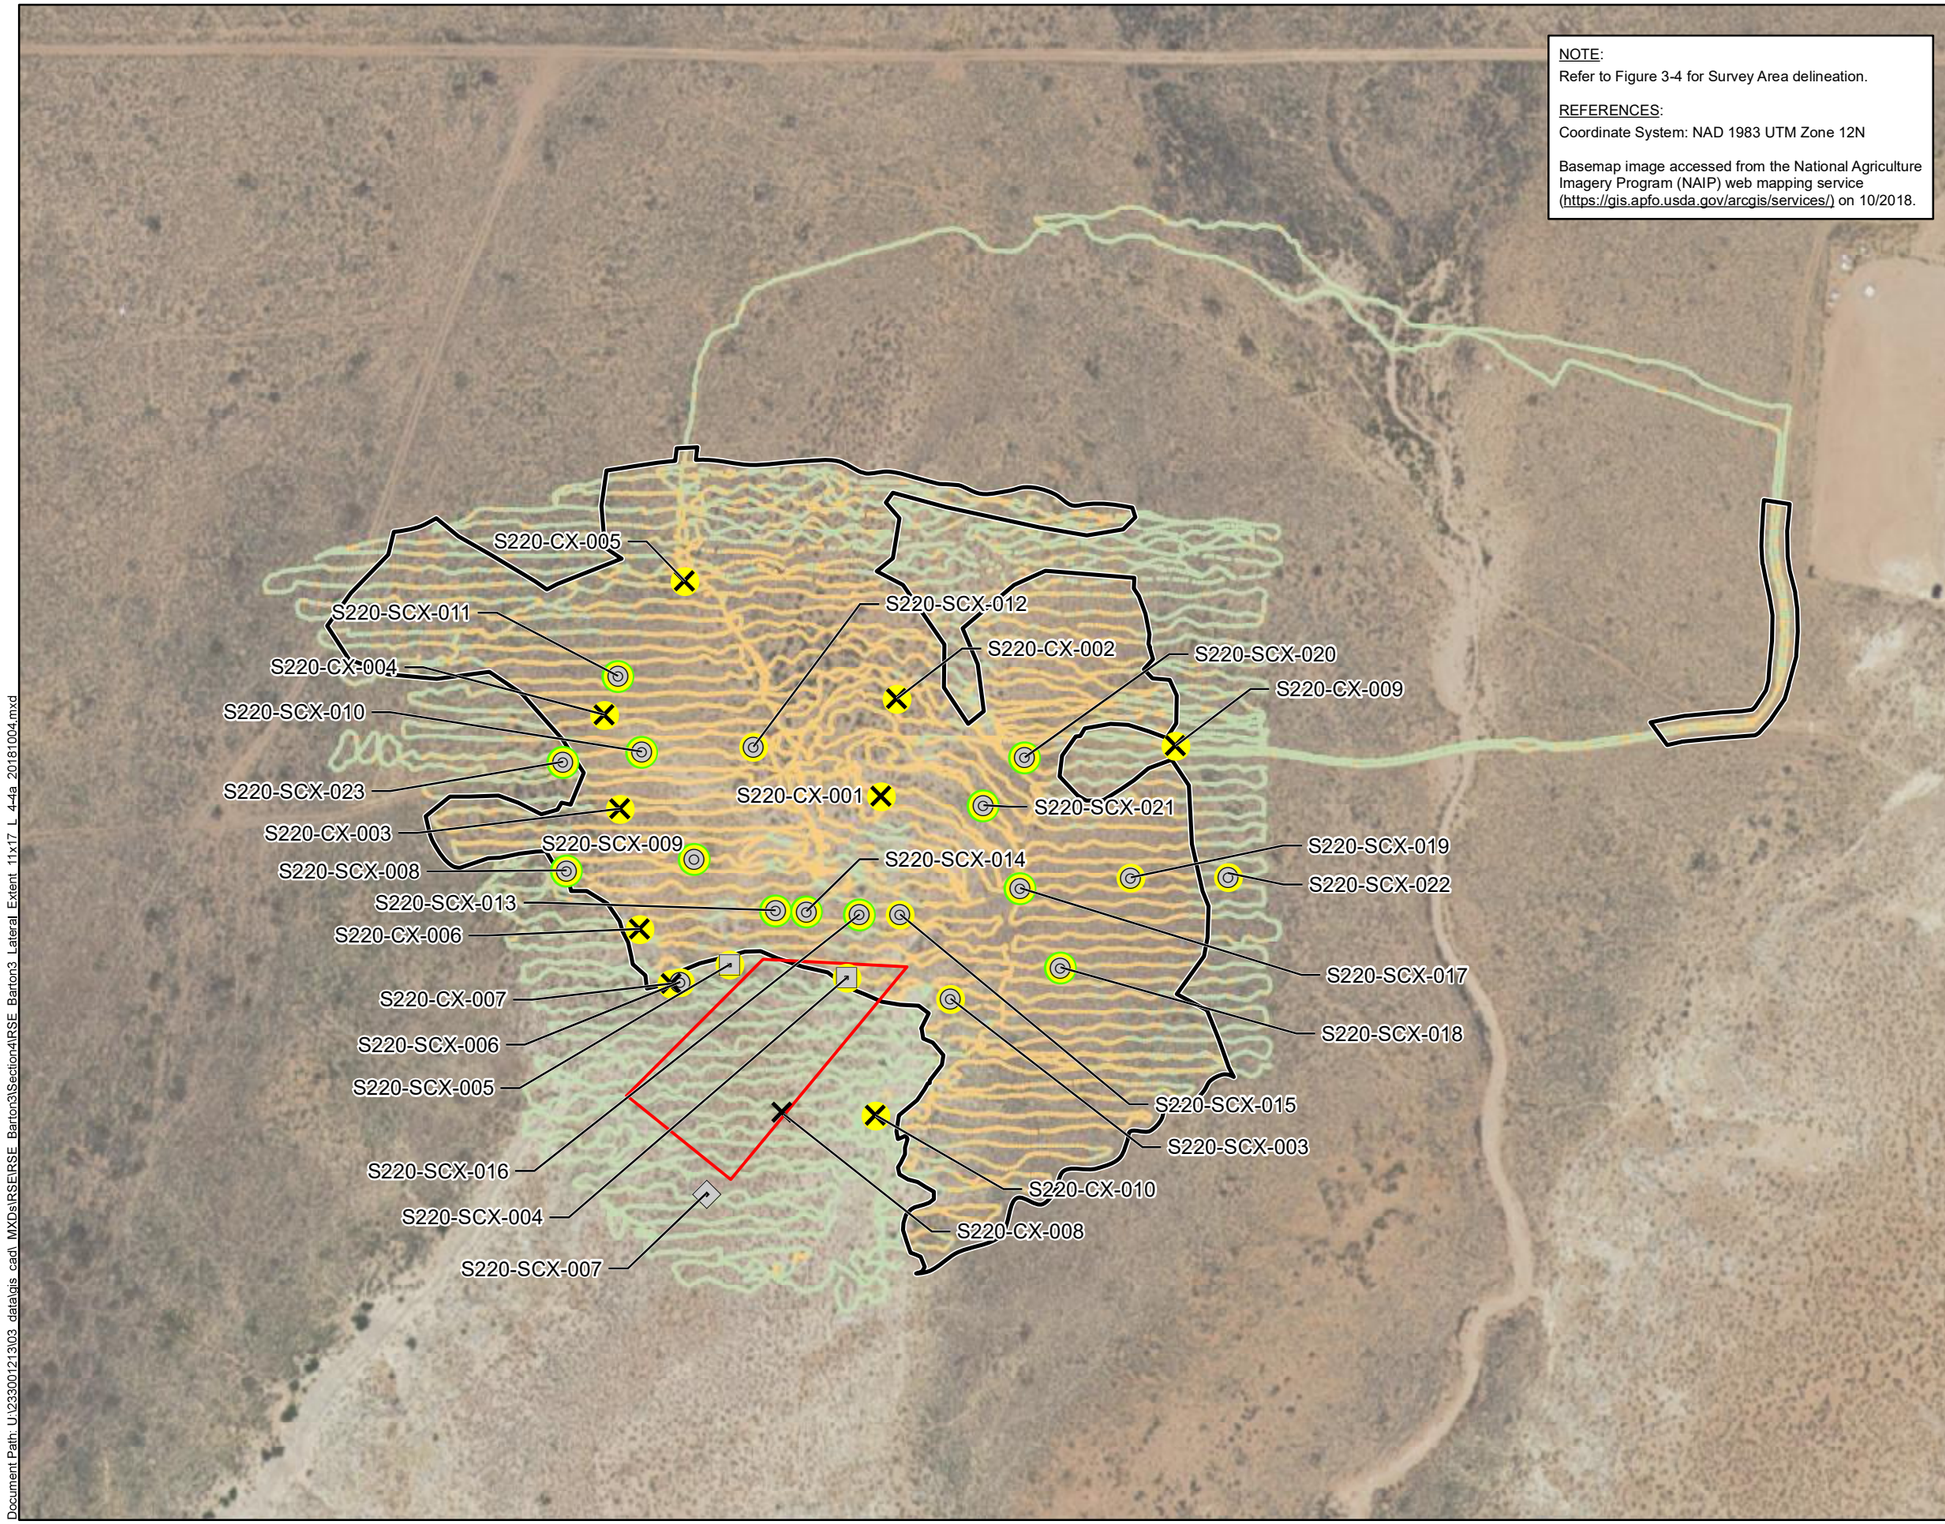
FIGURE: 4-4a

The lateral extent of the IL exceedances (for surface gamma data) shown in Figure 4-4a were compared to the predicted Ra-226 concentrations that exceeded ILs in Figure 4-2c. Predicted Ra-226 concentrations exceeded the Ra-226 IL in a smaller area of the Survey Area A than the surface gamma measurements exceeded the IL. . For Survey Area B, the predicted Ra-226 concentrations exceeded the Ra-226 IL over a larger area than the surface gamma measurements exceeded the surface gamma IL, but the patterns were generally similar. The smaller area of predicted Ra-226 IL exceedances in Survey Area A was the most notable and may indicate that the actual Ra-226 IL is higher when compared to the surface gamma IL for that area and/or that predicted Ra-226 values are lower.

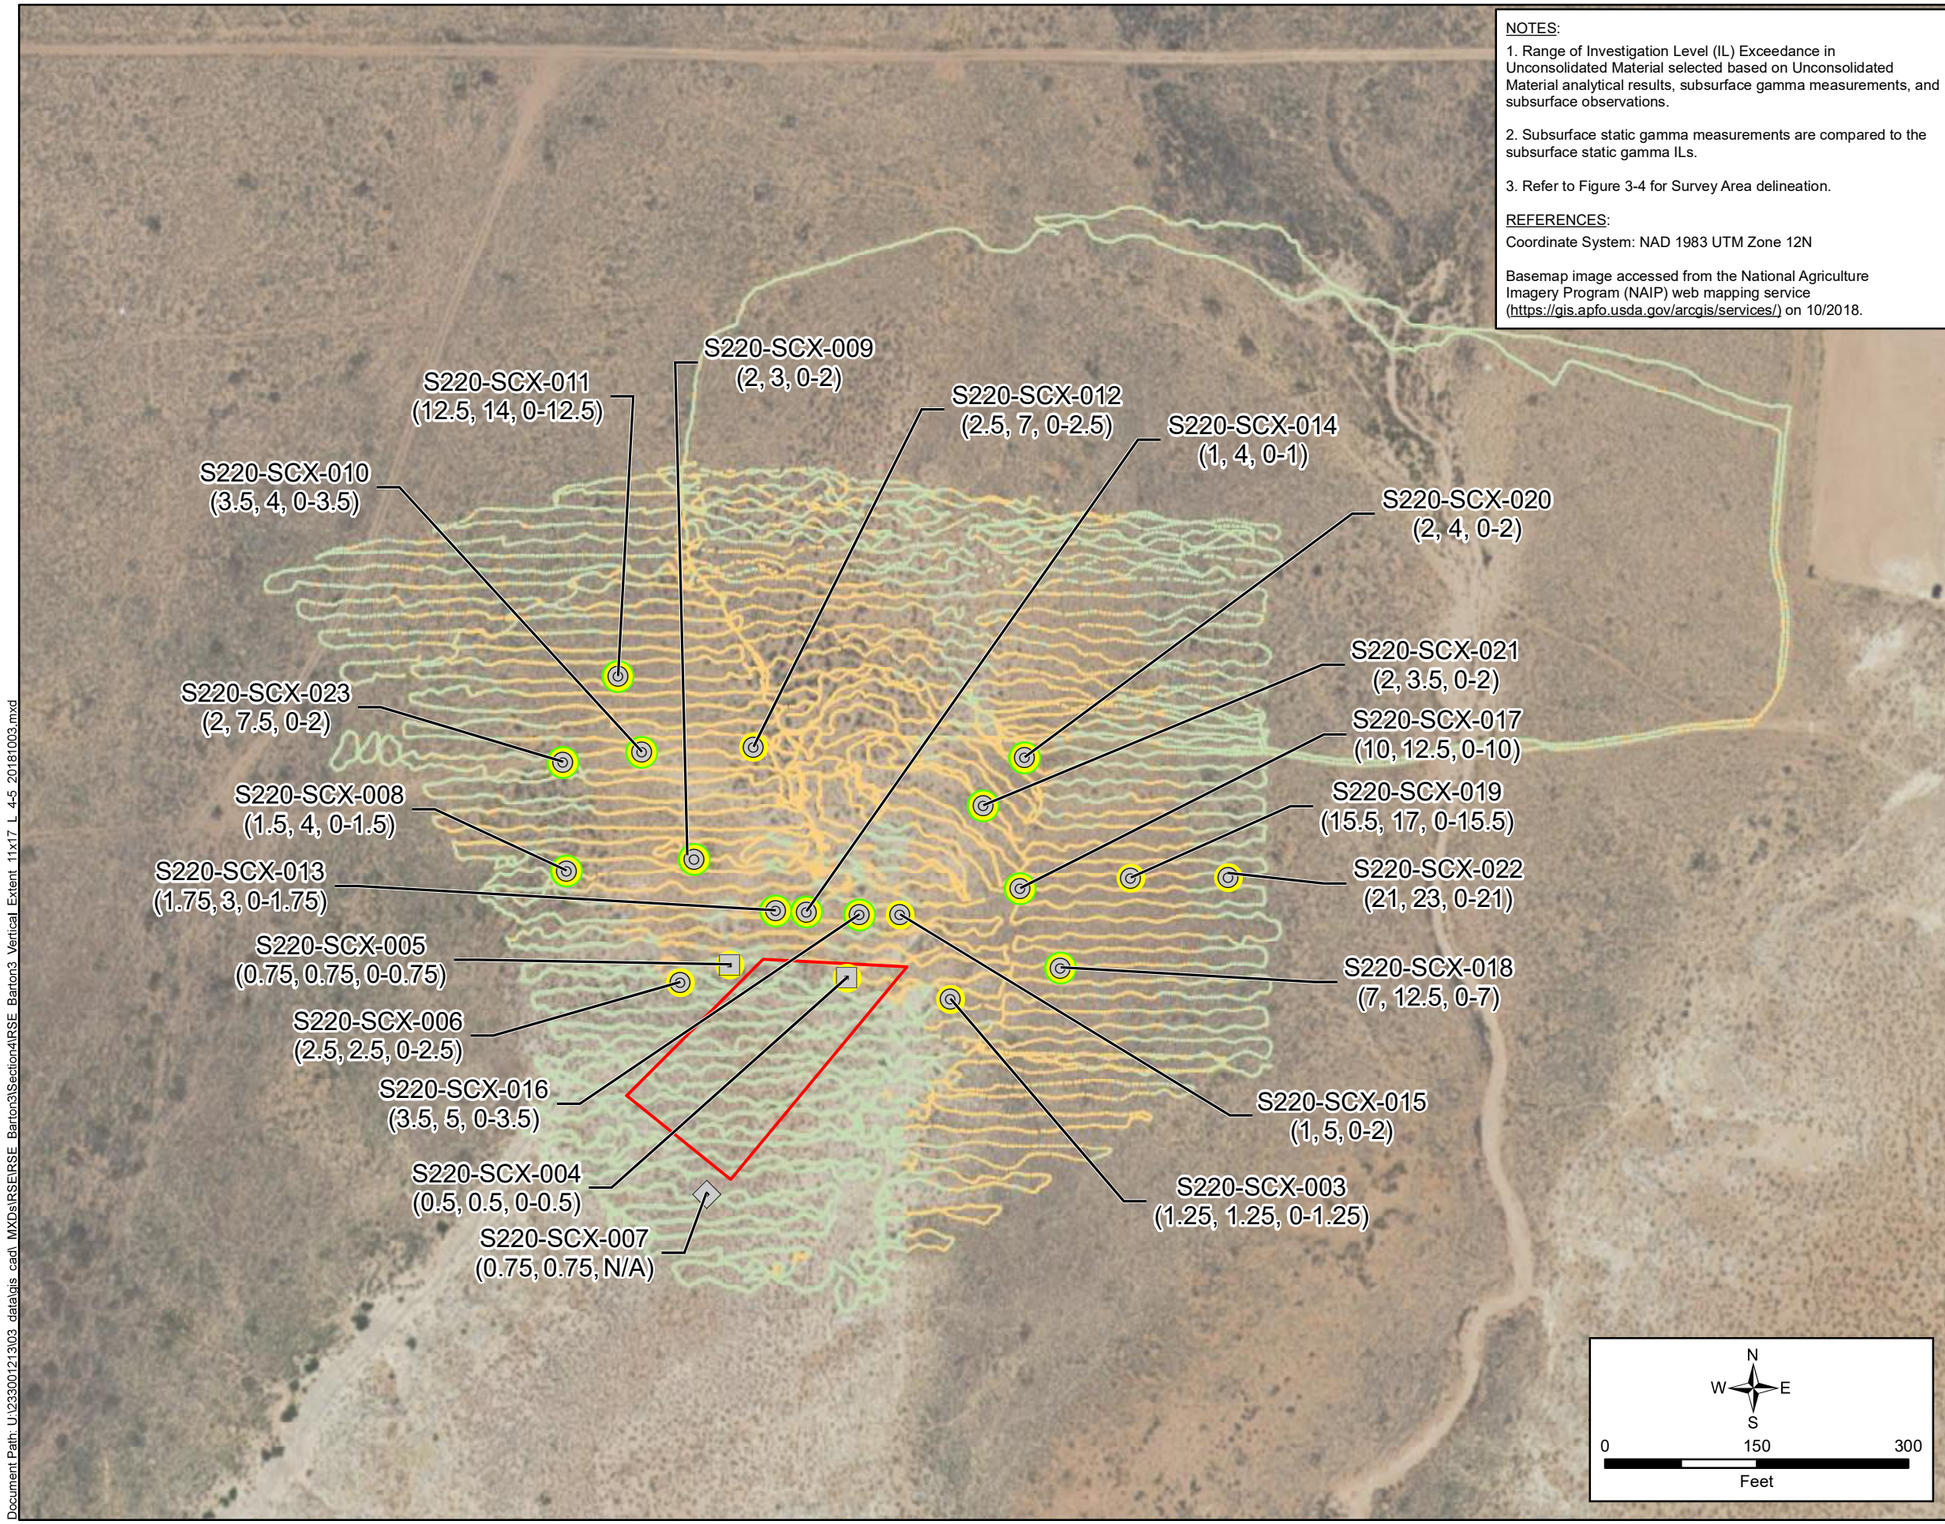
FIGURE: 4-5

Figure 4-5 shows the vertical extent of IL exceedances in each borehole by incorporating information from each location, including: (1) depth to bedrock; (2) total borehole depth; and (3) depth range of IL exceedances. Table 4-5 lists the IL exceedances identified at each borehole location and Figure 4-5 shows the surface gamma IL exceedances for reference.

- Soils outside the mining disturbed area, within the plains, extended from a few feet to over 20 ft bgs, based on the results of subsurface sampling, as shown in Figure 4-5.

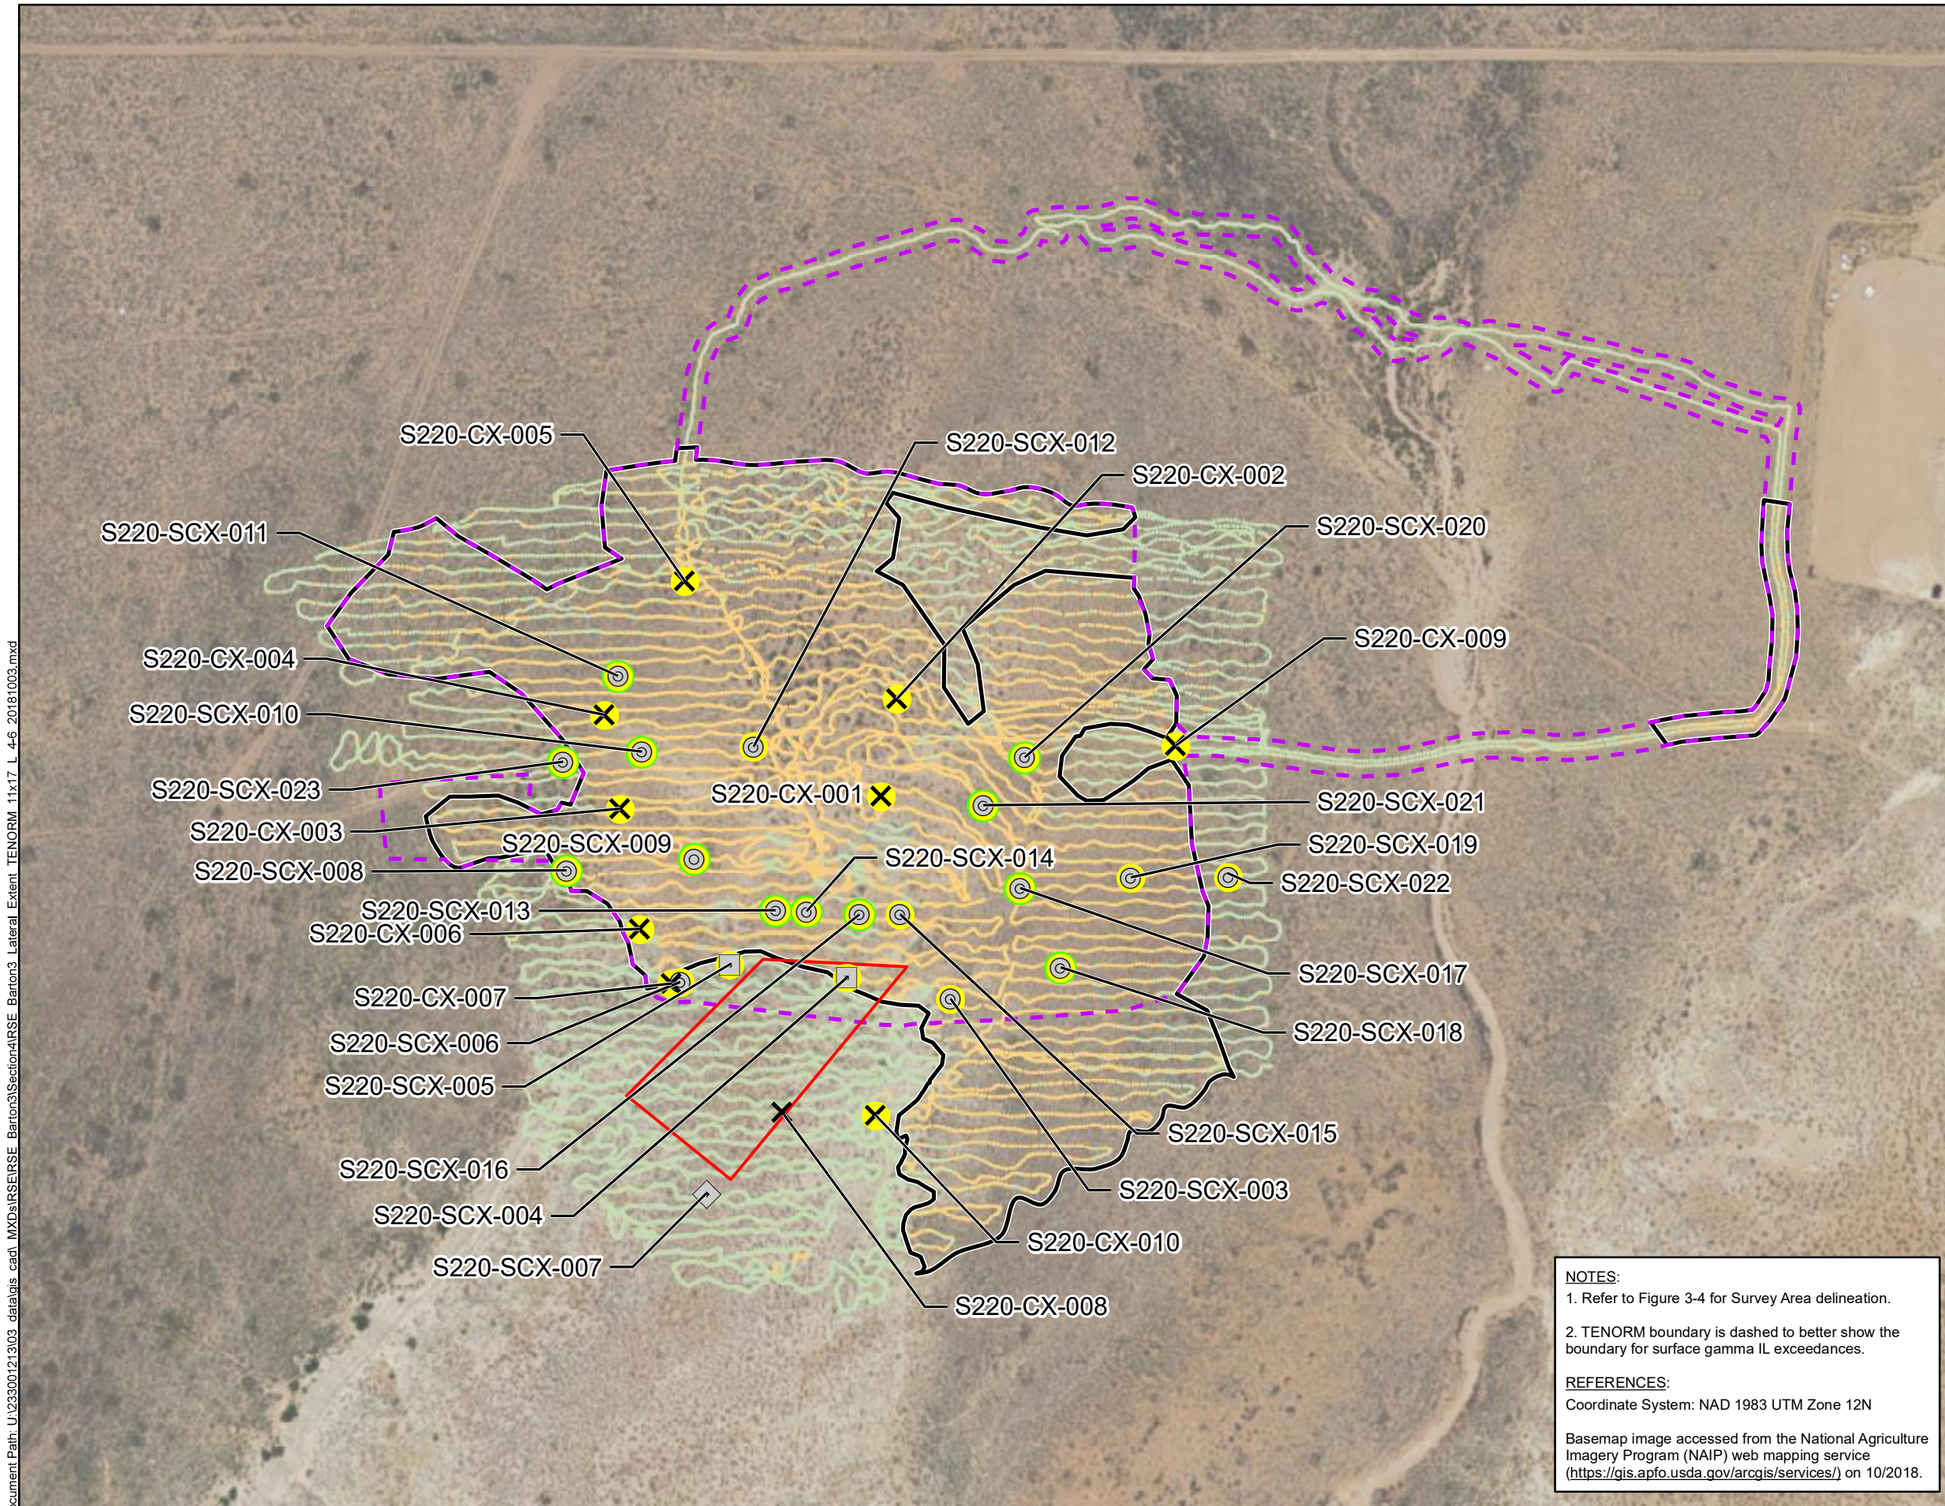
FIGURE: 4-6

A multiple lines of evidence approach was used to evaluate the Site and distinguish areas of TENORM from areas of NORM within the Survey Area, as described in Section 3.3.3. Based on this evaluation, 9.4 acres, out of the 15.4 acres of the Survey Area, were estimated to contain TENORM at the Site. This estimate is inclusive of three areas: (1) Waste Pile 1, the graded/disturbed reclaimed area, and the excavation area; (2) the ridges and plains downgradient from the Site to the north, east and, west and (3) the potential haul roads. The area containing TENORM is shown in relation to the lateral extent of IL exceedances in Figure 4-6 and in relation to the gamma measurements in Figure 4-7.

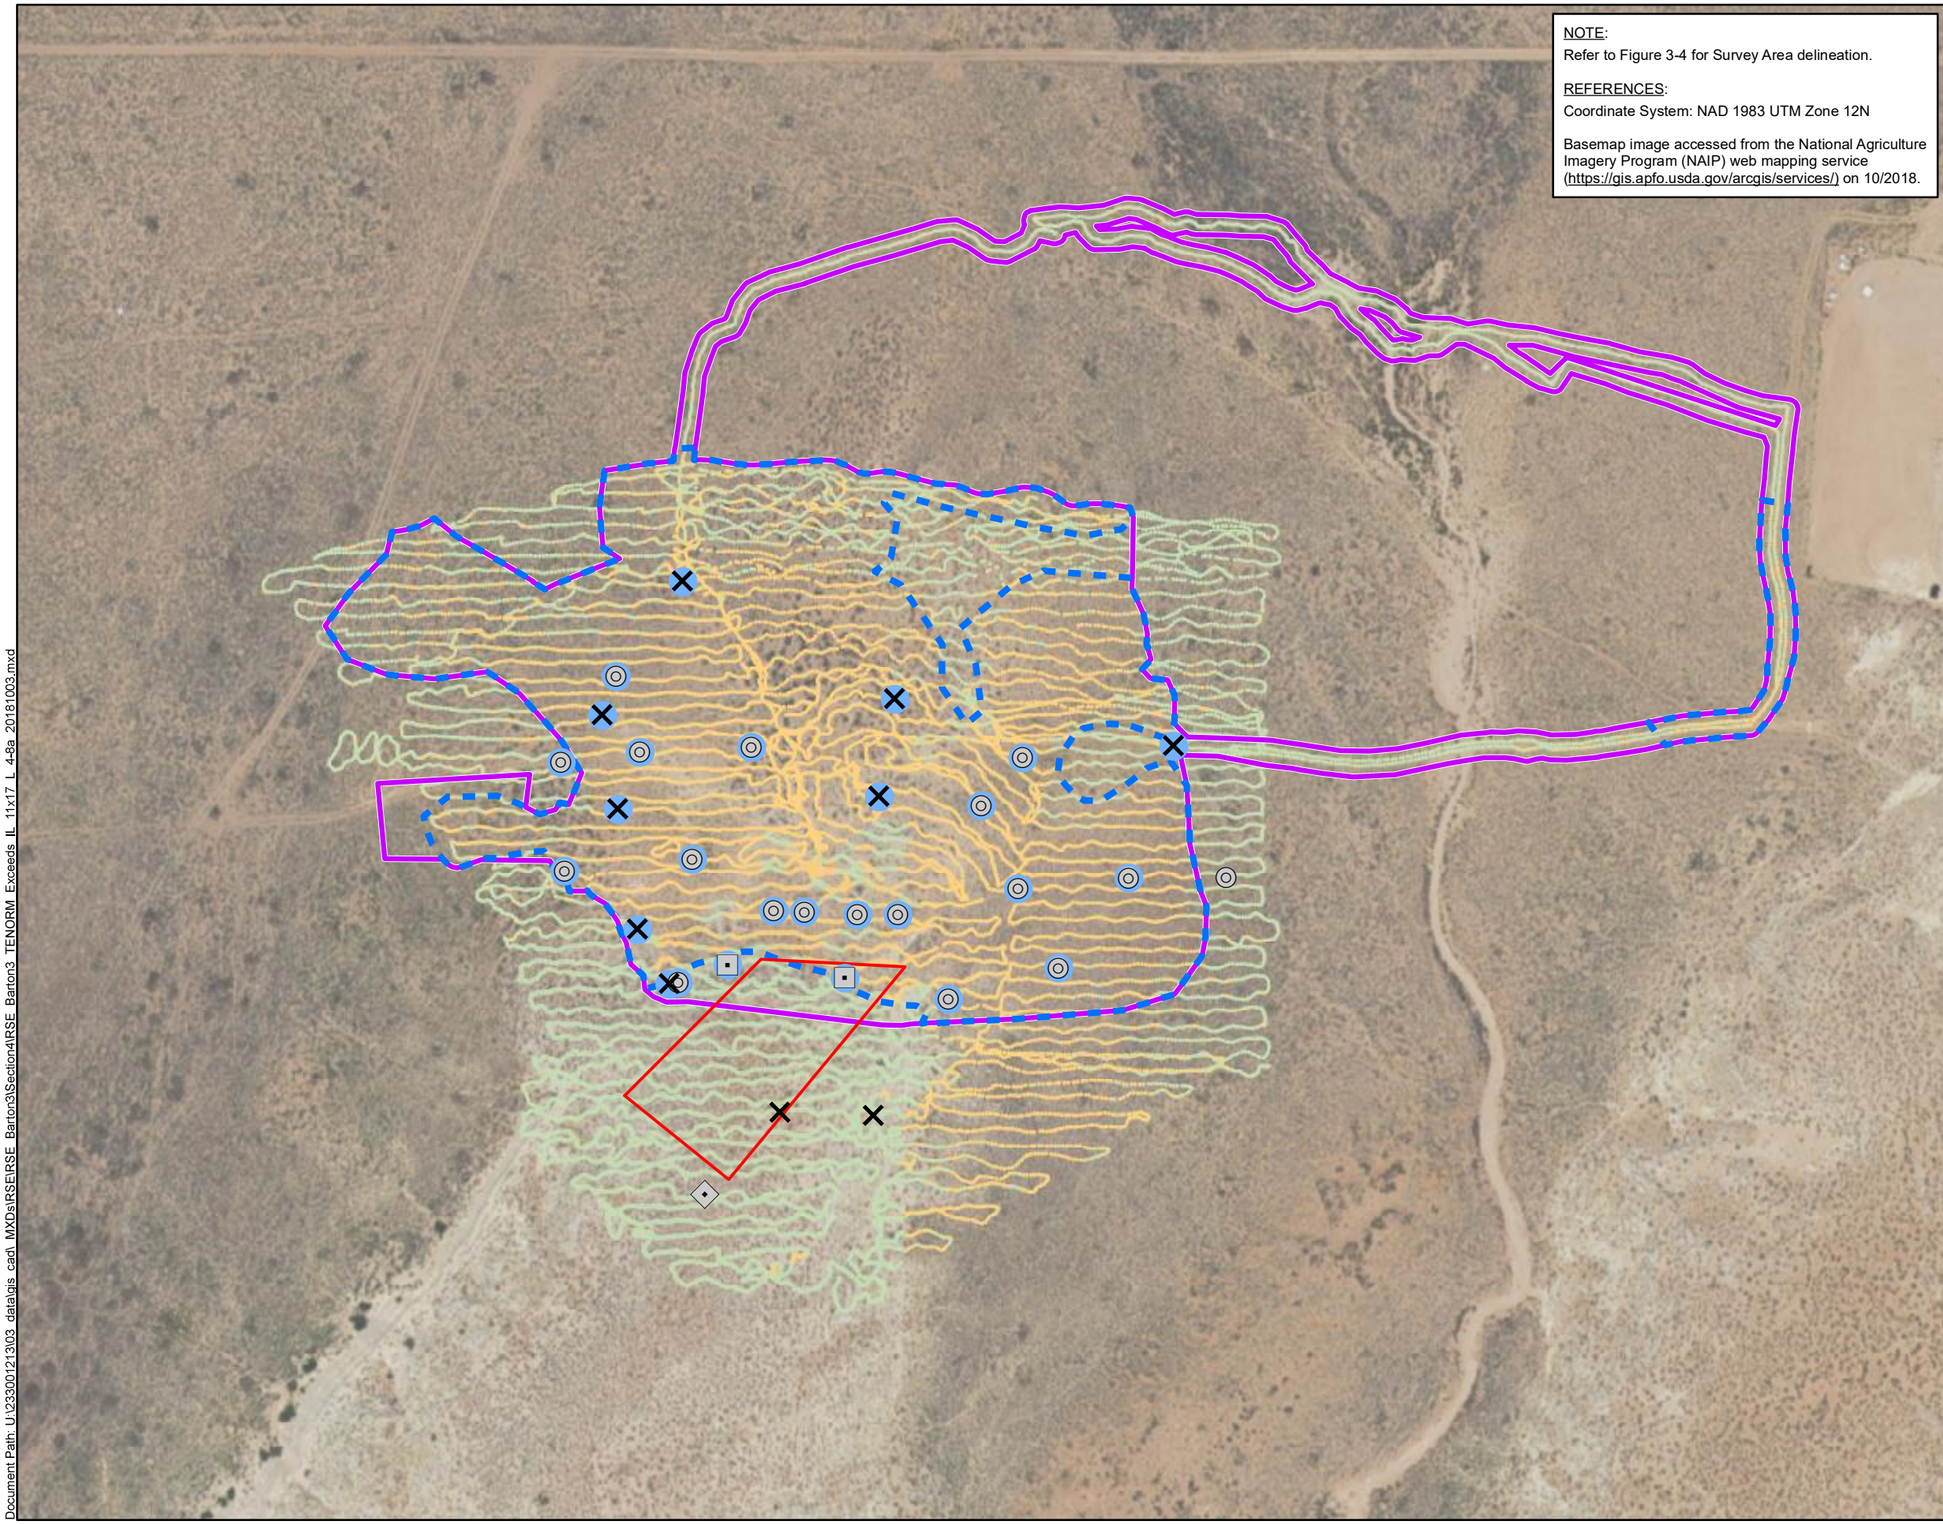
FIGURE: 4-8a

The area of the Site considered to contain TENORM (i.e., multiple lines of evidence indicated the presence of mining-related impacts) was 9.4 acres, as shown on Figure 4-8a. Portions of the TENORM exceeded one or more IL, where approximately 7.2 acres contained TENORM that exceeded the surface gamma IL and the majority of the sample locations where TENORM exceeded the ILs. TENORM exceeding the ILs was observed at four sample locations (S220-CX-007, -CX-009, -SCX-005, and -SCX-006) that were directly adjacent to areas of the Site that exceeded the surface gamma IL. TENORM that exceeded the ILs in Survey Areas A and Survey Area B is shown on Figures 4-8b and 4-8c, respectively, and is compared to mining-related features in Figure 4-8d.

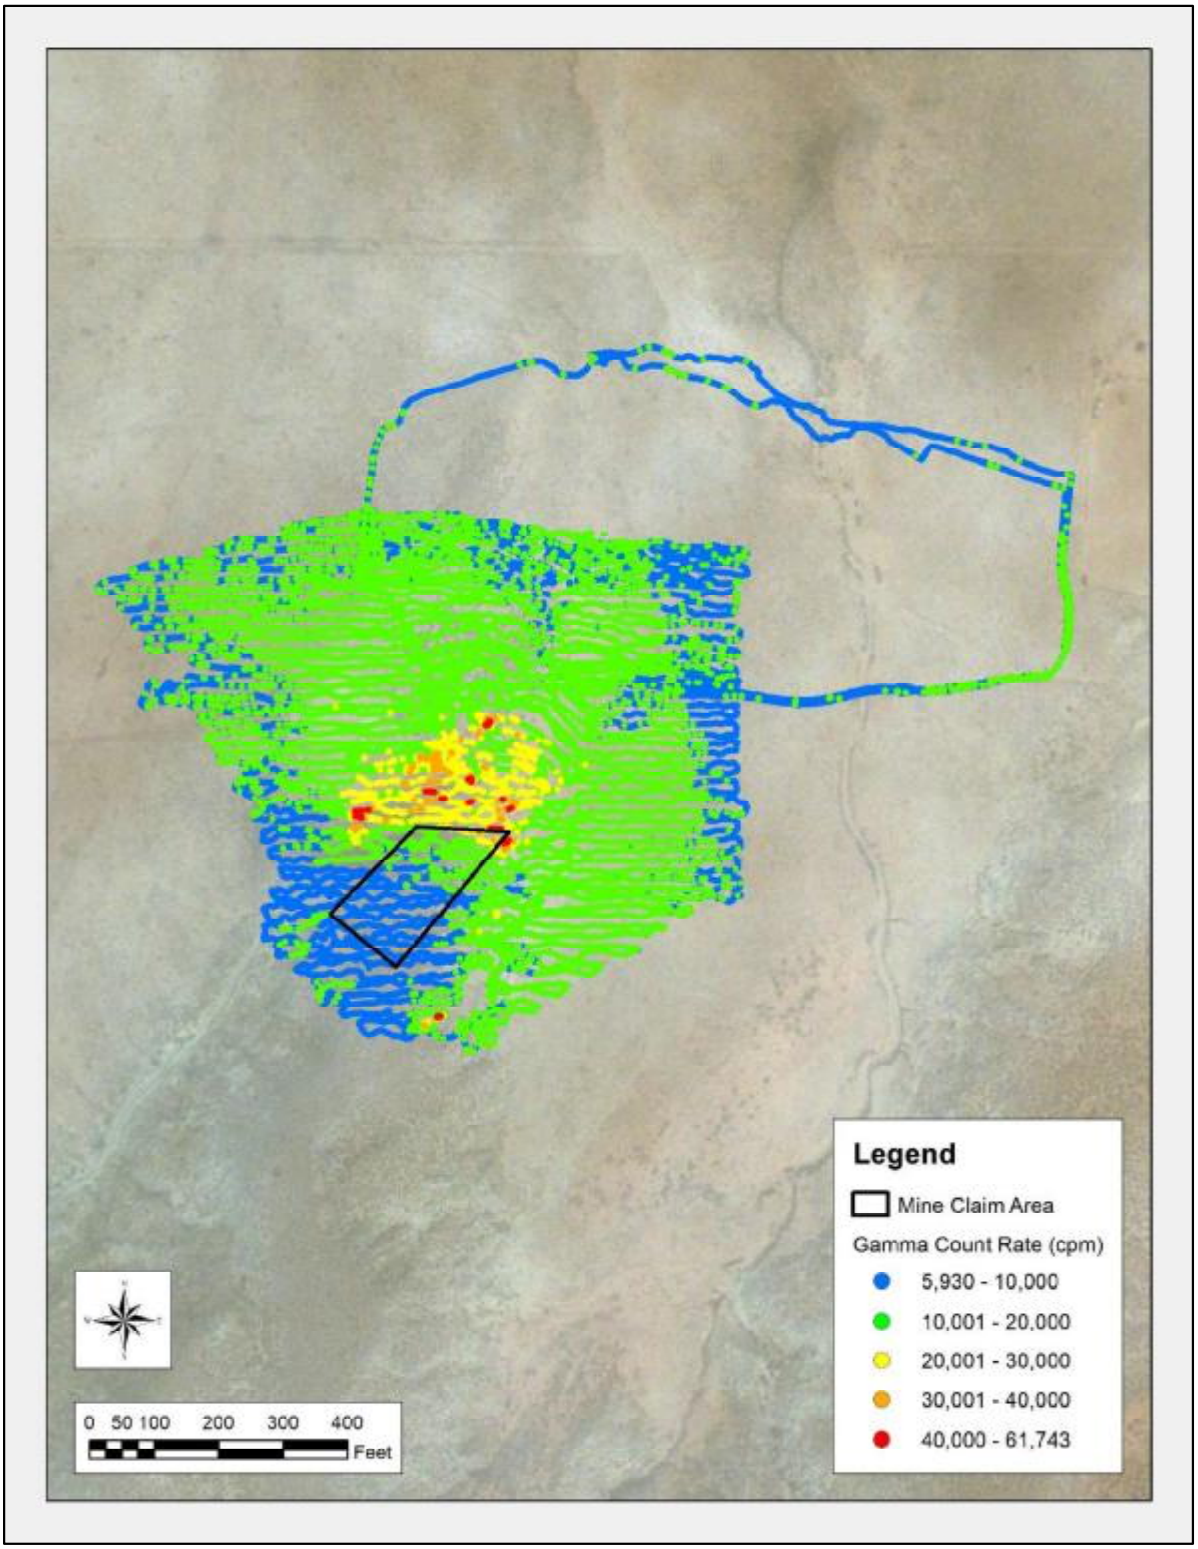
Figure 4. Gamma count rates in the Survey Area.

The gamma count rates observed in the Survey Area are depicted in Figure 4. The highest count rates were observed north of the mine claim, on and around the reclaimed area.

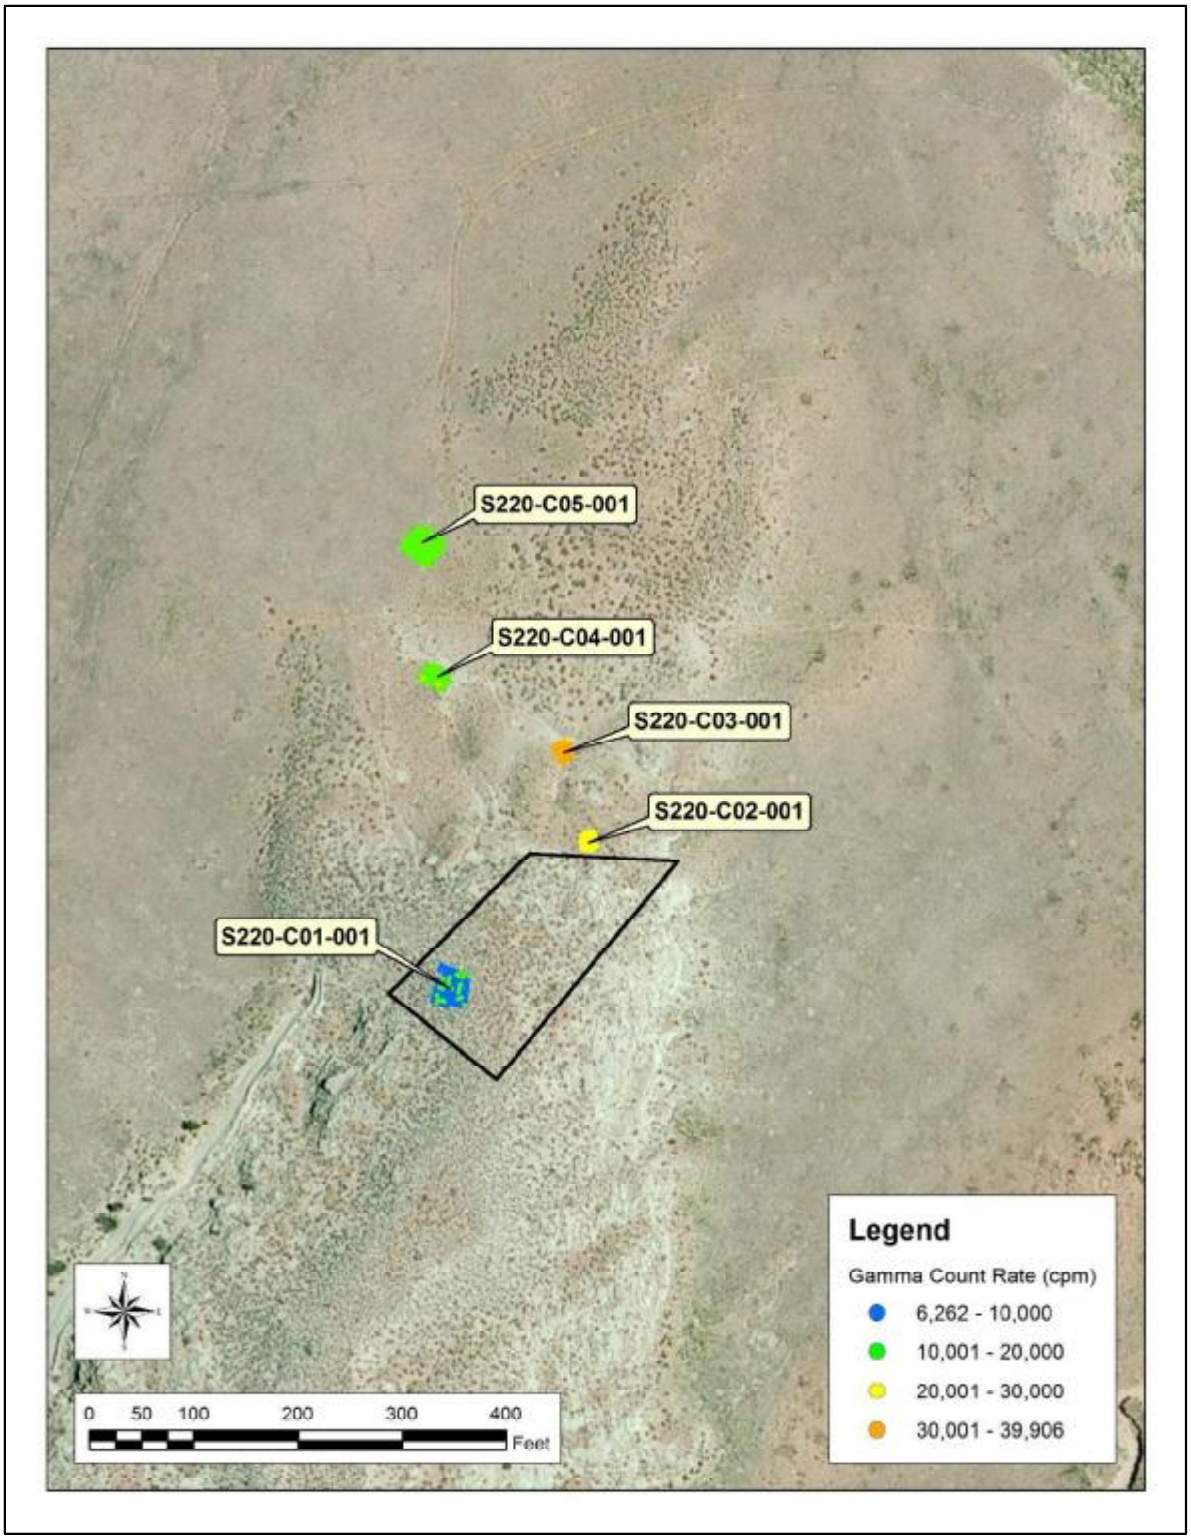
Figure 7. GPS-based gamma count rate measurements made for the correlation study.

On October 14, 2016 field personnel made GPS-based gamma count rates measurements and collected five-point composite samples of surface soils in each of five areas at the AUM. These areas were selected using criteria established in the RSE Work Plan. No DQO was established for homogeneity of the correlation plots and as described in Section 4.3 and Appendix E of the RSE Work Plan, homogeneity of the correlation plots was evaluated qualitatively. Sub-samples were collected from the correlation plot centroid and at each corner of the plot. The activities were performed contemporaneously, by area and all on the same day, such that variations in the gamma count rate measurements could be limited largely to those posed by the soils and rocks at the locations. Figure 7 shows the GPS-based gamma count rate measurements in the five areas (labeled with location identifiers).

The soil samples were analyzed by ALS Laboratories in Ft Collins, CO for radium-226 and isotopic thorium. The latter analysis was included to assess the potential effects of thorium series isotopes on the correlation and evaluate thorium-230 and radium-226 activities to indicate the status of equilibrium in the uranium decay series. Table 4 lists the results of the gamma count rate measurements and radium-226 concentrations in the soil samples. The means of the gamma count rate measurements range from 8,673 to 32,608 cpm. The concentrations of radium-226 in the soil samples range from 0.98 to 10.6 pCi/g.

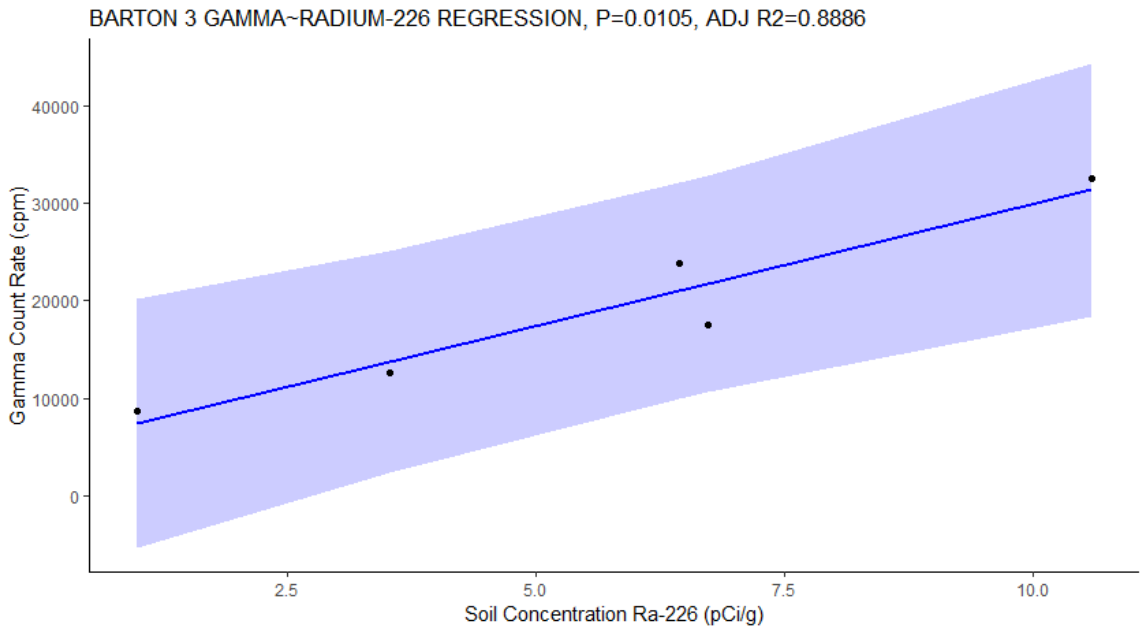
Figure 8. Correlation of gamma count rates and concentrations of radium-226 in surface soils (blue line) with 95% upper prediction level bands plotted (shaded blue area).

A model was made of the results in Table 4, predicting the concentrations of radium-226 in surface soils from the mean gamma count rate in each area. The mean relationship between the measurements, shown in **Figure 8**, is a linear function with an adjusted Pearson's Correlation Coefficient (adjusted R^2) of 0.89, as expressed in the equation:

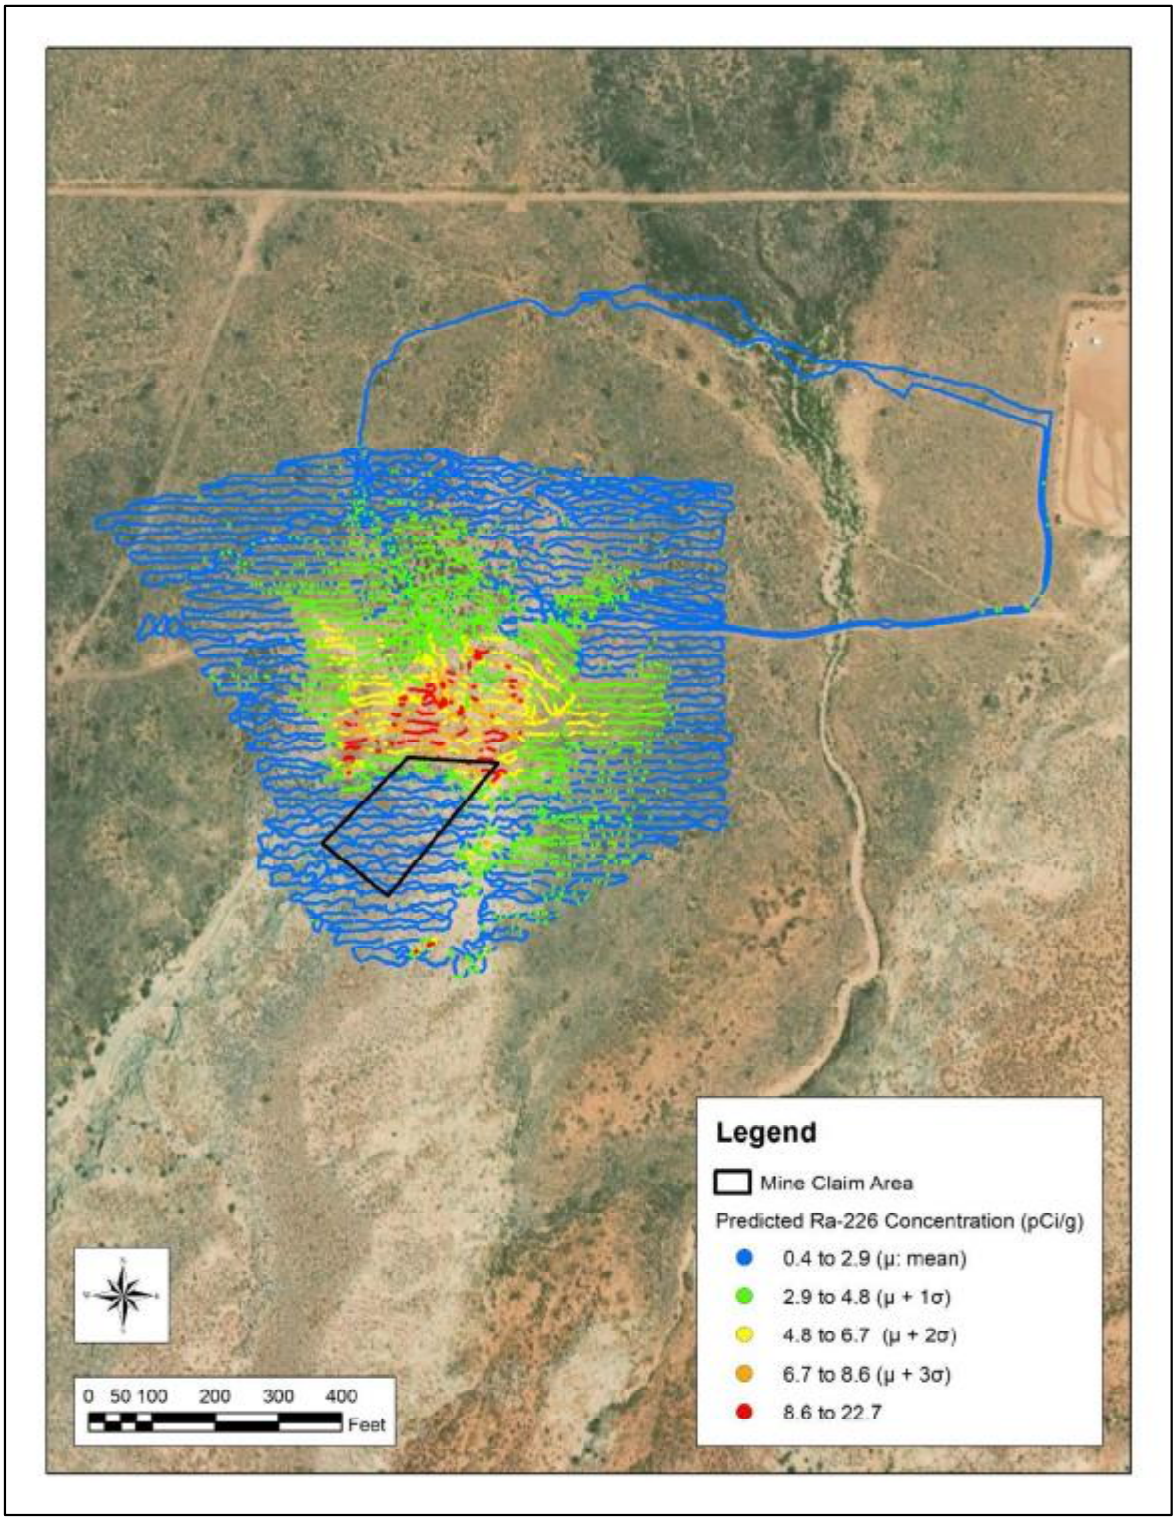
Figure 9. Predicted concentrations of radium-226 in the Survey Area.

predicted concentrations of radium-226 in the Survey Area is 0.4 to 22.7 pCi/g, with a mean and median of 2.9 and 2.3 pCi/g, respectively. Note that the radium-226 concentrations predicted from gamma count rate measurements exceeding approximately 33,000 cpm are extrapolated from the regression model and are outside of the correlation dataset and therefore inherently uncertain. While the gamma correlation equation can be used to convert gamma count rates to concentrations of Ra-226 in soil, the resulting radium concentrations are highly uncertain estimates, as the wide prediction interval bands illustrated in Figure 8 demonstrate. Users of the regression equation should be aware of the limitations of the dataset and be cautious when estimating radium-226 concentrations.

Figure 9 shows the predicted concentrations of radium-226, the spatial and numerical distribution of which mirror those depicted in Figure 4.
