THIRD FIVE-YEAR REVIEW REPORT FOR BOARHEAD FARMS SUPERFUND SITE BUCKS COUNTY, PENNSYLVANIA

U.S. Environmental Protection Agency Region 3 Philadelphia, Pennsylvania

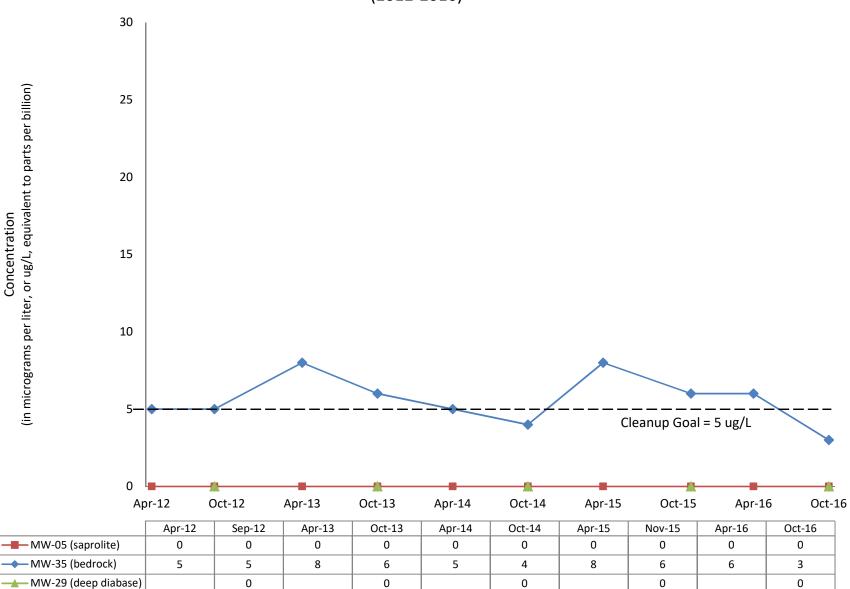
Concentrations of 1,1,1-TCA in Perimeter Well Triplet MW-05, MW-35, and MW-29 (2012-2016)

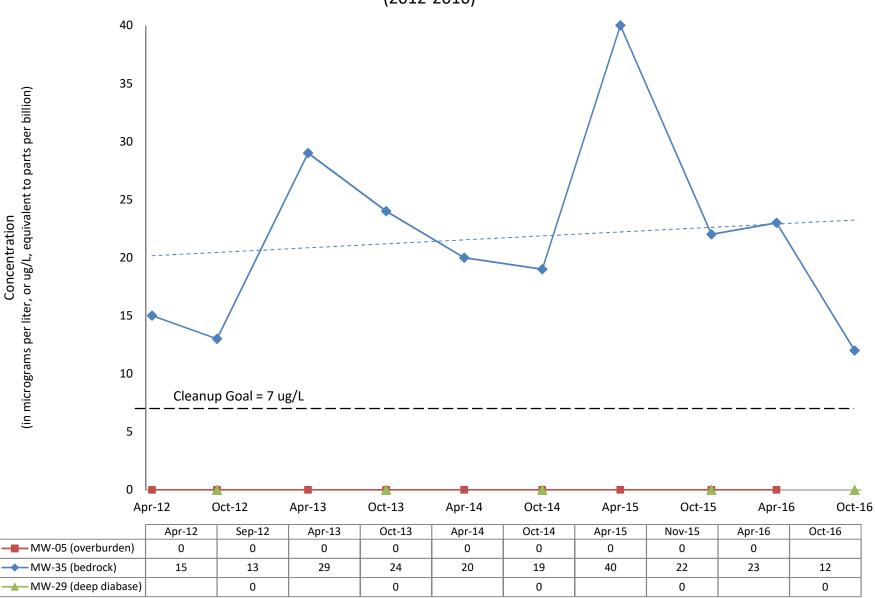
Concentrations of PCE in Perimeter Well Triplet MW-05, MW-35, and MW-29 (2012-2016)

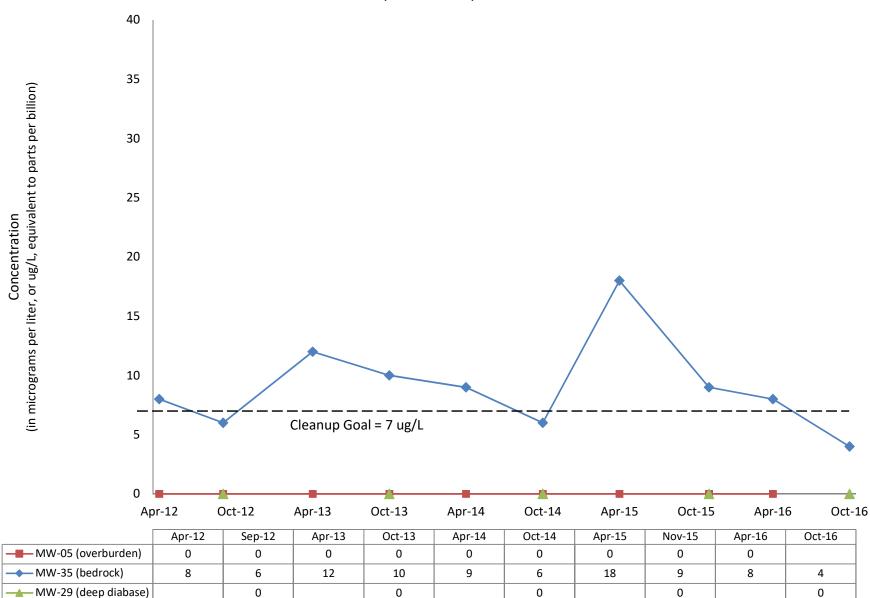
Concentrations of cis-1,2-DCE in Perimeter Well Triplet MW-05, MW-35, and MW-29 (2012-2016)
