Barton 3 (#220)

Removal Site Evaluation Report

Final | October 9, 2018

NAVAJO NATION
AUM Environmental Response Trust-First Phase

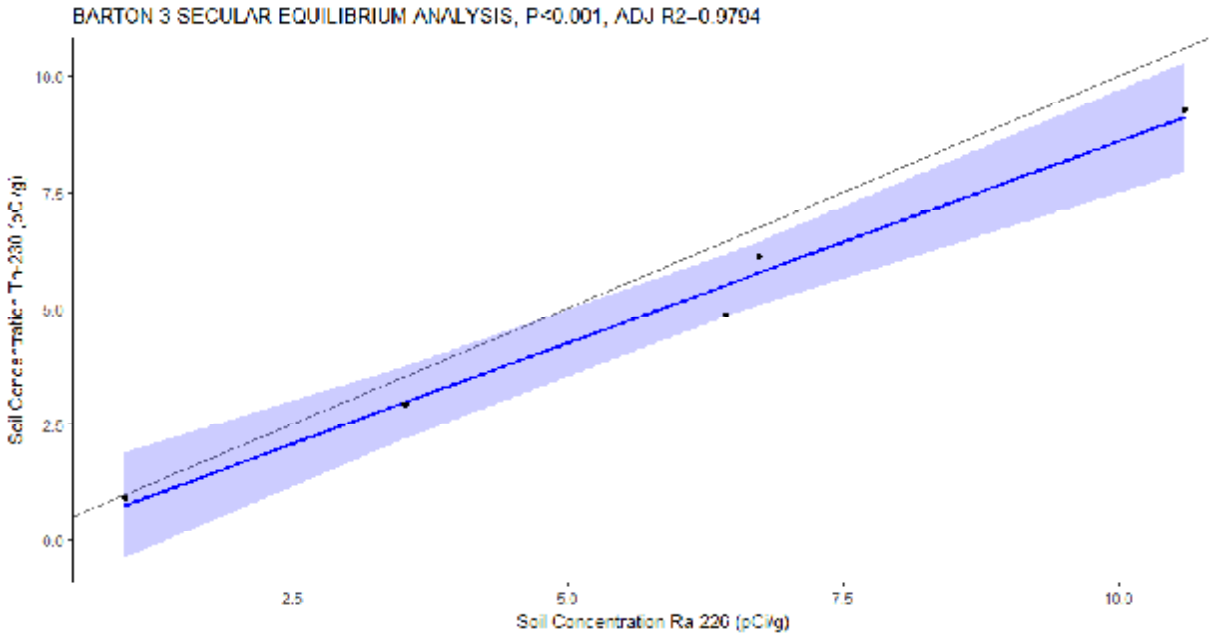
Figure 10. Evaluation of secular equilibrium in the uranium decay series.

Based on this method, ERG concludes there is evidence that thorium-230 and radium-226 are in equilibrium, but not secular equilibrium (Figure 10).

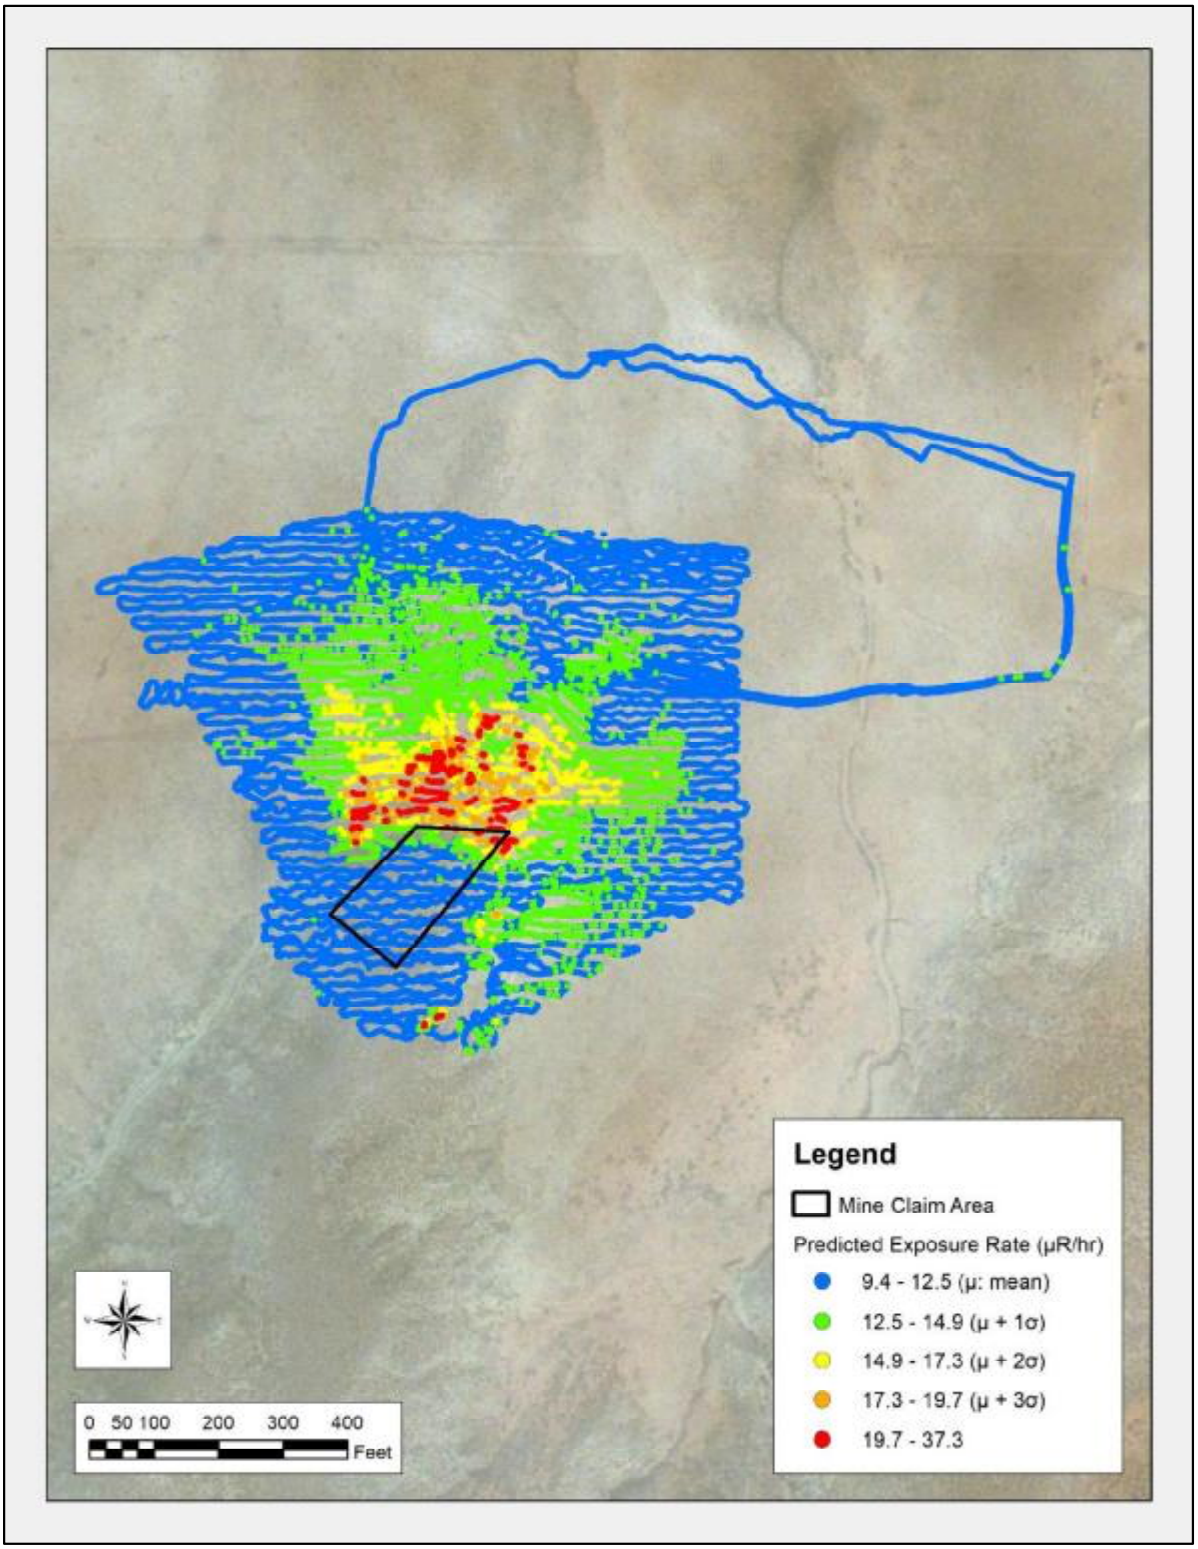
Figure 12. Predicted exposure rates in the Survey Area.

Figure 12 presents the exposure rates predicted from the gamma count rate measurements, the spatial and numerical distribution of which mirror those depicted in Figure 4.

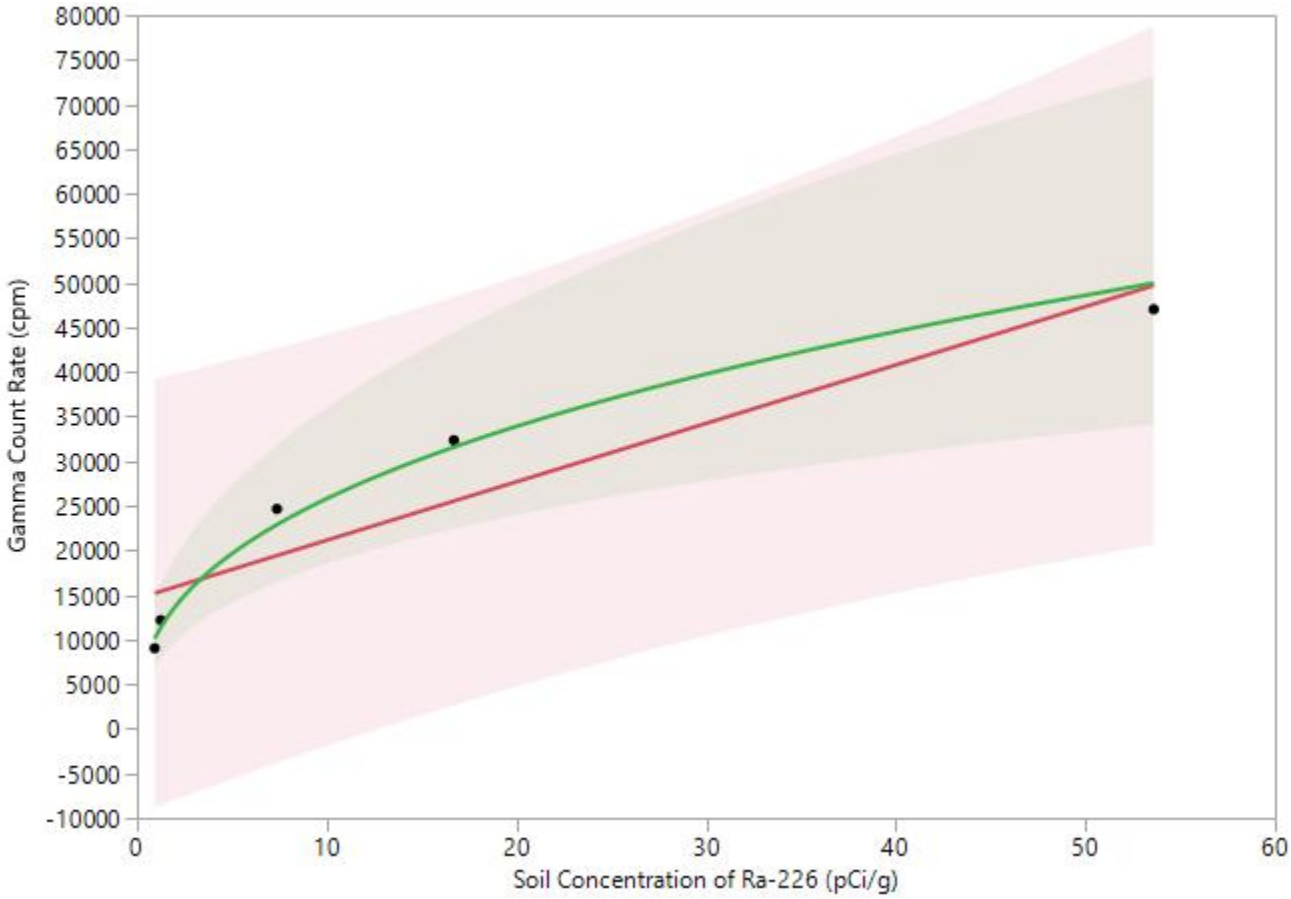
The failure to construct statistically defensible correlation models at four AUMs has been identified as a data gap in the relevant AUM report. The unsatisfactory correlation result at these locations is likely due to the small number of correlation locations, or environmental conditions at the AUMs (e.g., spatial heterogeneity in radionuclide concentration in soil, topographic features influencing gamma count rate, etc.), or some combination thereof.

Note that while the statistical measures (i.e., conformance with the study DQO of $R^2 > 0.8$) associated with these regressions can be improved by fitting a power curve to the data, and reporting unadjusted R^2 values, with only five data points at each AUM, ERG does not believe that any statistical correlation model is sufficiently robust to make meaningful inferences concerning soil radium-226 concentration from the gamma scanning data. ERG believes that linear functions – not power curves – best mimic the conceptual model for the physical processes governing the observed data. Fitting any other function in an effort to achieve the study DQO for R^2 is not a statistically rigorous approach, and improving R^2 does not commensurately improve a statistical model's predictive ability. Figure *1* compares the result of fitting a linear versus a power function to the available correlation data for one AUM (Hoskie Tso); the other AUM results are similar.

Figure 1. Regression models (linear versus power curve) for gamma count rate regressed on radium-226 showing 95% UPLs (upper prediction limits). Both models meet the study DQO for adjusted R^2 (greater than 0.8). Gamma count rate is not an especially strong predictor of soil concentration of radium-226 for either function.

ERG has updated the individual AUM reports with linear correlation functions and reported the more robust measures of statistical performance described in this memo.

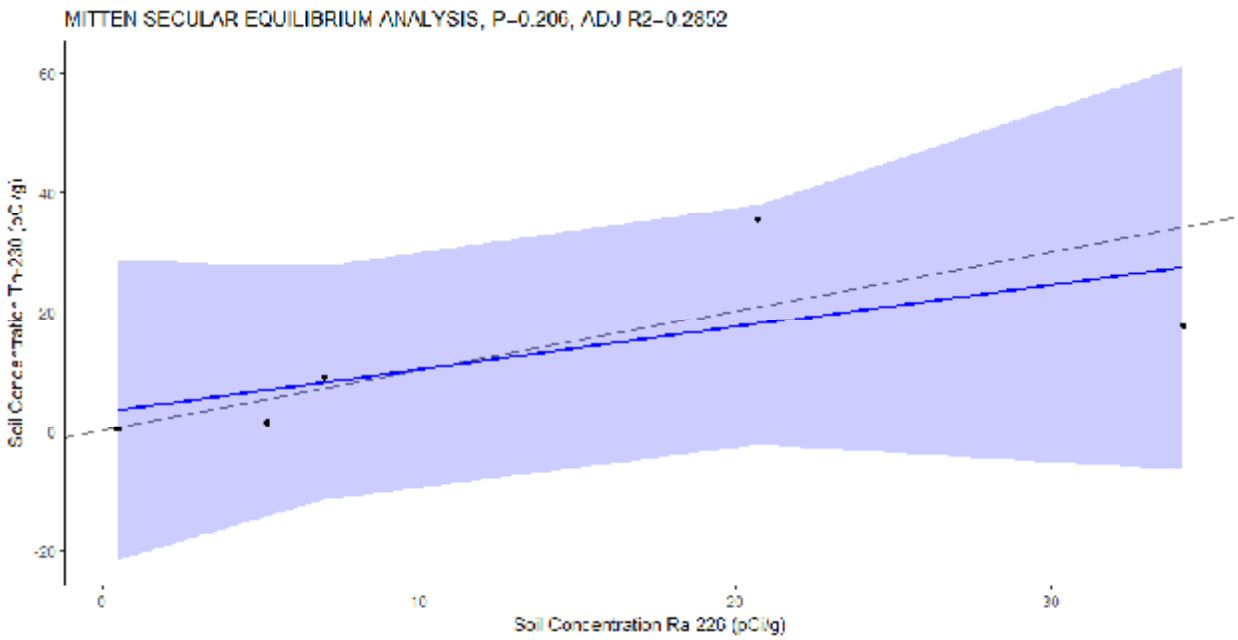
Figure 2. Result for Mitten secular equilibrium analysis, showing failure to meet p-value and adjusted R^2 criteria, i.e., the data are poorly correlated.

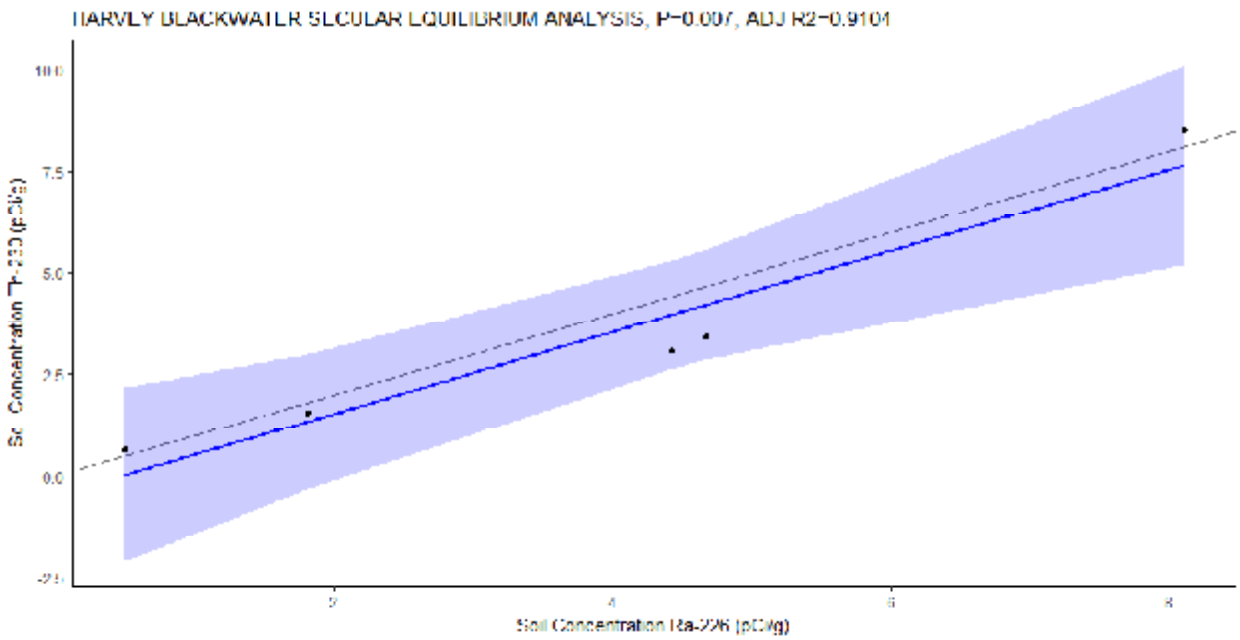
Figure 3. Result for Harvey Blackwater secular equilibrium analysis, showing excellent correlation between the data and the y=x line, i.e., Th-230 and Ra-226 are in secular equilibrium.

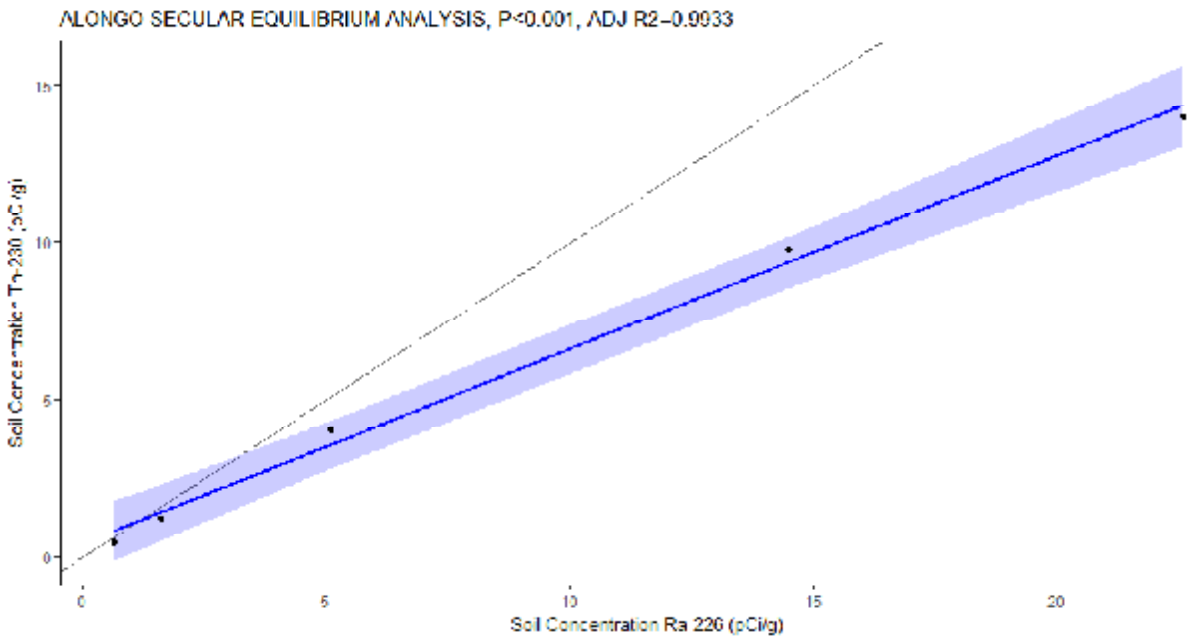
Figure 4. Result for Alongo Mines secular equilibrium analysis, showing excellent correlation between the data, but poor agreement with the y=x line, i.e., Th-230 and Ra-226 are in equilibrium, but not secular equilibrium.

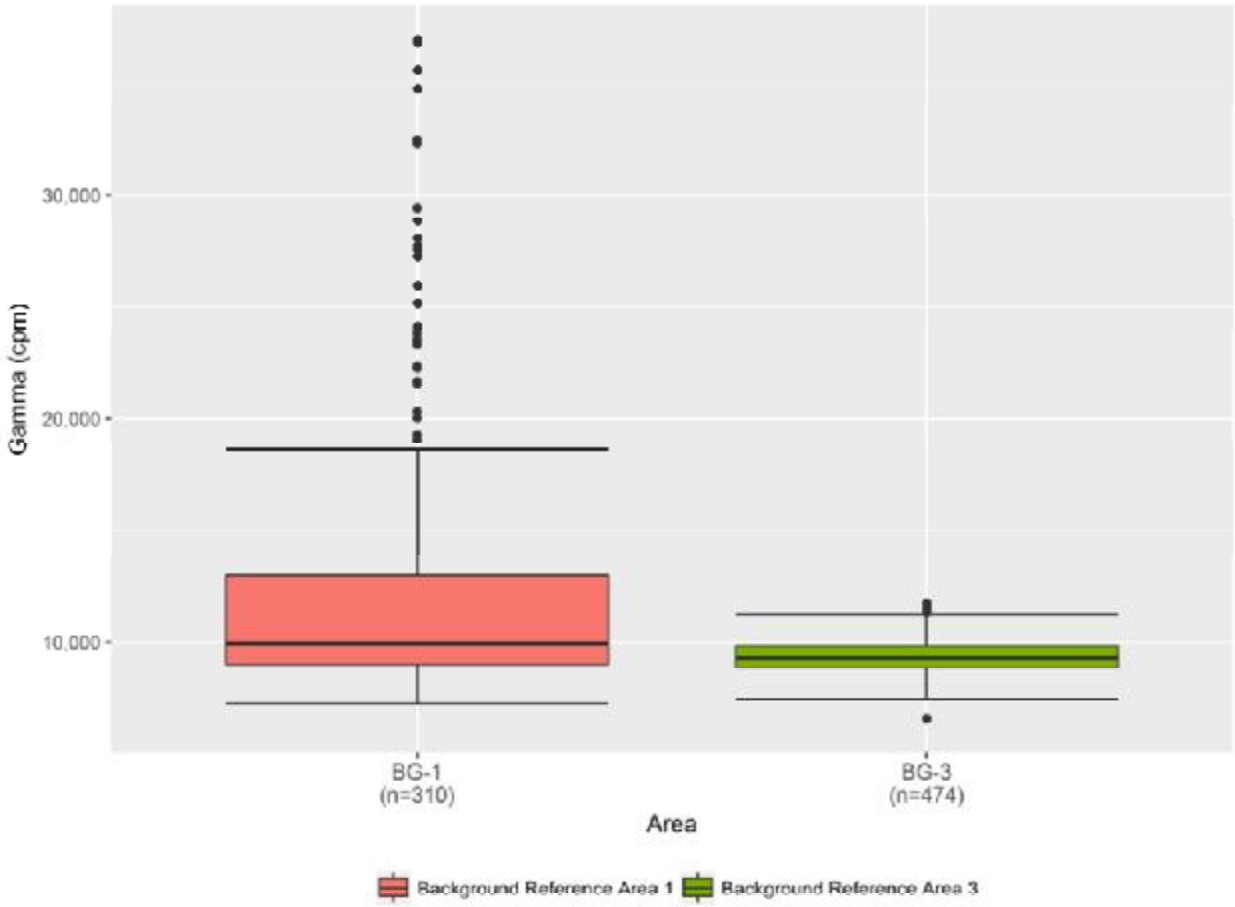
As shown in Figure 2B there are potential outlier values shown for the gamma data in the BG-1 dataset. These values are quite high, up to 37,000 counts per minute (cpm), and may represent heterogeneity within BG-1.
