Section 26 (#1011, 1012, 1035)

Removal Site Evaluation Report

Final | September 21, 2018

NAVAJO NATION
AUM Environmental Response Trust-First Phase

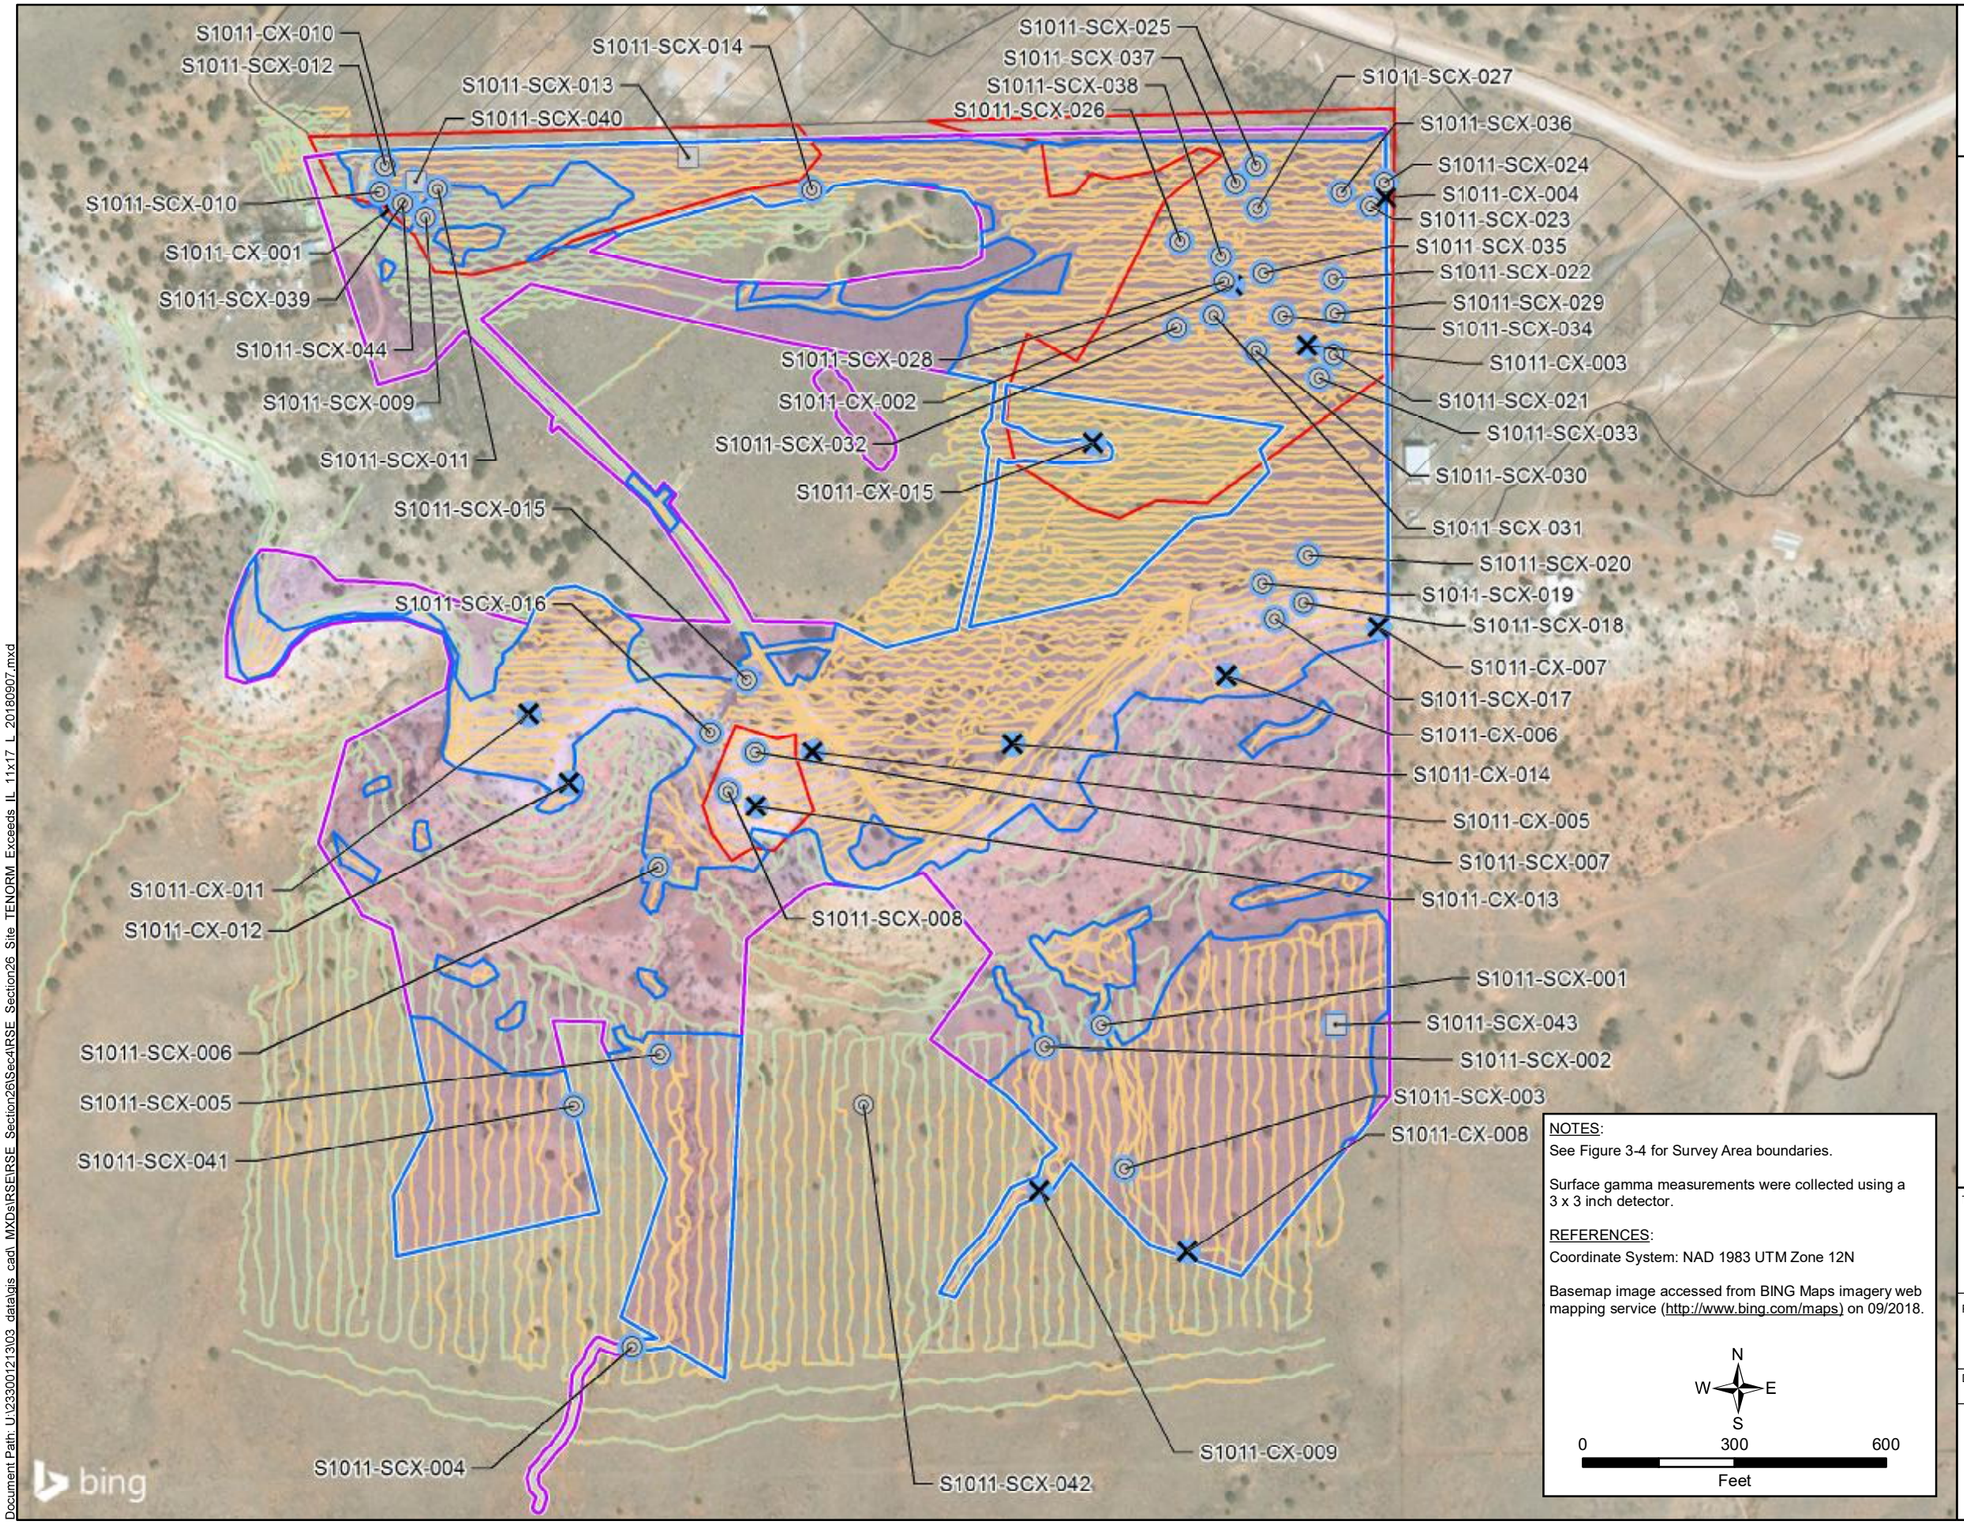
FIGURE: 4-7

A multiple lines of evidence approach was used to evaluate the Site and distinguish areas of TENORM from areas of NORM within the Survey Area, as described in Section 3.3.3. Based on this evaluation, 72.2 acres out of the 101.3 acres of the Survey Area were estimated to contain TENORM at the Site. This estimate was inclusive of three areas: (1) portions of the mesa top; (2) the mesa sidewall; and (3) the plains, which included three of the drainages. The area containing TENORM is shown in relation to the lateral extent of IL exceedances in Figure 4-6 and in relation to the gamma measurements in Figure 4-7.

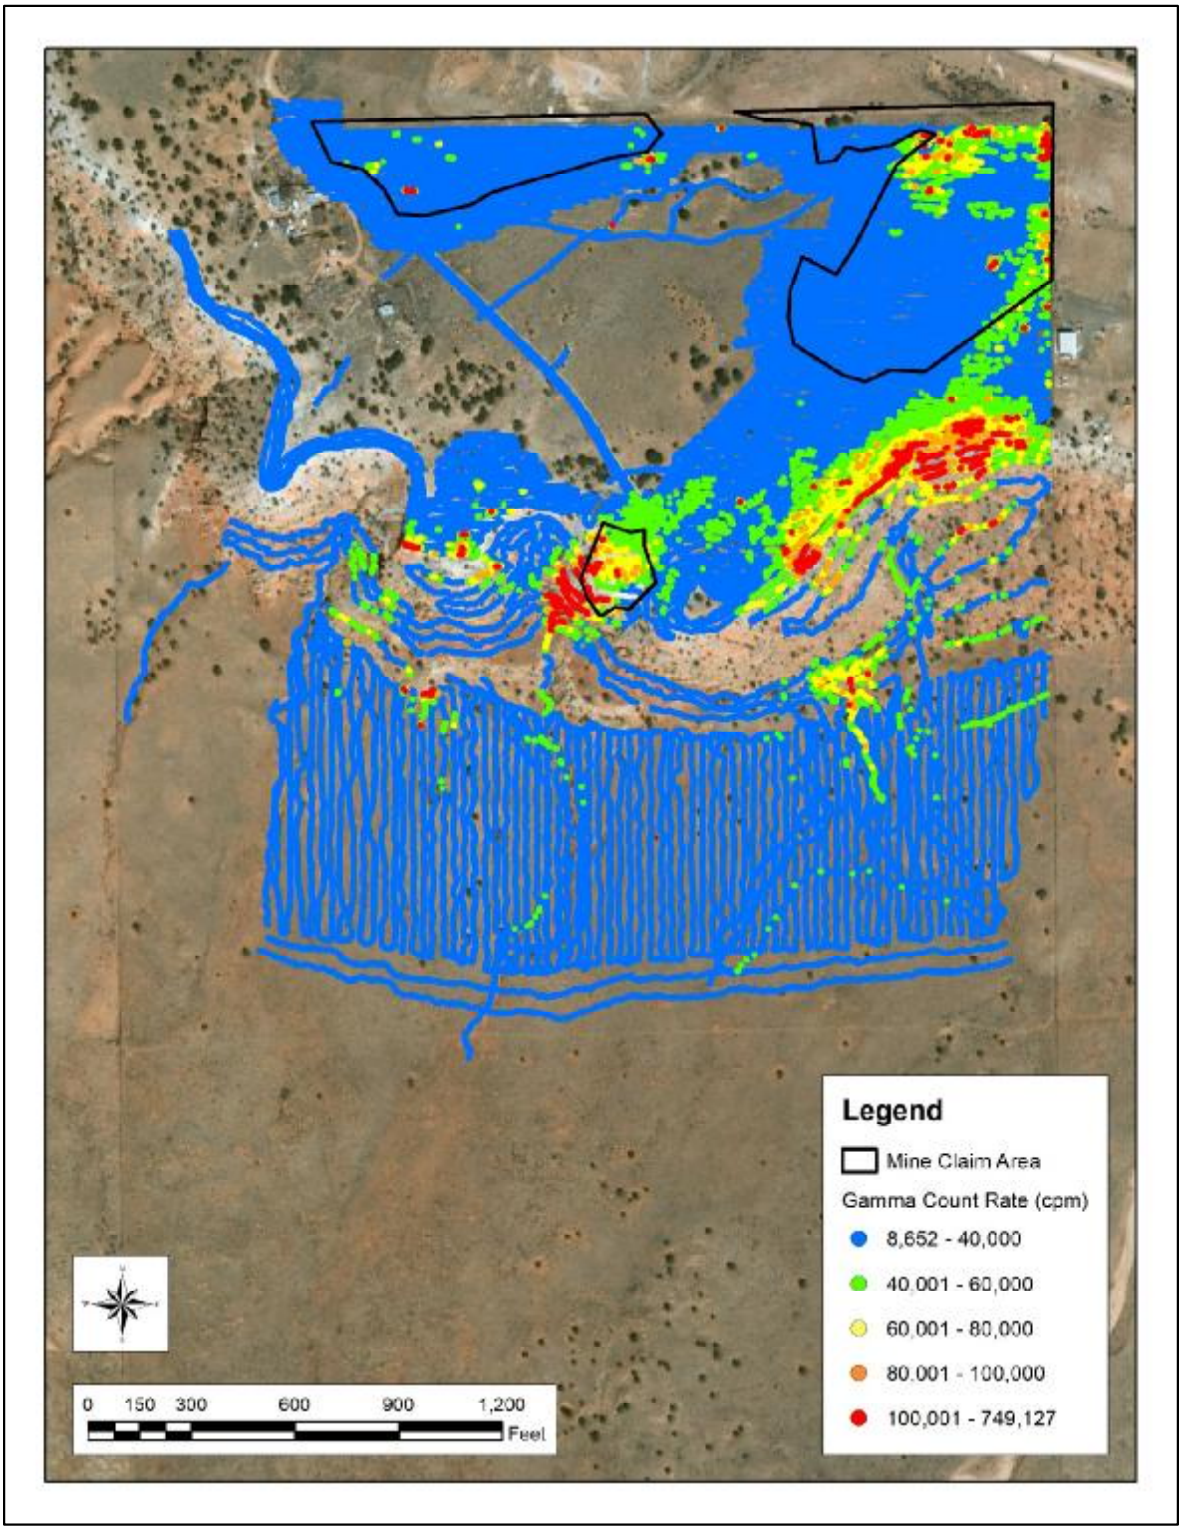
Figure 4. Gamma count rates in the Survey Area.

The gamma count rates observed in the Survey Area are depicted in Figure 4. Elevated count rates were associated with waste rock in each of the mine claims; i.e., in several small areas of the northwestern claim, the north and east edges of the northeastern claim, and the center of the southern claim. Elevated count rates also were observed outside the northeastern and southern claims along the edge of the mesa and continuing onto the valley floor below.

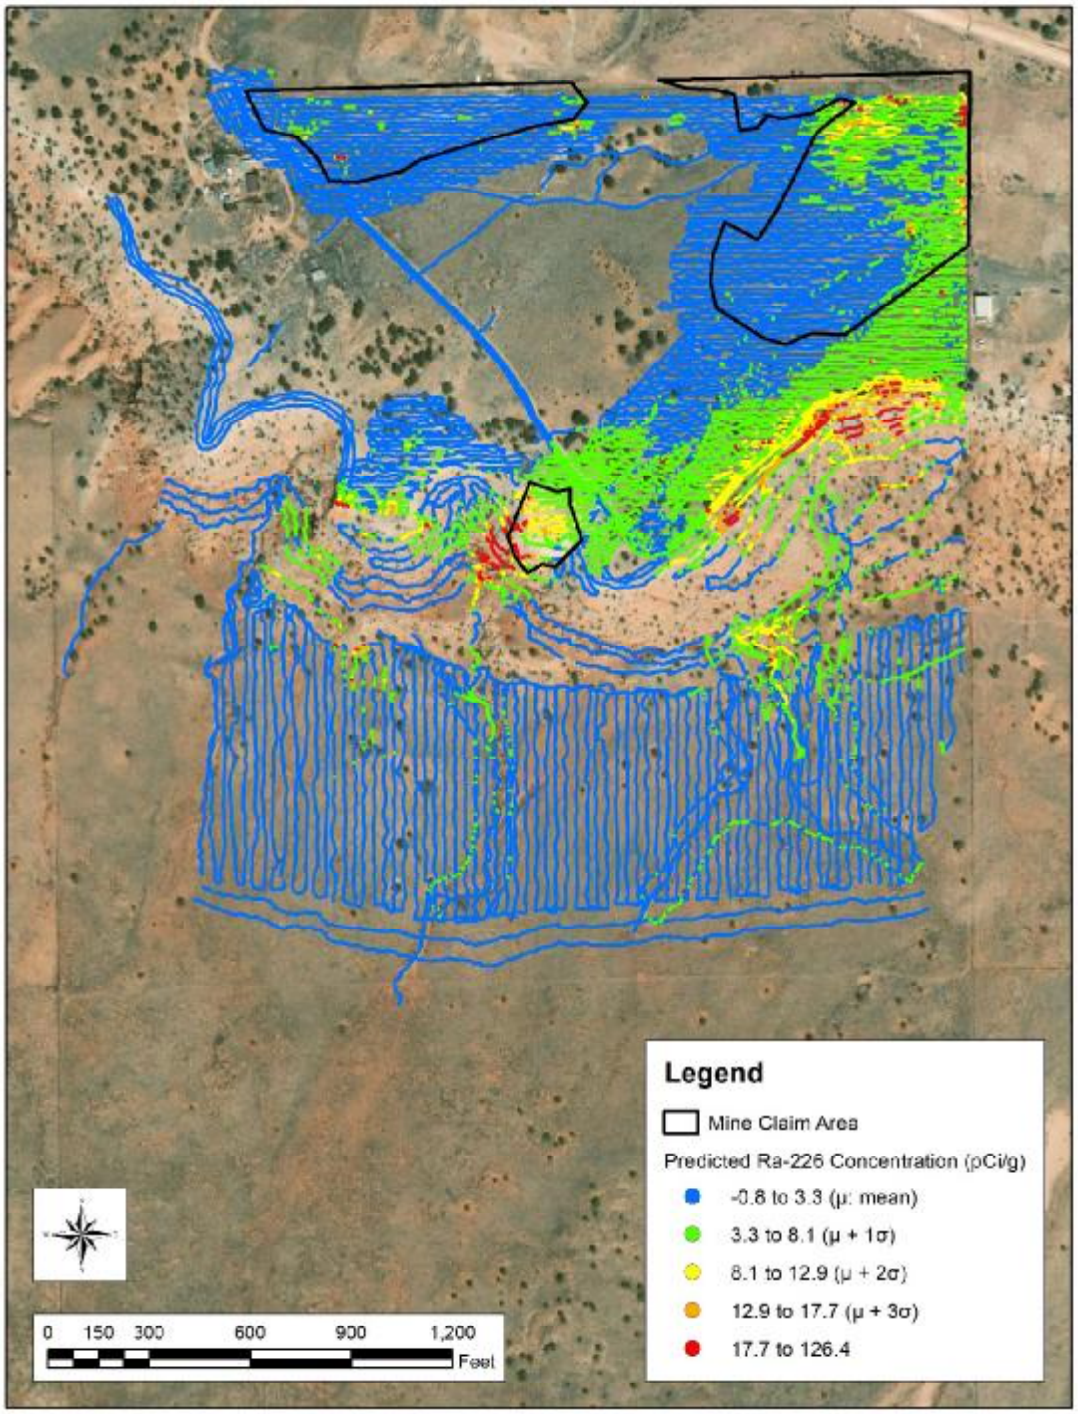
Figure 9. Predicted concentrations of radium-226 in the Survey Area.

This equation was used to convert the gamma count rate measurements observed in the gamma surveys to predicted concentrations of radium-226. Table 6 presents summary statistics for the predicted concentrations of radium-226 in the Survey Area. The range of the predicted concentrations of radium-226 in the Survey Area is -0.8 to 126.4 pCi/g, with a mean and median of 3.3 and 2.2 pCi/g,

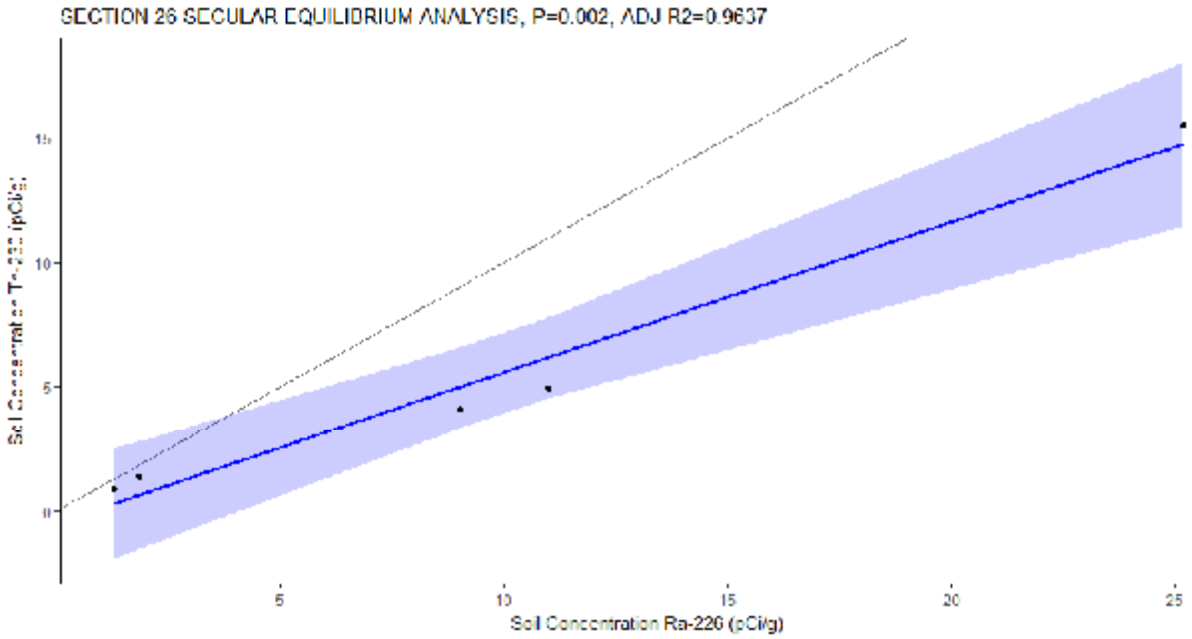
Figure 10. Evaluation of secular equilibrium in the uranium decay series.

Based on this method, ERG concludes that there is evidence that radium-226 and thorium-230 are in equilibrium, but not secular equilibrium at the site. (Figure 10).

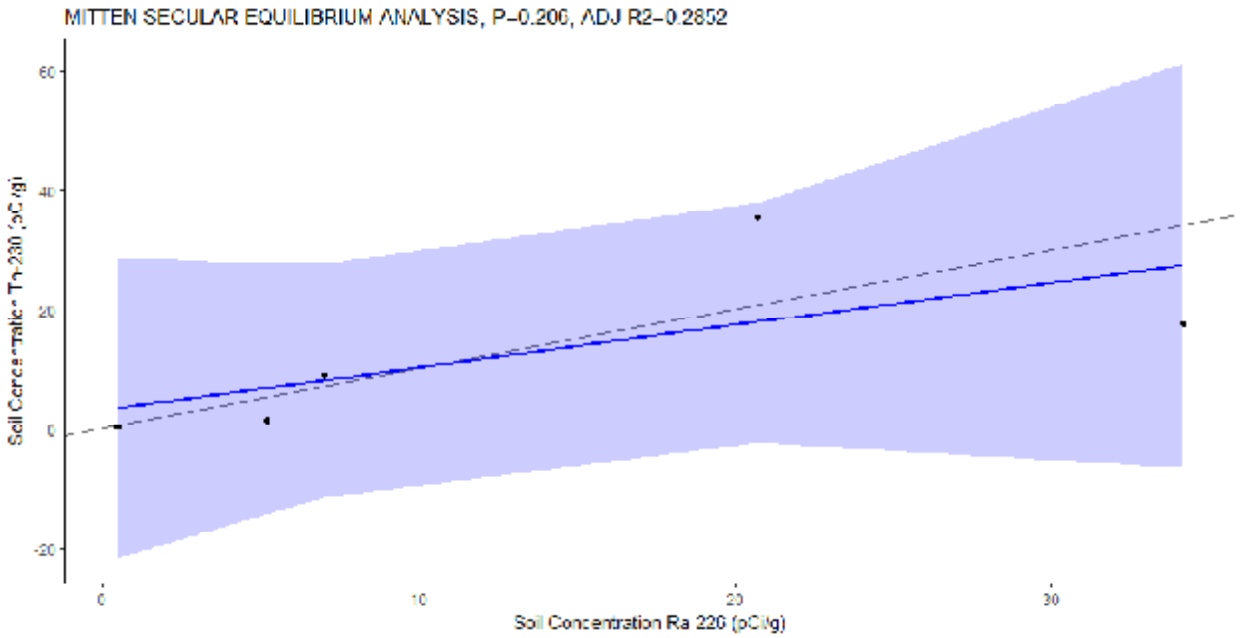
Figure 2. Result for Mitten secular equilibrium analysis, showing failure to meet p-value and adjusted R^2 criteria, i.e., the data are poorly correlated.

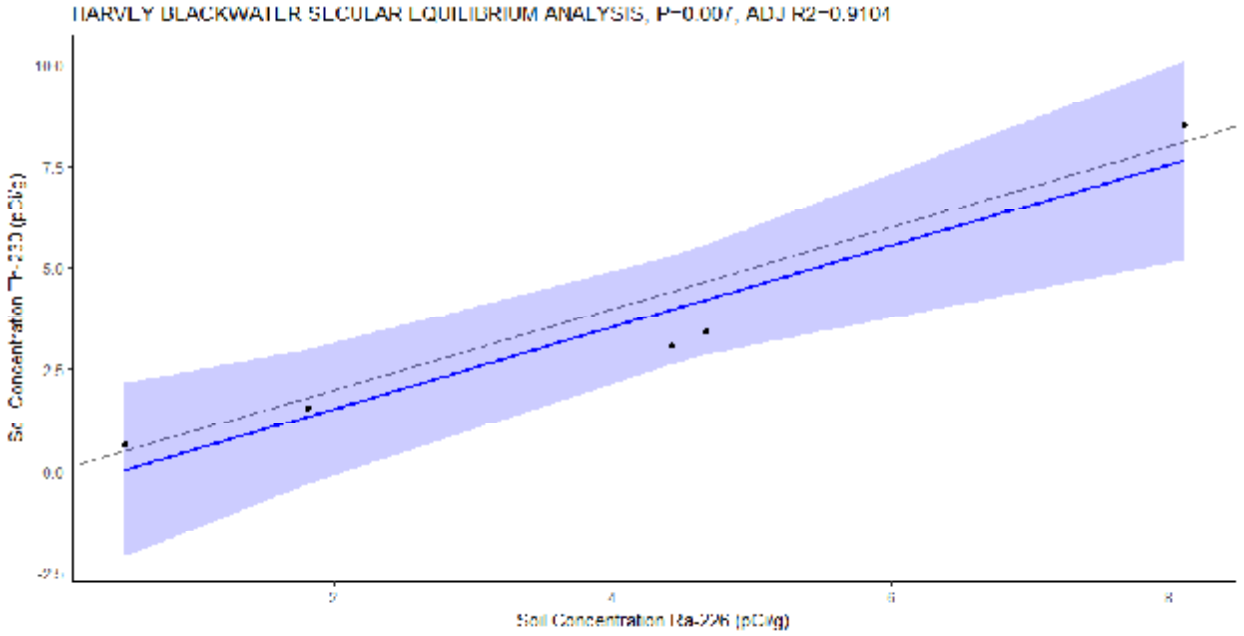
Figure 3. Result for Harvey Blackwater secular equilibrium analysis, showing excellent correlation between the data and the y=x line, i.e., Th-230 and Ra-226 are in secular equilibrium.

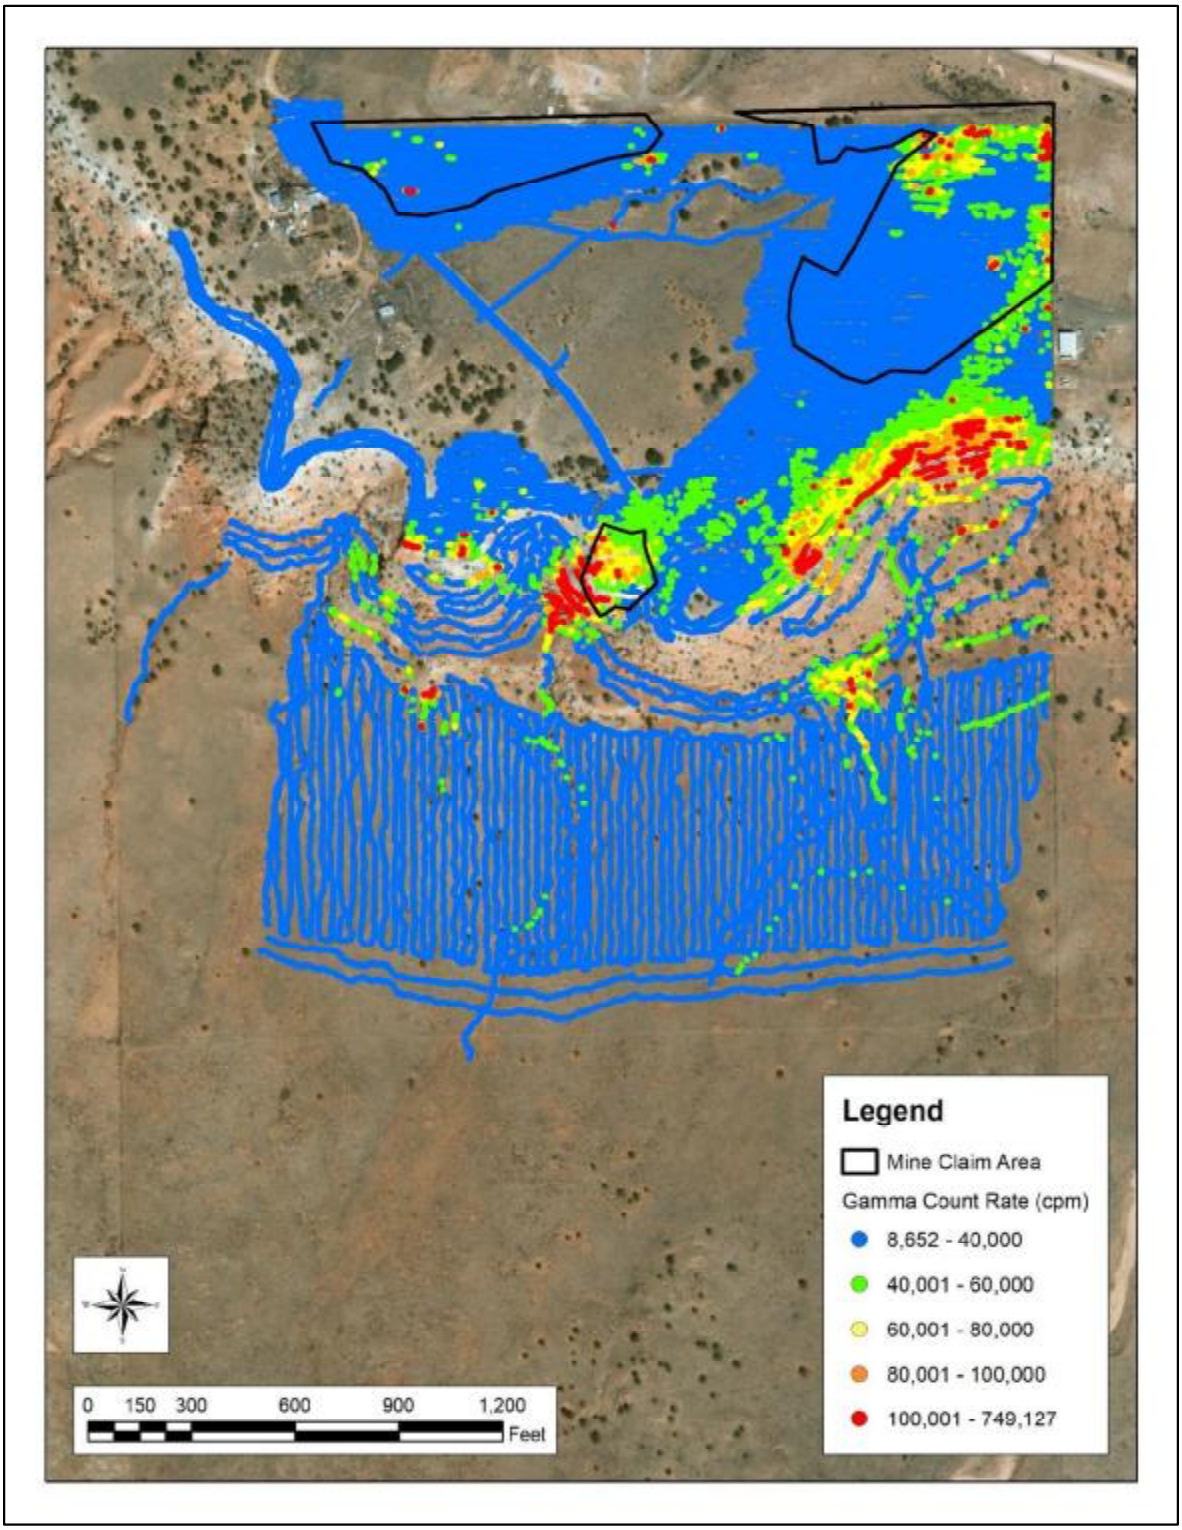
Figure 4. Gamma count rates in the Survey Area.

The gamma count rates observed in the Survey Area are depicted in Figure 4. Elevated count rates were associated with waste rock in each of the mine claims; i.e., in several small areas of the northwestern claim, the north and east edges of the northeastern claim, and the center of the southern claim. Elevated count rates also were observed outside the northeastern and southern claims along the edge of the mesa and continuing onto the valley floor below.

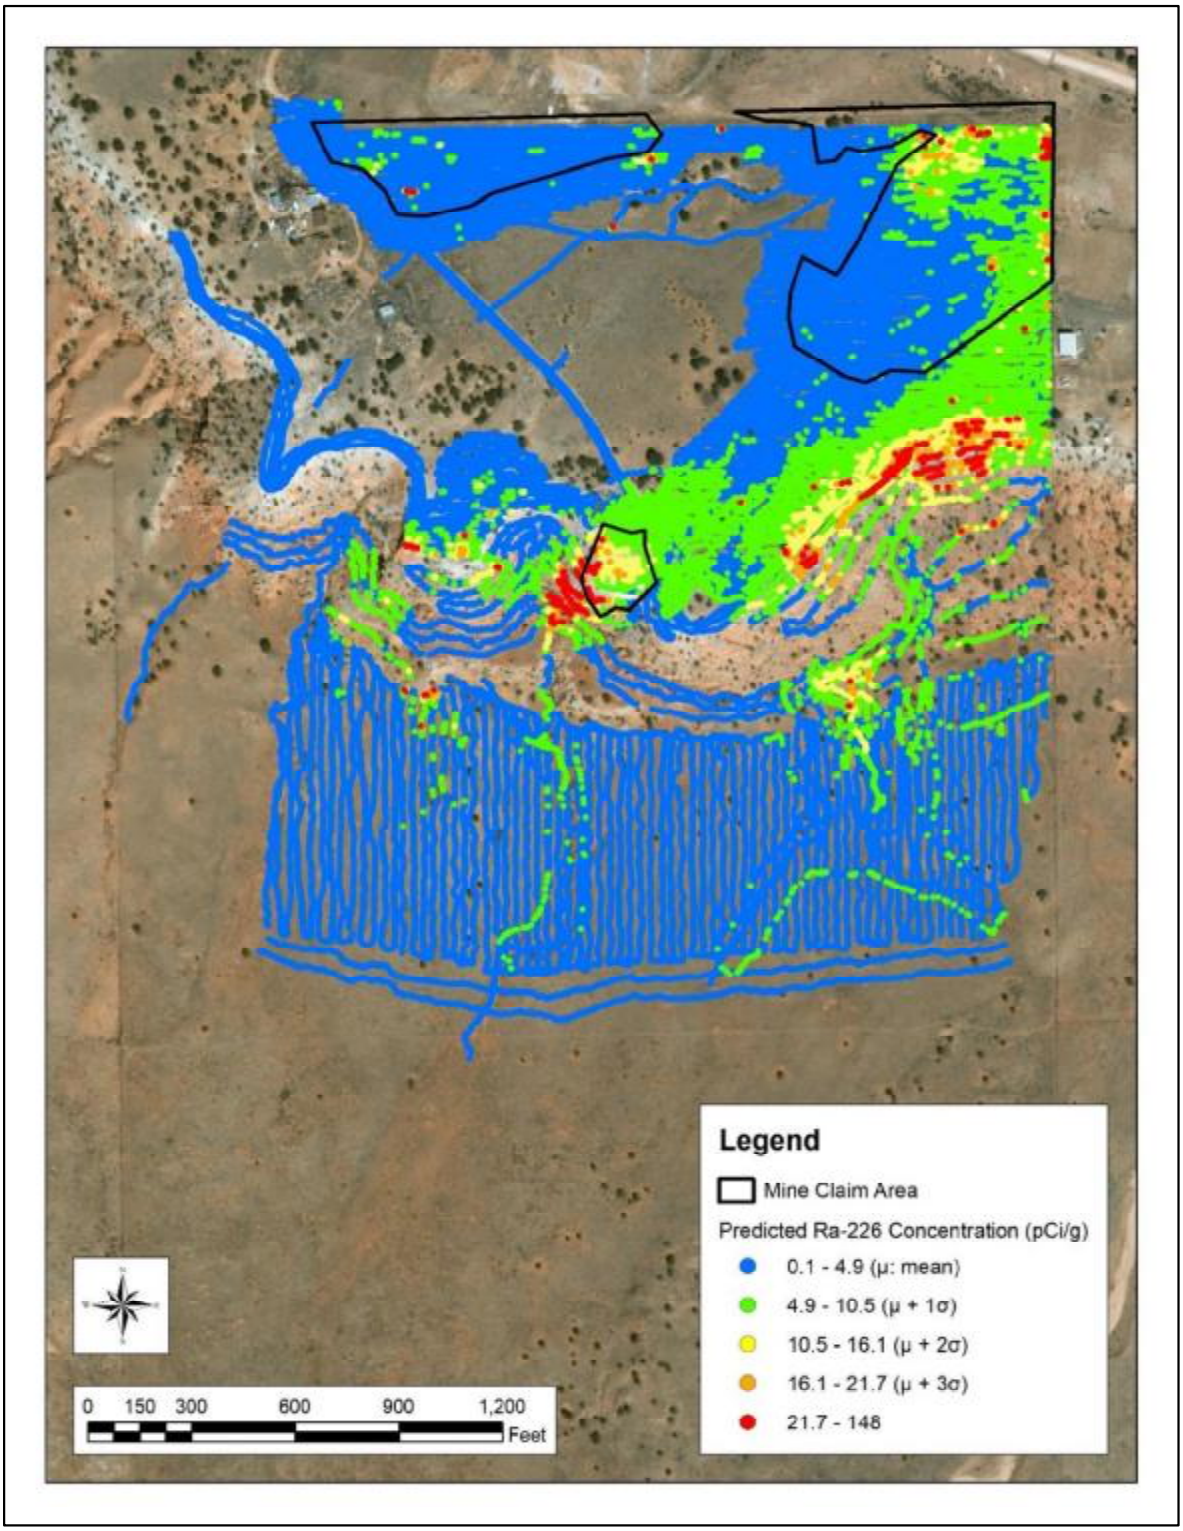
Figure 9. Predicted concentrations of radium-226 in the Survey Area.

Figure 9 shows the predicted concentrations of radium-226, the spatial and numerical distribution of which mirror those depicted in Figure 4.

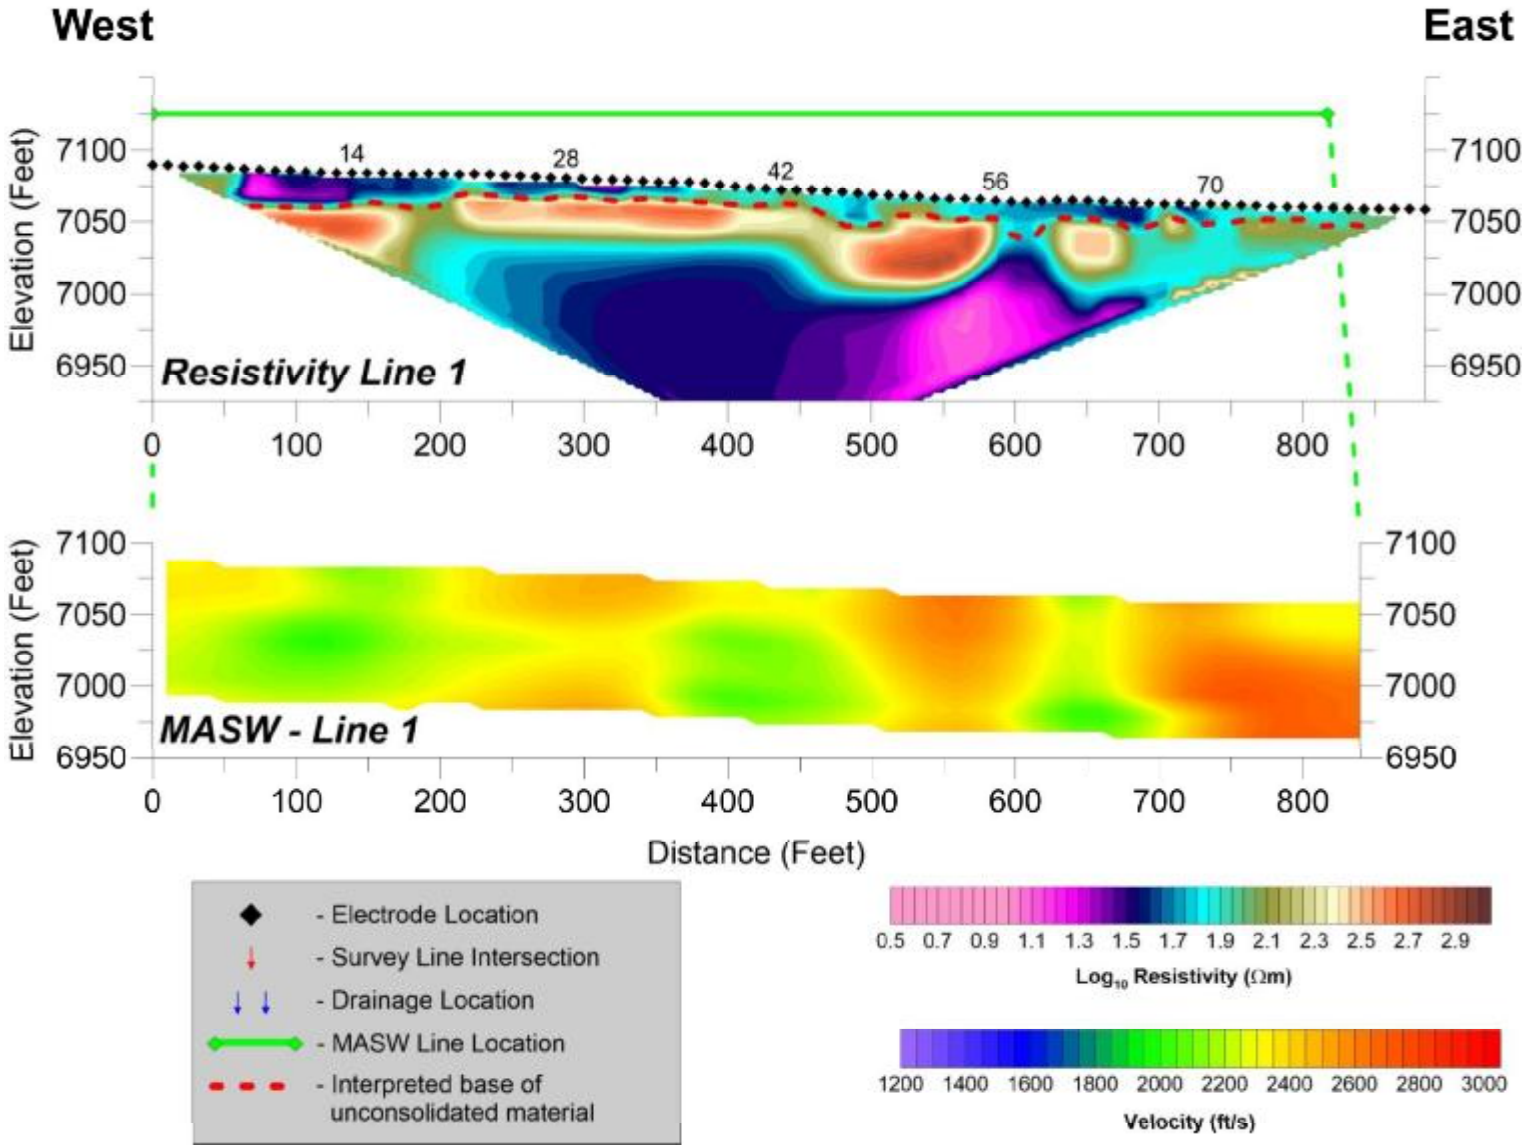
Figure 9. Line 1 Electrical Resistivity and MASW Model Results.

Figure 9 displays the resistivity and MASW model results for Line 1, which runs in a west to east direction. The resistivity model results display a three-layer structure; with a conductive near-surface layer, which varies in thickness across the profile. This overlies a resistive layer, which is on average 30 feet thick, with a more conductive layer extending to the depth limits of the model beneath this. A number of boreholes were drilled and logged across the site (Figure 8); these were typically extended a short way into the bedrock which tended to be either limestone or marl based on the geological logs. The geological logs for boreholes S1011-SCX-015 through -018 indicate that the limestone bedrock in this area is very close to the ground surface, with less than a foot of gravelly soil cover in some cases. These boreholes are located towards the southern end of Lines 5 through 7, where a highly resistive layer is observed approaching the ground surface. This would indicate that the resistive layer in the resistivity model results represents the limestone bedrock unit for these lines, and therefore likely represents the shallow bedrock in the model results from across the site. Therefore, the resistive layer running across this profile is interpreted to be a response to the bedrock, with the geological logs from S1011-SCX-012 indicating marl and sandstone in this area.

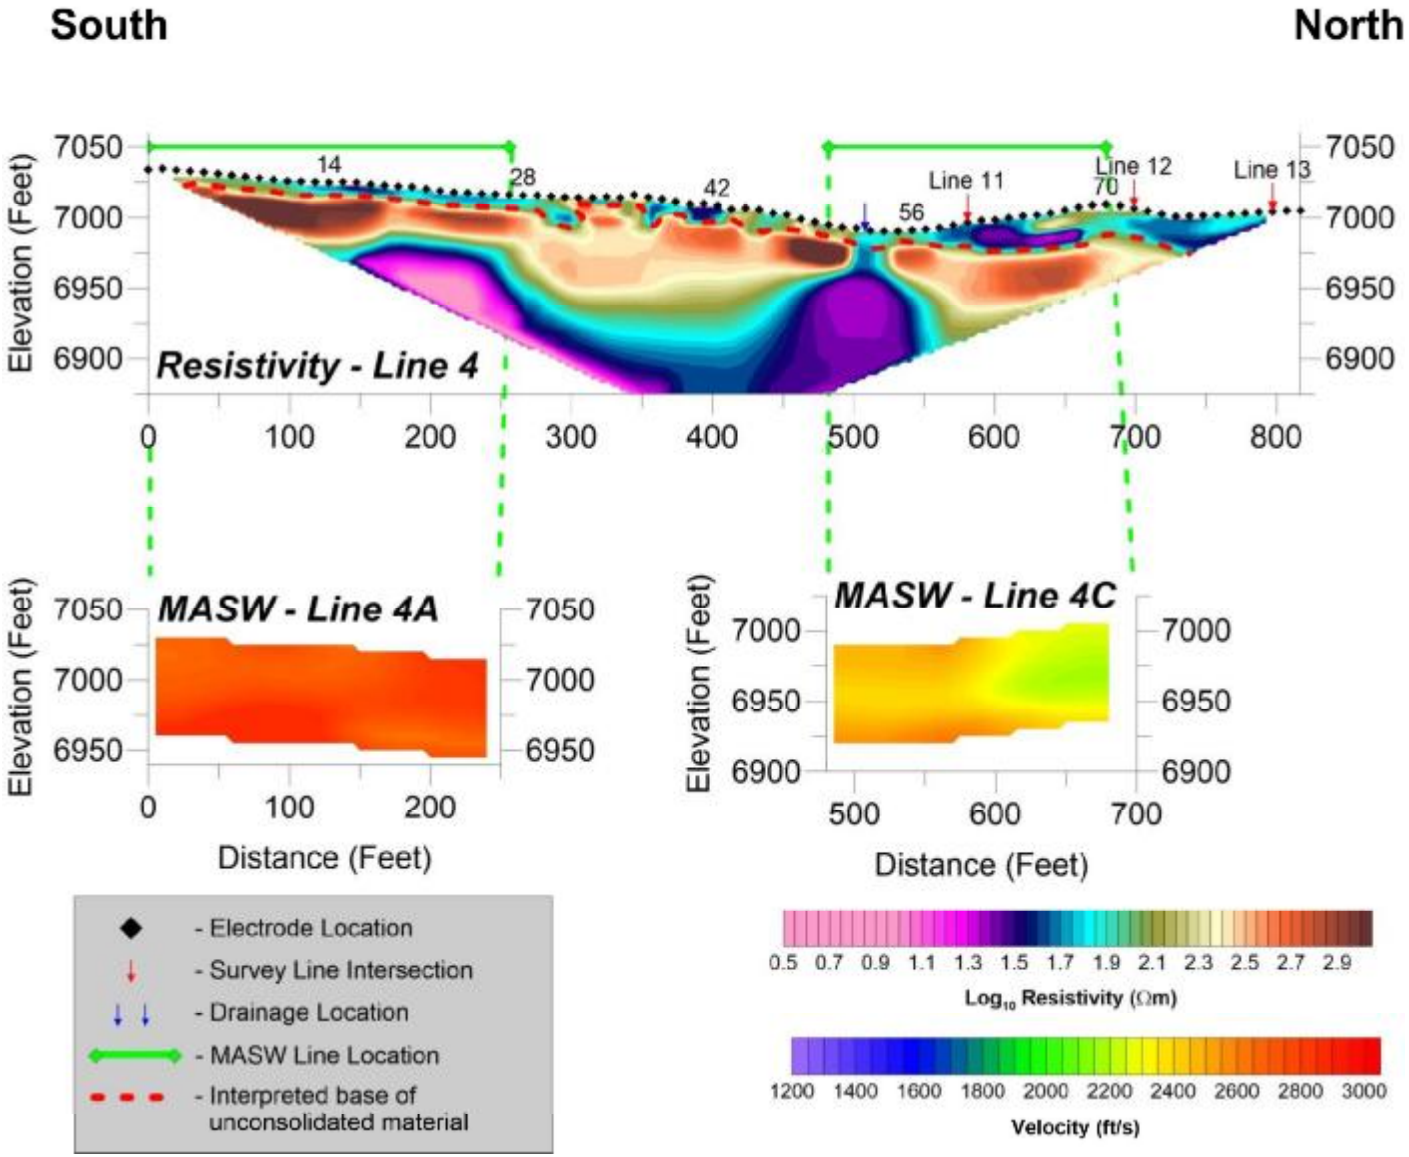
Figure 12. Line 4 Electrical Resistivity and MASW Model Results.

Figure 12 displays the resistivity and MASW model results for Line 4, which runs in a south to north direction. The resistivity model results again display a three-layer structure; with a conductive near-surface layer, which varies in thickness across the profile. This overlies a resistive layer, which is on average 30 feet thick although appears to thicken significantly towards the middle of the line, with a more conductive layer extending to the depth limits of the model beneath this. The geological logs from boreholes S1011-SCX-021 and -023, which are located 680 and 730 feet along the line respectively, indicate approximately 18 and 20 feet of

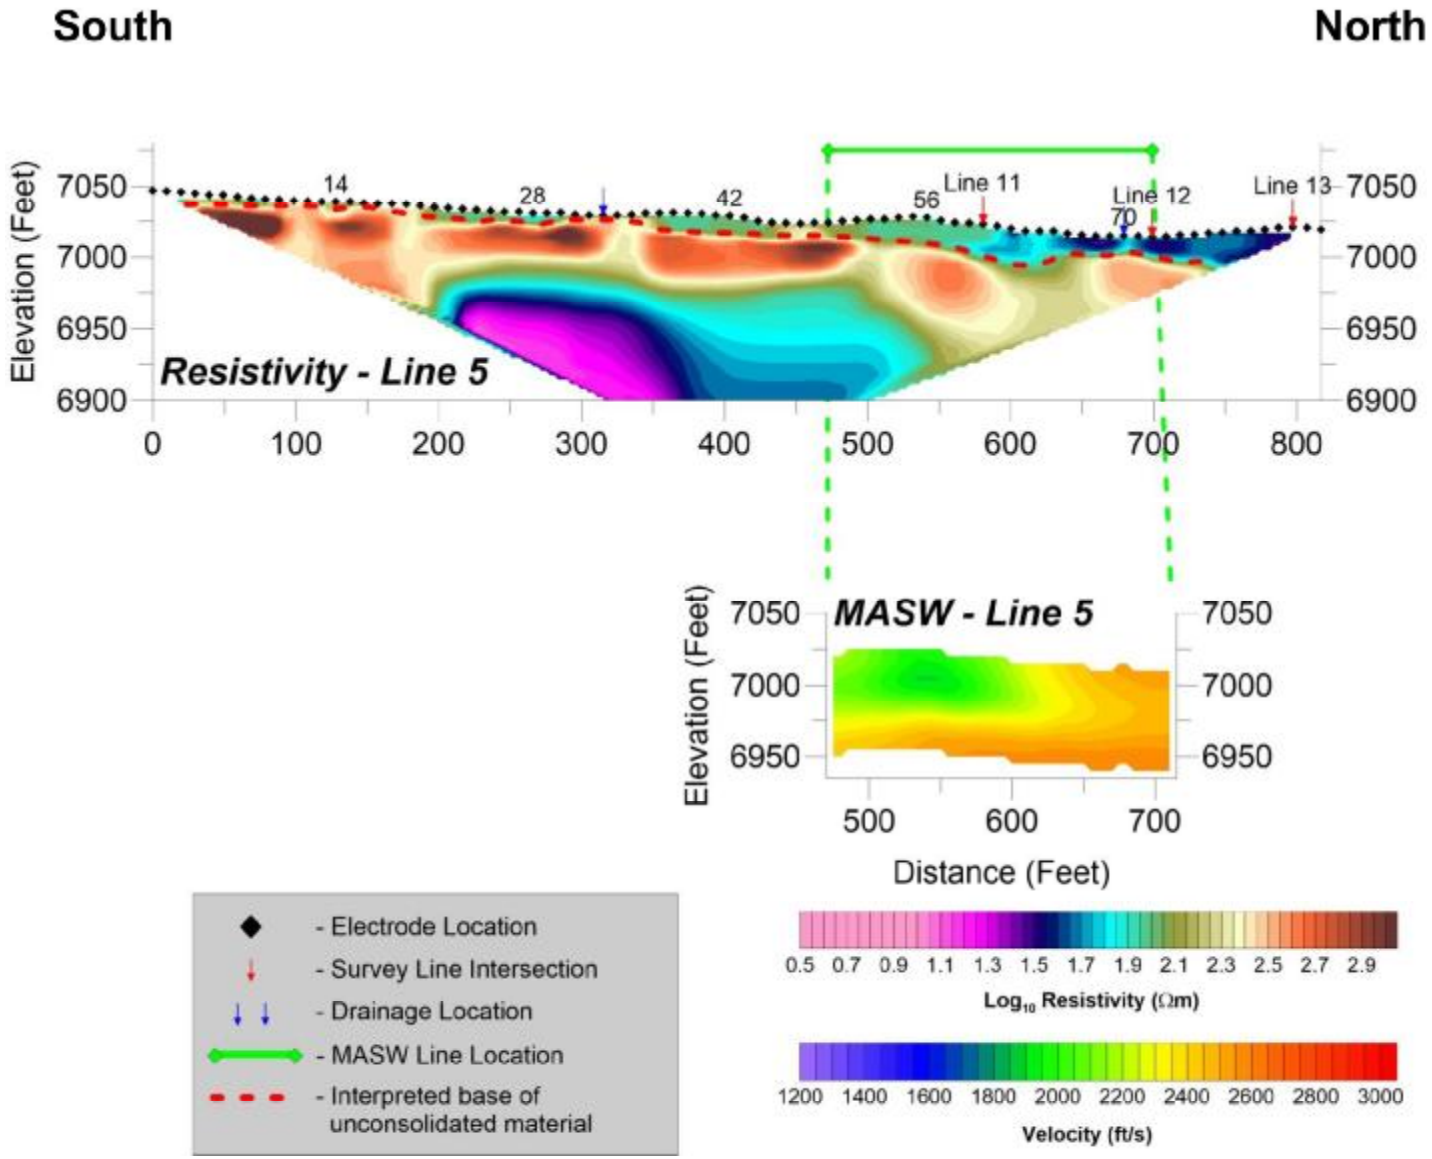
Figure 13. Line 5 Electrical Resistivity and MASW Model Results.

Figure 13 displays the resistivity and MASW model results for Line 5, which runs in a south to north direction. The resistivity model results again display a three-layer structure; with a conductive near-surface layer, which varies in thickness across the profile. This overlies a resistive layer, which varies between 25 and 30 feet in thickness, with a more conductive layer extending to the depth limits of the model beneath this.

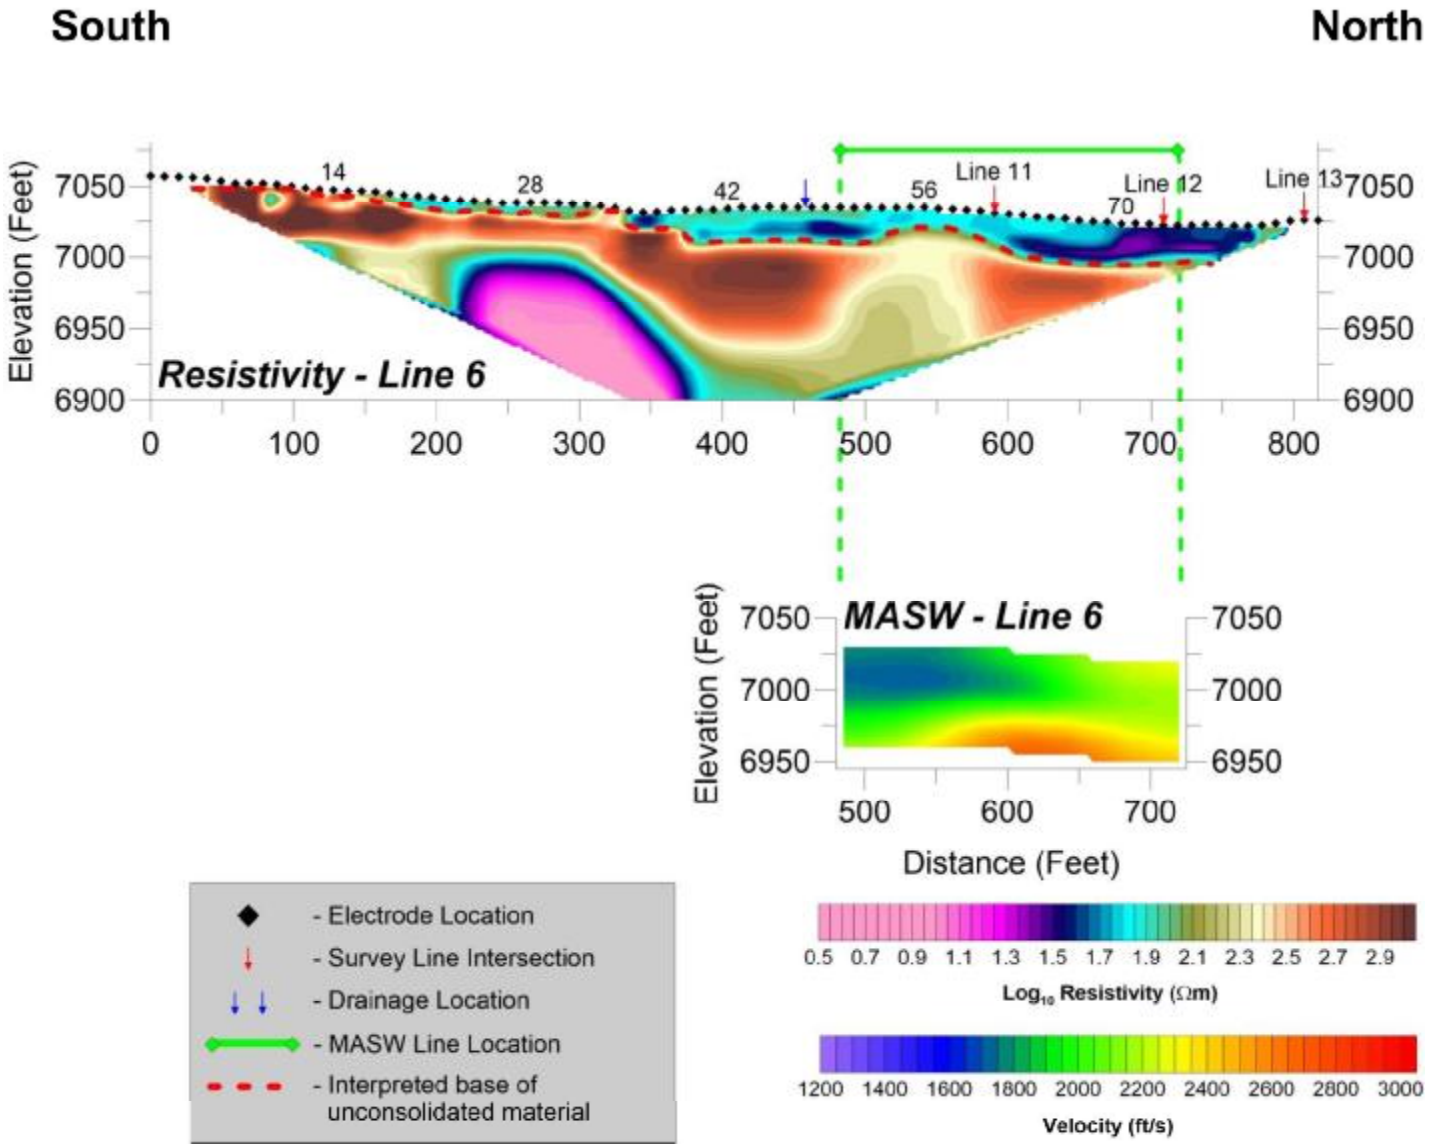
Figure 14. Line 6 Electrical Resistivity and MASW Model Results.

Figure 14 displays the resistivity and MASW model results for Line 6, which runs in a south to north direction. The resistivity model results again display a three-layer structure; with a conductive near-surface layer, which varies in thickness across the profile. This overlies a resistive layer, which varies between approximately 20 and 30 feet thick although appears to thicken significantly towards the middle of the line, with a more conductive layer extending to the depth limits of the model beneath this. The geological logs from borehole S1011-SCX-032, which is located 485 feet along the line, indicate approximately 9 feet of fine-grained sediments overlying the marl bedrock. The depth to bedrock does not correlates well to the approximate thickness of the near-surface conductive layer in this location, which tends to indicate approximately 20 feet of unconsolidated materials. This discrepancy could be related to the bedrock material, with the marl potentially being more conductive than the limestone based on the texture or weathering of the materials. There does appear to be a transition around 10 feet (bgs) depth in the conductive layer which may reflect this difference, with the deeper interface with the resistive layer, at 20 feet (bgs), potentially reflecting a contact with the limestone bedrock.

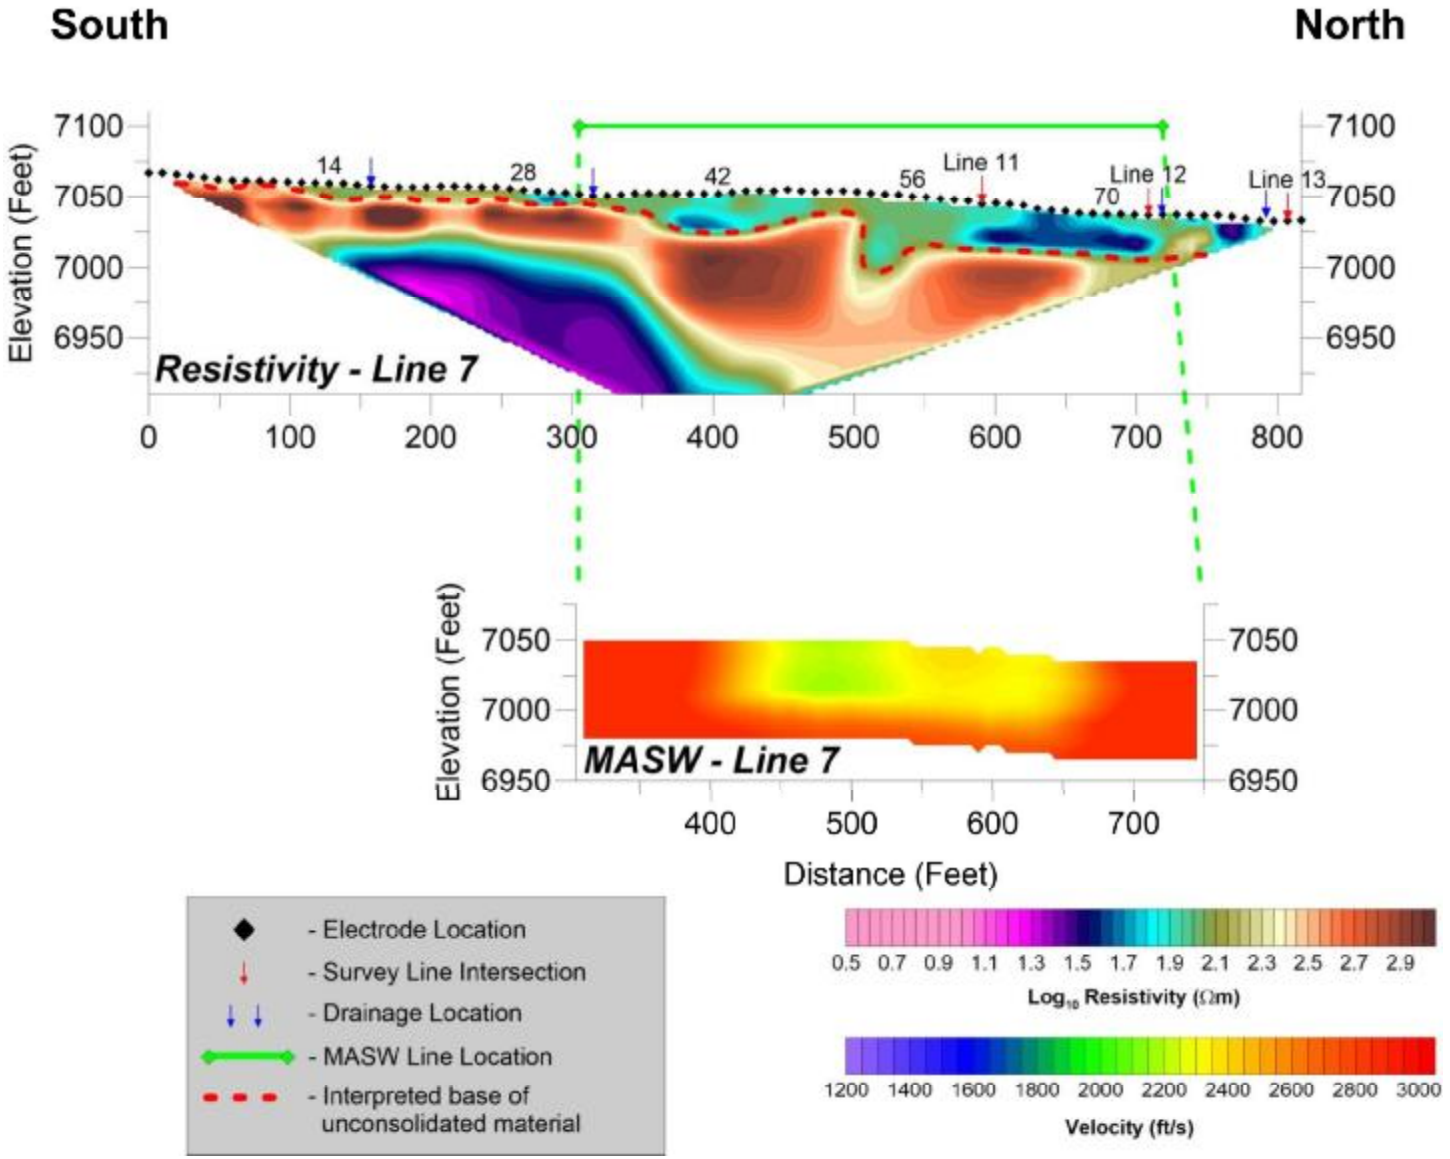
Figure 15. Line 7 Electrical Resistivity and MASW Model Results.

Figure 15 displays the resistivity and MASW model results for Line 7, which runs in a south to north direction. The resistivity model results again display a three-layer structure; with a conductive near-surface layer, which varies in thickness across the profile. This overlies a resistive layer, which varies between approximately 25 and 30 feet thick although appears to thicken significantly towards the middle of the line, with a more conductive layer, evident between 150 and 500 feet along the line, extending to the depth limits of the model beneath this. In addition, Line 7 passes to the immediate west of the fenced enclosure around the vertical open mine shaft (located approximately 10 feet to the east of the line), at 640 feet along the line.
