Silver Lake Cleanup – Overview Slide

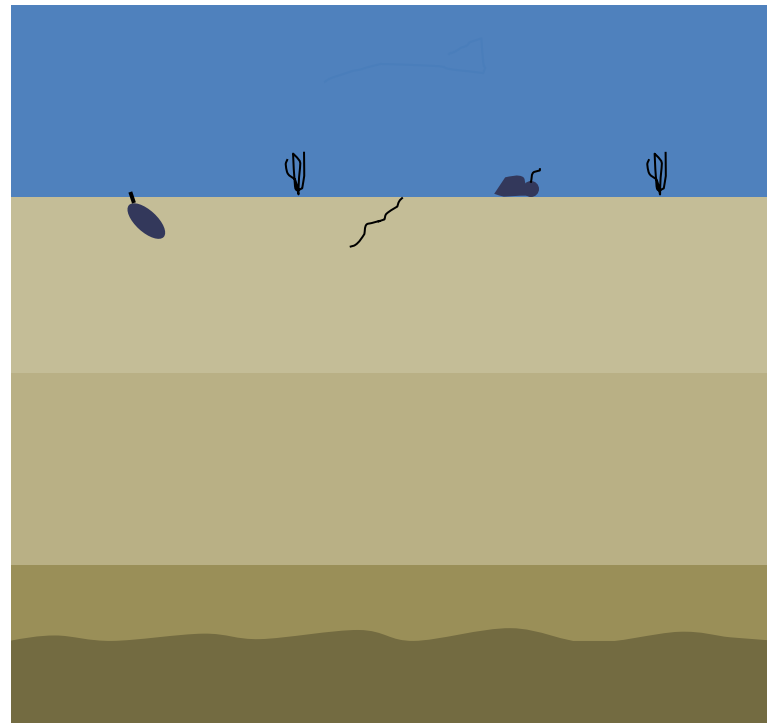
14-inch sand/topsoil cap over entire lake bed, placed in 1" lifts

Lake water

6" Bioturbation Layer

6" Isolation Layer

2" Mixing Layer

Native Lake Sediment

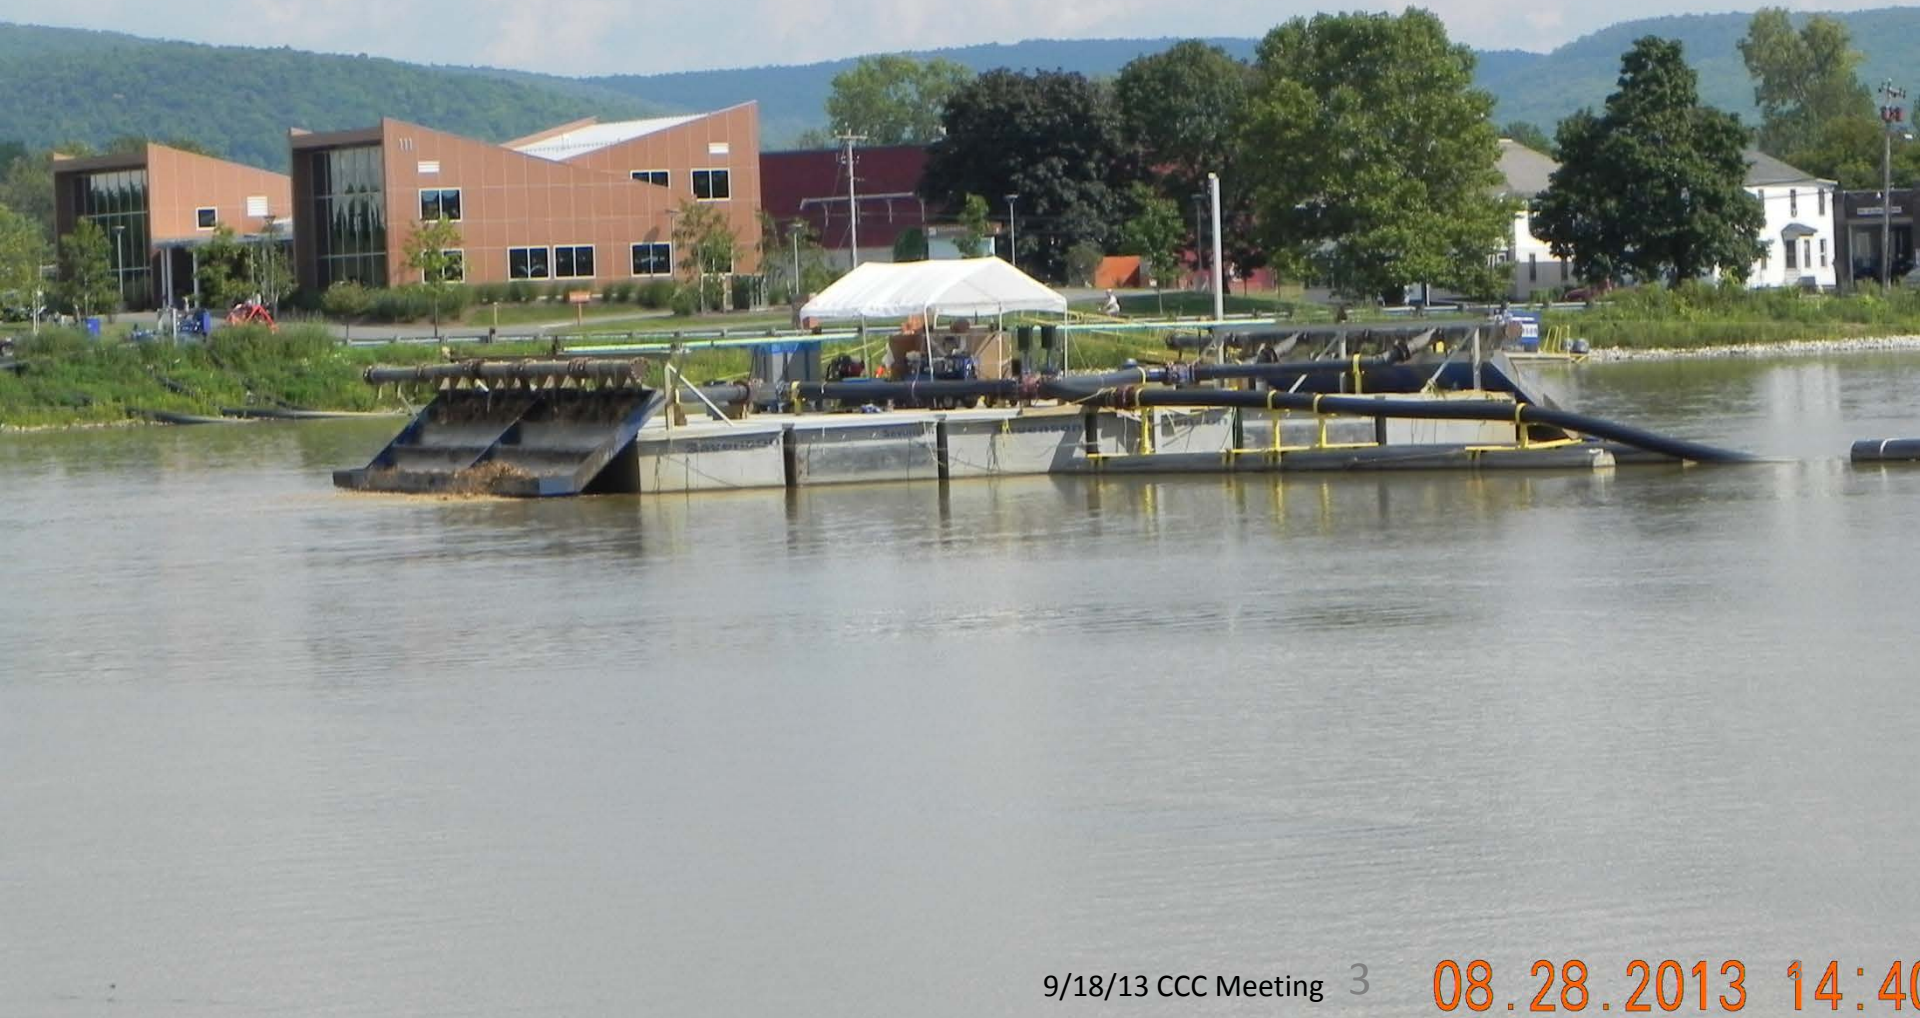
The hydraulic capping spreader-barge placing cap material

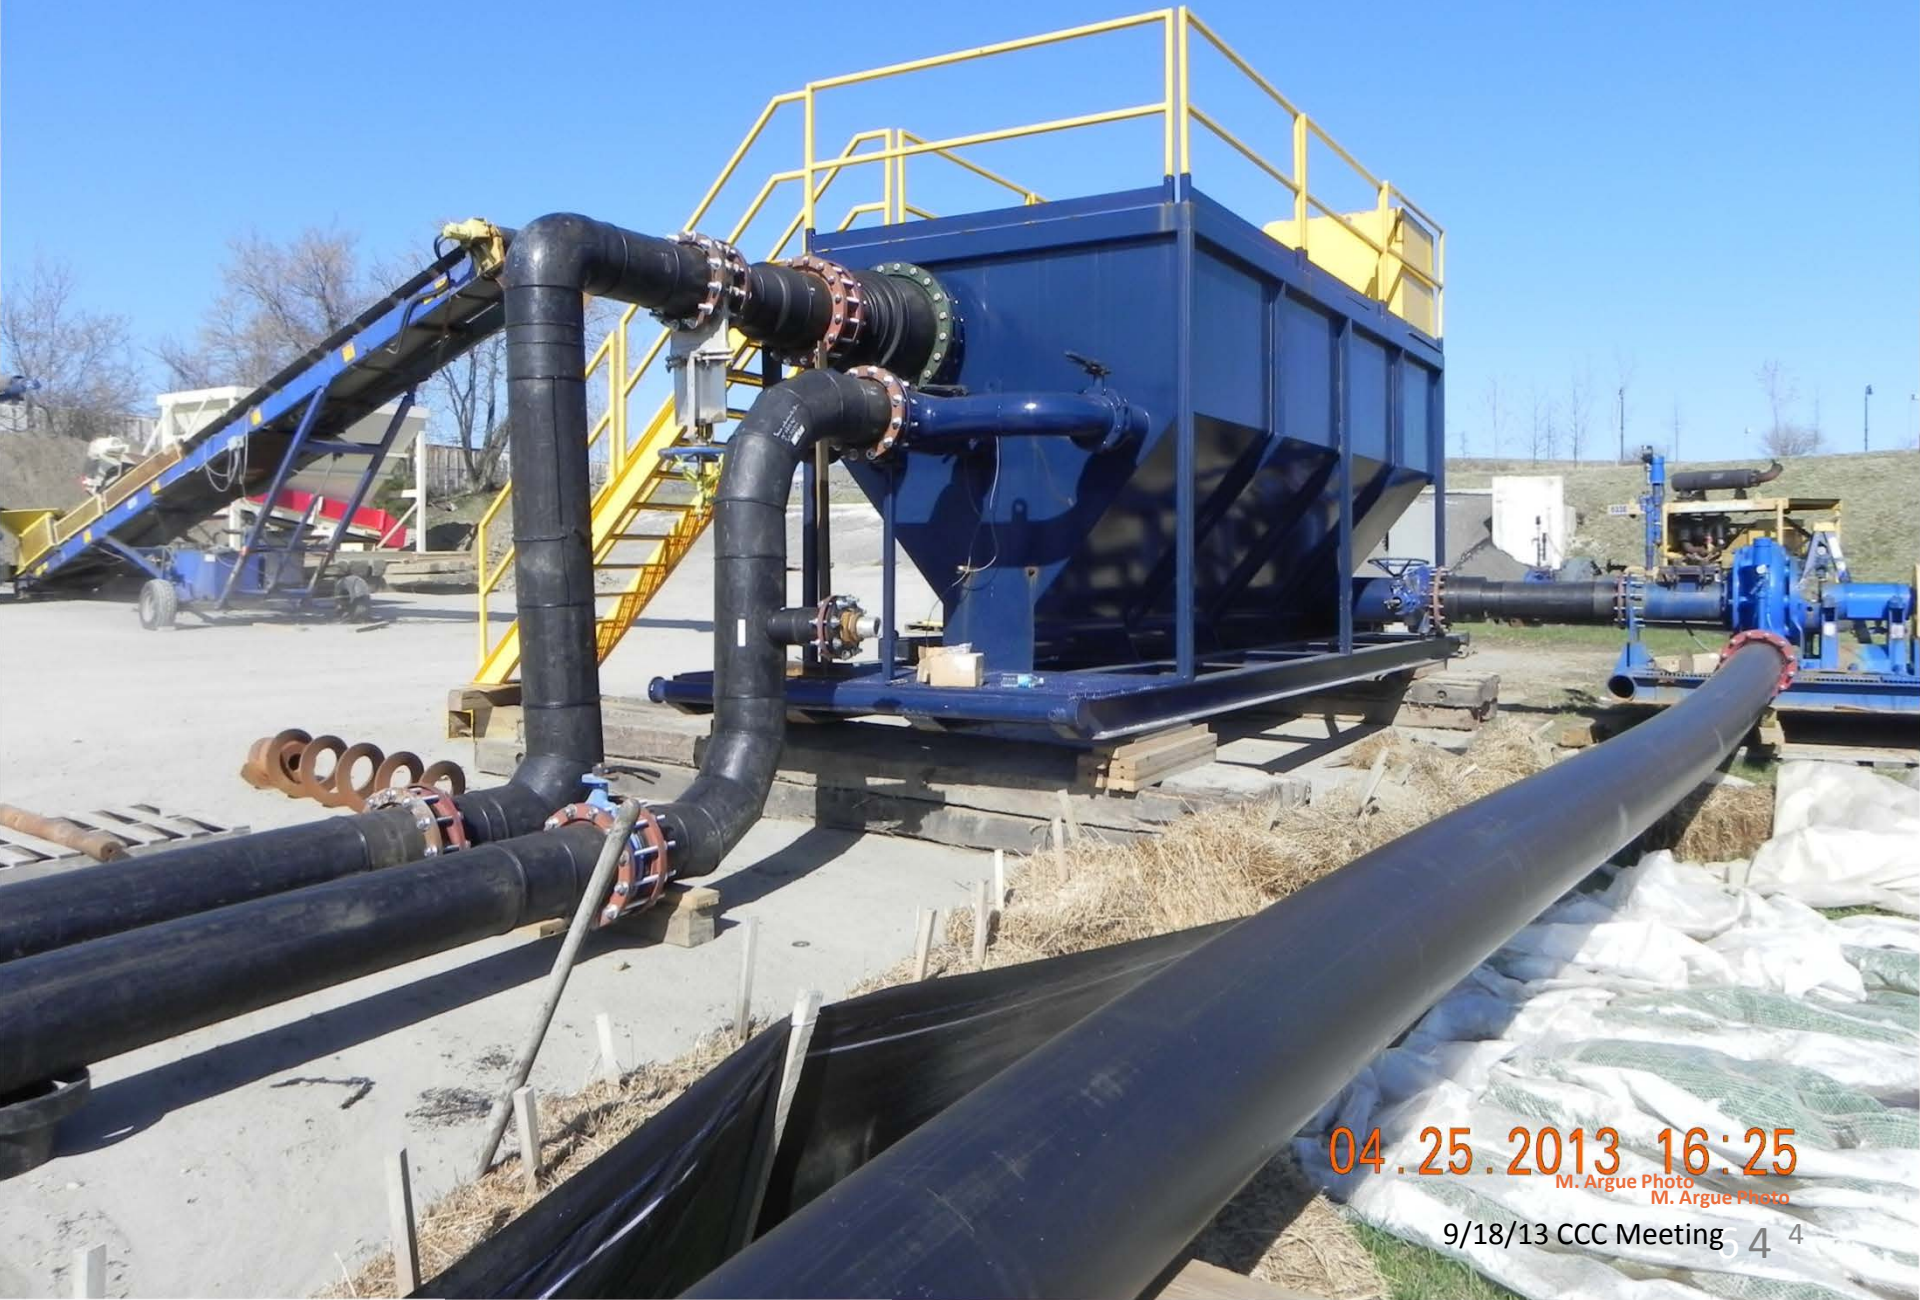
Mixing area for the hydraulic capping slurry

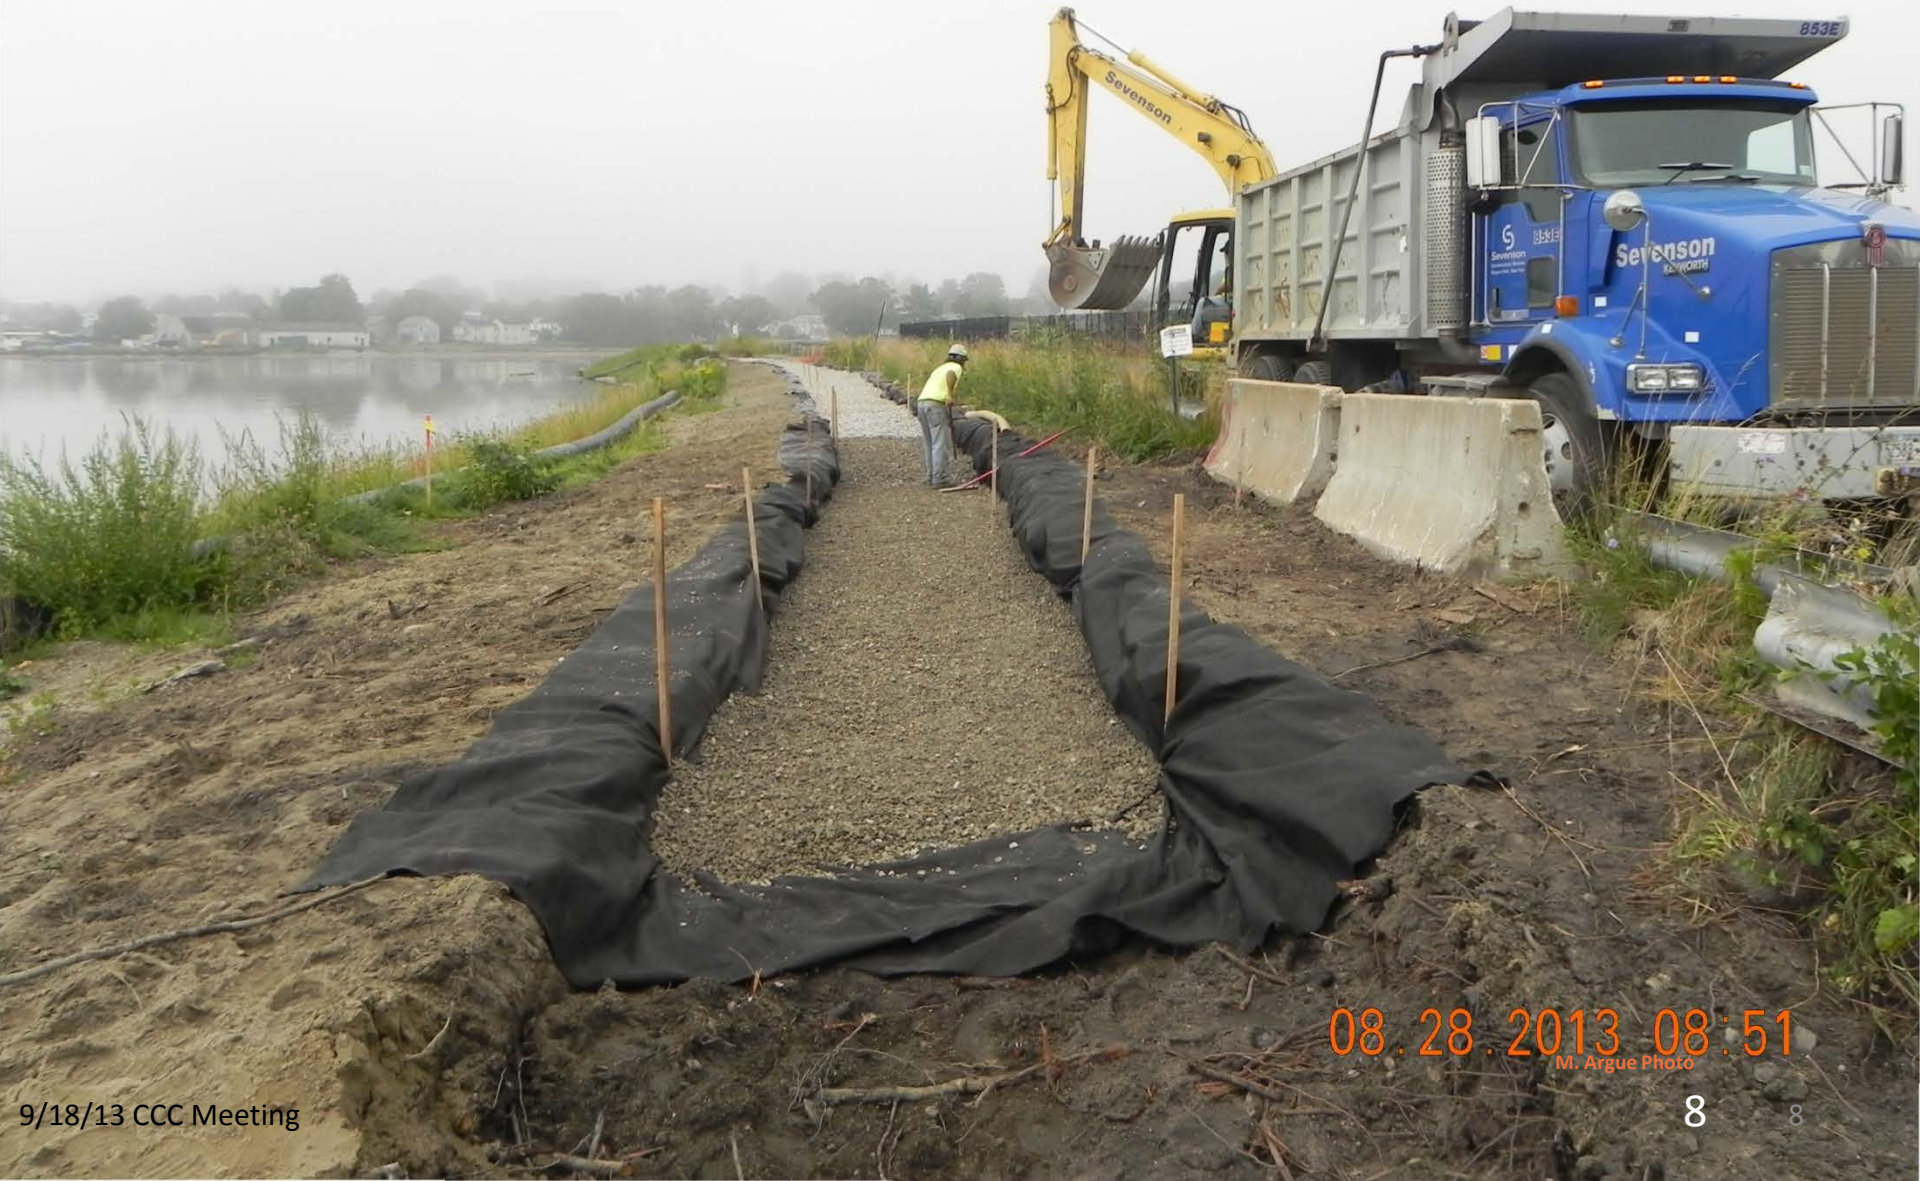
Walking path under construction

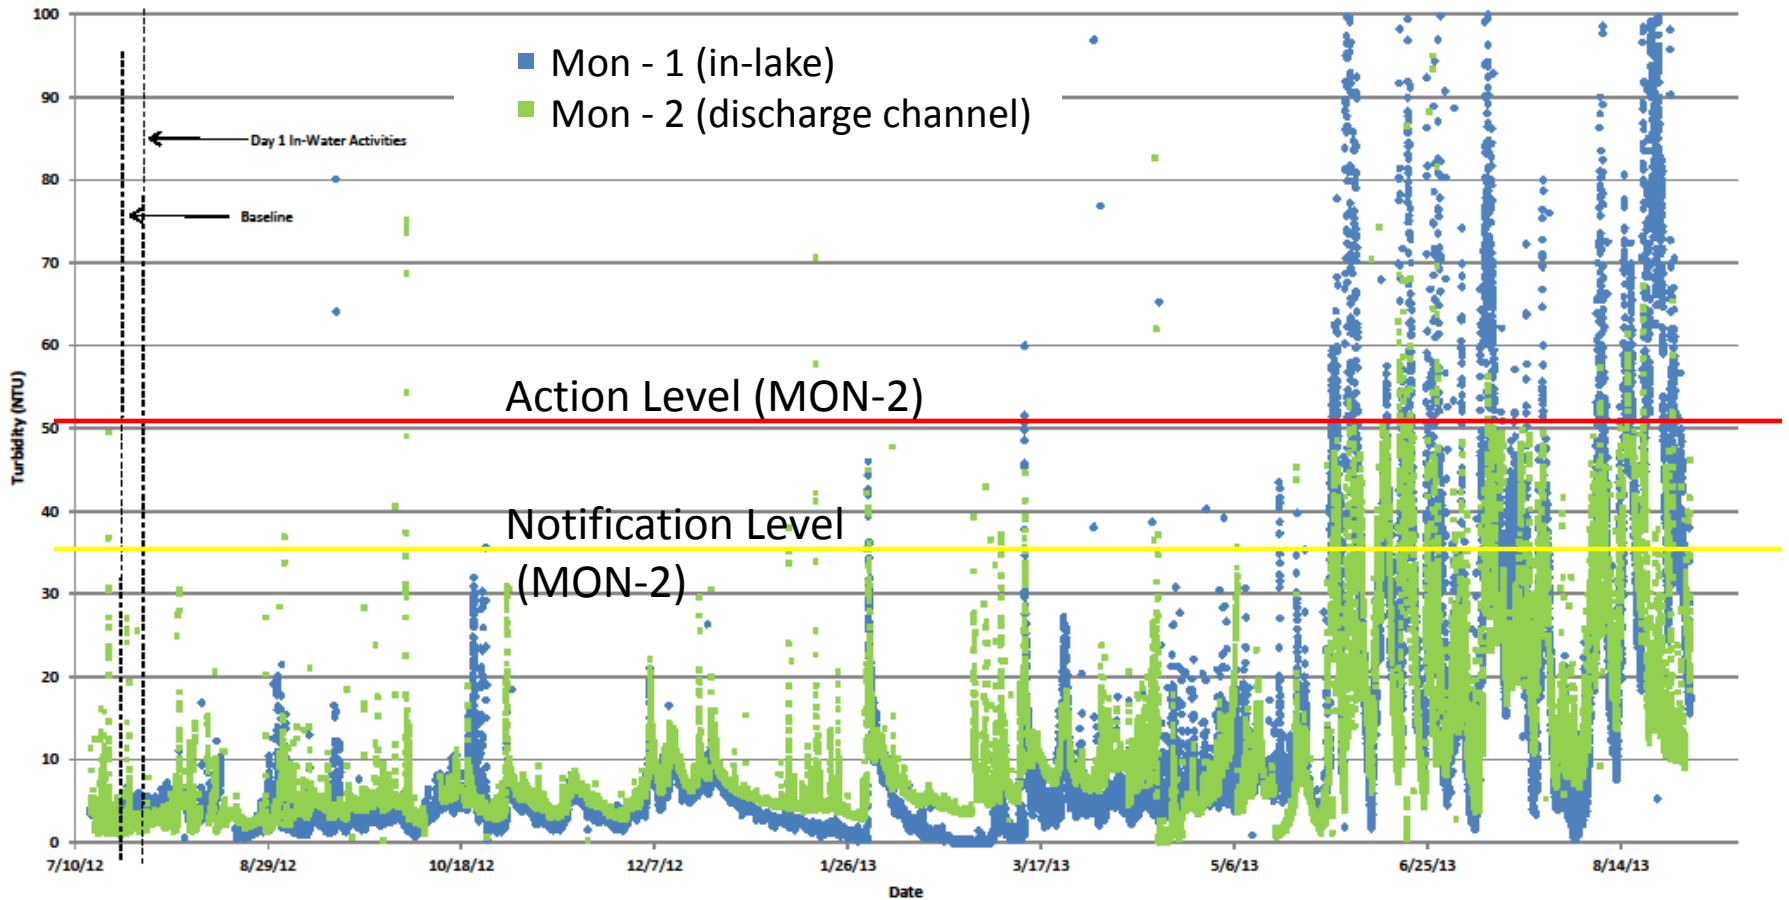
Turbidity Monitoring - Silver Lake 2012/13

1. Major tick marks along the horizontal axis are at midnight. Turbidity measurements were recorded every 15 minutes.
2. Exceedances above 50 NTU at MON-2 were also observed during non-work hours on 7/24, 8/5, 8/17, 8/27, 9/5, 9/8, 9/22, and 9/30 (in 2012) and 1/31, 5/11, 5/22, 5/29, 6/5, 6/7, 6/14, 6/24, 7/3, 7/7, 7/11, 7/12, 7/13, 7/14, 7/19, 7/20, 7/21, 7/23, 7/24, 8/6, 8/7, 8/8, 8/9, 8/13, 8/15, 8/16, 8/17, 8/18, 8/30, and 8/31 (in 2013). As these exceedances were caused by weather events and/or field conditions not attributed to active construction, the observations have been removed from the above Figure.

3. A water quality sample was collected due to the exceedance above 50 NTU at MON-2 on 10/3/12, 1/17/13, 4/15/13, 6/4/13, 6/17/13, 6/18/13, 6/20/13, 6/26/13.

4. Malfunctions in the real-time turbidity monitor (used to collect the data presented in this Figure) indicated turbidity levels exceeded 50 NTU at MON-1 and/or MON-2 at certain times during and outside of work hours. At such times (or before work was started the following day), manual readings and/or visual observation were performed at MON-2 to confirm that turbidity levels were below the early action level of 35 NTU. The most extraneous of these exceedances have been removed from the above Figure.

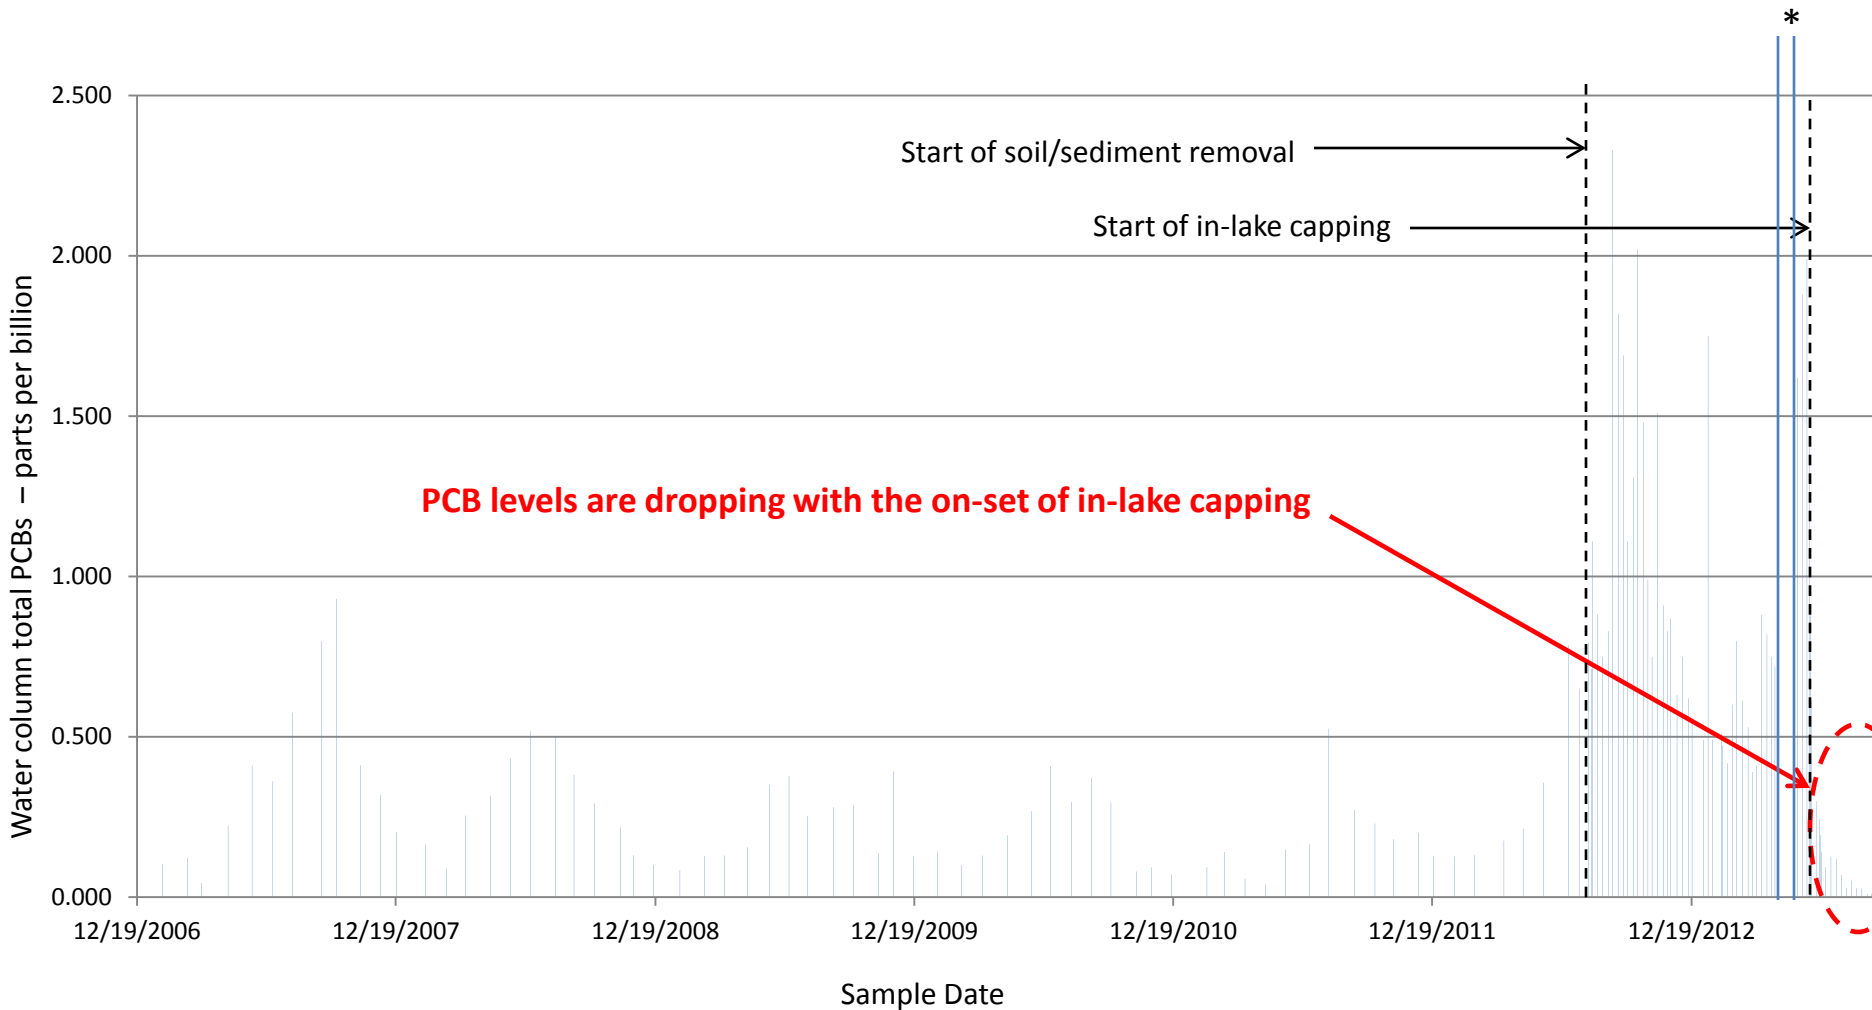
Preliminary Post-Capping Water Column PCB Data Silver Lake

* 4/25/13 = 6.1 ppb; 5/3/13 = 8.38 ppb; 5/10/13 = 5.31 ppb

NOTE: MON-2 data used for 12/2006 – 5/2013; MON-1 data used thereafter since MON-2 area not yet fully remediated (MON-1 is approximately 50 ft north of MON-2).
