Section 26 (#1011, 1012, 1035)

Removal Site Evaluation Report

Final | September 21, 2018

NAVAJO NATION
AUM Environmental Response Trust-First Phase

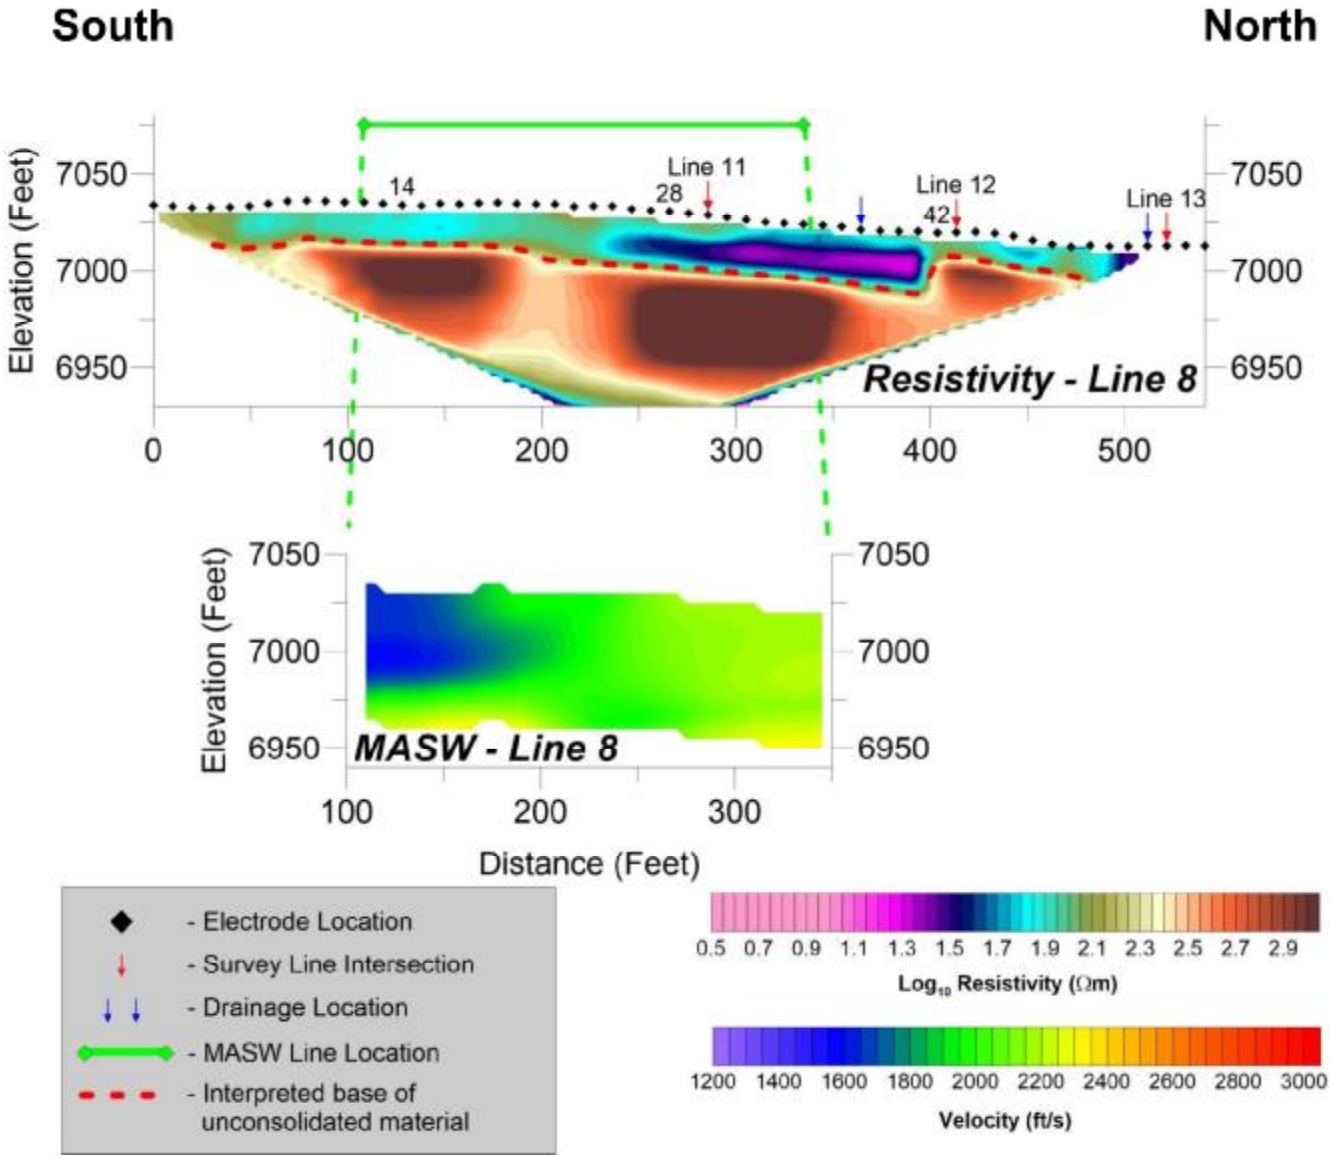
Figure 16. Line 8 Electrical Resistivity and MASW Model Results.

Figure 16 displays the resistivity and MASW model results for Line 8, which runs in a south to north direction. The resistivity model results again display a three-layer structure; with a conductive near-surface layer, which varies in thickness across the profile. This overlies a resistive layer, which is on average 55 feet thick, with a more conductive layer just apparent at the base of the model results beneath this (due to the shorter length of Lines 8 to 10 the imaging depth is reduced accordingly). The geological logs from boreholes S1011-SCX-030 and -024, which are located 155 and 320 feet along the line respectively, indicate approximately 10 and 4 feet of fine-grained sediments overlying the marl bedrock. We observe a good agreement with the approximate thickness of the near-surface conductive layer associated with the S1011-SCX-030 location, suggesting again that this layer represents unconsolidated materials at the site. However, the S1011-SCX-024 location displays a significant discrepancy, with an approximate 20 feet conductive layer thickness. This could be a results of the borehole locations being approximately 30 feet to the west of the line, thus undulations in the thickness of the overlying

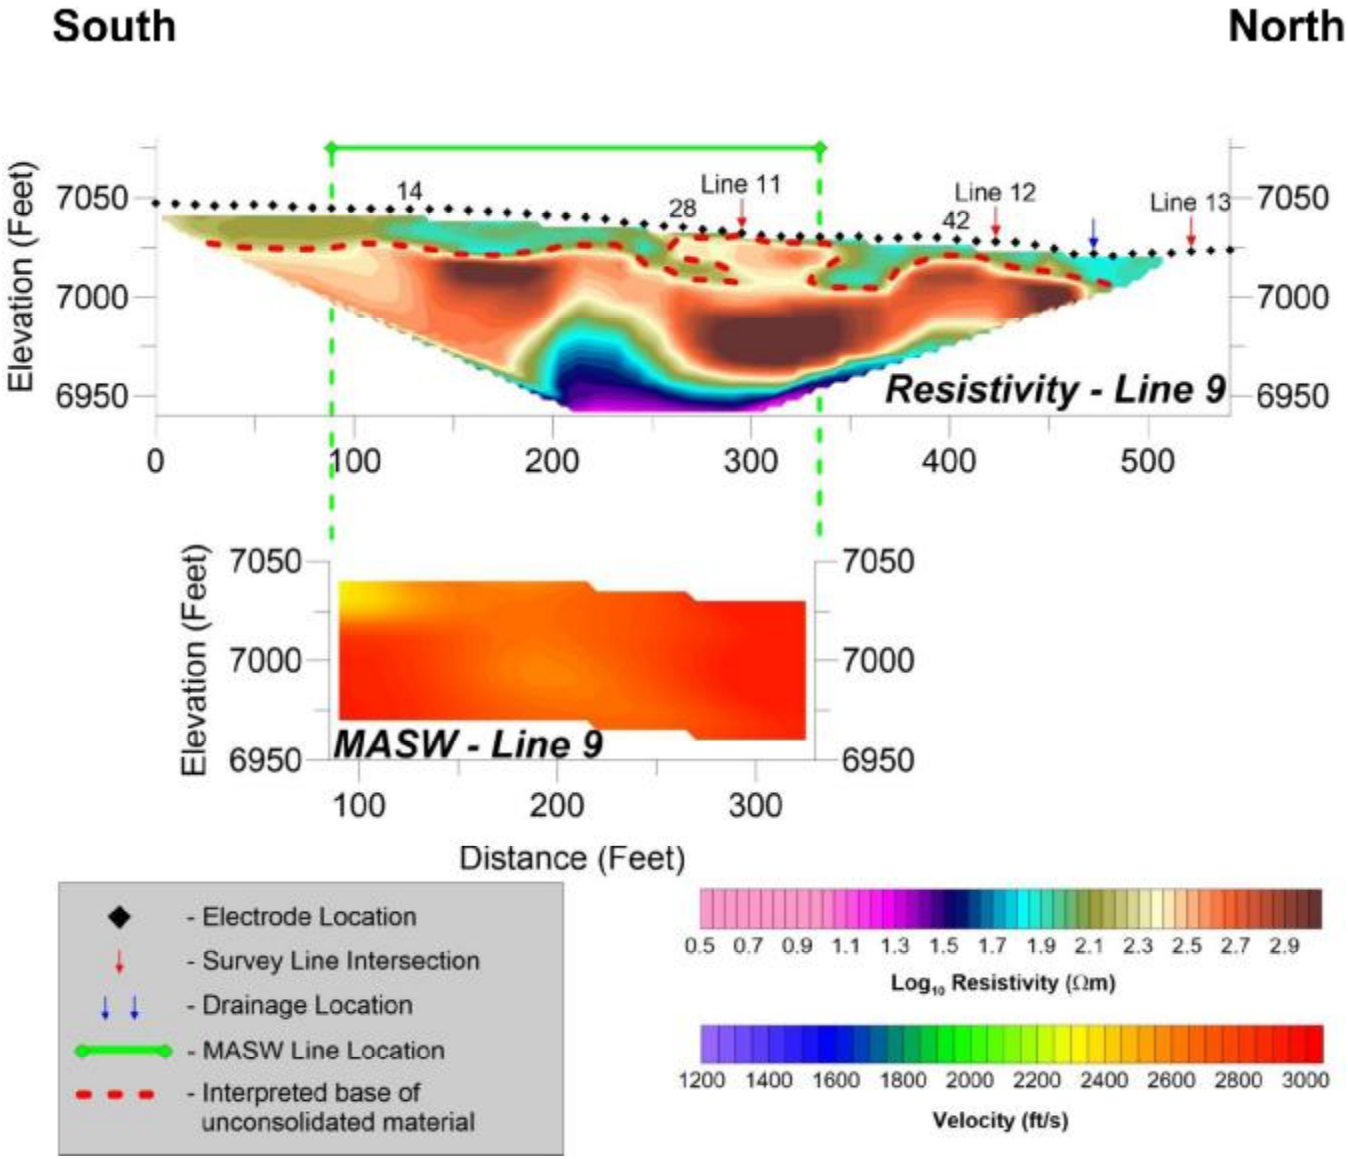
Figure 17. Line 9 Electrical Resistivity and MASW Model Results.

Figure 17 displays the resistivity and MASW model results for Line 9, which runs in a south to north direction. The resistivity model results again display a three-layer structure; with a conductive near-surface layer, which varies in thickness across the profile. This overlies a resistive layer, which ranges between 30 and 50 feet thick, with a more conductive layer apparent at the base of the model results beneath this (due to the shorter length of Lines 8 to 10 the imaging depth is reduced accordingly). The closest geological logs are from boreholes S1011-SCX-030 and -024 again, which are located 140 and 320 feet along the line respectively, although are offset approximately 45 feet to the east of the line in each case. The geological logs indicate approximately 10 and 4 feet of fine-grained sediments overlying the marl bedrock respectively. We observe a good agreement with the approximate thickness of the near-surface

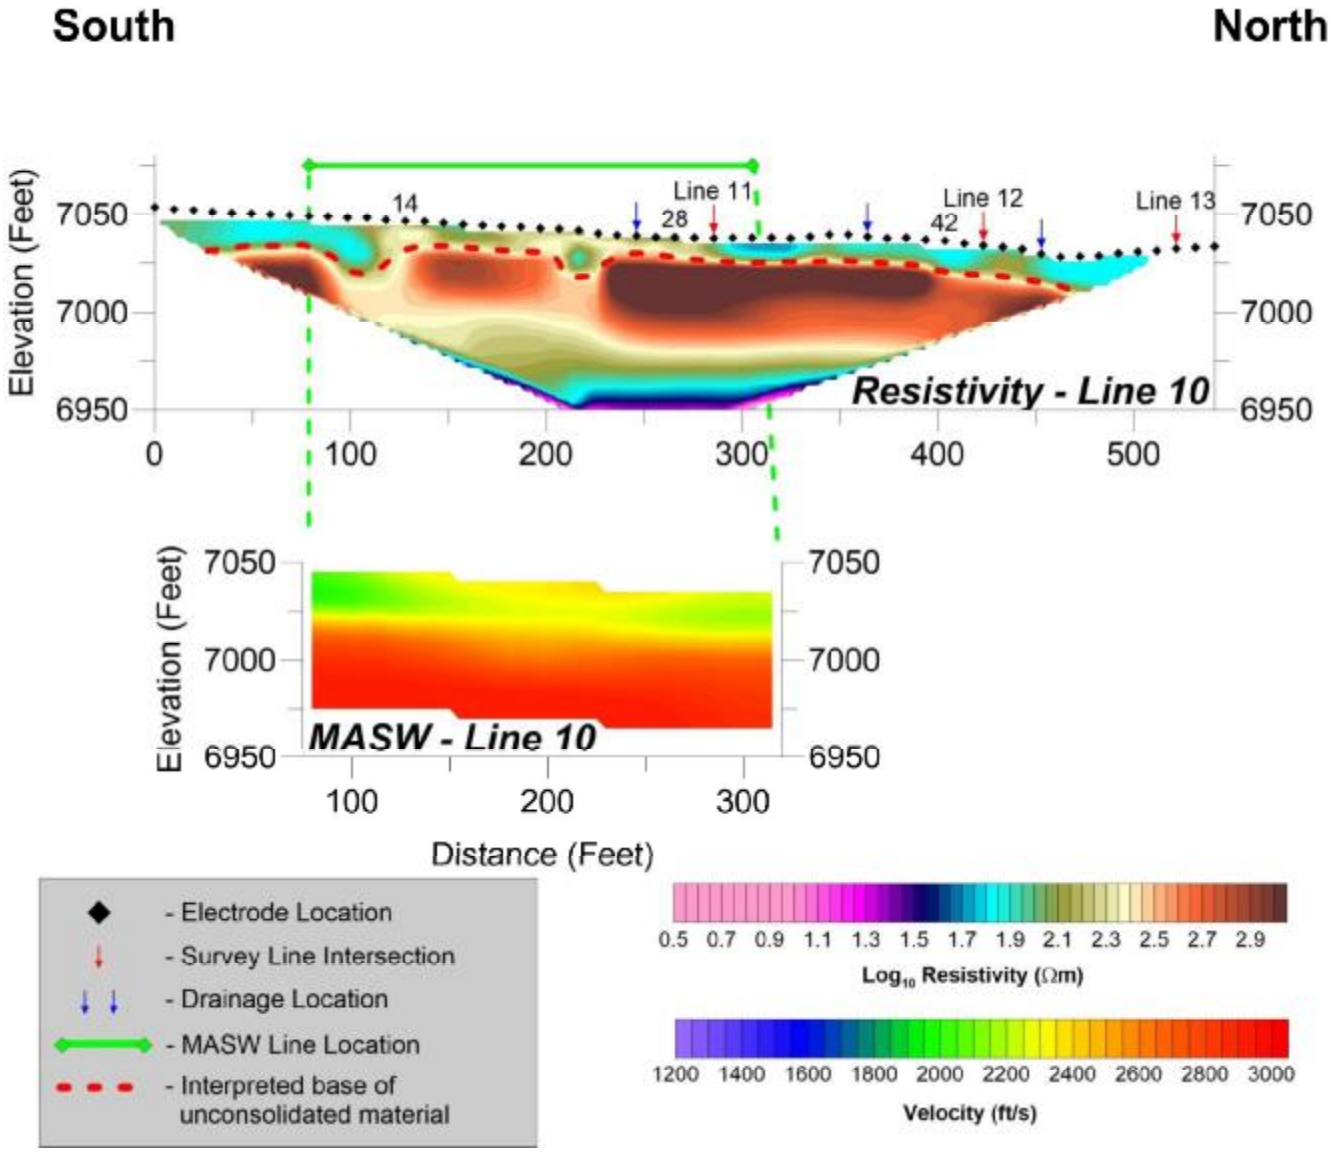
Figure 18. Line 10 Electrical Resistivity and MASW Model Results.

Figure 18 displays the resistivity and MASW model results for Line 10, which runs in a south to north direction. The resistivity model results again display a three-layer structure; with a conductive near-surface layer, which varies in thickness across the profile. This overlies a resistive layer, which is on average approximately 35 feet thick, with a more conductive layer apparent at the base of the model results beneath this (due to the shorter length of Lines 8 to 10 the imaging depth is reduced accordingly). There are no boreholes within proximity to Line 10.

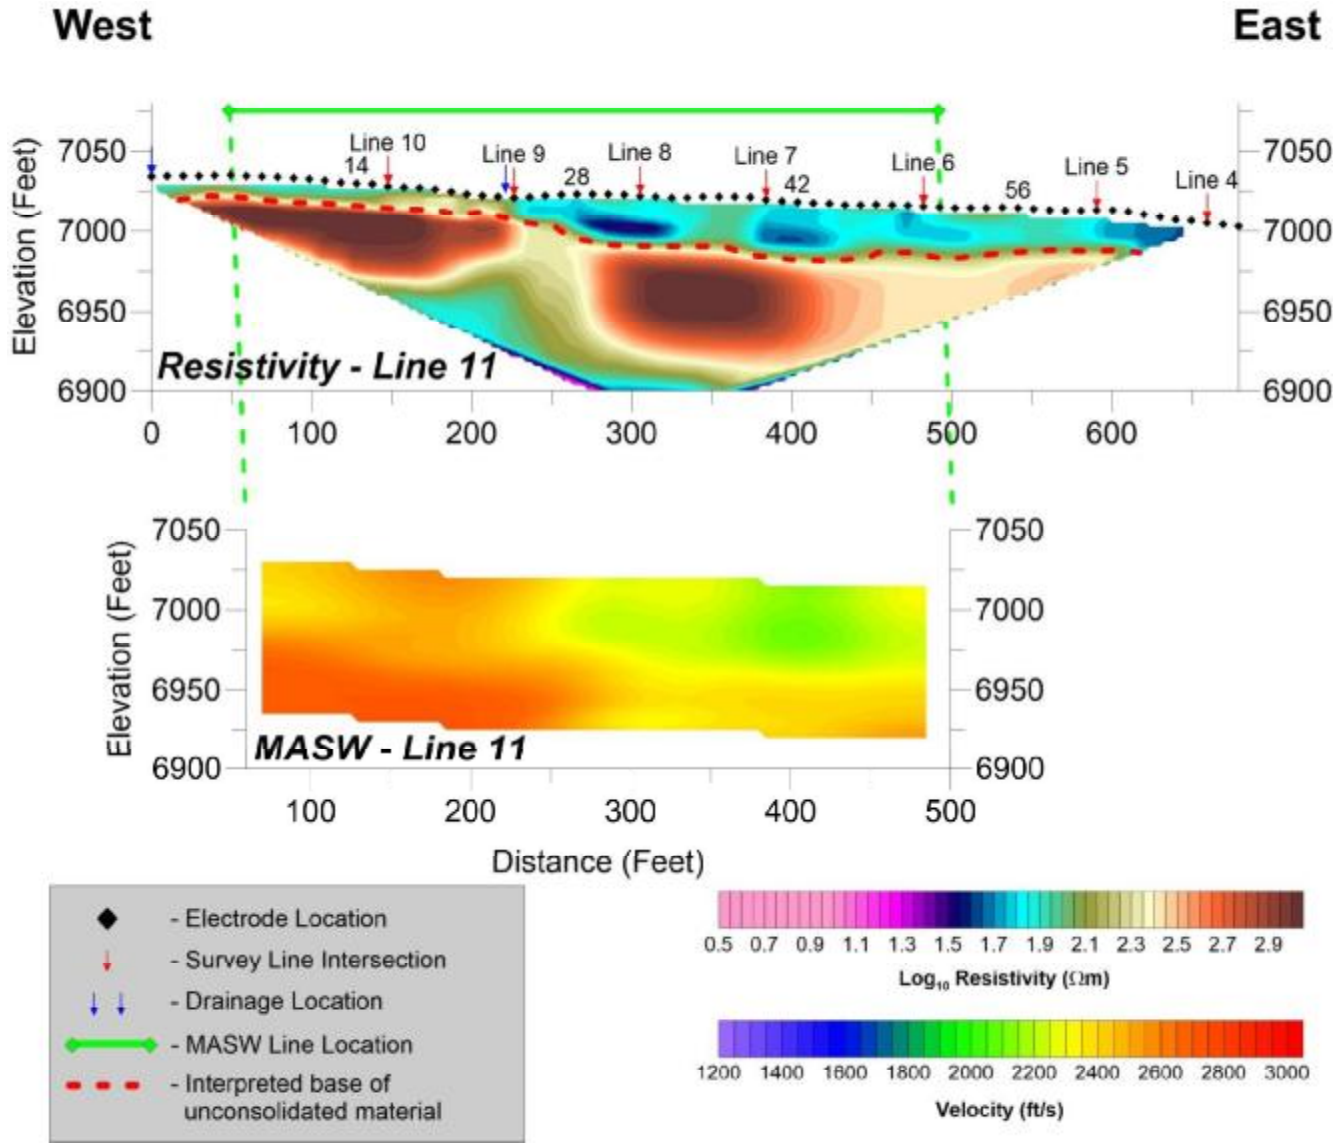
Figure 19. Line 11 Electrical Resistivity and MASW Model Results.

Figure 19 displays the resistivity and MASW model results for Line 11, which runs in a west to east direction. The resistivity model results again display a three-layer structure; with a conductive near-surface layer, which varies in thickness across the profile. This overlies a resistive layer, which ranges between 40 and 65 feet thick, with a more conductive layer apparent at the base of the model results beneath this (due to the shorter length of Lines 11 to 13 the imaging depth is reduced accordingly). The closest geological log is from borehole S1011-SCX-036, which is located 360 feet along the line, which indicates approximately 4 feet of fine-grained sediments overlying the marl bedrock. The depth to bedrock does not correlates well to the approximate thickness of the near-surface conductive layer in these locations, which tends to indicate approximately 20 feet of fine-grained sediments. This discrepancy could be related to the bedrock material, as with previous survey lines where the bedrock is indicated to be marl it is potentially more conductive than the limestone based on texture of the materials. Alternatively, since the borehole does not coincide directly with the survey line and the bedrock topography has been observed to vary significantly over short distances, this could lead to these discrepancies.

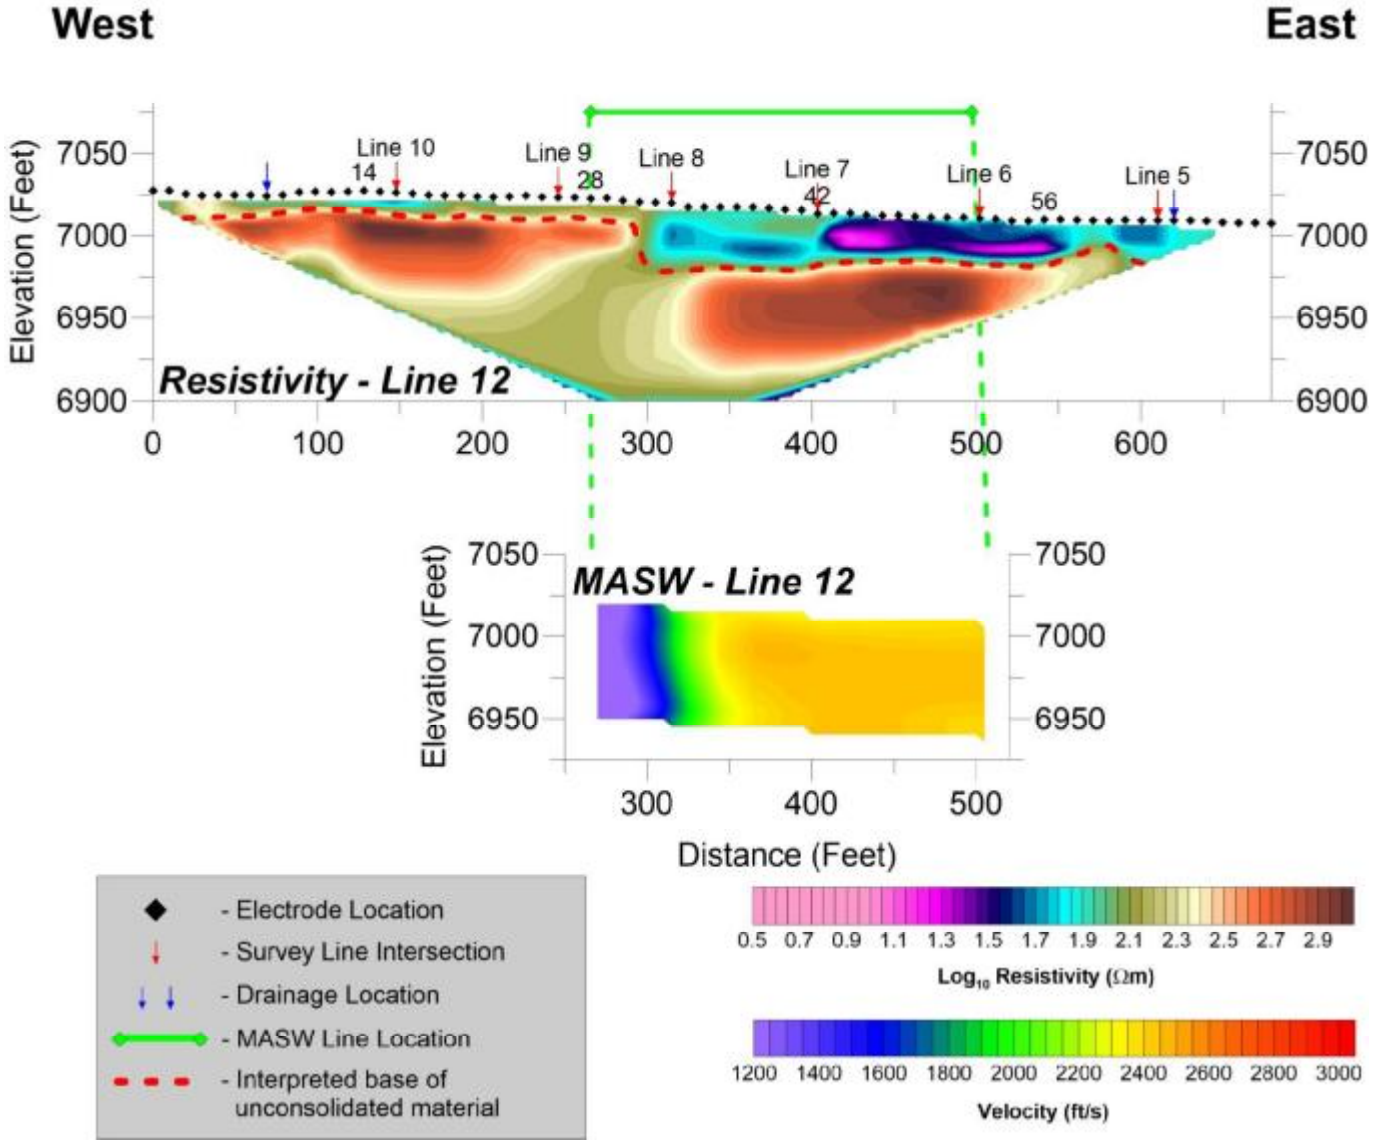
Figure 20. Line 12 Electrical Resistivity and MASW Model Results.

Figure 20 displays the resistivity and MASW model results for Line 12, which runs in a west to east direction. The resistivity model results again display a three-layer structure; with a conductive near-surface layer, which varies in thickness across the profile. This overlies a resistive layer, which ranges between 30 and 60 feet thick, with a more conductive layer apparent at the base of the model results beneath this (due to the shorter length of Lines 11 to 13 the imaging depth is reduced accordingly). The geological logs from boreholes S1011-SCX-035, -034, and -021, which are located approximately 395, 600, and 660 feet along the line respectively, indicate approximately 17, 12, and 18 feet of fine-grained sediments overlying the marl and limestone bedrock. In general, we observe a good agreement with the approximate thickness of the near-surface conductive layer associated with the first two borehole locations along this line, suggesting that this layer represents unconsolidated materials at the site. We do not have coverage for the location of S1011-SCX-021 due to the position towards the end of the line, where the imaging depth is limited.

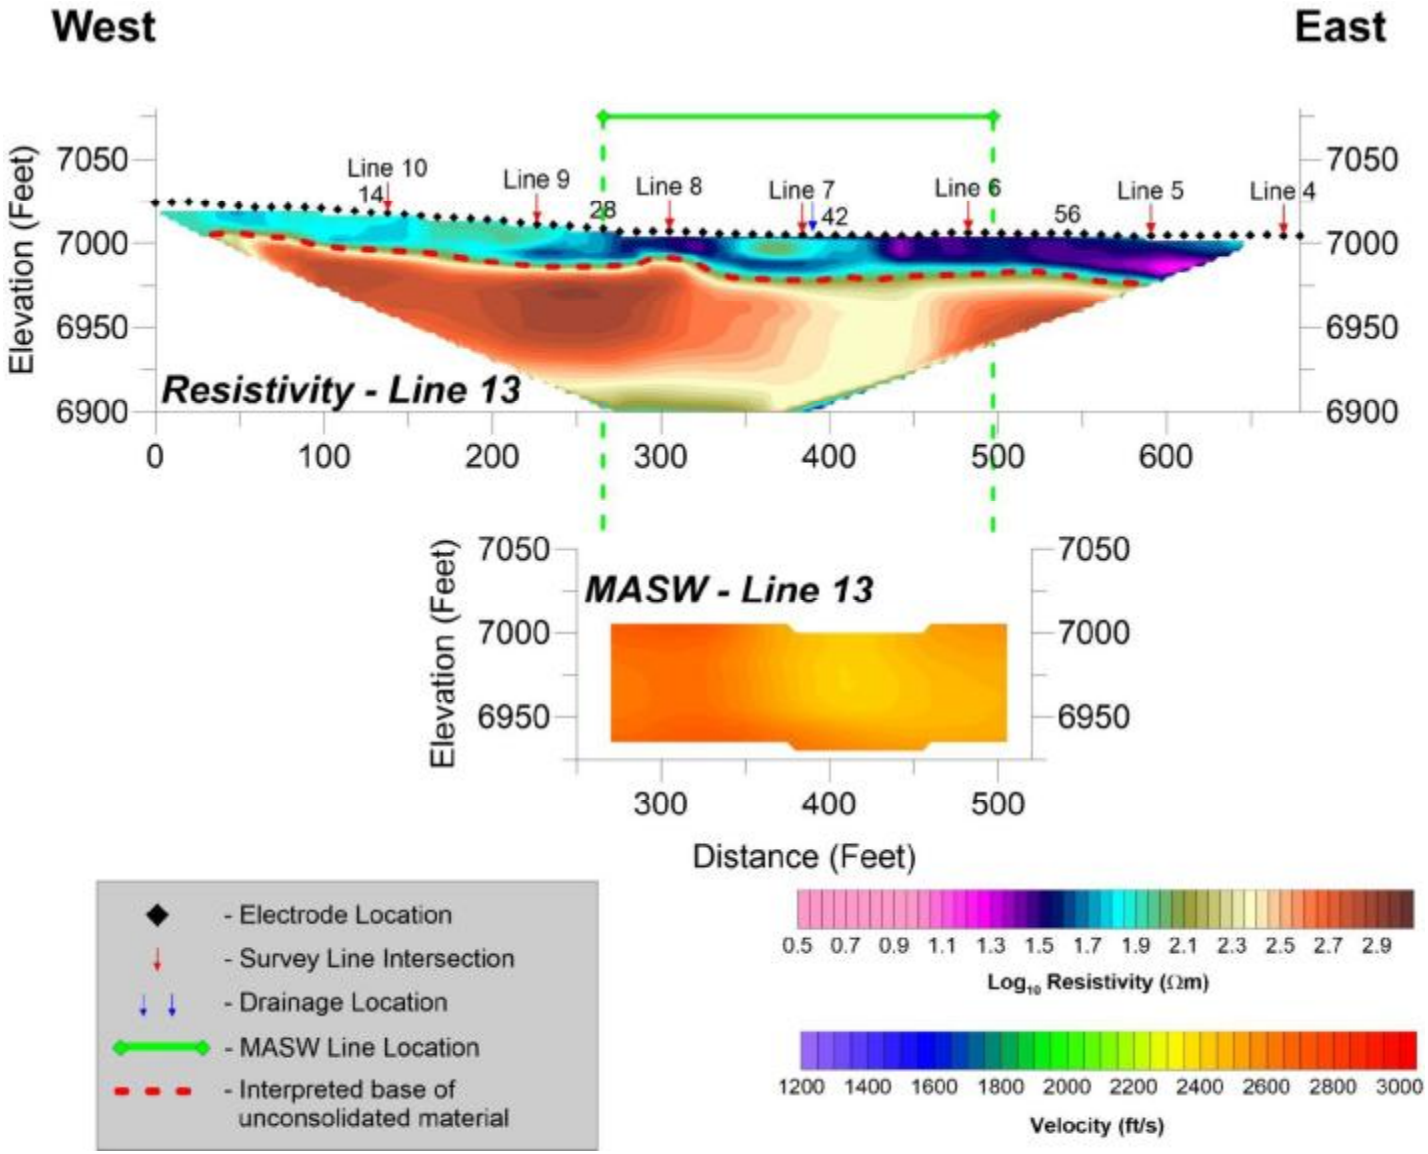
Figure 21. Line 13 Electrical Resistivity and MASW Model Results.

Figure 21 displays the resistivity and MASW model results for Line 13, which runs in a west to east direction. The resistivity model results again display a three-layer structure; with a conductive near-surface layer, which varies in thickness across the profile. This overlies a resistive layer, which appears on average approximately 65 feet thick, with a more conductive layer apparent at the base of the model results beneath this (due to the shorter length of Lines 11 to 13 the imaging depth is reduced accordingly). There are no boreholes within proximity to Line 13.

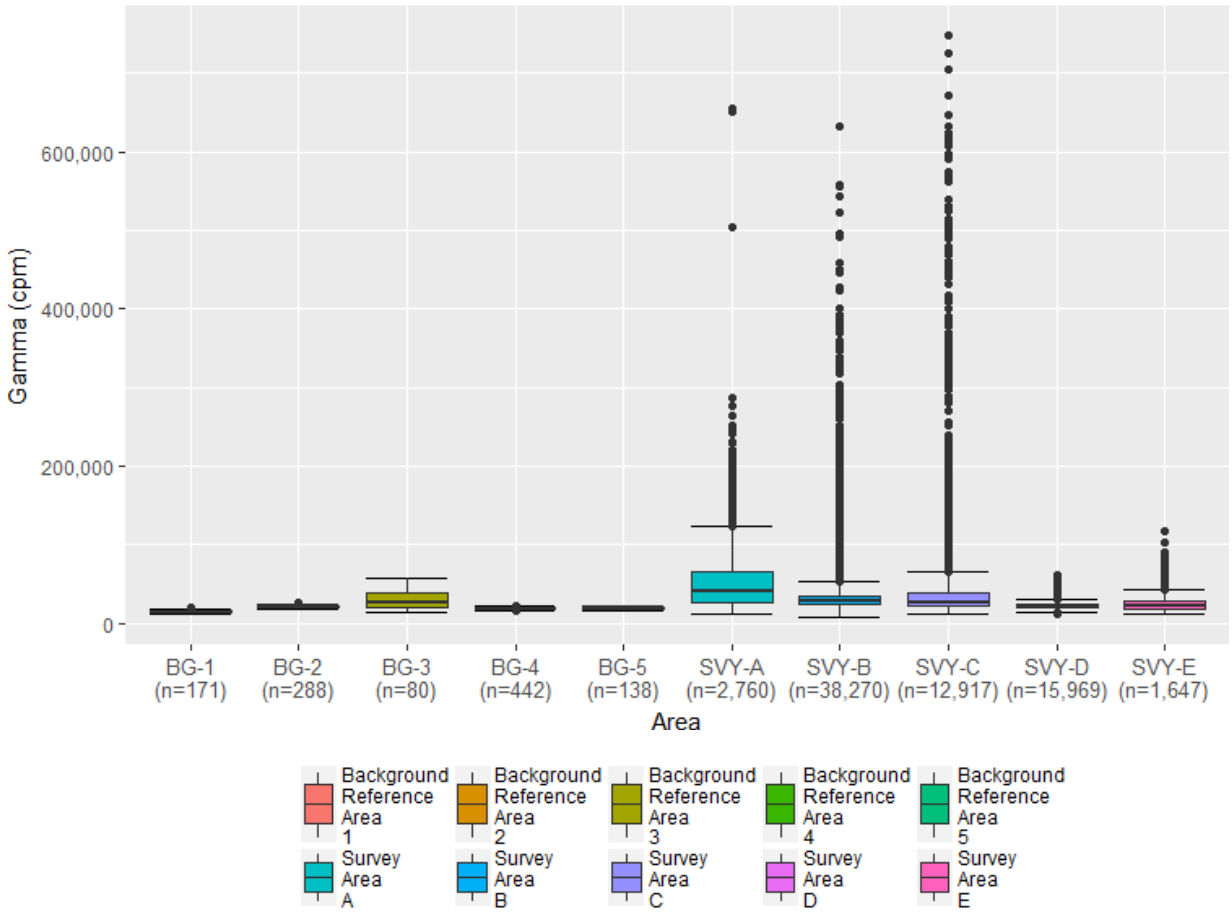
Figure 2A. Survey Areas and Background Reference Area Gamma Radiation Box Plots

The gamma radiation survey results box plots shown on Figure 2A depict differences in the data distribution for gamma measurements between background reference areas and Survey Areas. The large number of potential outlier values in the Survey Area box plots indicate high skewness or possibly non-normally distributed data, instead of outlier values. Based on Site geology, the potential gamma radiation outlier values observed for the Survey Area data on Figure 2A represent localized areas of higher gamma radiation with respect to other parts of each of the Survey Areas, as would be expected in areas with varying levels of mineralization, naturally occurring radioactive material (NORM) and potential TENORM.

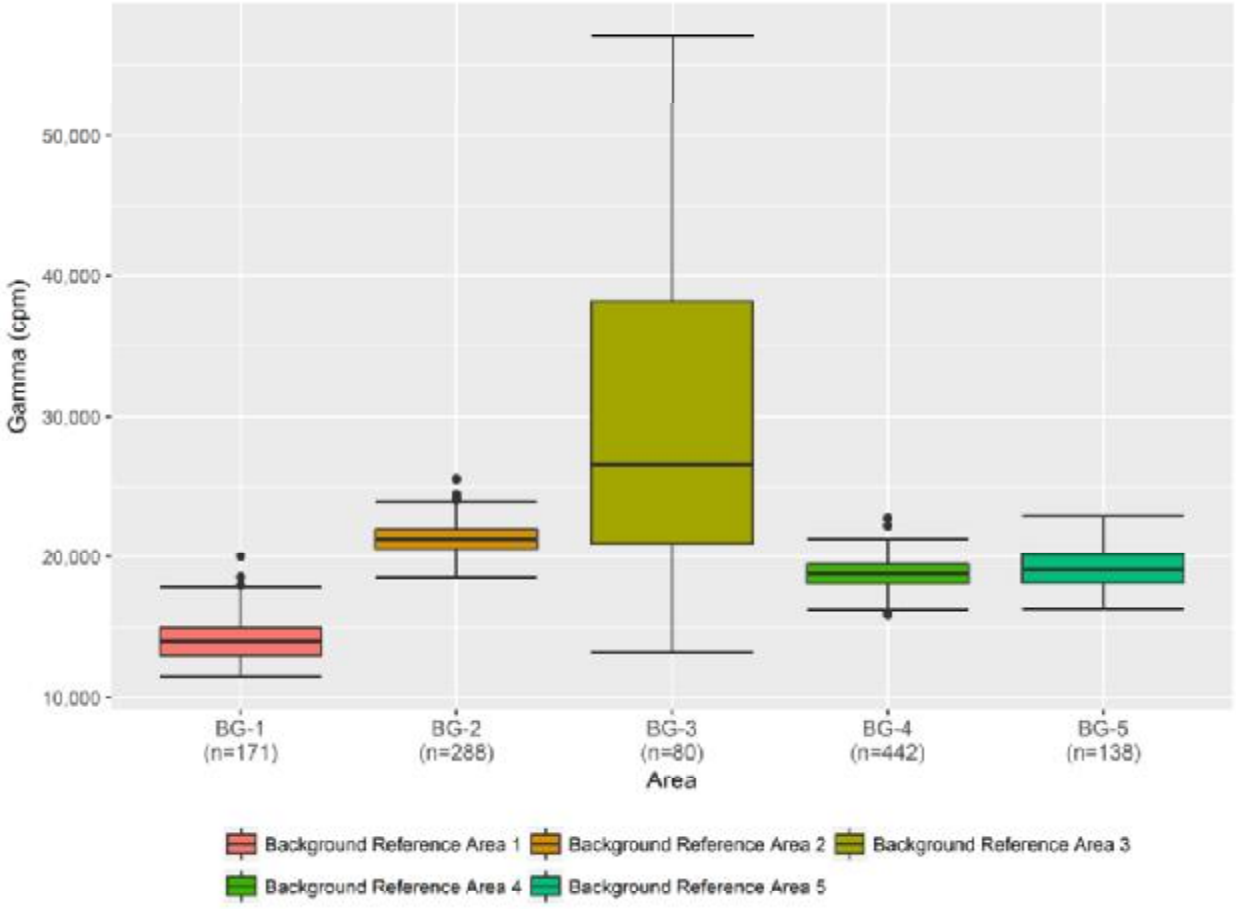
Figure 2B. Background Reference Areas Gamma Radiation Box Plots

As shown in Figure 2B, there are five, six, and four high potential outlier values shown for gamma data in the BG-1, BG-2, and BG-4 datasets, respectively. These potential outlier values do not represent skewed data as do the Survey Area results, and the gamma data are shown to be more normally distributed in the background reference areas than in the Survey Areas. The potential outlier values shown in the background reference areas are most likely representative of natural variation of gamma in these areas. These observations are further evaluated with the use of probability plots in Section 3.1.2 and statistical outlier testing in Section 3.1.4.
