**Re: GE-Pittsfield/Housatonic River Site
Rest of River (GECD850)
Revised Operation, Monitoring, and Maintenance Plan for Woods Pond Dam**

Lee & Lenox, Massachusetts

Revised December 2024
GZA File No.: 01.0019896.80

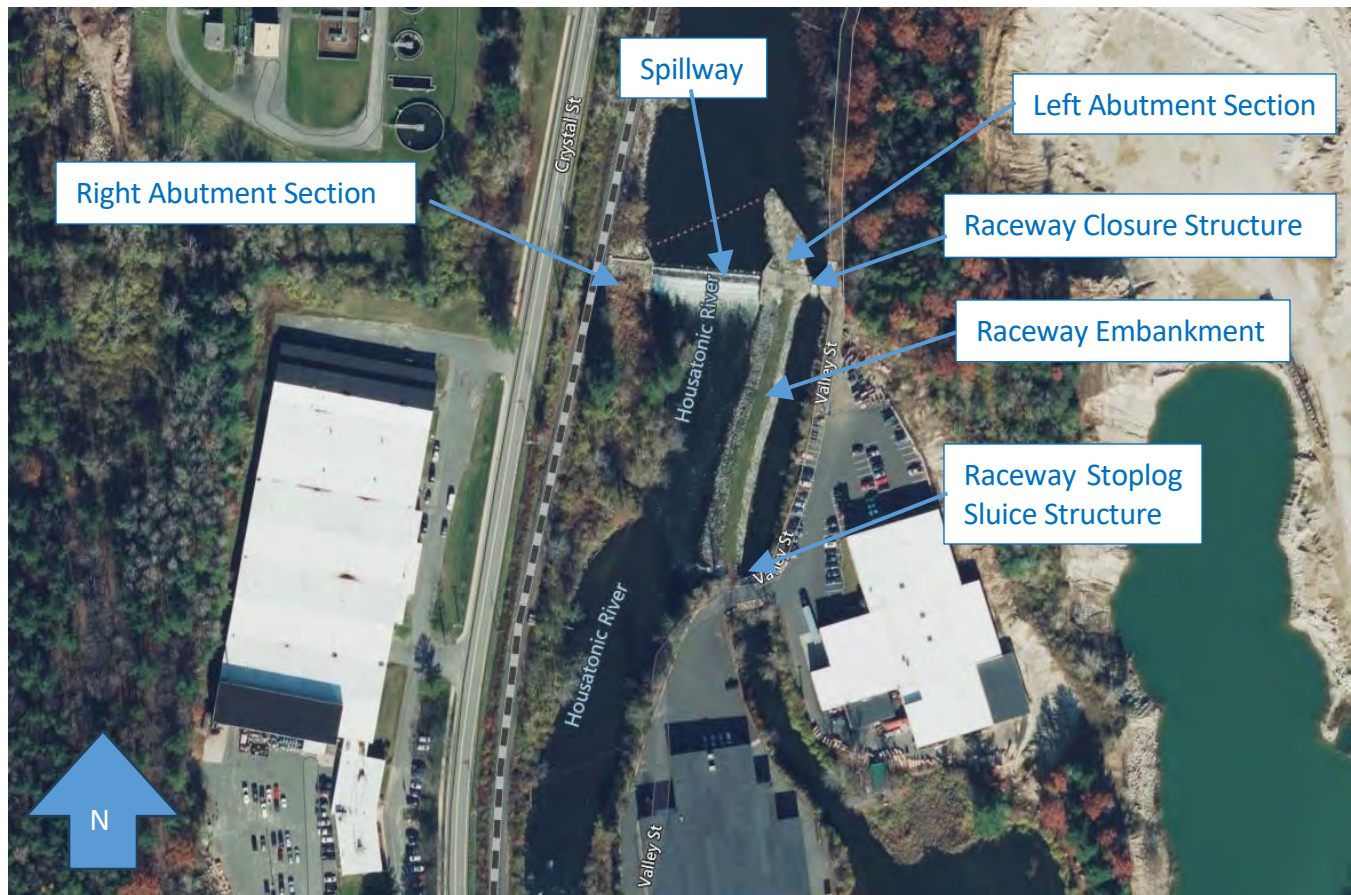
Source: GZA ArcGIS Mapper Tool

Woods Pond Dam is a run-of-the-river structure consisting of the following (moving from right/west to left/east) a concrete section as the right abutment, a primary spillway, sheetpile cells filled with concrete as the left abutment section, and a raceway closure structure which controls flow into the raceway channel. Additionally, a raceway embankment extends both upstream and downstream of the left abutment cellular sheetpiles. Outflow at the downstream end of the raceway channel is controlled by the raceway stoplog sluice structure. The raceway channel is no longer used to feed the downstream mill, and the raceway embankment

no longer impounds the reservoir or serves a functional role in the current Dam. An aerial photograph of the Dam and its appurtenances is shown below.

The right abutment section is a concrete gravity structure that extends approximately 60 feet between the railroad tracks and the spillway with a top elevation of 954.0 feet. The right abutment section is referred to as the non-overflow gravity section on the record drawings. Although this structure is termed “non-overflow,” the right abutment section of the Dam is designed to overflow during the applicable Spillway Design Flood (SDF).
