HRS DOCUMENTATION RECORD--REVIEW COVER SHEET

Name of Site: Dewey Loeffel Landfill

Date Prepared: March 2010

HRS DOCUMENTATION RECORD

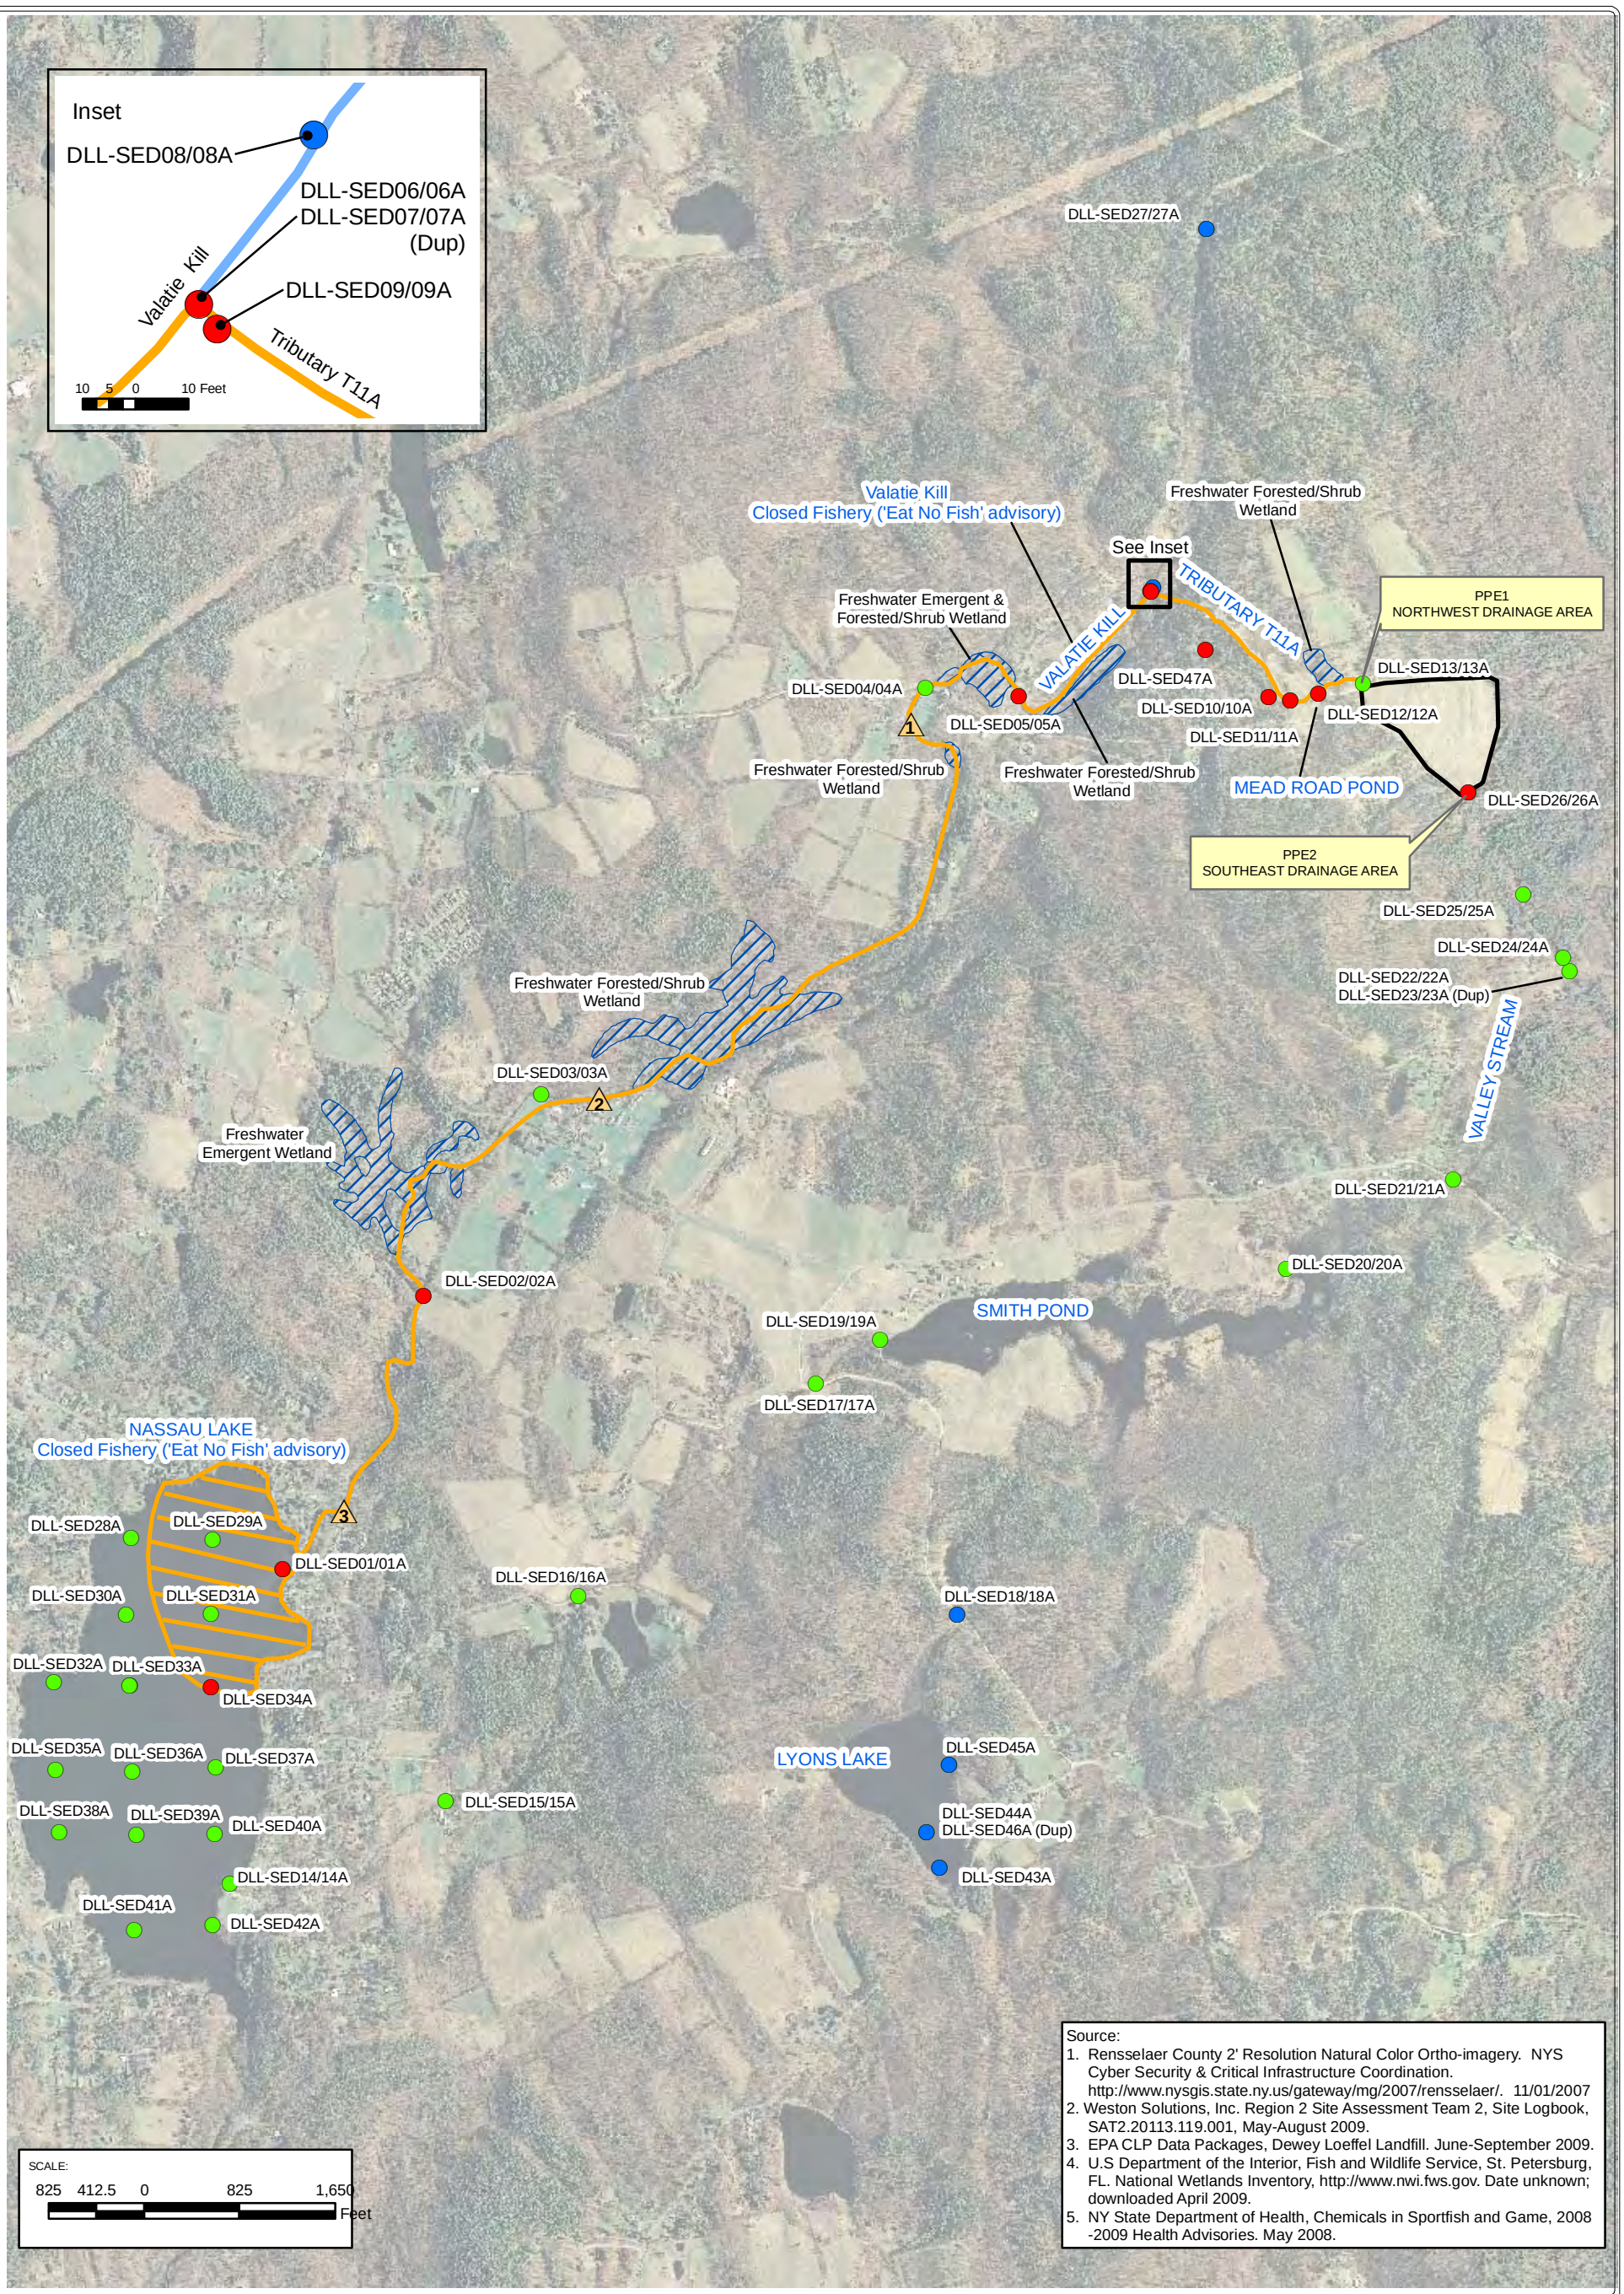
Figure 2
Sample Location Map
June-August 2009

In June and August 2009, EPA conducted sediment sampling along the surface water migration pathway downstream of the facility, including the former Mead Road Pond, Tributary T11A, Valatie Kill, Valley Stream, Smith Pond, and Nassau Lake [Ref. 13, pp. 8-48; 14, pp. 3-6, 9; 15, pp. 3-8, 11]. Samples were analyzed for Target Compound List (TCL) Aroclors, total organic carbon (TOC), and grain size [Ref. 16 through 22]. The analytical results indicated the continuing presence of PCBs in sediment samples from the former Mead Road Pond, Tributary T11A, Valatie Kill, and Nassau Lake [Ref. 16, pp. 30-32; 17, pp. 3-5, 17, 20-22, 24, 31-32, 45, 74]. Nassau Lake and the Valatie Kill between County Route 18 and Nassau Lake are fisheries that have been closed due to the site-related PCB contamination, and there are 1.7 miles of wetland frontage located within the zone of contamination [Figure 2; Ref. 8, pp. 21, 26; 23, pp. 13, 17, 21; 25, p. 1; 38, pp. 1-2].

An observed release by chemical analysis is documented along the surface water migration pathway downstream of the Dewey Loeffel Landfill facility, between sample location DLL-SED12 in the former Mead Road Pond and sample location DLL-SED34A in Nassau Lake, approximately 3.4 miles downstream [Figure 2].
