FIRST FIVE-YEAR REVIEW REPORT

ARLINGTON BLENDING AND PACKAGING SITE

September 2002

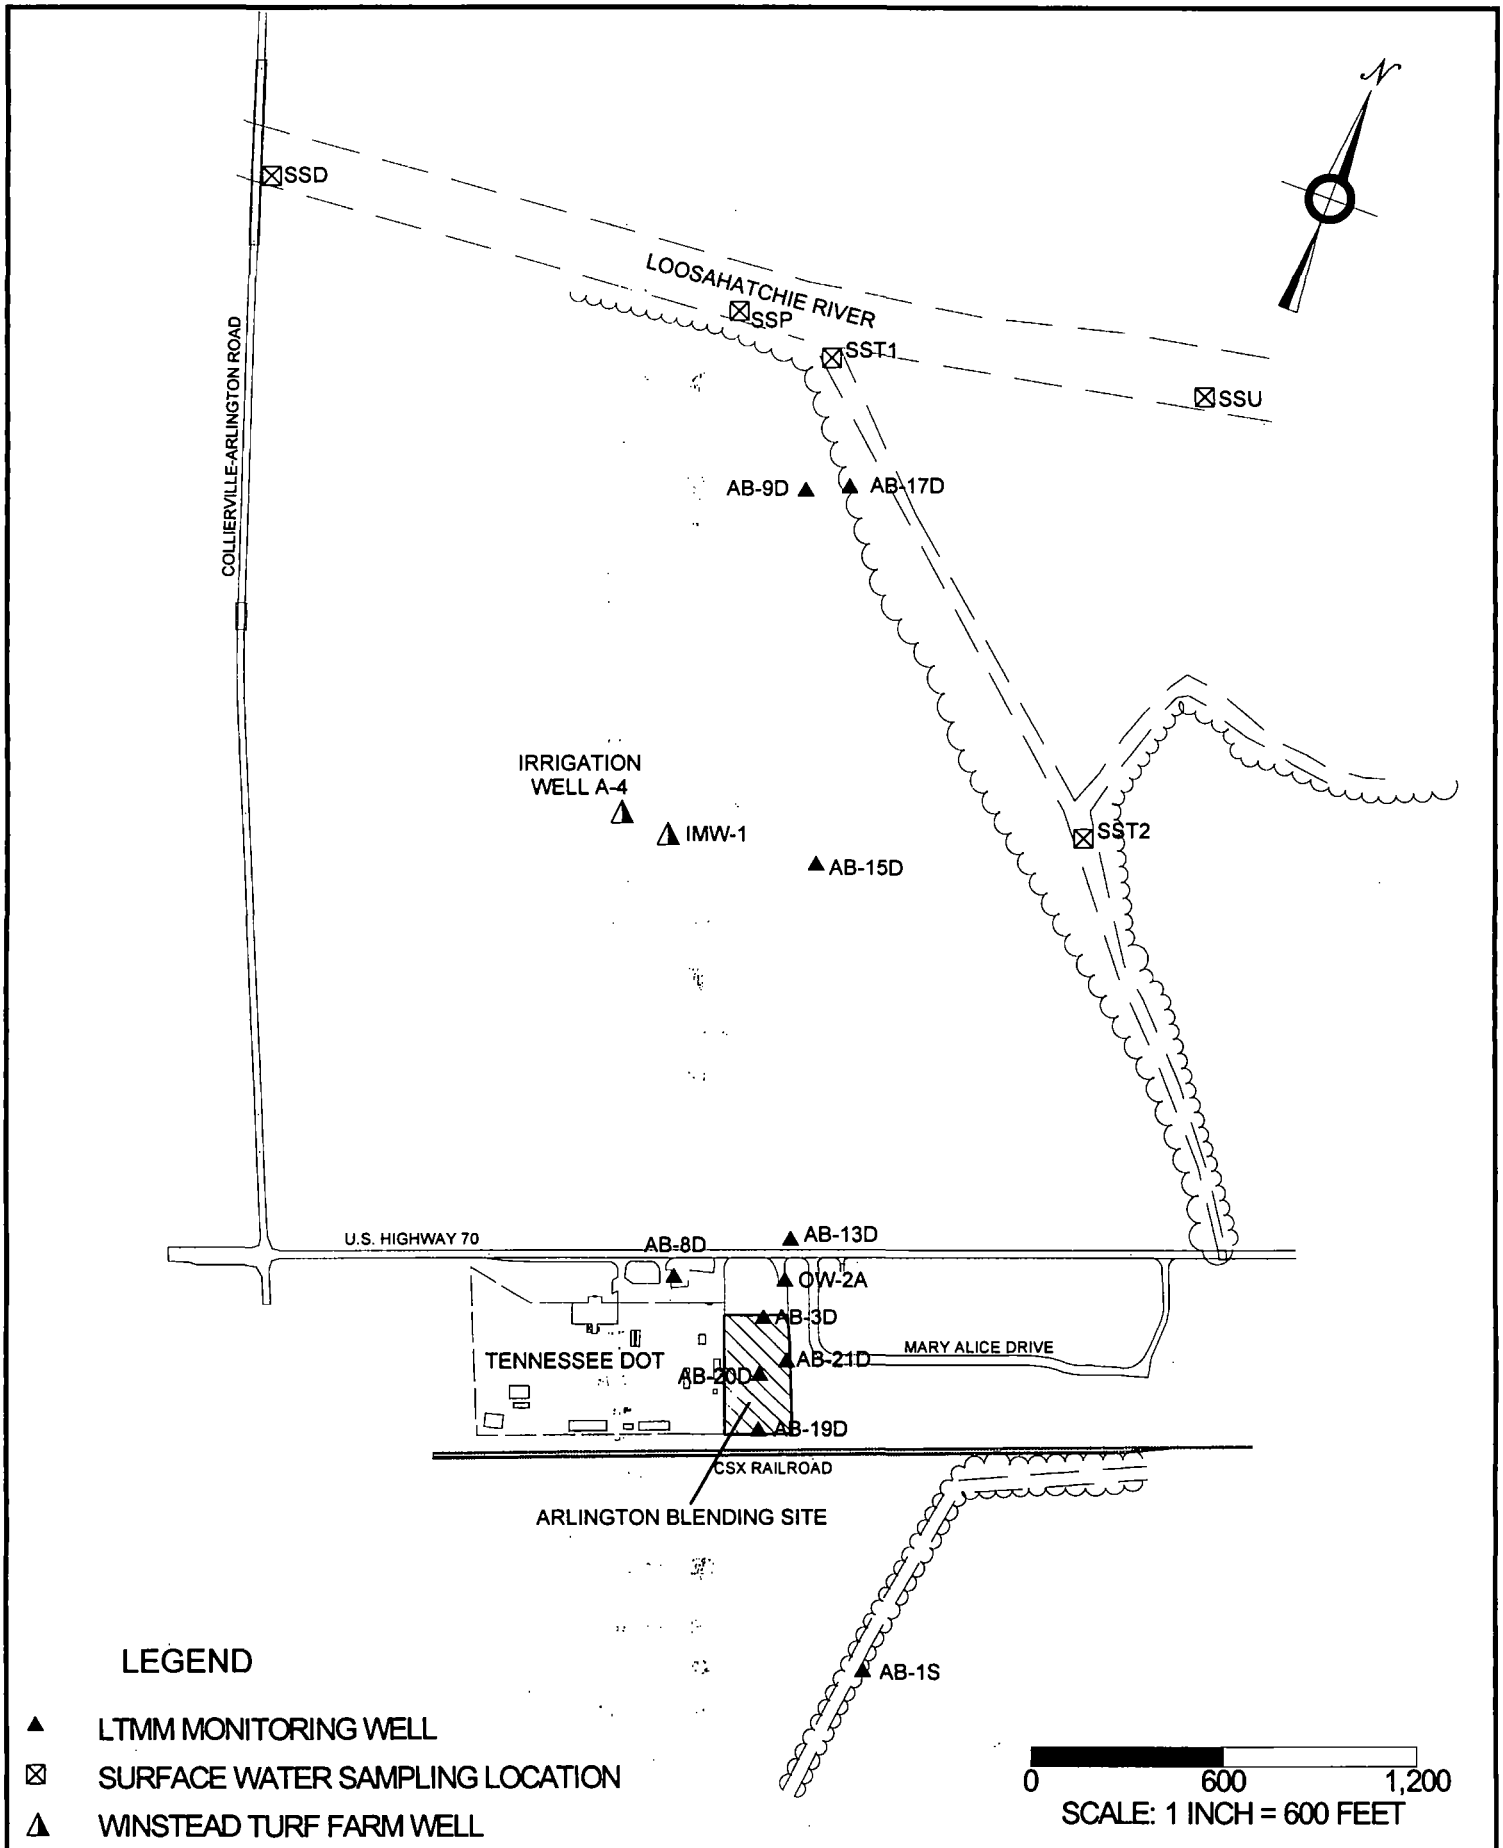
Figure 3
Groundwater Contour Map (6/5/01)
Arlington Blending & Packaging Site
Arlington, Tennessee

groundwater flow direction in the surficial aquifer is north-northwest towards the Loosahatchie River, as shown in ***Figure 3***.

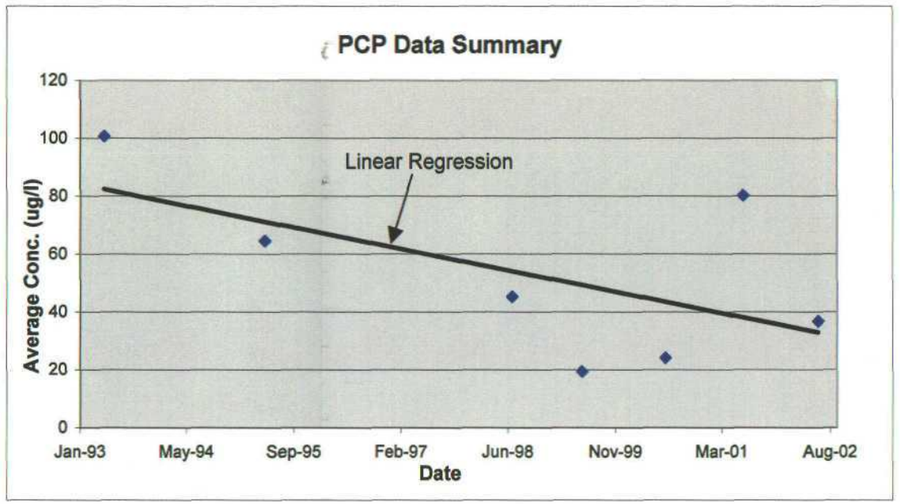
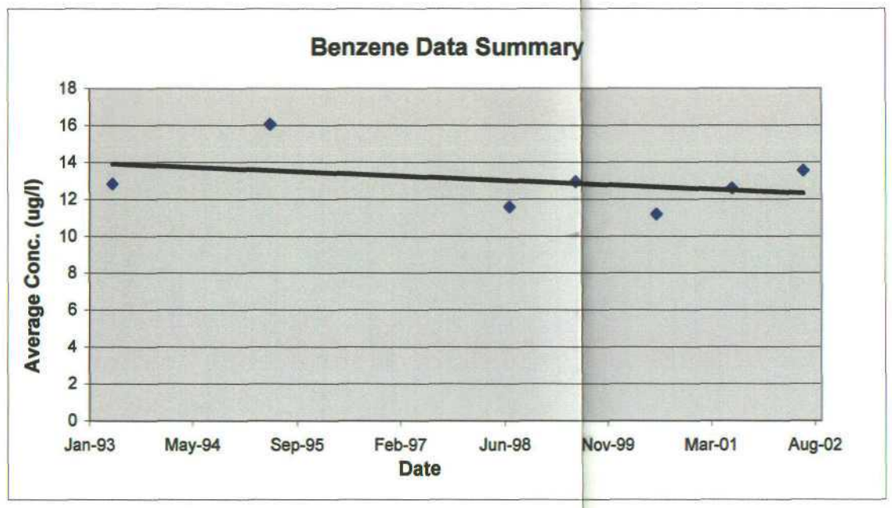
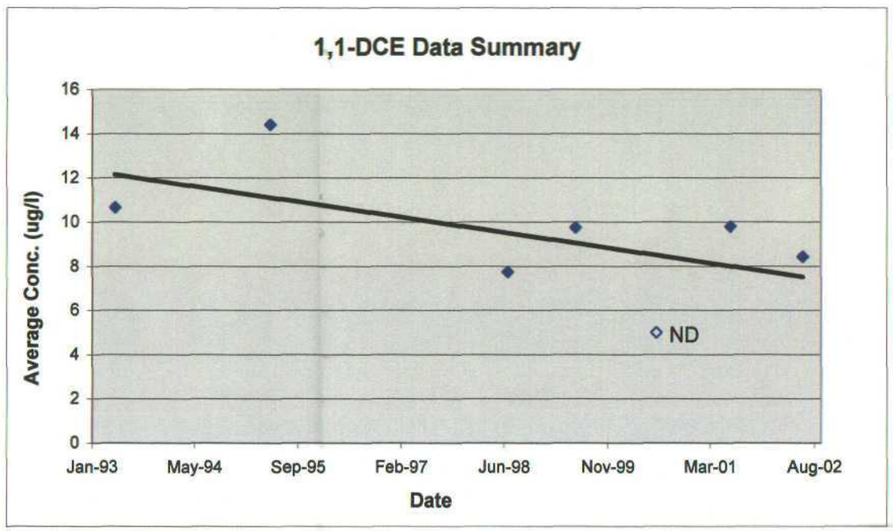
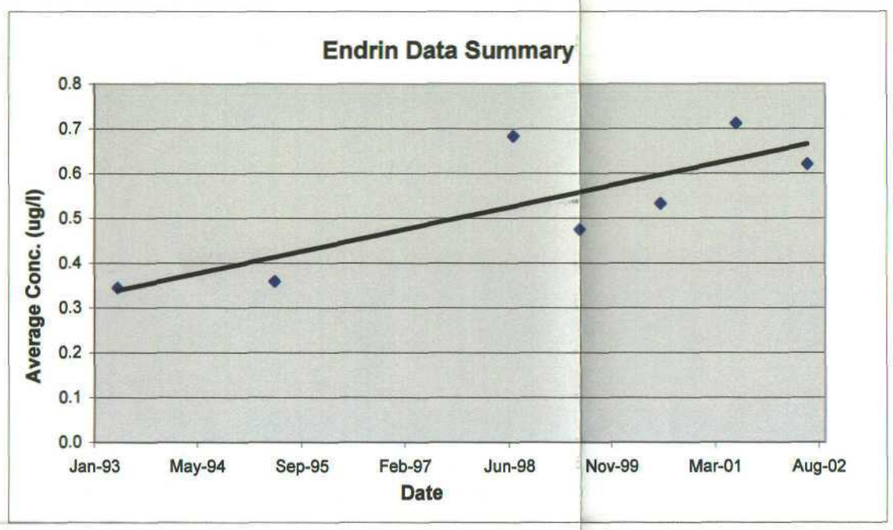
Figure 9
Plume Average Concentration Evaluation

Review of ***Figure 9*** shows that there are observed decreasing trends in average concentration for PCP, benzene, and 1,1-DCE. An increasing trend in average concentration for endrin is observed. For this reason, it is important to evaluate the magnitude of the contaminant plume and the potential for a continued increasing concentration. This was accomplished by calculating the plume mass and comparing to the mass of contamination removed and the mass of contamination remaining onsite at the completion of the soil remedy. The plume mass was determined using the plume area, average concentration, an assumed aquifer thickness of 25 feet, and a porosity of 0.39. A summary of the temporal trends in plume mass is shown in ***Figure 10***.

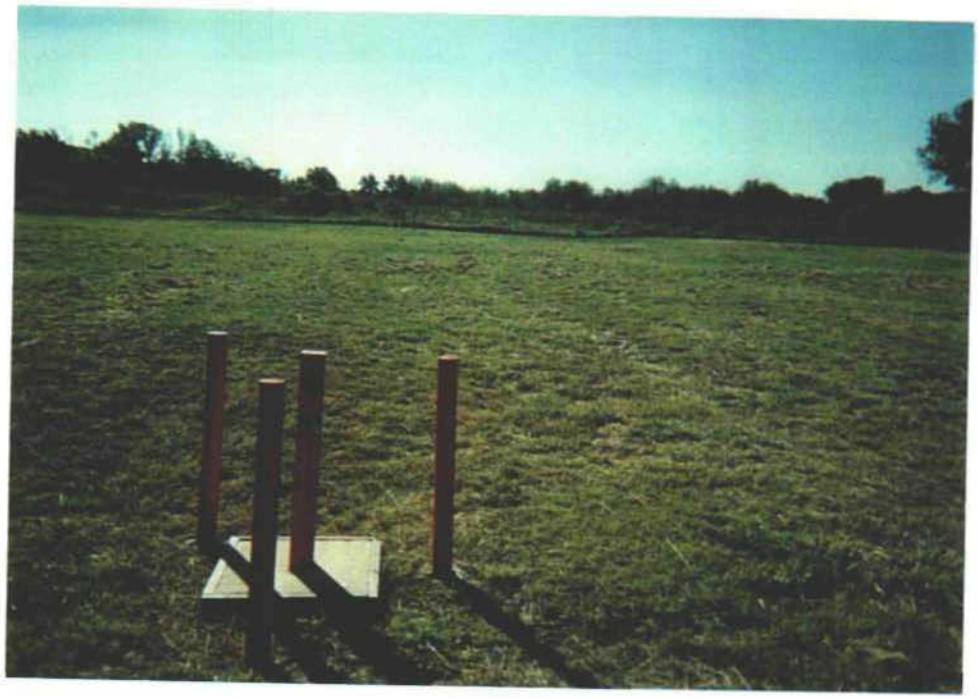
13) Monitoring Well AB-20D

All of the groundwater monitoring wells were inspected for proper identification, accessibility, and general integrity. All 11 wells were properly identified, locked, and appeared to be in good condition (Photographs 4-14). In addition to identifying monitoring well locations, three surface water sampling locations were observed, as well. The surface water and groundwater monitoring locations are shown on ***Figure 4***. During the inspection the EPA Remedial Project Manager requested that a fourth surface water sample be collected from the drainage ditch flowing into the Loosahatchie River. As part of the routine semi-annual surface water sampling event on November 16, a fourth sample was collected from the drainage ditch (SST1 location). The location of the sample is shown on ***Figure 4***.
