**Re: GE-Pittsfield/Housatonic River Site
Rest of River (GECD850)
Revised Operation, Monitoring, and Maintenance Plan for Woods Pond Dam**

Lee & Lenox, Massachusetts

Revised December 2024
GZA File No.: 01.0019896.80

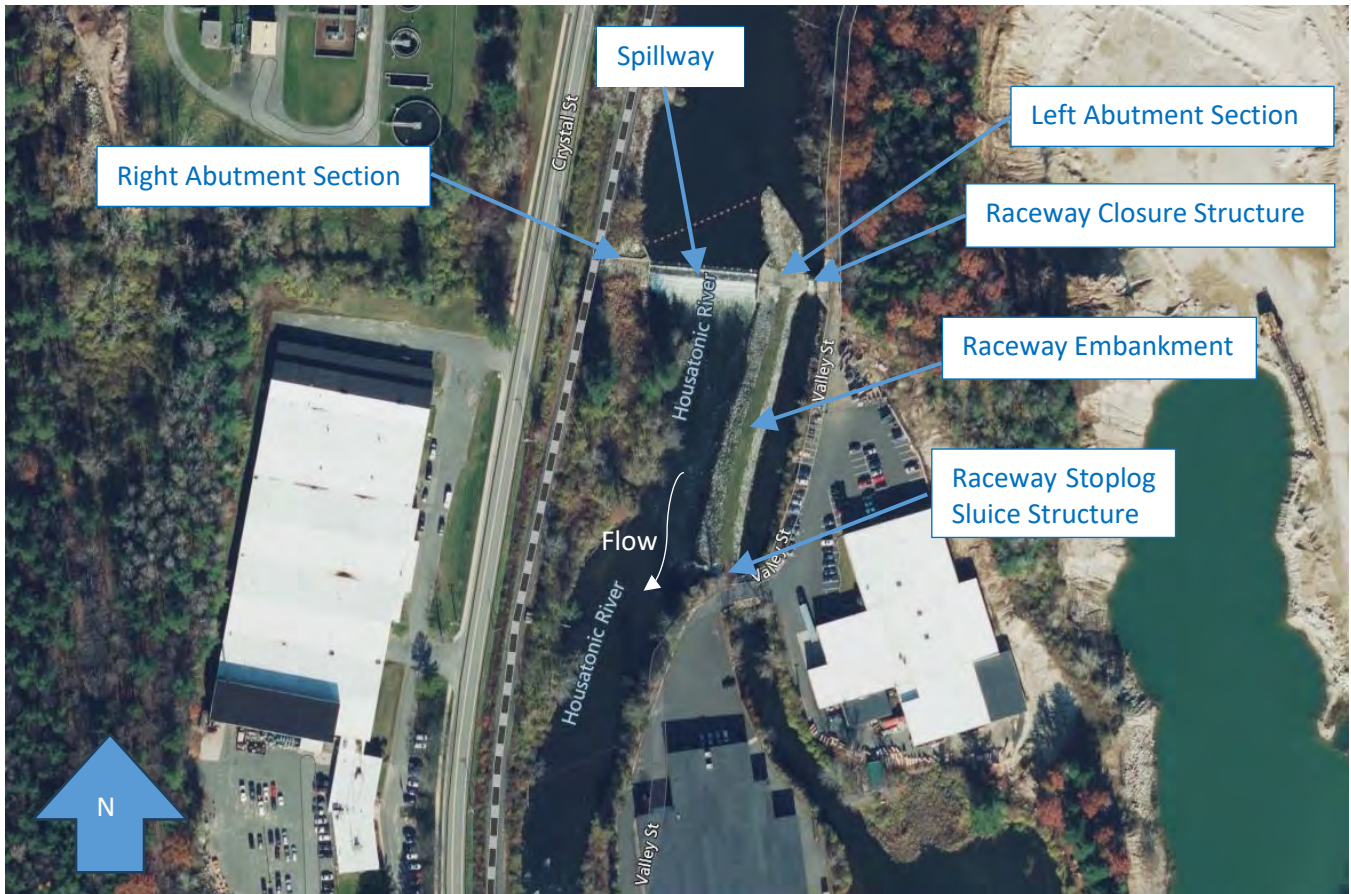
Source: GZA ArcGIS Mapper Tool

Woods Pond Dam is a run-of-the-river structure consisting of the following (moving from right/west to left/east) a concrete section as the right abutment, a primary spillway, sheetpile cells filled with concrete as the left abutment section, and a raceway closure structure which controls flow into the raceway channel. Additionally, a raceway embankment extends both upstream and downstream of the left abutment cellular sheetpiles. Outflow at the downstream end of the raceway channel is controlled by the raceway stoplog sluice structure. The raceway channel is no longer used to feed the downstream mill, and the raceway embankment no longer impounds the reservoir or serves a functional role in the current Dam. An aerial photograph of the Dam and its appurtenances is shown below.

The right abutment section is a concrete gravity structure that extends approximately 60 feet between the railroad tracks and the spillway with a top elevation of 954.0 feet. The right abutment section is referred to as the non-overflow gravity section on the record drawings. Although this structure is termed “non-overflow,” the right abutment section of the Dam is designed to overflow during the applicable Spillway Design Flood (SDF).
