FIRST FIVE-YEAR REVIEW REPORT
FOR
ARLINGTON BLENDING AND PACKAGING SITE

Prepared For:
United States Environmental Protection Agency
Region IV
Atlanta, Georgia

Prepared By:
Memphis Environmental Center, Inc.
Memphis, Tennessee

September 2002

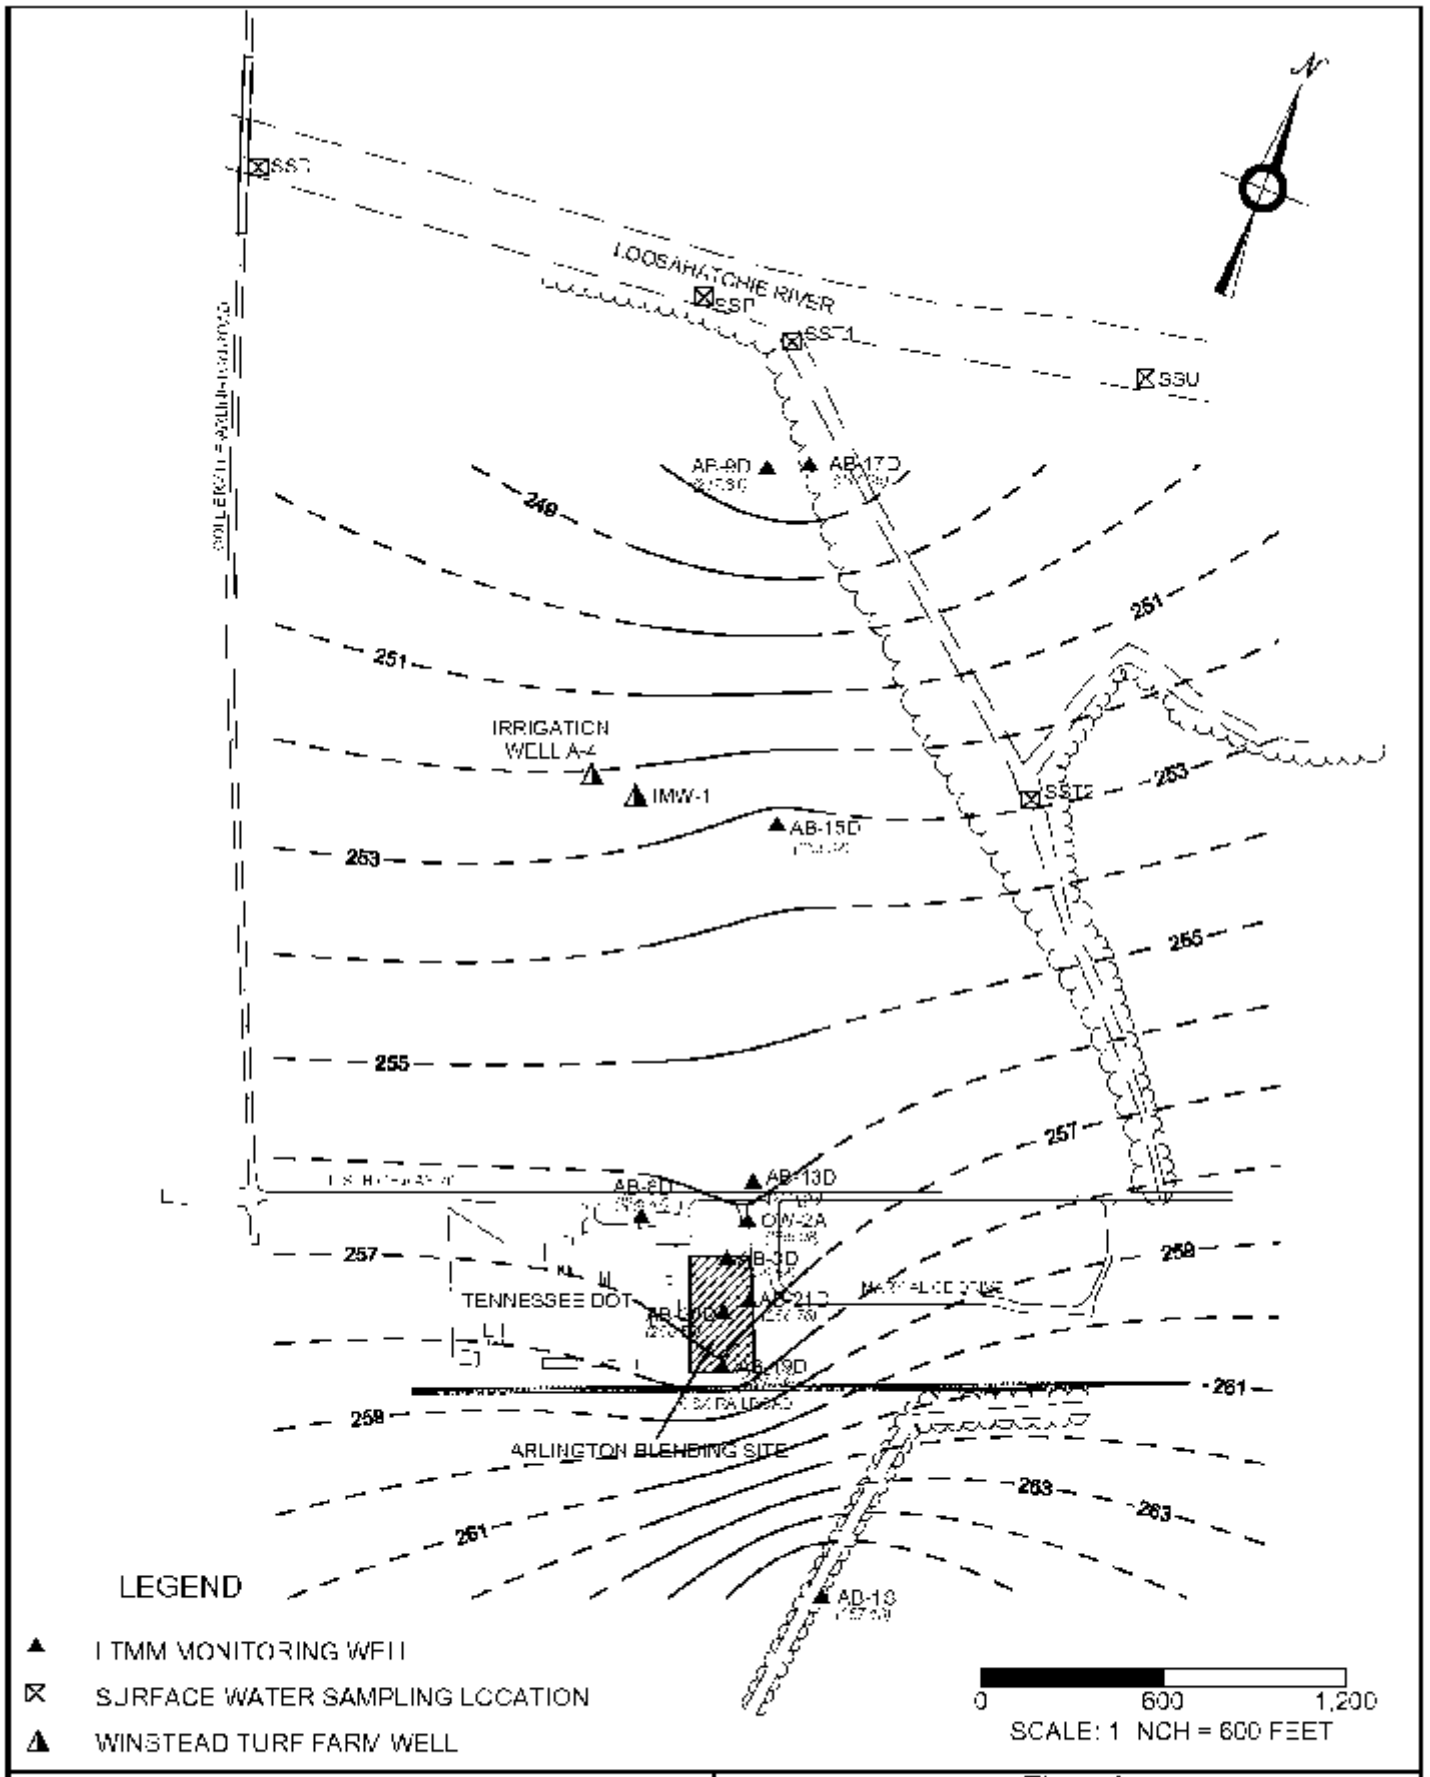
Figure 3
Groundwater Contour Map (6/5/01)
Arlington Blending & Packaging Site
Arlington, Tennessee

The land surface is topped mainly by Pleistocene loess, except in flood plain locations where alluvial deposits are prevalent. Previous investigations of the Site have identified four hydrogeologic units: (1) Unit I, a 20-foot thick silt semi-confining layer, (2) Unit II, a 30-foot thick confined/semi-confined sand aquifer (surficial aquifer), (3) Unit III, a 70-foot thick clay confining unit, and (4) Unit IV, the upper portion of the Memphis Sand confined aquifer. A cross-section of the site showing the units described above is illustrated in **Figure 2**. The groundwater flow direction in the surficial aquifer is north-northwest towards the Loosahatchie River, as shown in Figure 3.

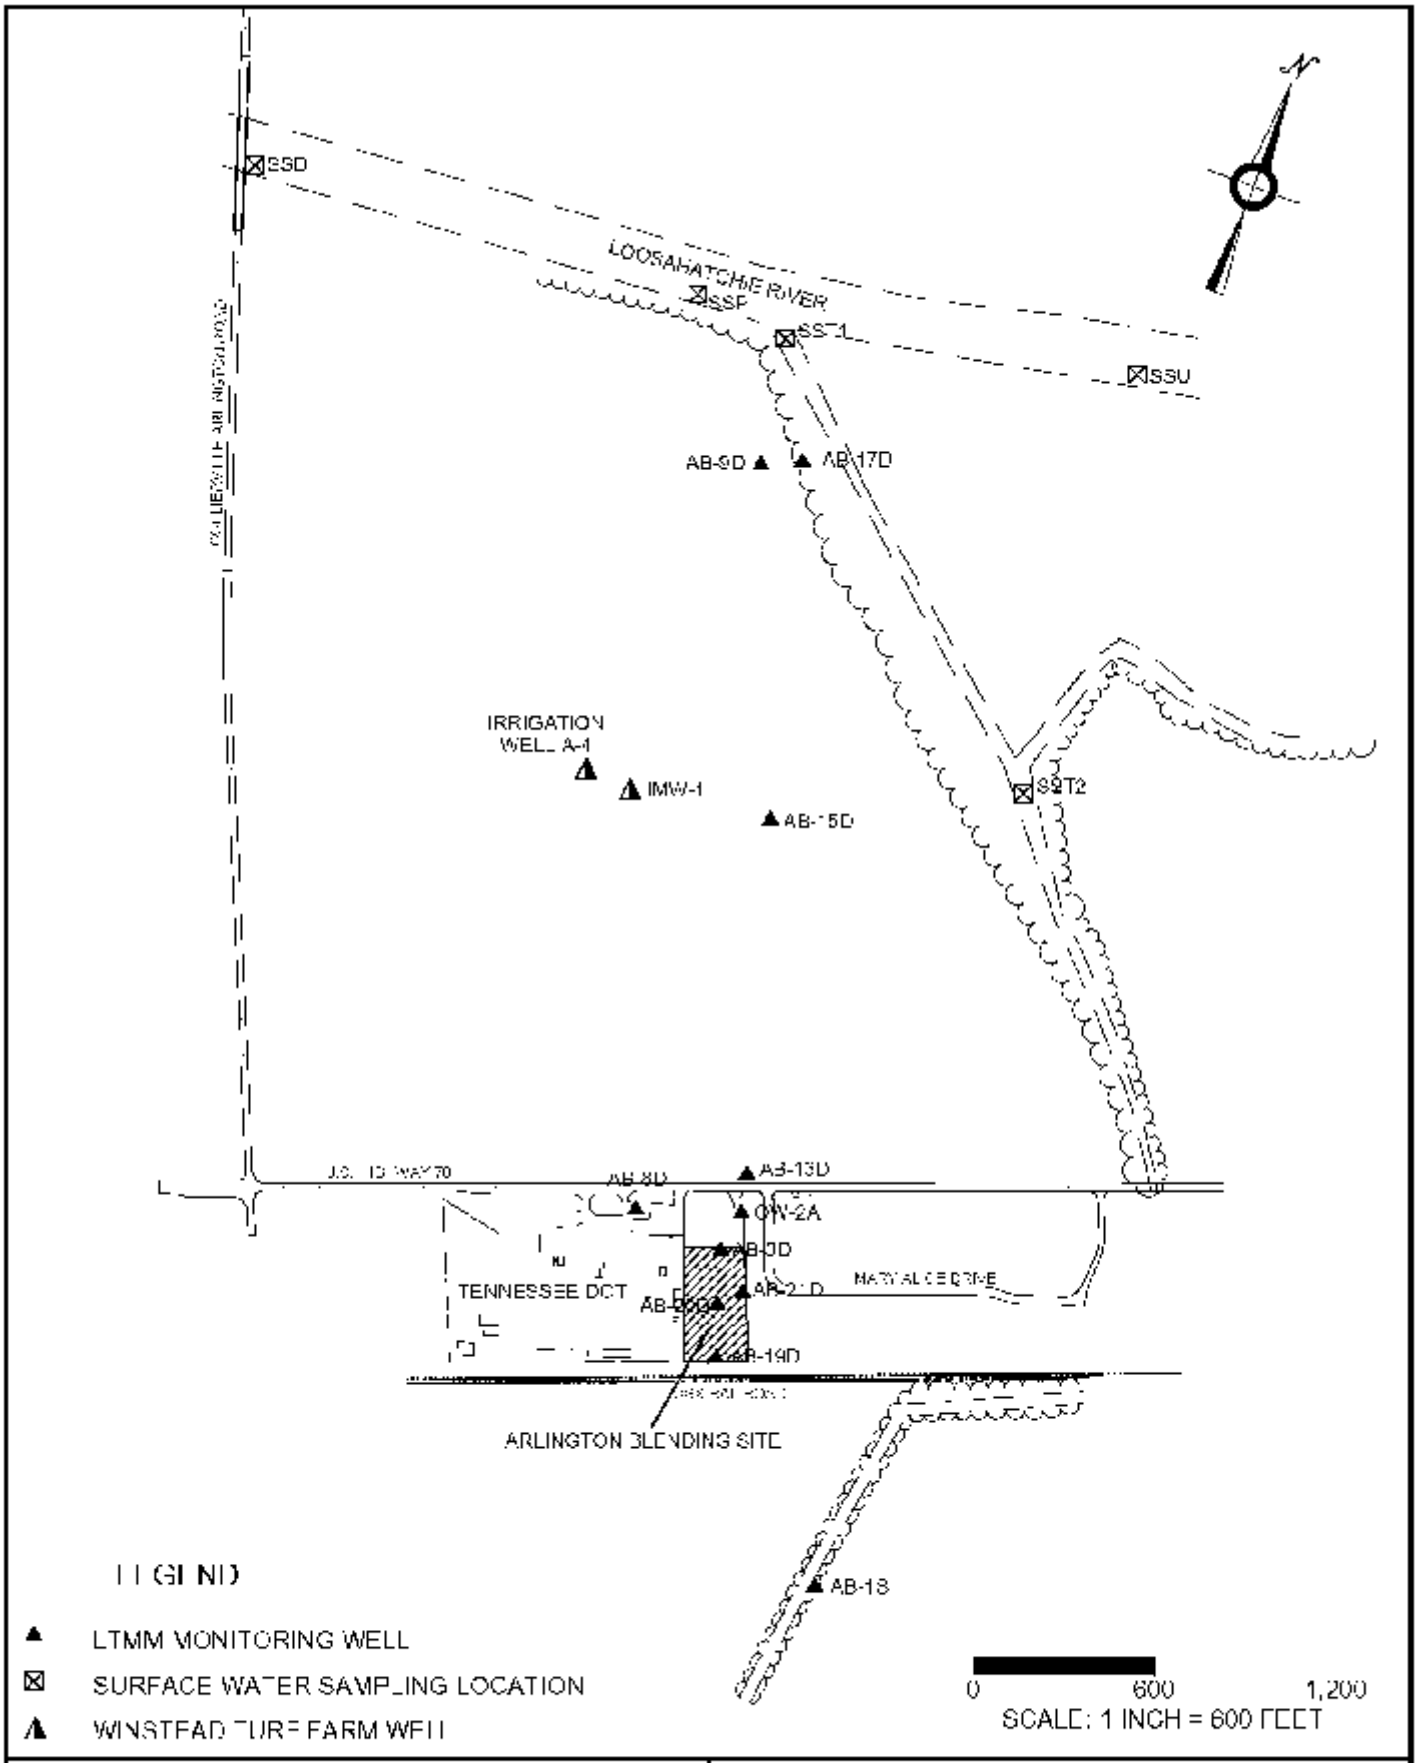
Figure 4
Monitoring Locations
Arlington Blending & Packaging Site
Arlington, Tennessee

All of the groundwater monitoring wells were inspected for proper identification, accessibility, and general integrity. All 11 wells were properly identified, locked, and appeared to be in good condition (Photographs 4-14). In addition to identifying monitoring well locations, three surface water sampling locations were observed, as well. The surface water and groundwater monitoring locations are shown on **Figure 4**. During the inspection the EPA Remedial Project Manager requested that a fourth surface water sample be collected from the drainage ditch flowing into the Loosahatchie River. As part of the routine semi-annual surface water sampling event on November 16, a fourth sample was collected from the drainage ditch (SST1 location). The location of the sample is shown on **Figure 4**.

Samples were collected from the drainage ditch east of the turf farm (location SST2 on **Figure 4**) in 1995, 1996, and 1997. All samples resulted in non-detect concentrations for Site contaminants. A sample was collected from the drainage ditch near the confluence with the Loosahatchie River (location SST1) during the Remedial Investigation in 1988. Due to positive results for 1,1-DCE and toluene in that sample, EPA requested that an additional sample be collected prior to the five-year review. The drainage ditch sample was collected on November 16, 2001. There was no flow in the ditch and the sample was collected in stagnant water approximately 30 feet upstream from the confluence with the Loosahatchie River. The drainage ditch was dry upstream from the sampling point. A second sample was collected from the SST1 location during the June 2002 sampling event.

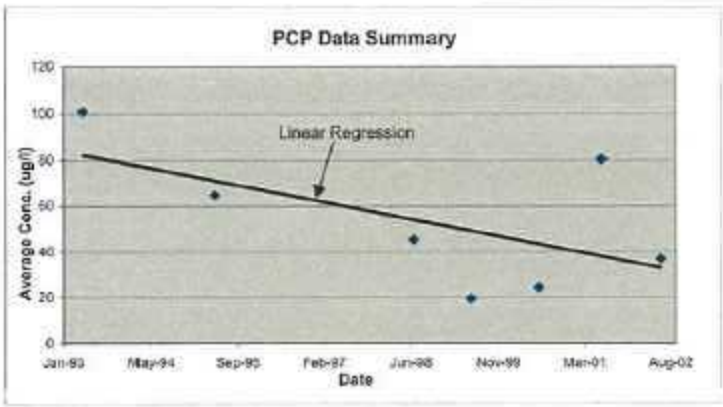
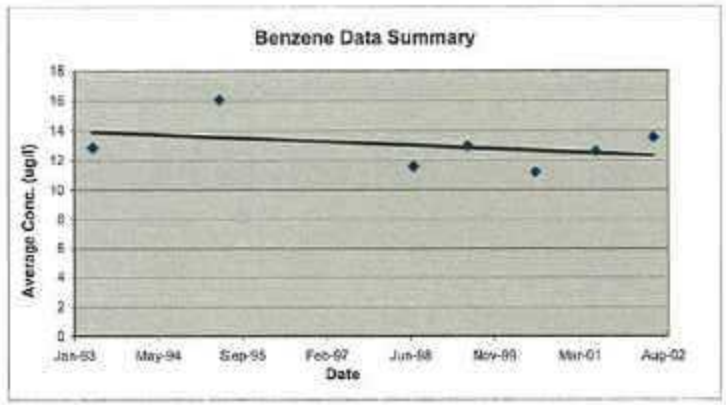
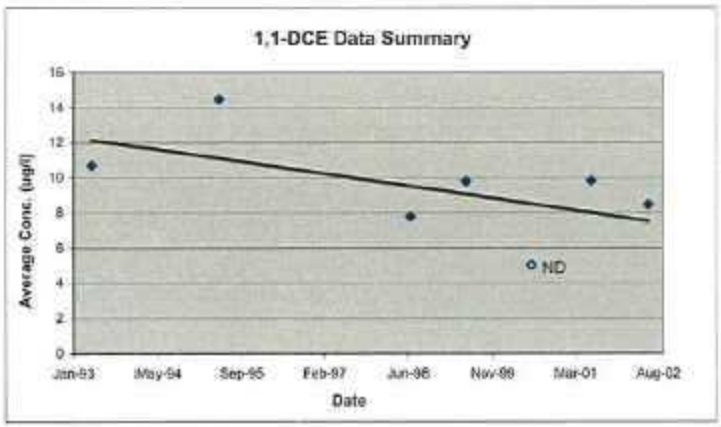
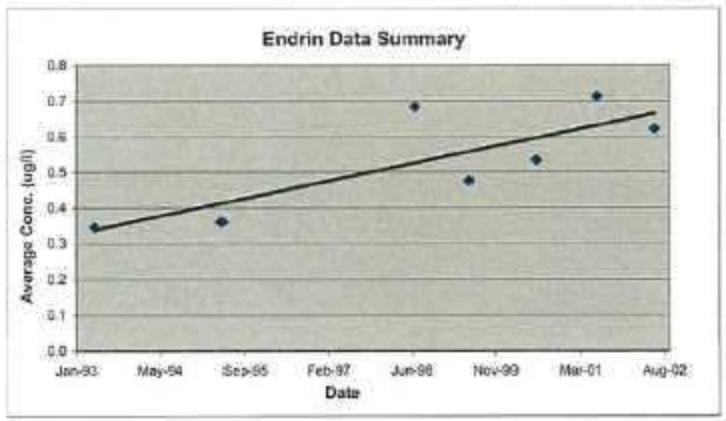
Figure 9
Plume Average Concentration Evaluation

Review of **Figure 9** shows that there are observed decreasing trends in average concentration for PCP, benzene, and 1,1-DCE. An increasing trend in average concentration for endrin is observed. For this reason, it is important to evaluate the magnitude of the contaminant plume and the potential for a continued increasing concentration. This was accomplished by calculating the plume mass and comparing to the mass of contamination removed and the mass of contamination remaining onsite at the completion of the soil remedy. The plume mass was determined using the plume area, average concentration, an assumed aquifer thickness of 25 feet, and a porosity of 0.39. A summary of the temporal trends in plume mass is shown in **Figure 10.**
