**FOURTH FIVE-YEAR REVIEW REPORT FOR
LEY CREEK PCB DREDGINGS SUBSITE
ONONDAGA LAKE SUPERFUND SITE
ONONDAGA COUNTY, NEW YORK**

**U.S. Environmental Protection Agency
Region 2
New York , New York**

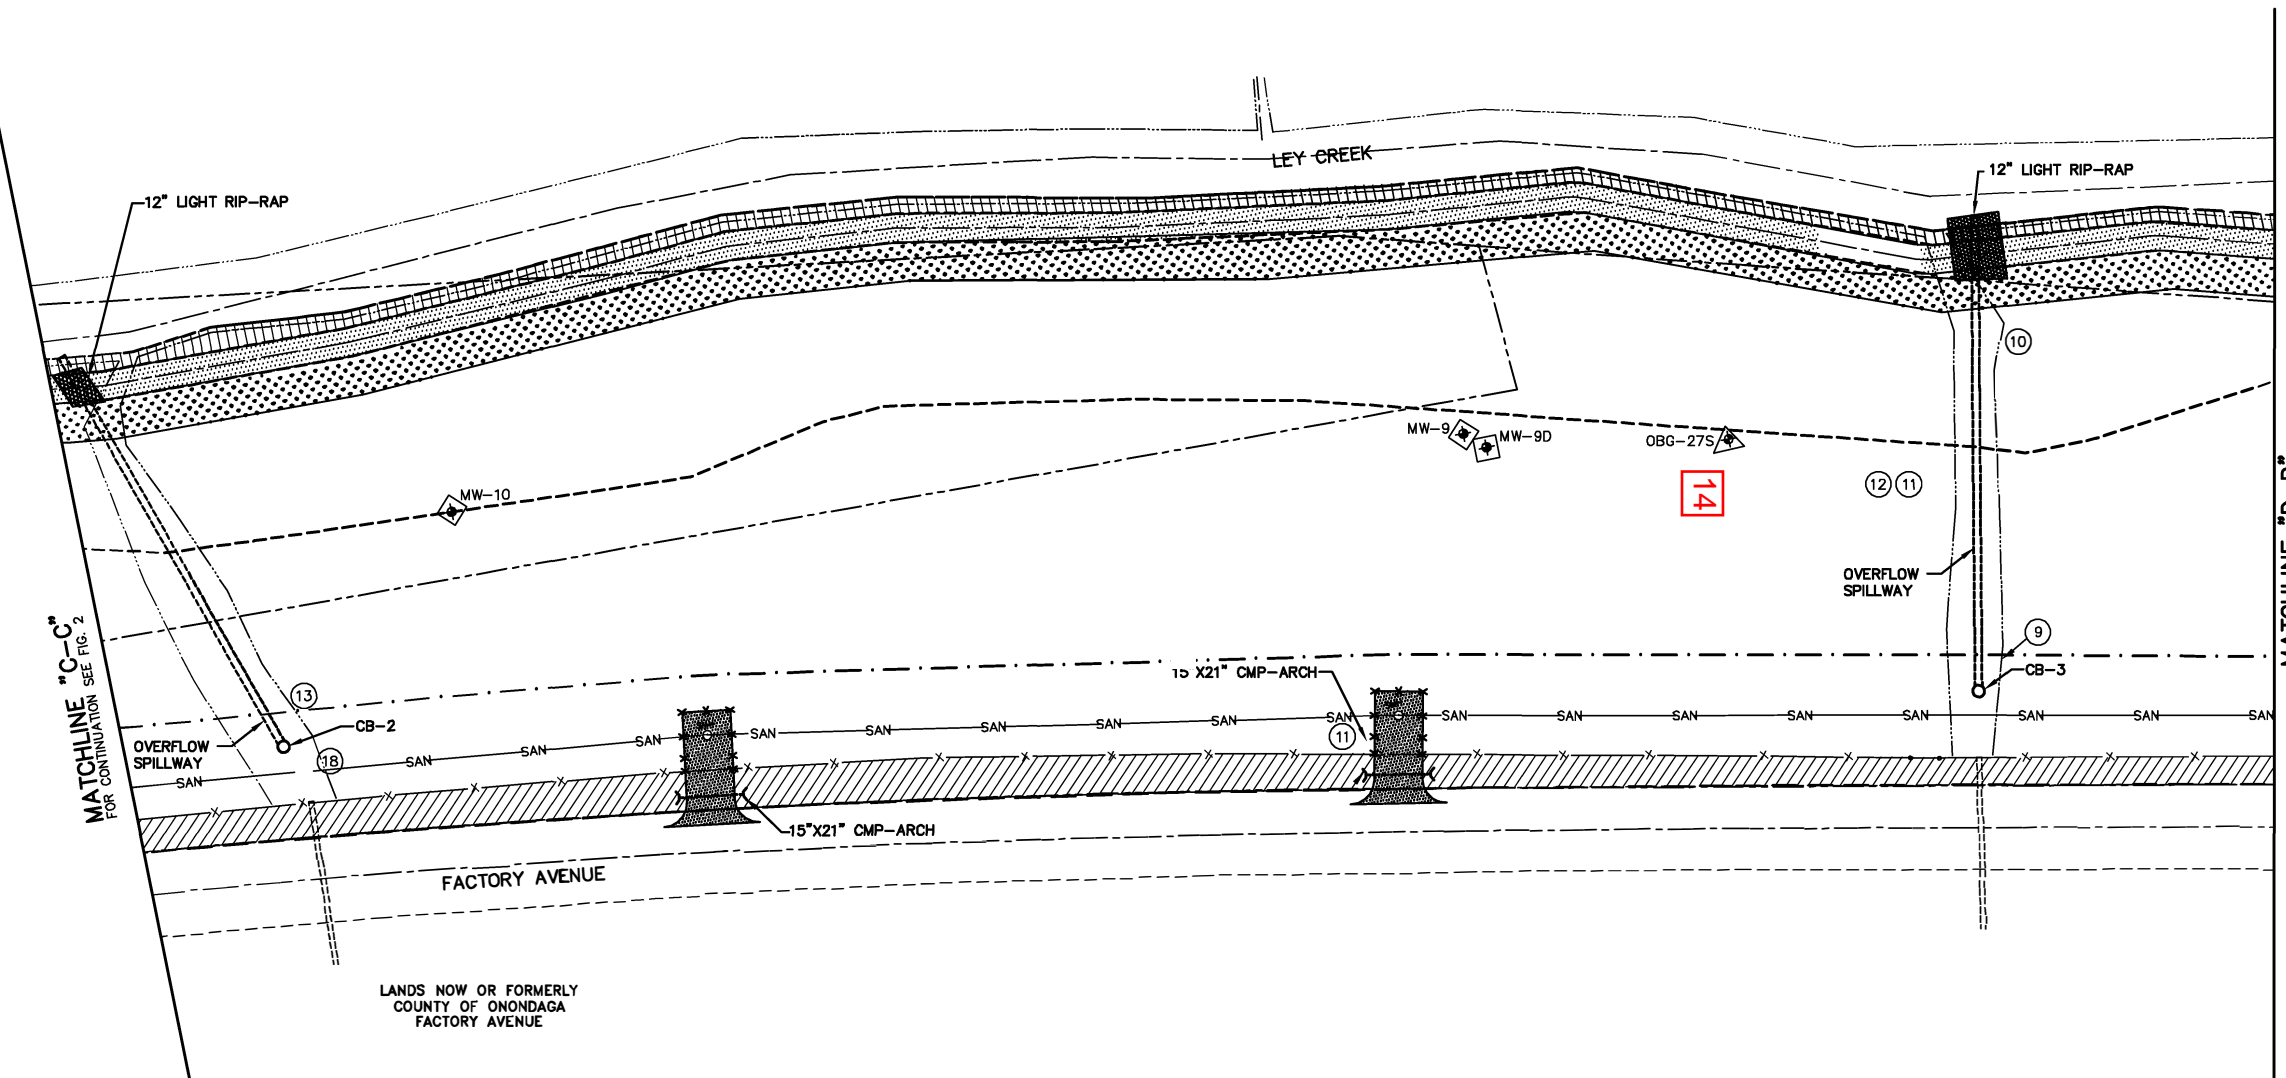
MATCHLINE "C-C"
FOR CONTINUATION SEE FIG. 2

MATCHLINE "D-D"
FOR CONTINUATION SEE FIG. 4
