**FIFTH FIVE-YEAR REVIEW REPORT FOR  
MILLCREEK DUMP SUPERFUND SITE  
MILLCREEK TOWNSHIP, PENNSYLVANIA**

**U.S. Environmental Protection Agency  
Region 3  
Philadelphia, Pennsylvania**

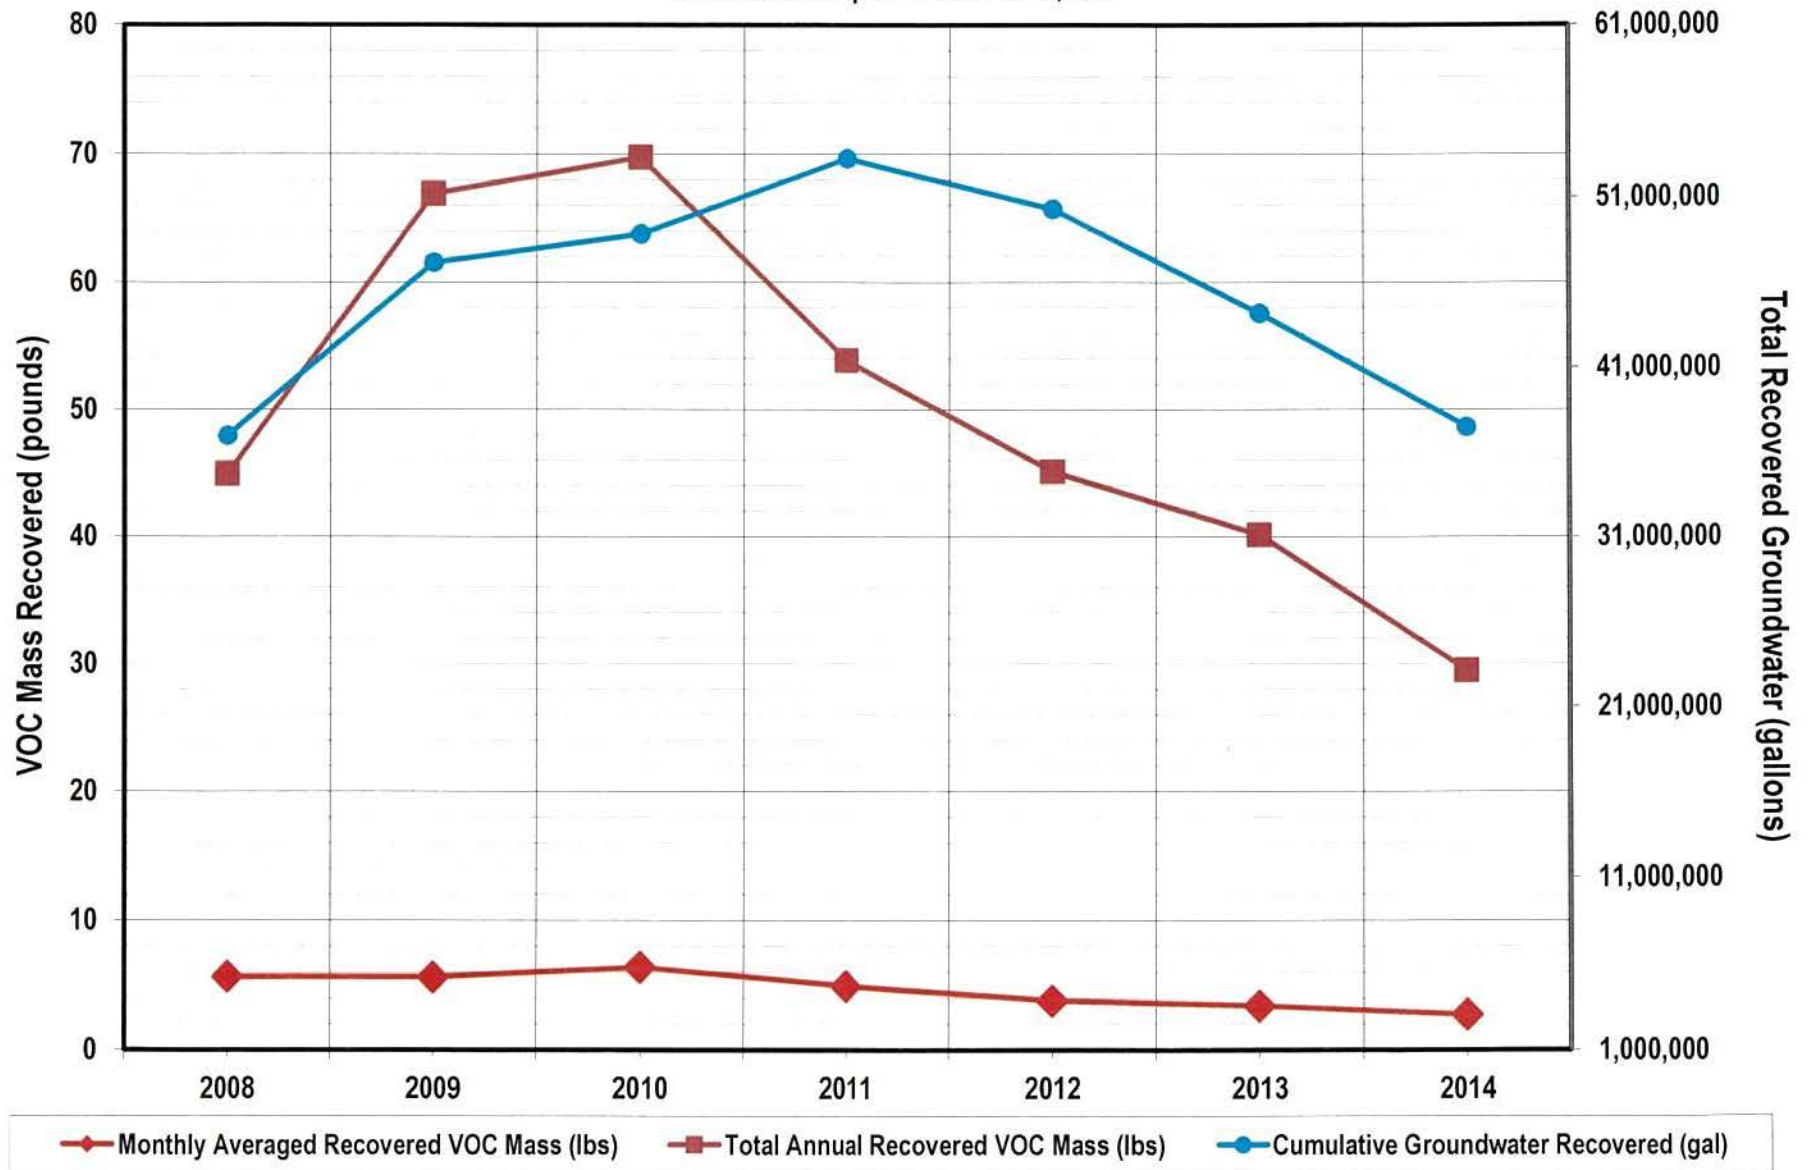
Figure 7

Annual Groundwater Recovery Trench Operational Summary 2008-2014  
2014 Annual Groundwater Monitoring Report  
Millcreek Dump NPL Site - Erie, PA

Over the past five years operation of the GWTP has remained relatively consistent but has shown reduction over time in the volume of recovered groundwater and a corresponding reduction in the mass of VOCs removed. This is shown graphically in Figure 7. In 2011 the recovery system extracted 53,229,400 gallons of groundwater and an estimated 53.9 pounds of VOCs were removed from the groundwater. In 2012, 50,270,500 gallons were extracted and 45.1 pounds removed. In 2013, 44,144,500 gallons extracted and 40.1 pounds removed. In 2014, 37,775,902 gallons extracted and 29.4 pounds removed. And in 2015, 31,513,212 gallons of groundwater were extracted and an estimated total 20.6 pounds of VOCs were removed. Along with the failure of Trench 3, several other factors have contributed to the loss of volume for the recovery system including loss of pump efficiency with age and increasing downtime for maintenance issues. Additionally, the individual flows from the trenches are adjusted to maximize the recovery of contaminants. Part of this operation included minimizing the volume pumped from trench 4, the least contaminated trench.
