The Payne Firm, Inc.
Environmental Consultants

STATEMENT OF WORK #1

SUBJECT: Former Process Wastewater Sewer (AOI B) Investigation and Former Scrap Building Underground Storage Tank (AOI I) Integrity Test

PROJECT NO.: 0654.13.05

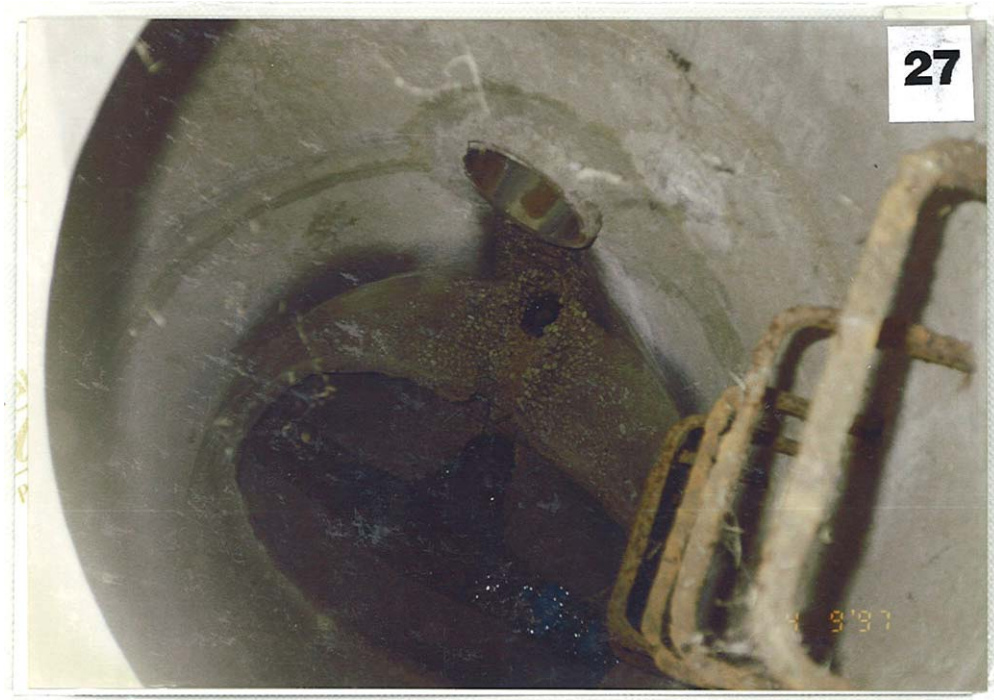
Figure 1. Suggested 6-inch former process waste sewer line inlet to 15-inch storm sewer.
(From Appendix I – Baseline Assessment Site Inspection Photographs, Baseline Environmental Assessment, Payne Firm, 1997).

A private utility locating service will be contracted to trace the sewer line using down-hole video surveillance equipment. The point of departure for accomplishing the stated goals above will be the storm sewer manhole location west of the facility that was identified and photographed in the 1997 sewer line investigation (Figure 1). The manhole will be opened and the video surveillance line will be run upstream (east) through the inlet of the 6-inch pipe towards the facility. To the extent possible, the equipment will video record the length of the sewer to its origination point. If the origination point cannot be opened or accessed from within the facility, total length will be recorded to approximately locate position. The origination point will then be matched to the former treatment unit configuration, if possible.
