Re: Five-Year Review Report (1999 to 2004), Pease Air Force Base NPL Site

**Former Pease Air Force Base
Portsmouth, New Hampshire**

5 Year Review Report (1999 to 2004)

**FORMER PEASE AIR FORCE BASE
FIVE-YEAR REVIEW REPORT (1999-2004)**

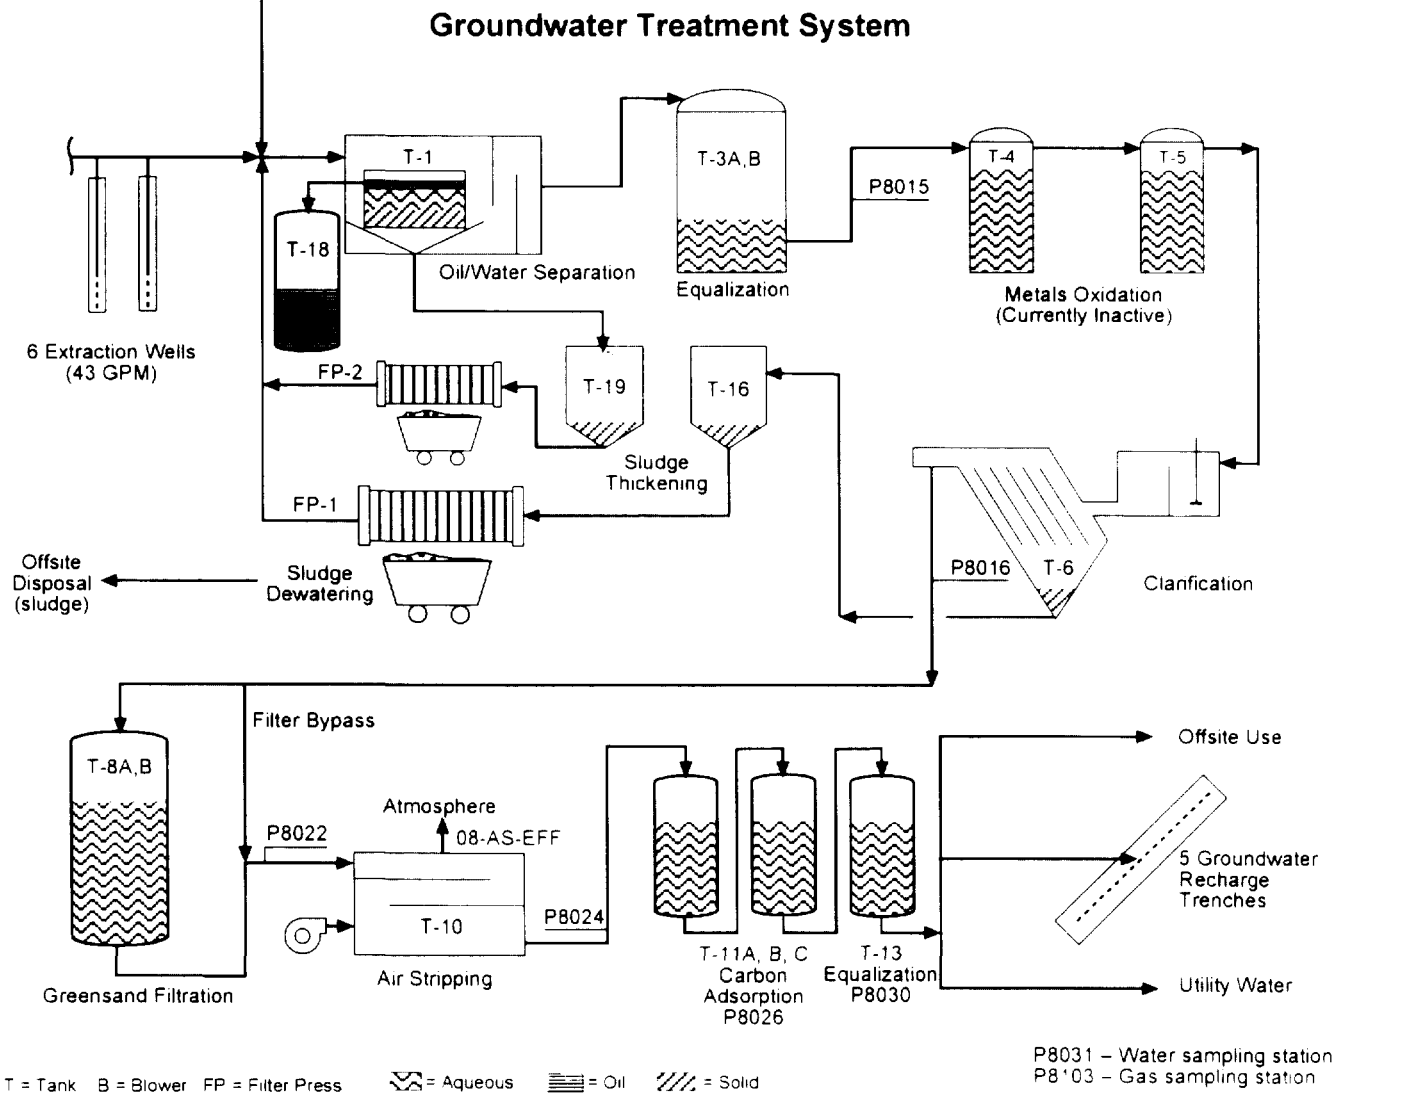
FIGURE 7.9-3

Site 8 Process Flow and Sampling Locations

Figure 7.9-3 presents a flow diagram for the Site 8 treatment system.

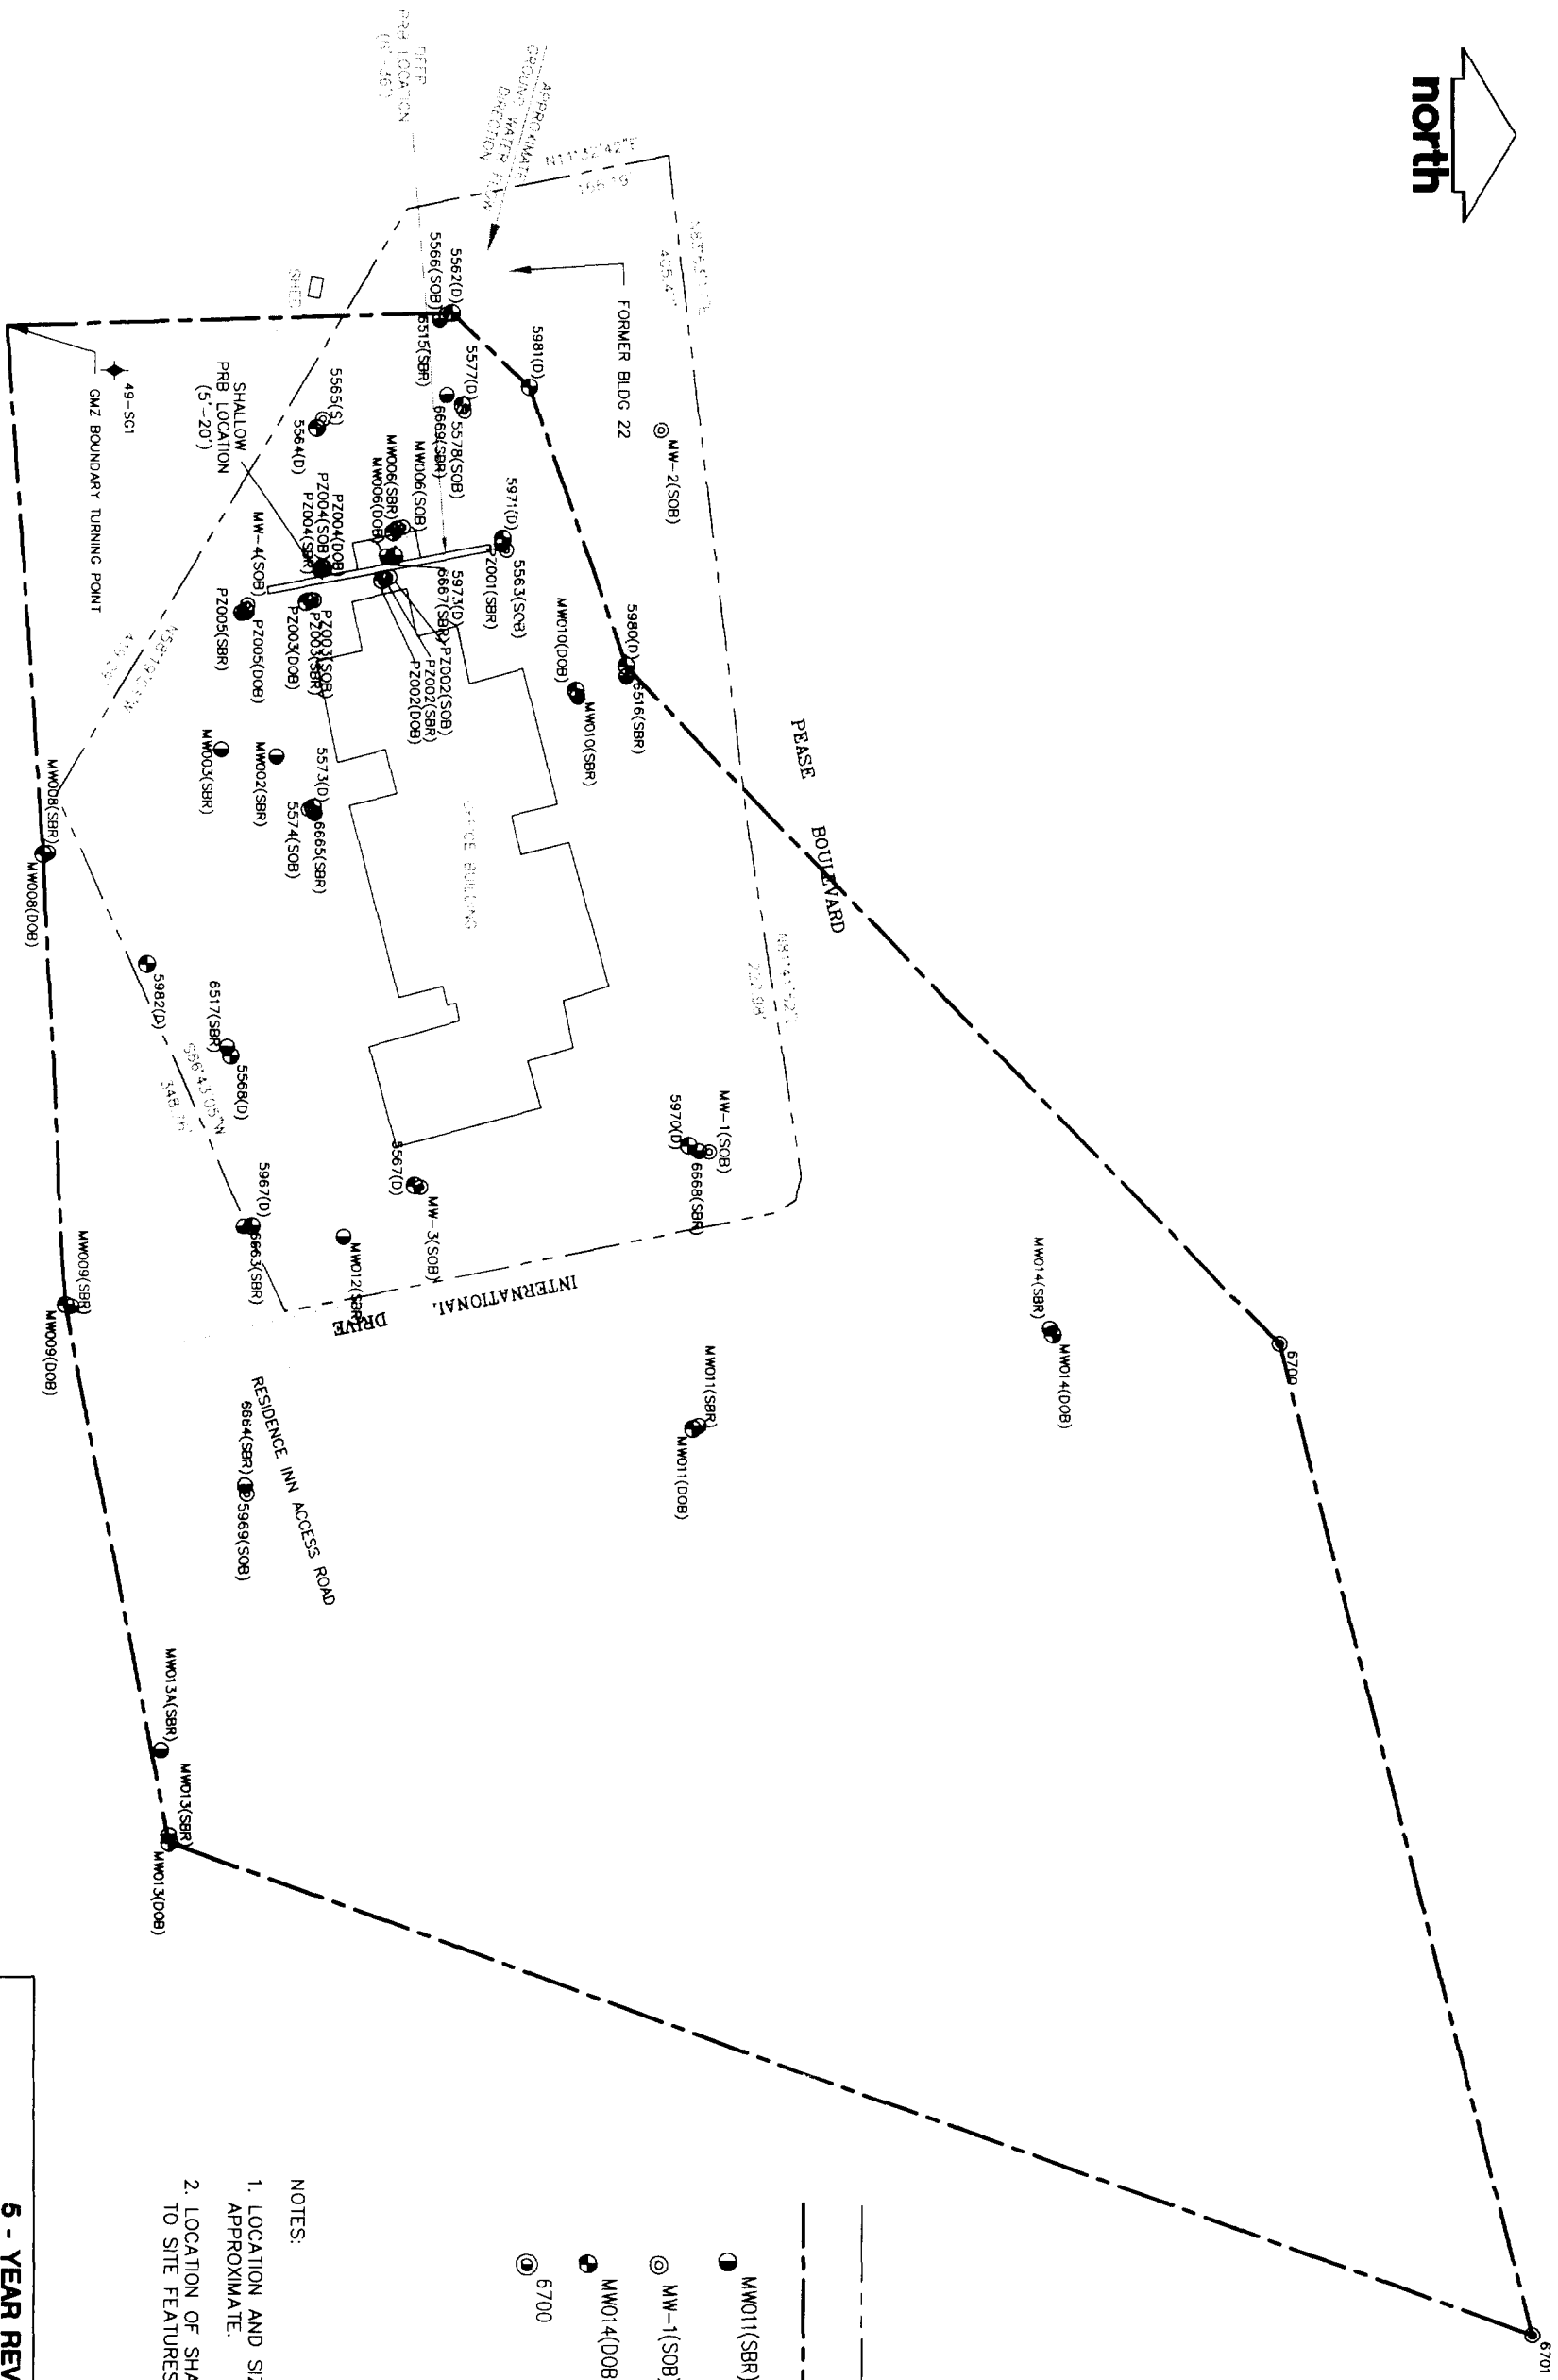
FIGURE 7.12-2

- PROPERTY LINE
- GROUNDWATER MANAGEMENT ZONE (GMZ) BOUNDARY
- MW011(SBR)
SHALLOW BEDROCK MONITORING WELL LOCATION
- ⊙ MW-1(SOB)
SHALLOW OVERBURDEN MONITORING WELL LOCATION
- ⦿ MW014(OOB)
DEEP OVERBURDEN MONITORING WELL LOCATION
- ⊕ 6700
HYBRID MONITORING WELL

- NOTES:
1. ALL AREAS ARE APPROXIMATE.
 2. AREAS BASED UPON SEPTEMBER/OCTOBER 2001 QUARTERLY SAMPLING RESULTS.
 3. NEW HAMPSHIRE AMBIENT GROUNDWATER QUALITY STANDARDS ARE:
 TCE = 5.0 µG/L
 cis-1,2-DCE = 70 µG/L
 VINYL CHLORIDE = 2.0 µG/L
