**Re: GE-Pittsfield/Housatonic River Site
Rest of River (GECD850)
Operation, Monitoring, and Maintenance Plans for Woods Pond Dam and Rising Pond Dam**

December 8, 2017

Woods Pond Dam

LEE/LENOX, MASSACHUSETTS
NID # MA 00731

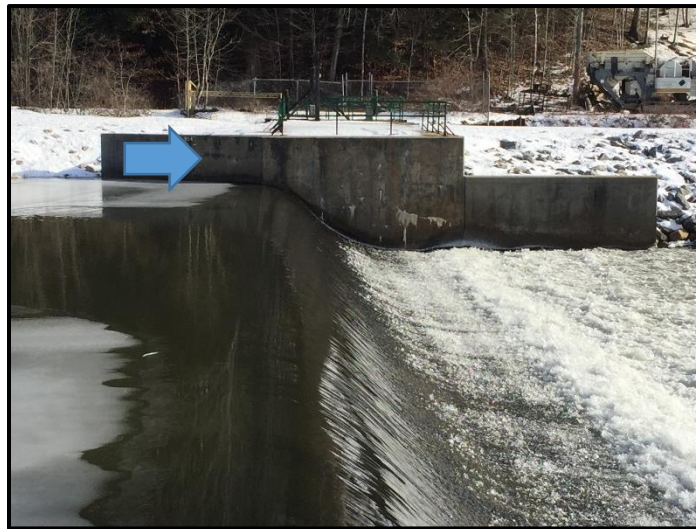
Photo 1 : Reservoir (headwater) measuring point on left training wall.

A staff gauge has been painted onto the training wall on the left (east) abutment of the spillway to determine the impoundment water level. The water level in the raceway will be measured down from the top of the raceway structure by using a measuring tape to find the distance from the top of the raceway structure to the raceway channel water surface. The photographs below show the measuring points for the reservoir and the raceway channel water surface elevations.

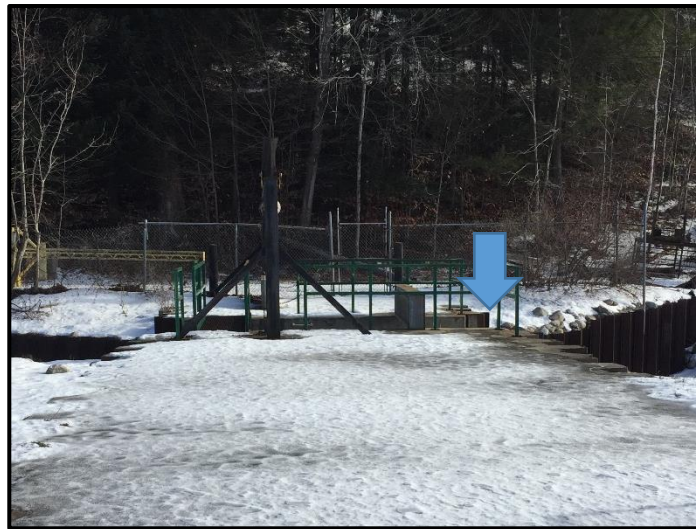
Photo 2: Raceway channel level measuring point.

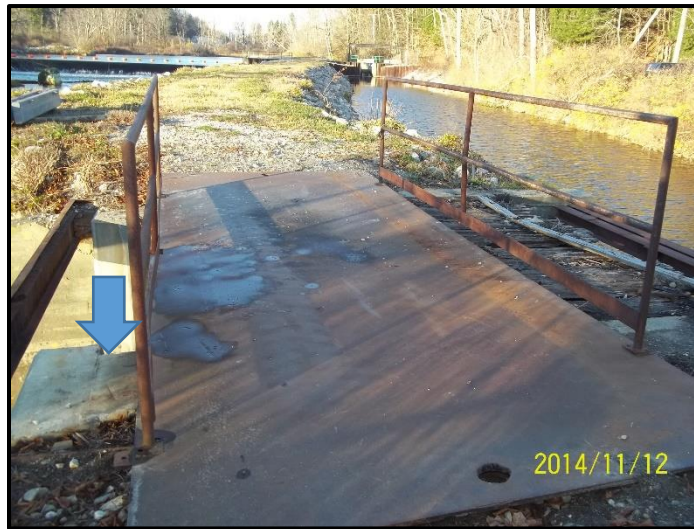
Photo 3: River (tailwater) measuring point.
