**Re: GE-Pittsfield/Housatonic River Site
Rest of River (GECD850)
Operation, Monitoring, and Maintenance Plans for Woods Pond Dam and Rising Pond Dam**

OPERATION, MONITORING, AND MAINTENANCE PLAN RISING POND DAM – MA 00250

Great Barrington, MA

GZA GeoEnvironmental, Inc.

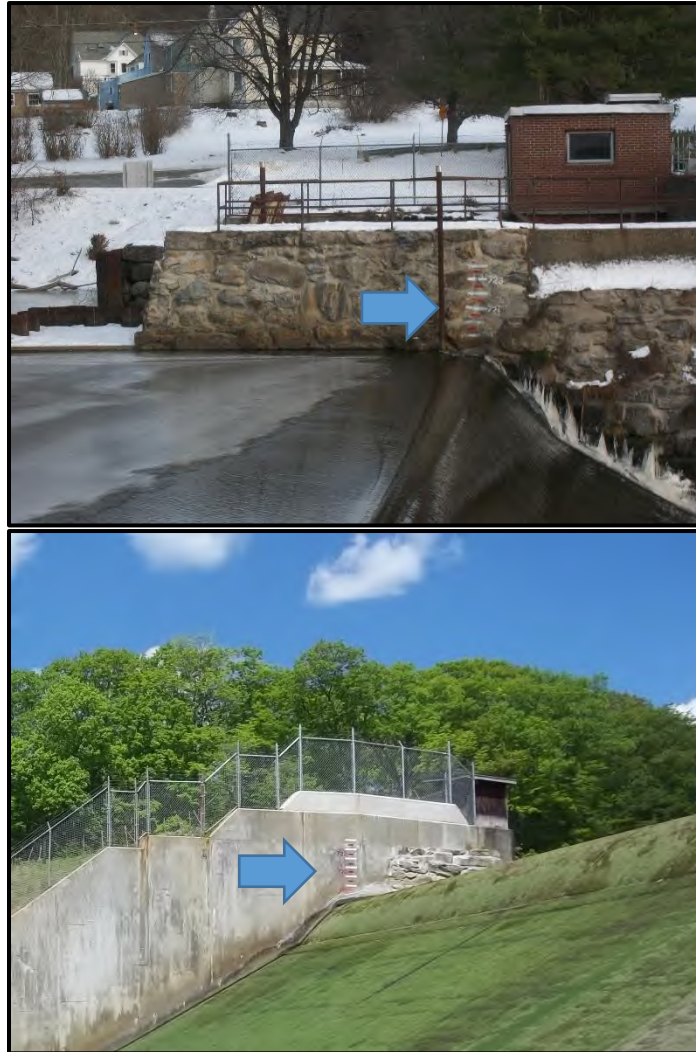
Staff gauges have been painted onto the training walls at several locations as shown in the photographs below.

Photos 1 and 2: Reservoir (headwater) measuring point on left and right training walls.

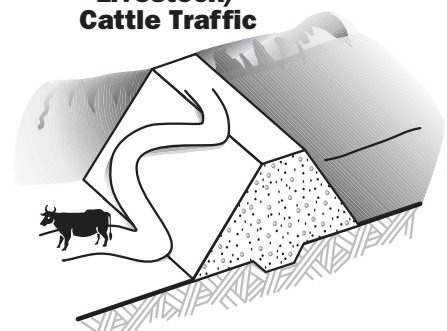
Figure 5.2i

**Livestock/
Cattle Traffic**
