LINERMENT AND FRACTURE-TRACE ANALYSIS FOR THE KESSLER
SITE, UPPER MERION TOWNSHIP, PENNSYLVANIA

Administrative Report

Prepared at the request of, and released to the
U.S. Environmental Protection Agency,
Office of Waste Programs Enforcement

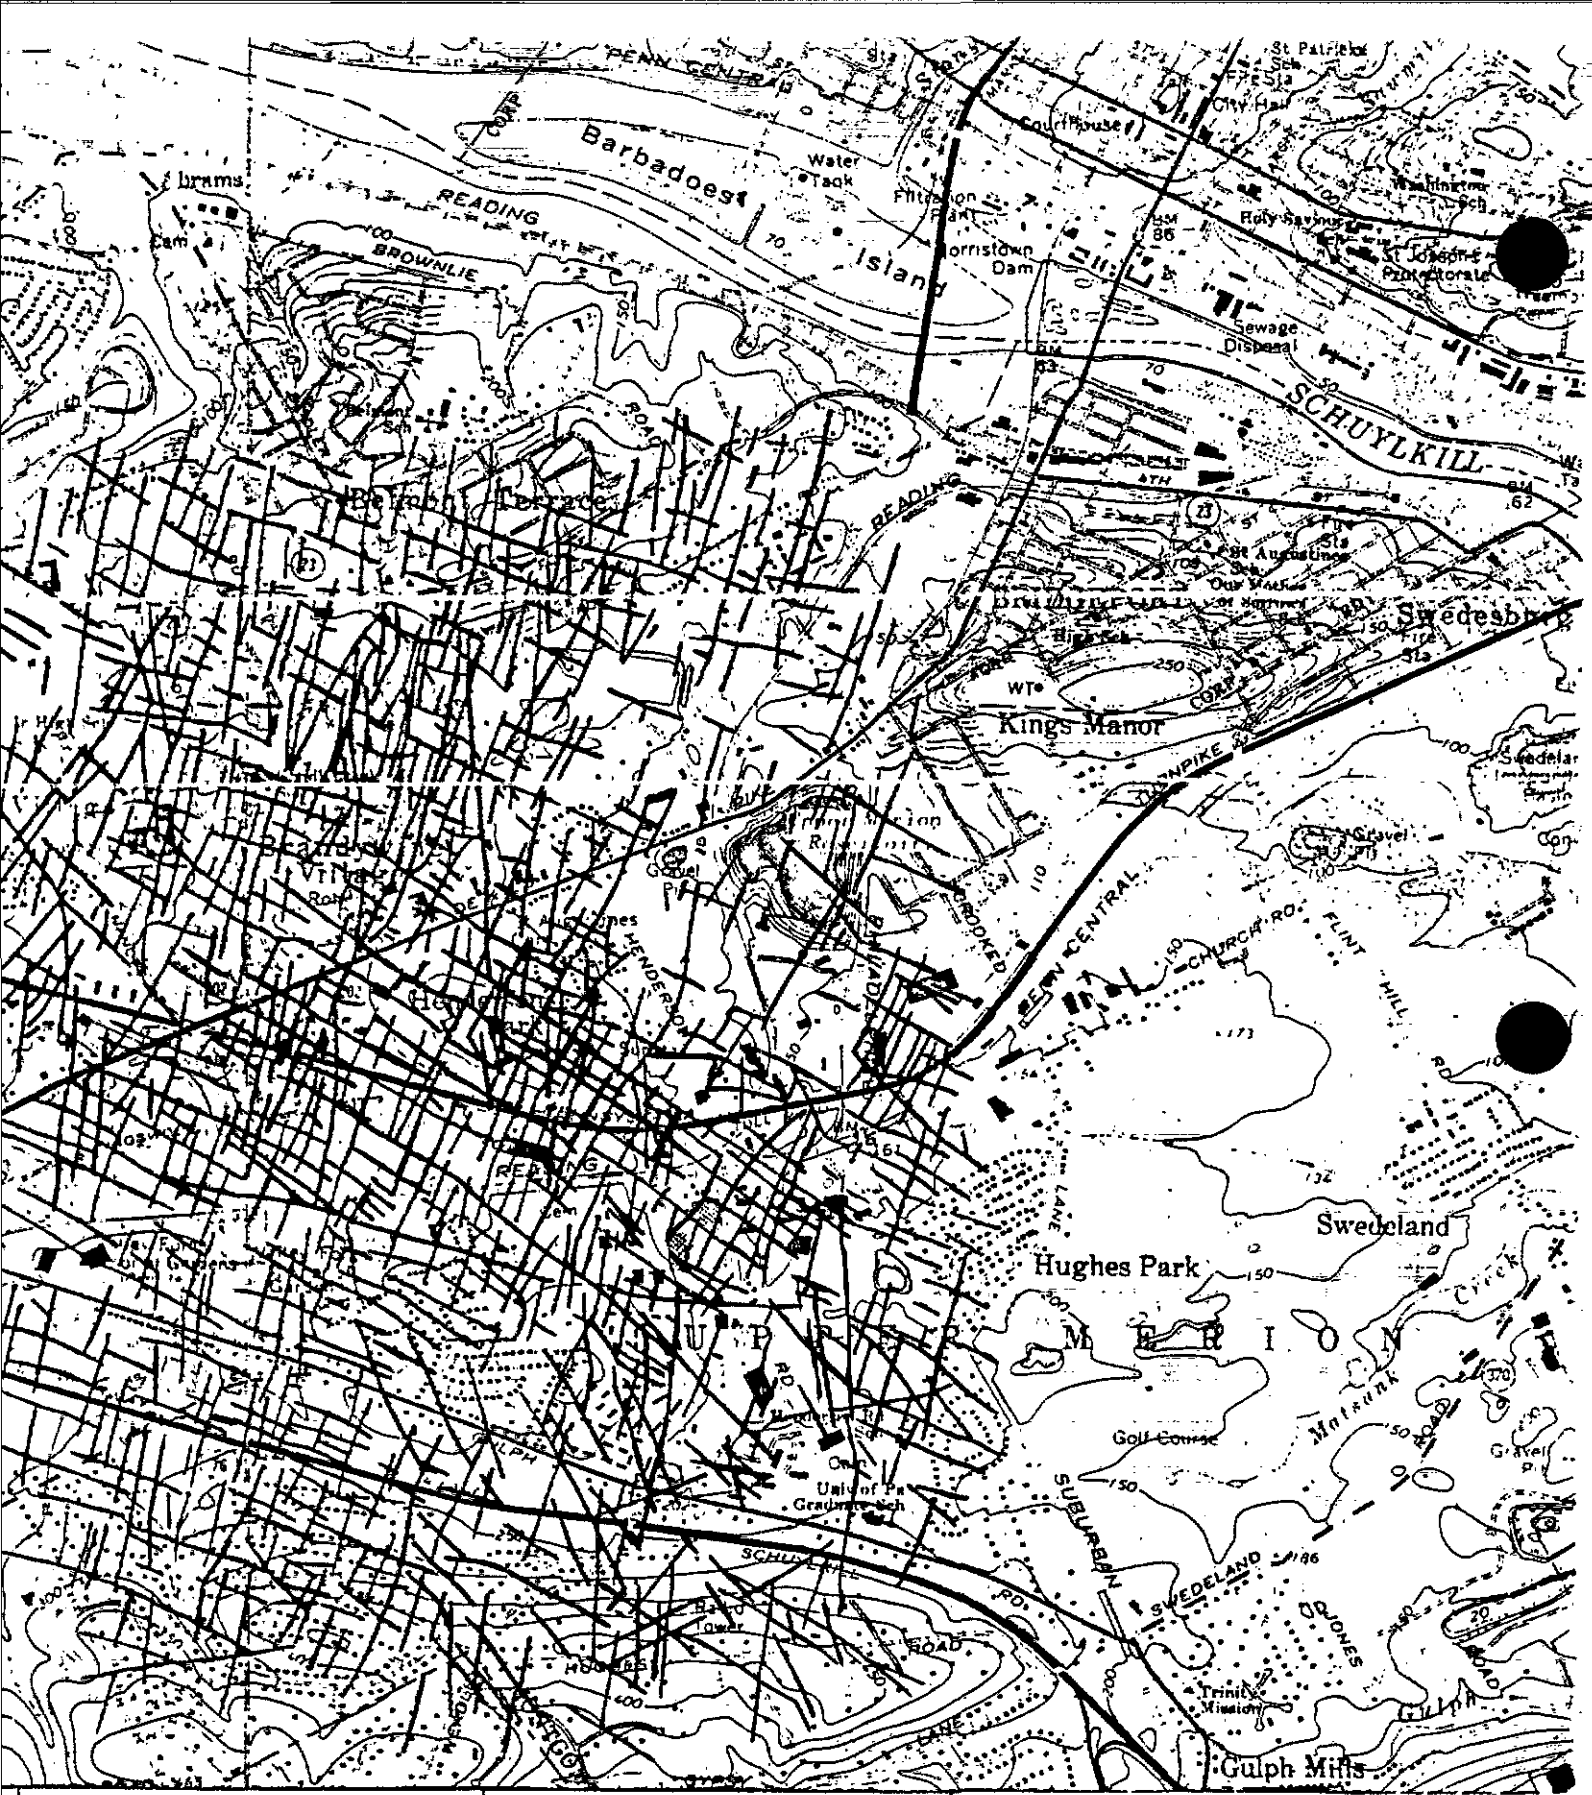
Figure 3.-- Lineaments and fracture-traces in the vicinity of the Upper Merion Reservoir, Bridgeport, Pa.

After the mapping was completed, map scales were adjusted and the mapped lineaments and fracture traces were transferred to mylar overlays (figs. 3 and 4) of the standard Norristown and Valley Forge, Pennsylvania Quadrangles, 7.5-minute series, topographic maps having a scale of 1:24,000 (1 inch = 2,000 feet).

Mapped lineaments and fracture traces are found in two principal alignments, west-northwest to east-southeast and north-northeast to south-southwest. These alignments correspond to the principal bedrock joints measured on reservoir walls. A third east-west alignment measured on the reservoir walls was not mapped as a fracture-trace orientation on the photographs. This suggests that east-west aligned joints have a minor influence on the movement of ground water.

The 1948 photographs show that the quarry walls contain numerous bedrock joints spaced about 30 feet apart. Although numerous lineaments and fracture traces are mapped near the reservoir, their spacing is generally greater than 125 feet. Therefore, mapped lineaments and fracture traces tend to overlie only major bedrock joints, which are probably the principal conduits for the movement of ground water to the reservoir. Although a source of ground-water contaminants cannot be determined from aerial photographs, these photographs probably indicate the principal pathways for the movement of contaminated ground water.
