Five-Year Review Report

Second Five-Year Review Report Kysor Industrial Corp., Superfund Site Cadillac, Wexford County, Michigan

U.S. Environmental Protection Agency
Region 5
Chicago, Illinois

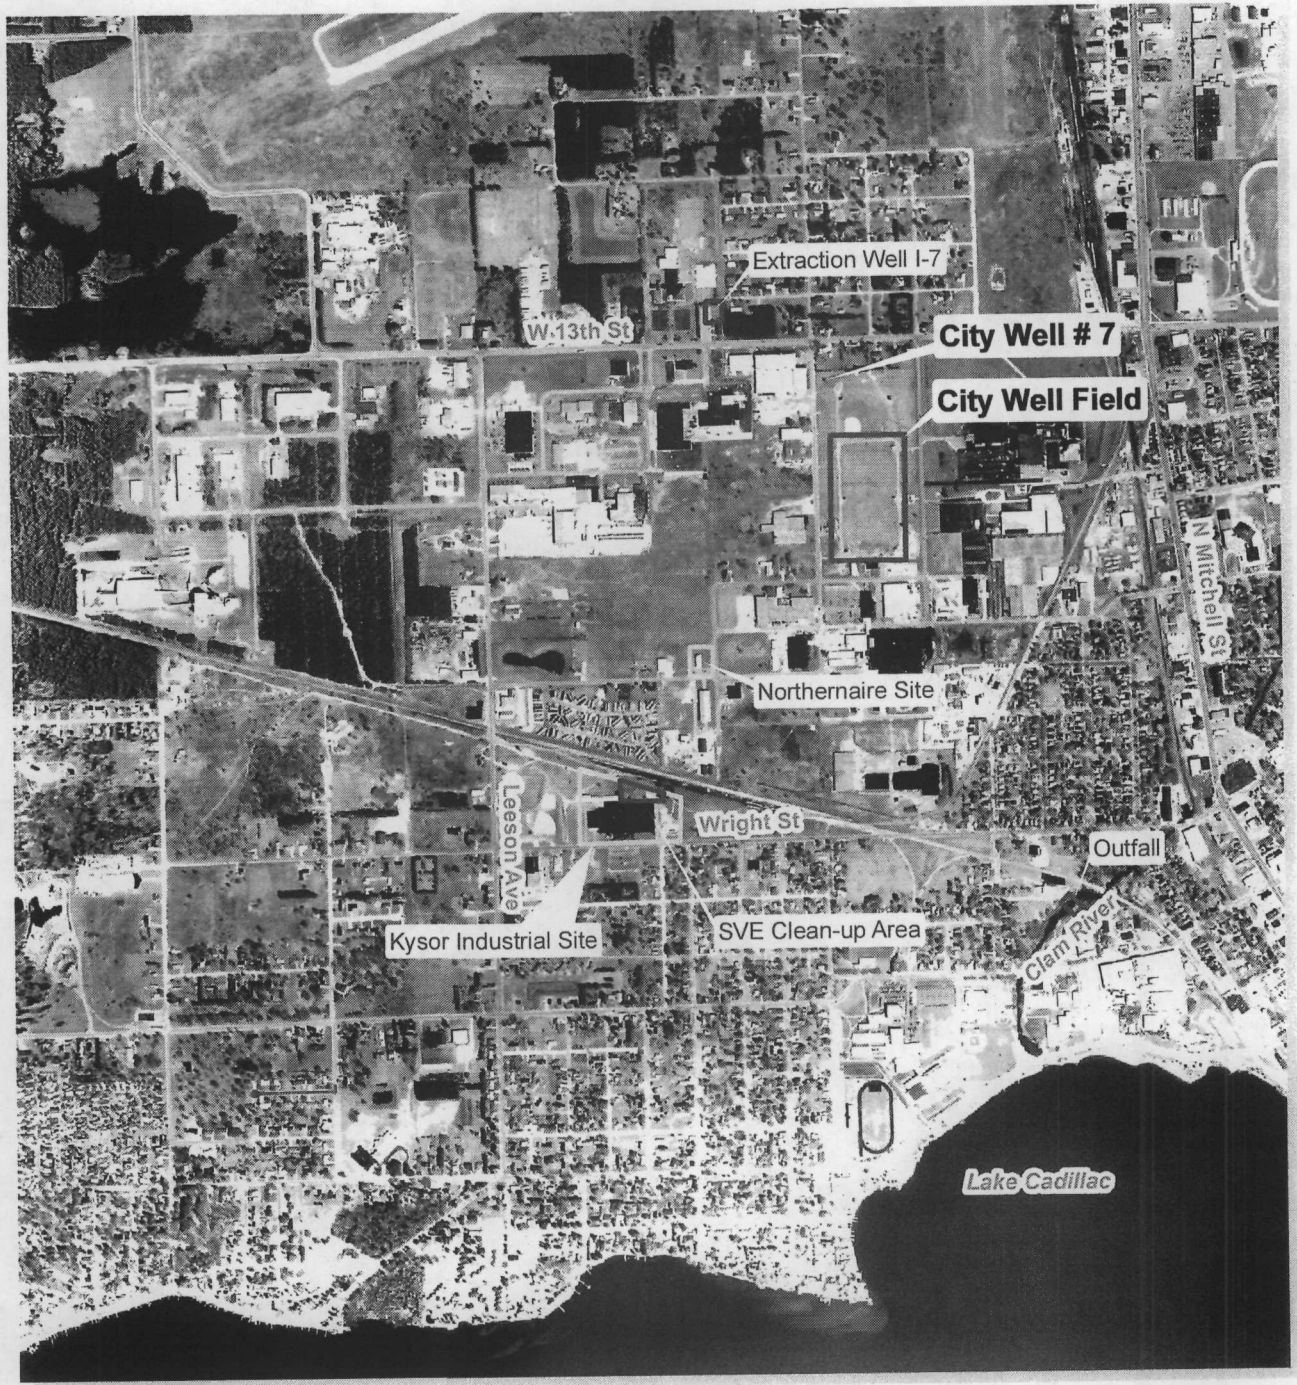
Figure 7

Location of City of Cadillac Well Field

The land and resource use of primary concern near the site is groundwater that is used for drinking. The City of Cadillac well field includes seven municipal wells and is the sole community drinking water source for the City’s 10,000 residents. (See Attachment 1, Figure 7). One of the seven city wells has been shut down since 1994 due to detections of TCE in 1993. Also, the residential area to the north of the Industrial Park, commonly referred to as the North Park subdivision, is located in Haring Township, a charter township adjacent to Cadillac. A number of the residences in the North Park area still operate private wells. Some of the residents still use their wells for drinking water, but the exact number of wells used for drinking is not known.

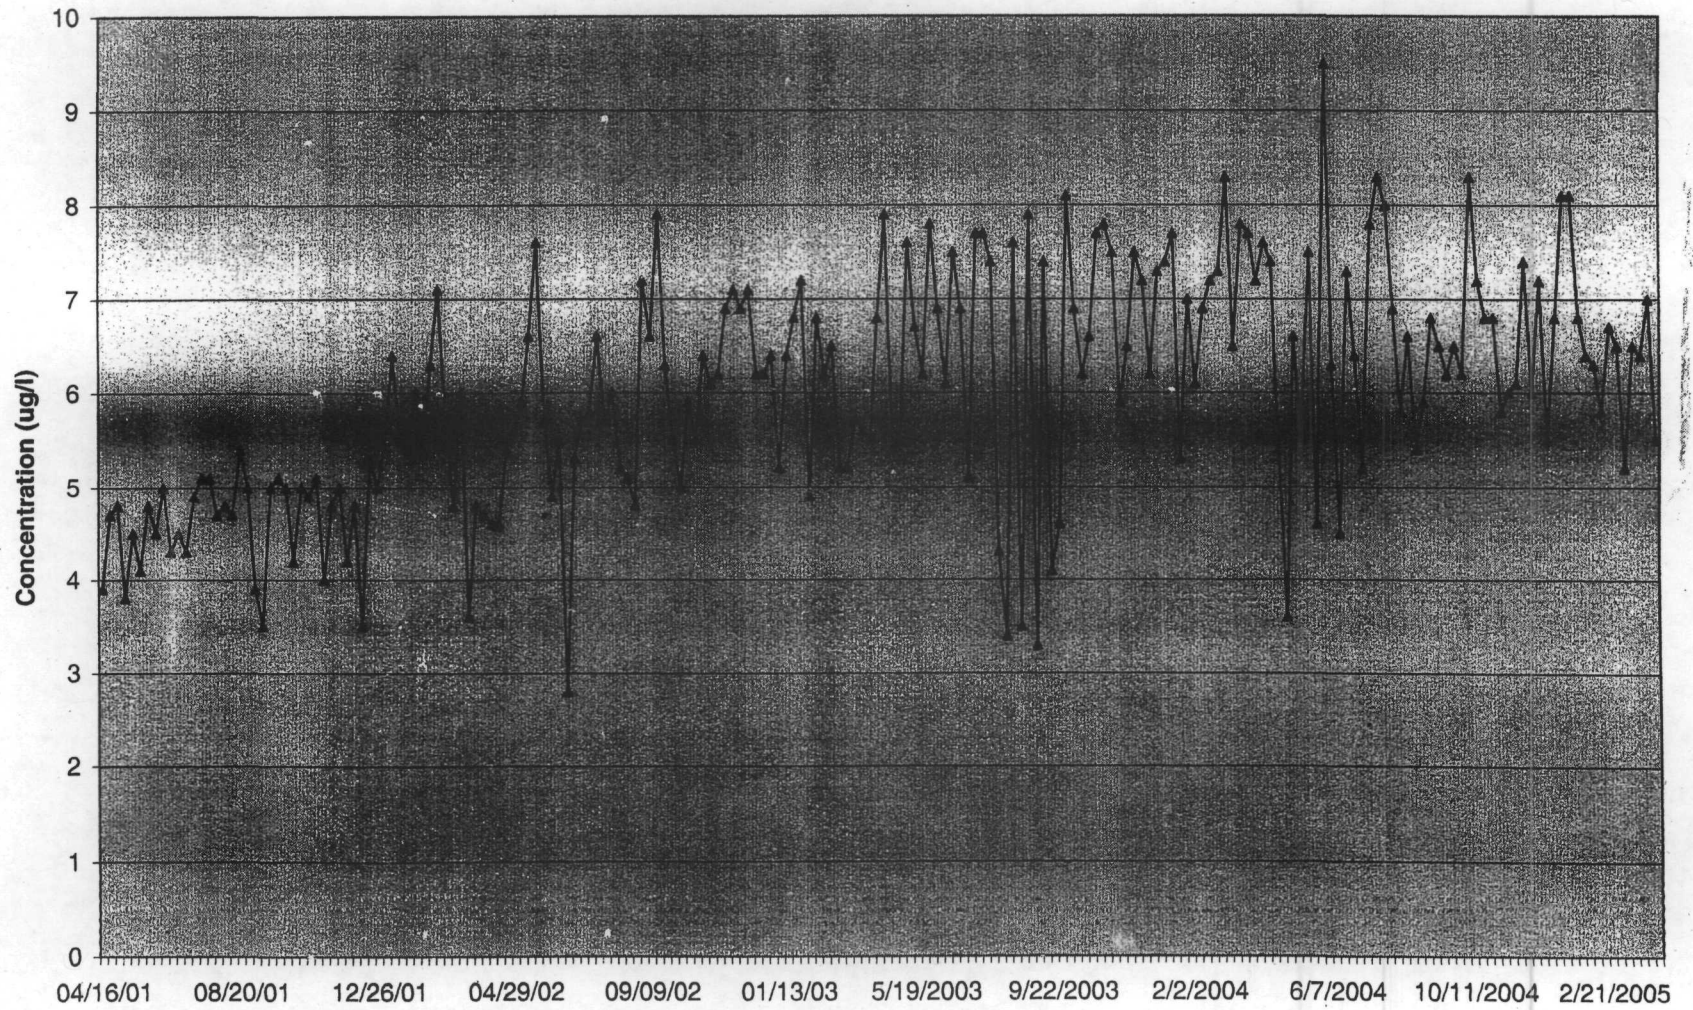
Figure 18. Concentration of PCE in Influent to Air Stripper

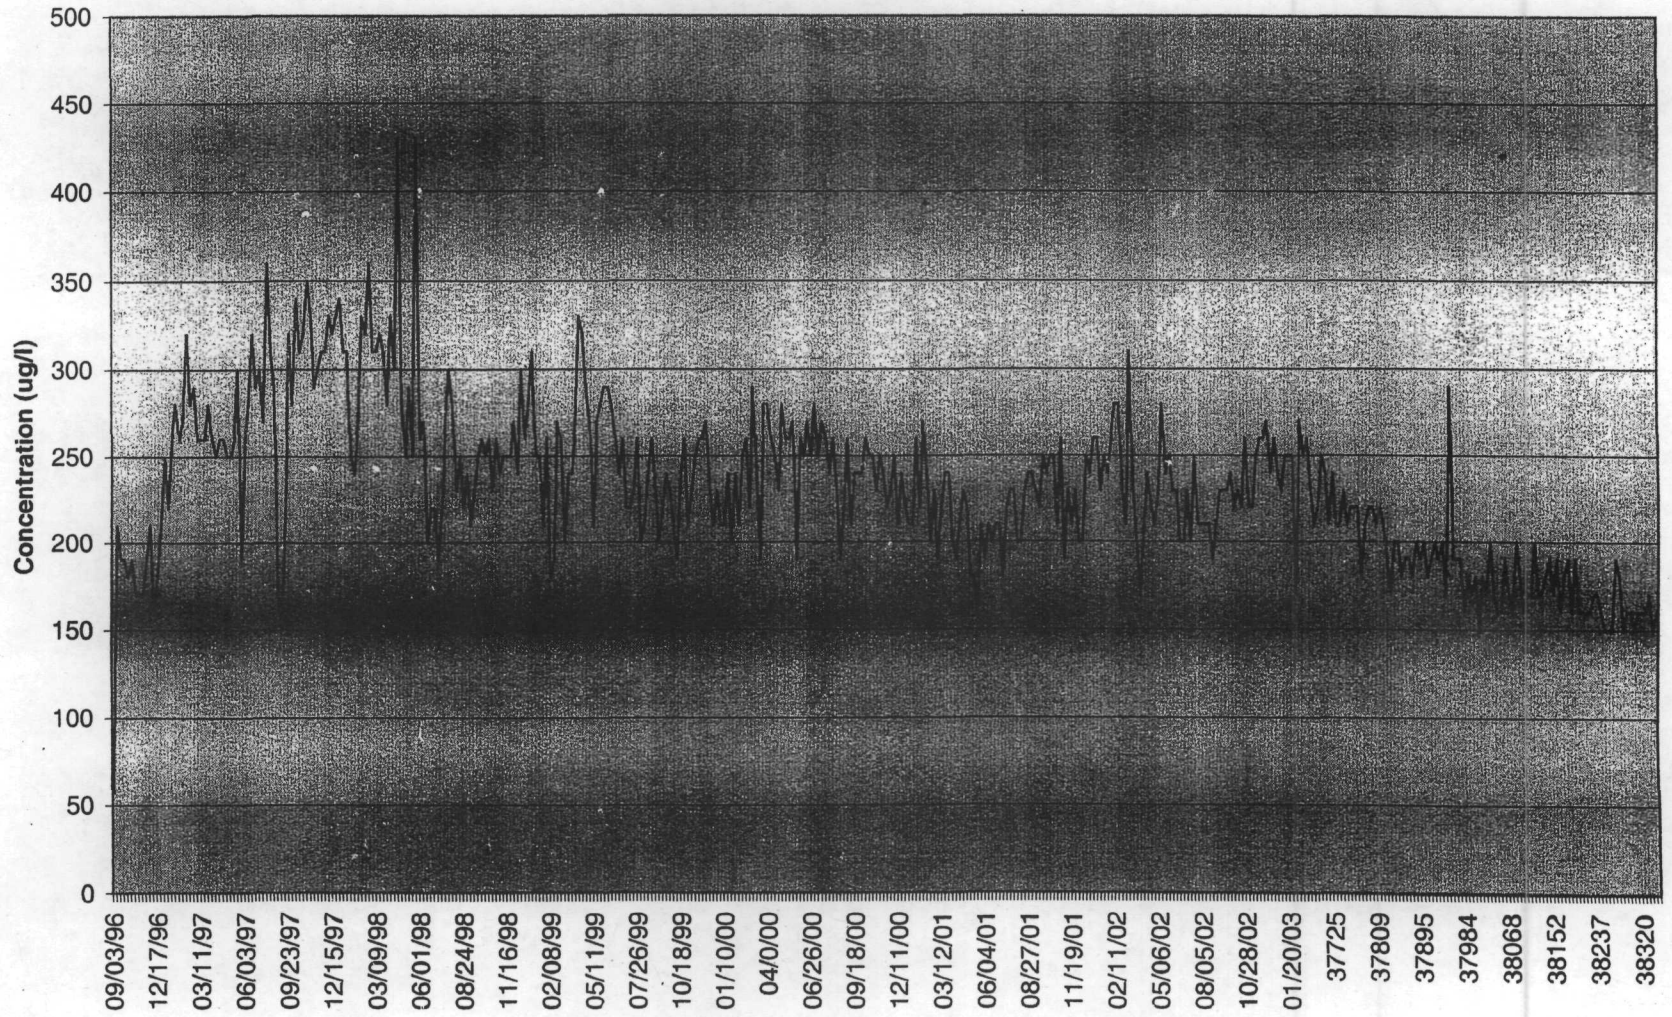
Figure 19. TCE in Influent to Air Stripper
