Antea USA, Inc.
40000 Grand River Ave. Suite 404
Novi, MI 48375
www.anteagroup.com

Subject: Additional Assessment Work Plan

Per your recent request and on behalf of Park Avenue \$2.75 Cleaners, Antea Group respectfully presents the below work plan for proposed additional assessment activities needed to more accurately define the nature and extent of subsurface impacts (PCE and related constituents) associated with at the Park Avenue \$2.75 Cleaners located at 260 South Cherry Hill Road, Canton MI 48188 (Figure 1 and 2). An updated project chronology is in Attachment 1 for reference. We would appreciate EPA's and MDEQ's feedback and/or concurrence regarding the below plan prior to execution. Also, please note that Antea Group cannot execute any of the below without the prior approval of Park Avenue \$2.75 Cleaners and their insurance carrier.

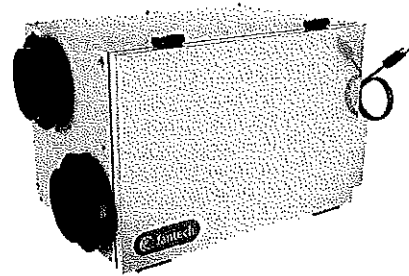
Heat Recovery Ventilator

Fantech's larger residential, full-featured HRV for budget conscious large house projects, the SHR 2004 is designed for higher static pressure and higher airflow applications. The unit brings a continuous supply of fresh air into a home while exhausting an equal amount of contaminated air. During winter, fresh incoming air is tempered by the heat that is transferred from the outgoing air so you save on energy costs, while during summer, the incoming air is pre-cooled if the house is equipped with an air cooling system. The SHR 2004 is equipped with automatic defrost mechanisms so you can use your HRV all year long.

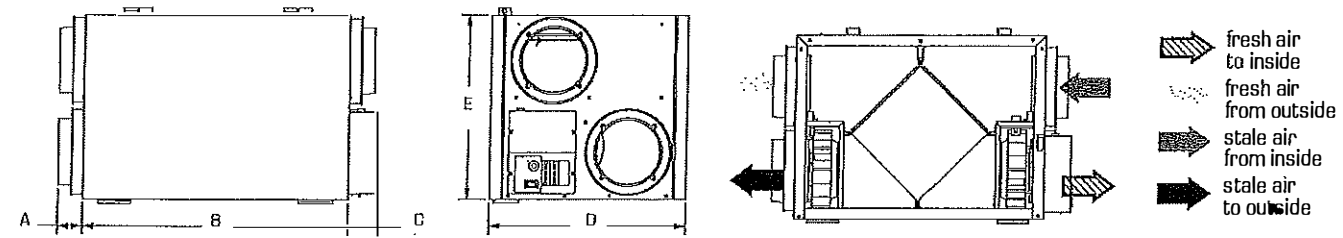
Dimensions & Airflow

Model	A		B		C		D		E	
	in	mm	in	mm	in	mm	in	mm	in	mm

SHR2004 2 1/4 57 27 7/8 708 2 5/8 67 17 3/8 441 20 1/2 521

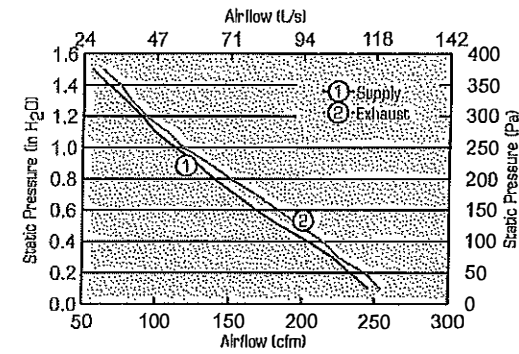
Ventilation Performance

In. wvg. (Pa)	0.3 (175)	0.6 (150)	0.9 (225)	1.2 (300)
Net supply airflow	218 (103)	158 (74)	101 (48)	59 (28)
Gross supply airflow	220 (104)	158 (75)	102 (48)	60 (28)
Gross exhaust airflow	227 (107)	176 (83)	124 (59)	86 (41)
