# Goathill North Final Mitigation Design Report - Part 1

## **GOATHILL NORTH FINAL MITIGATION DESIGN REPORT**

**RE: Goathill North Final Mitigation Design Report – Part 1**

Molycorp and Norwest are pleased to submit this Final Design report for the Goathill North Rock Pile Mitigation project. This report presents Part 1 of the Final Mitigation Design for the Goathill North rock pile. The purpose of the mitigation is to control sliding movements that are occurring within pre-sheared materials near the weathered bedrock contact with natural colluvium and/or mine rock materials. The Part 1 design is meant to include the major stabilization earthworks and an interim surface drainage network. Following a 12 month period of confirmatory monitoring to demonstrate that the slide has been successfully stabilized a final drainage plan will be developed and submitted for agency approval as Part 2.

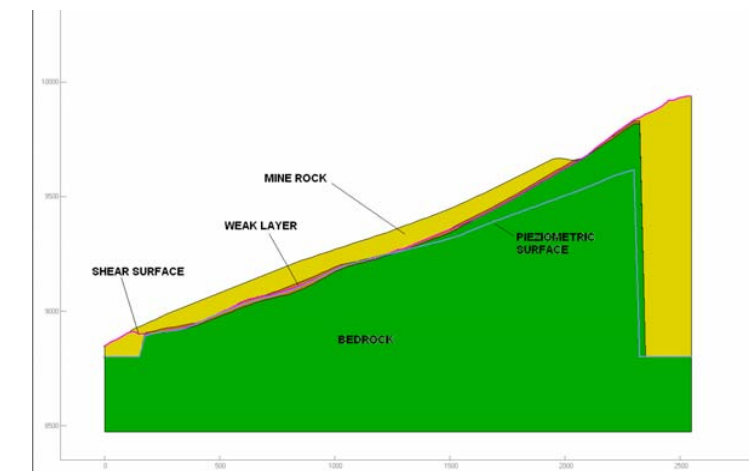
**Molycorp**  
FIGURE 3.2  
QUESTA MINE  
GOATHILL NORTH  
POST MITIGATION SHEARING SURFACE  
FROM CLARA 3D ANALYSIS

CLARA 3D MITIGATION MODEL - SECTION AA - X=425ft

CLARA 3D MITIGATION MODEL - SECTION BB - X=625ft

CLARA 3D MITIGATION MODEL - SECTION CC - Y=675ft

Figure 3.2 shows the CLARA-W output of the shear surface with the cut and fill design superimposed on it. The additional lateral shear resistance provided by the buttress is illustrated on Section C and local FOS values are shown on the inset figure illustrating the beneficial buttressing effects (i.e. higher local FOS values above the daylighted slip plane area).

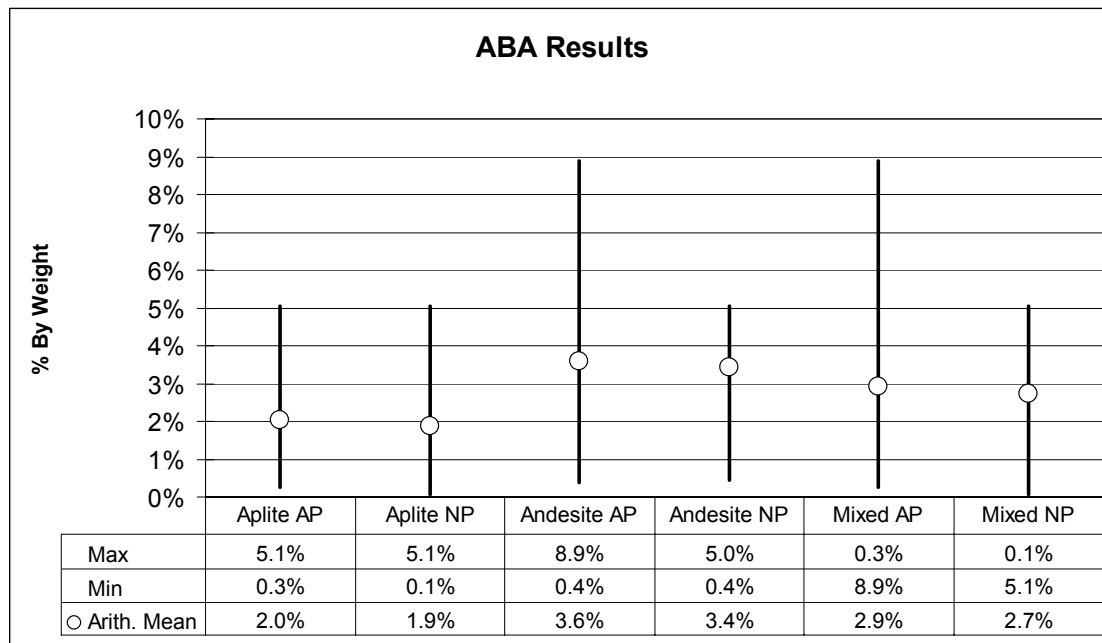
Figure 1. ABA results for the aplite, andesite, and mixed material from Spring Gulch.

suggesting equal amounts of carbonate minerals and sulfur minerals. Assuming that the NP is calcite and the AP is sulfides (e.g., pyrite), the calcite and pyrite content is less than 3% by weight. The average differences between the two materials is small, typically less than 1% (Figure 1).

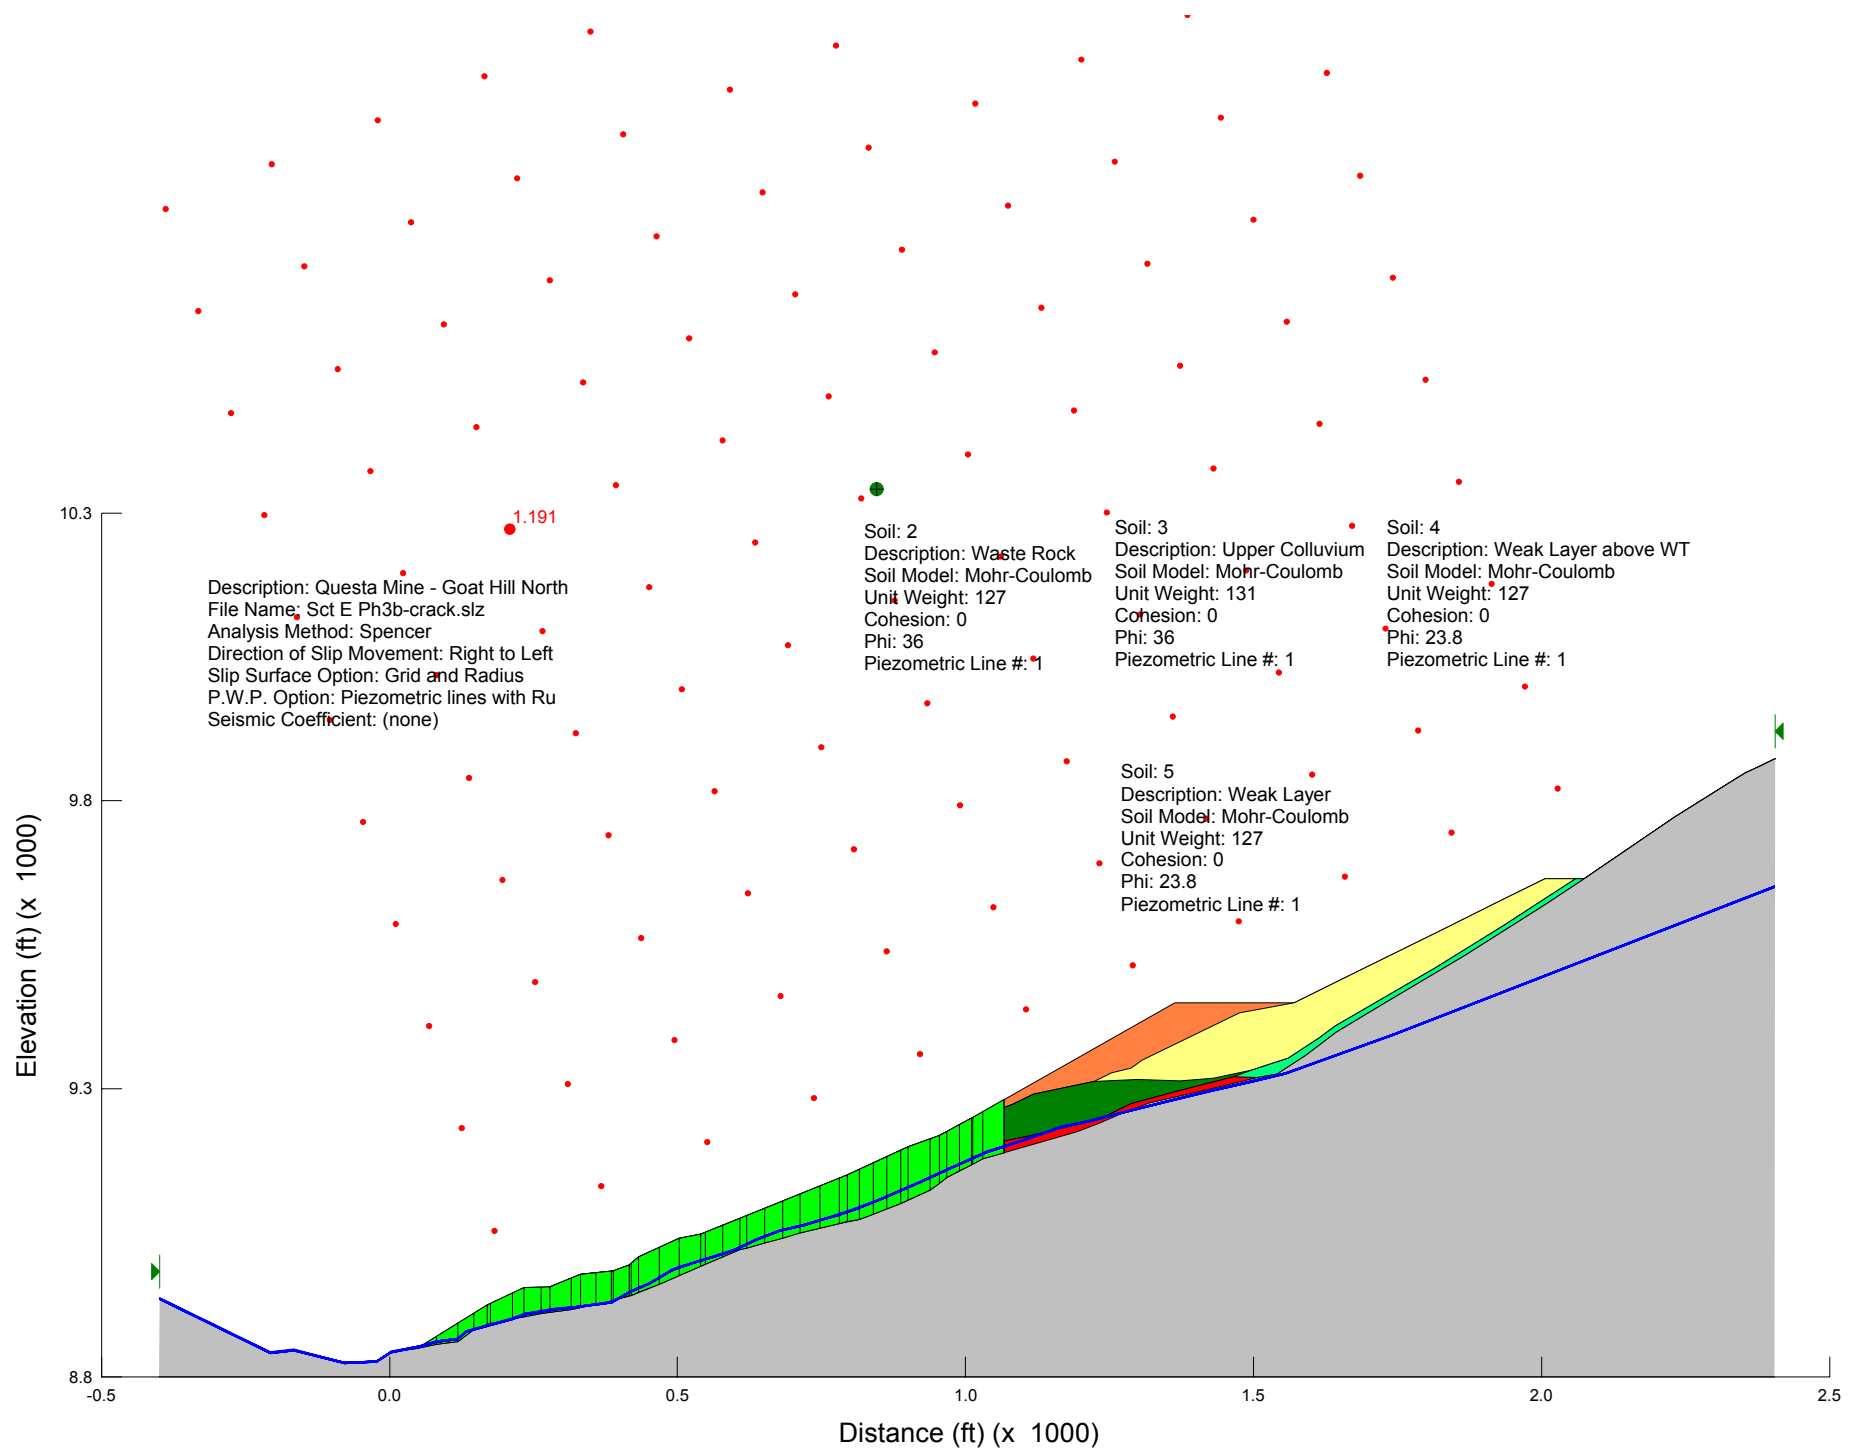
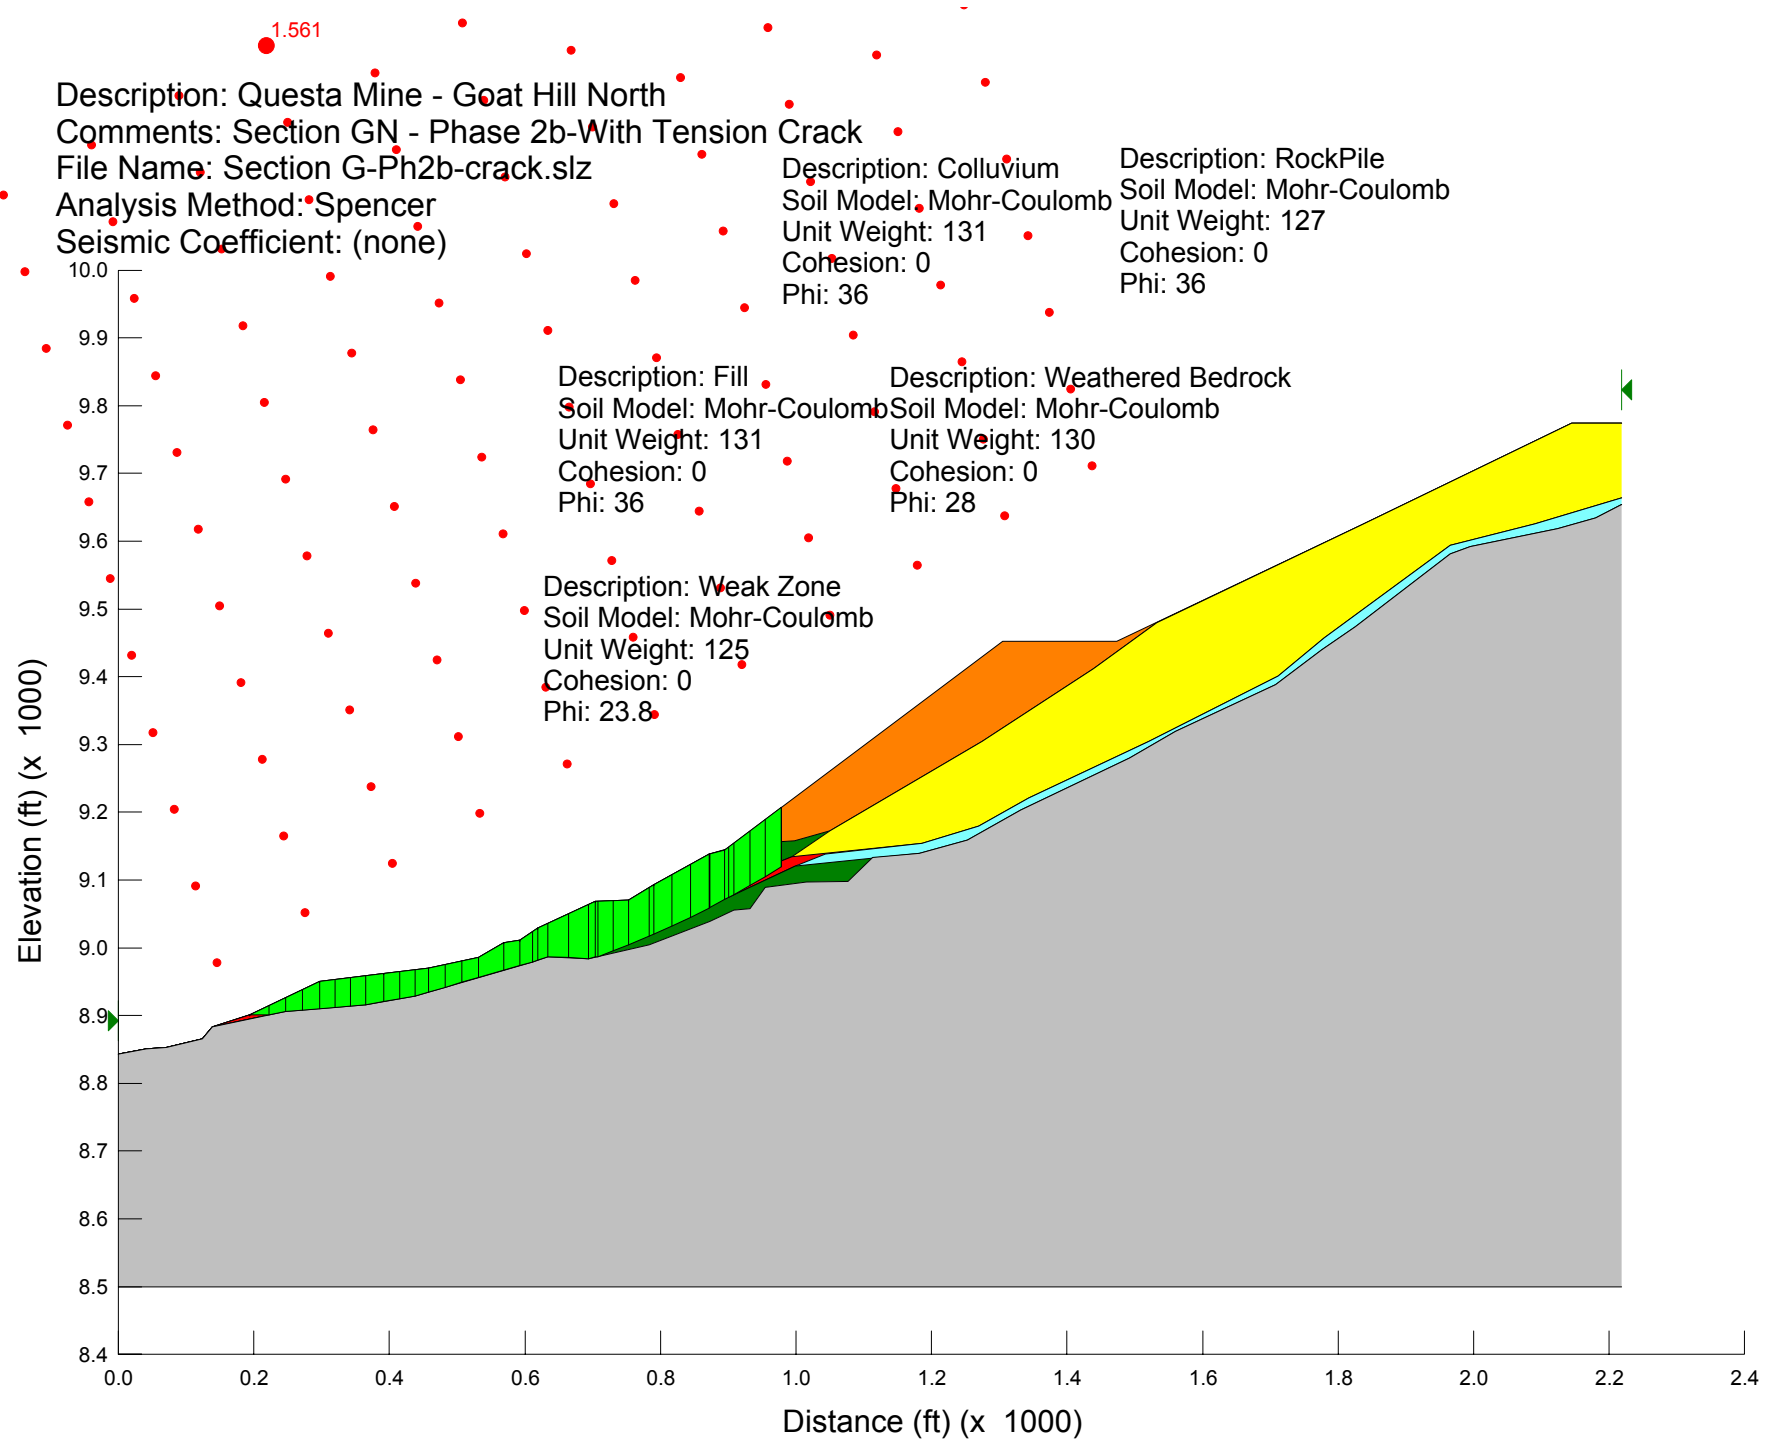
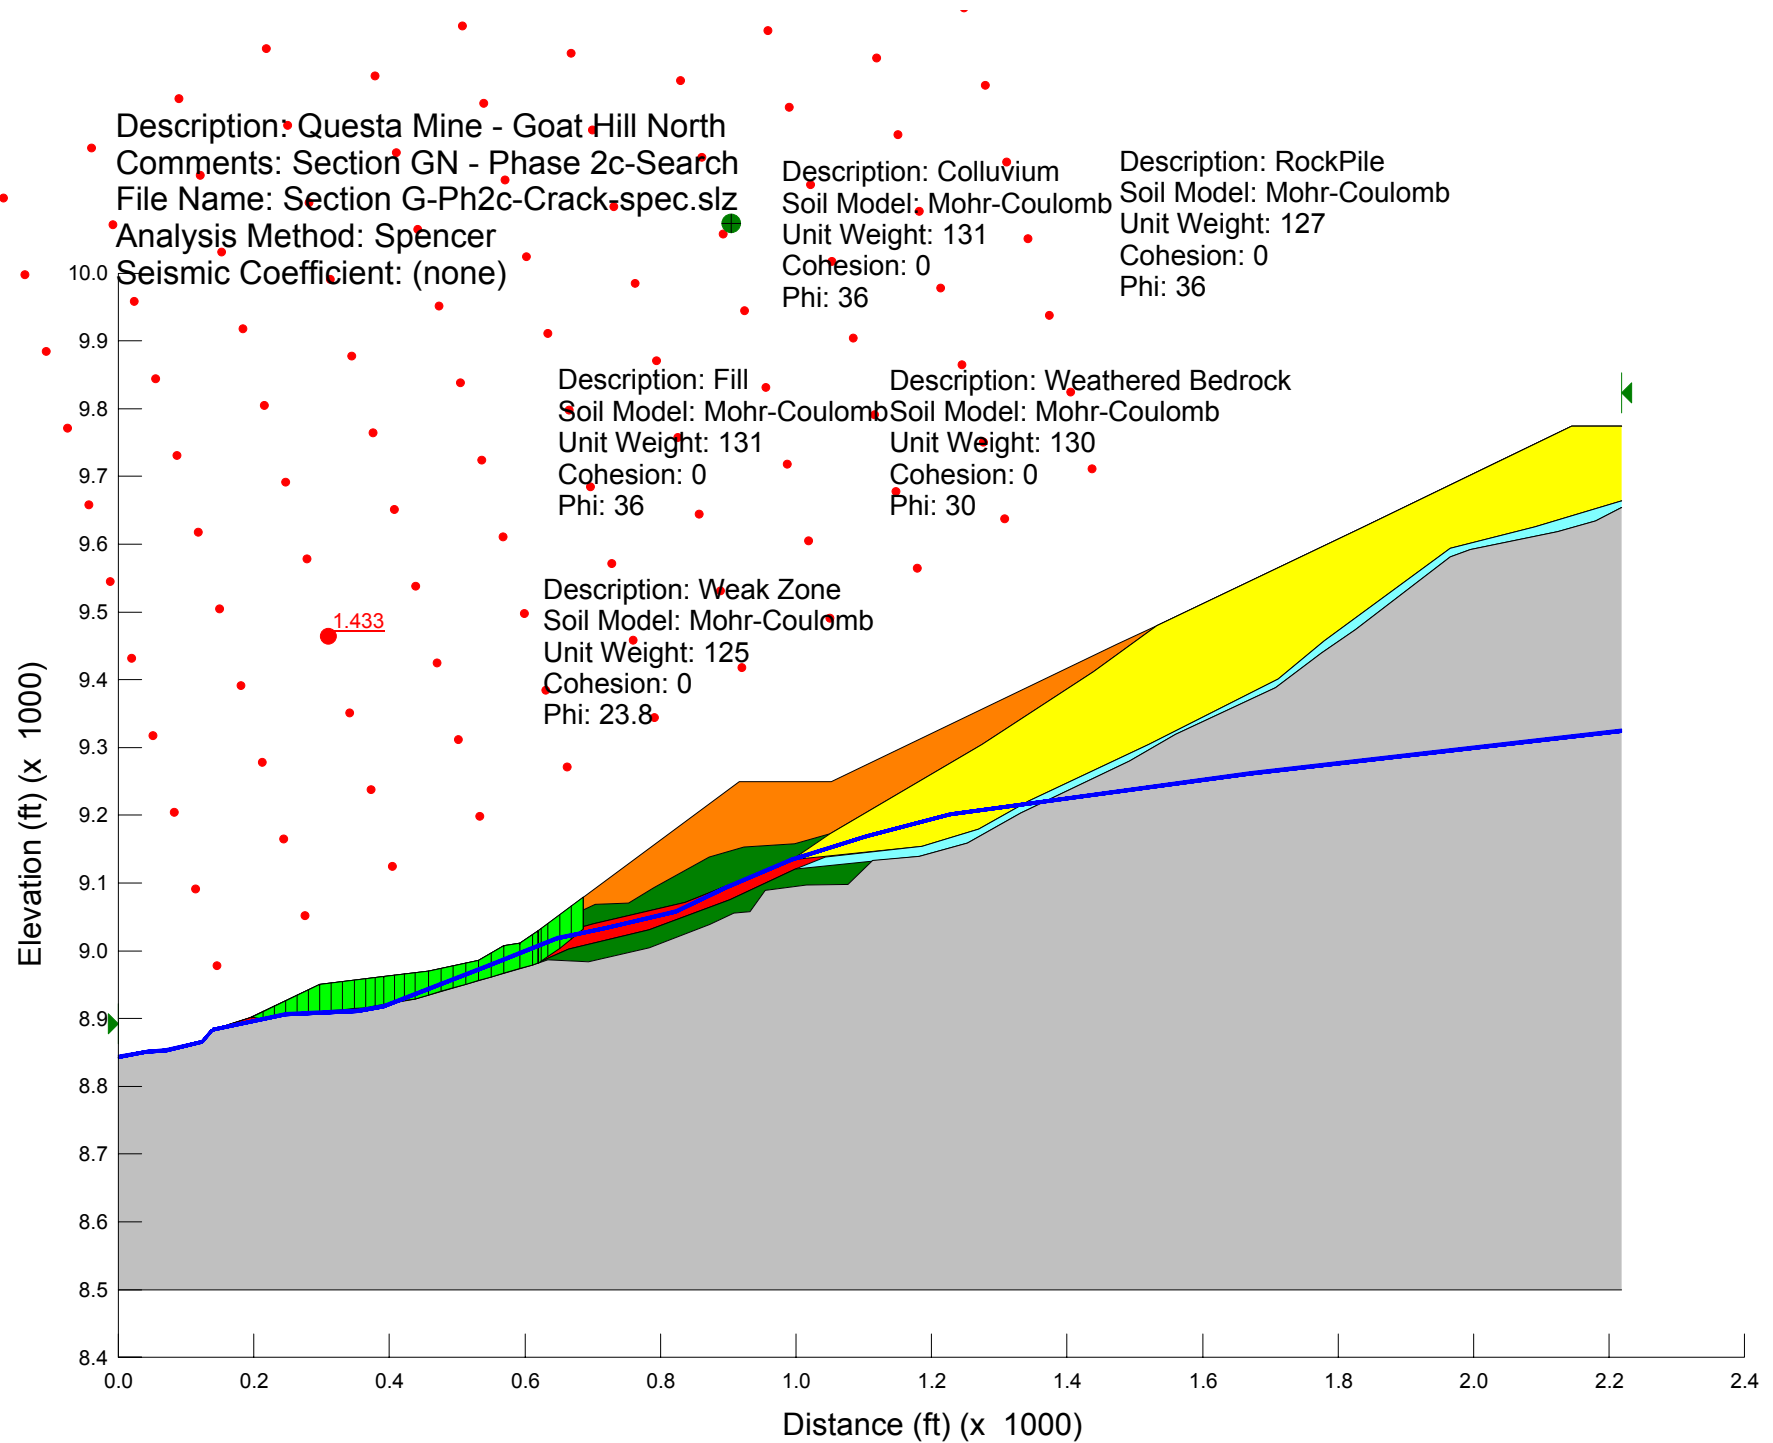
## **2D Stability Results**

### **Tension Cracks**
