Engineering Evaluation Cost Analysis

May 1996

Prepared for
Federal Tailings Pile Site

by
Environmental Protection Agency -- Region VII

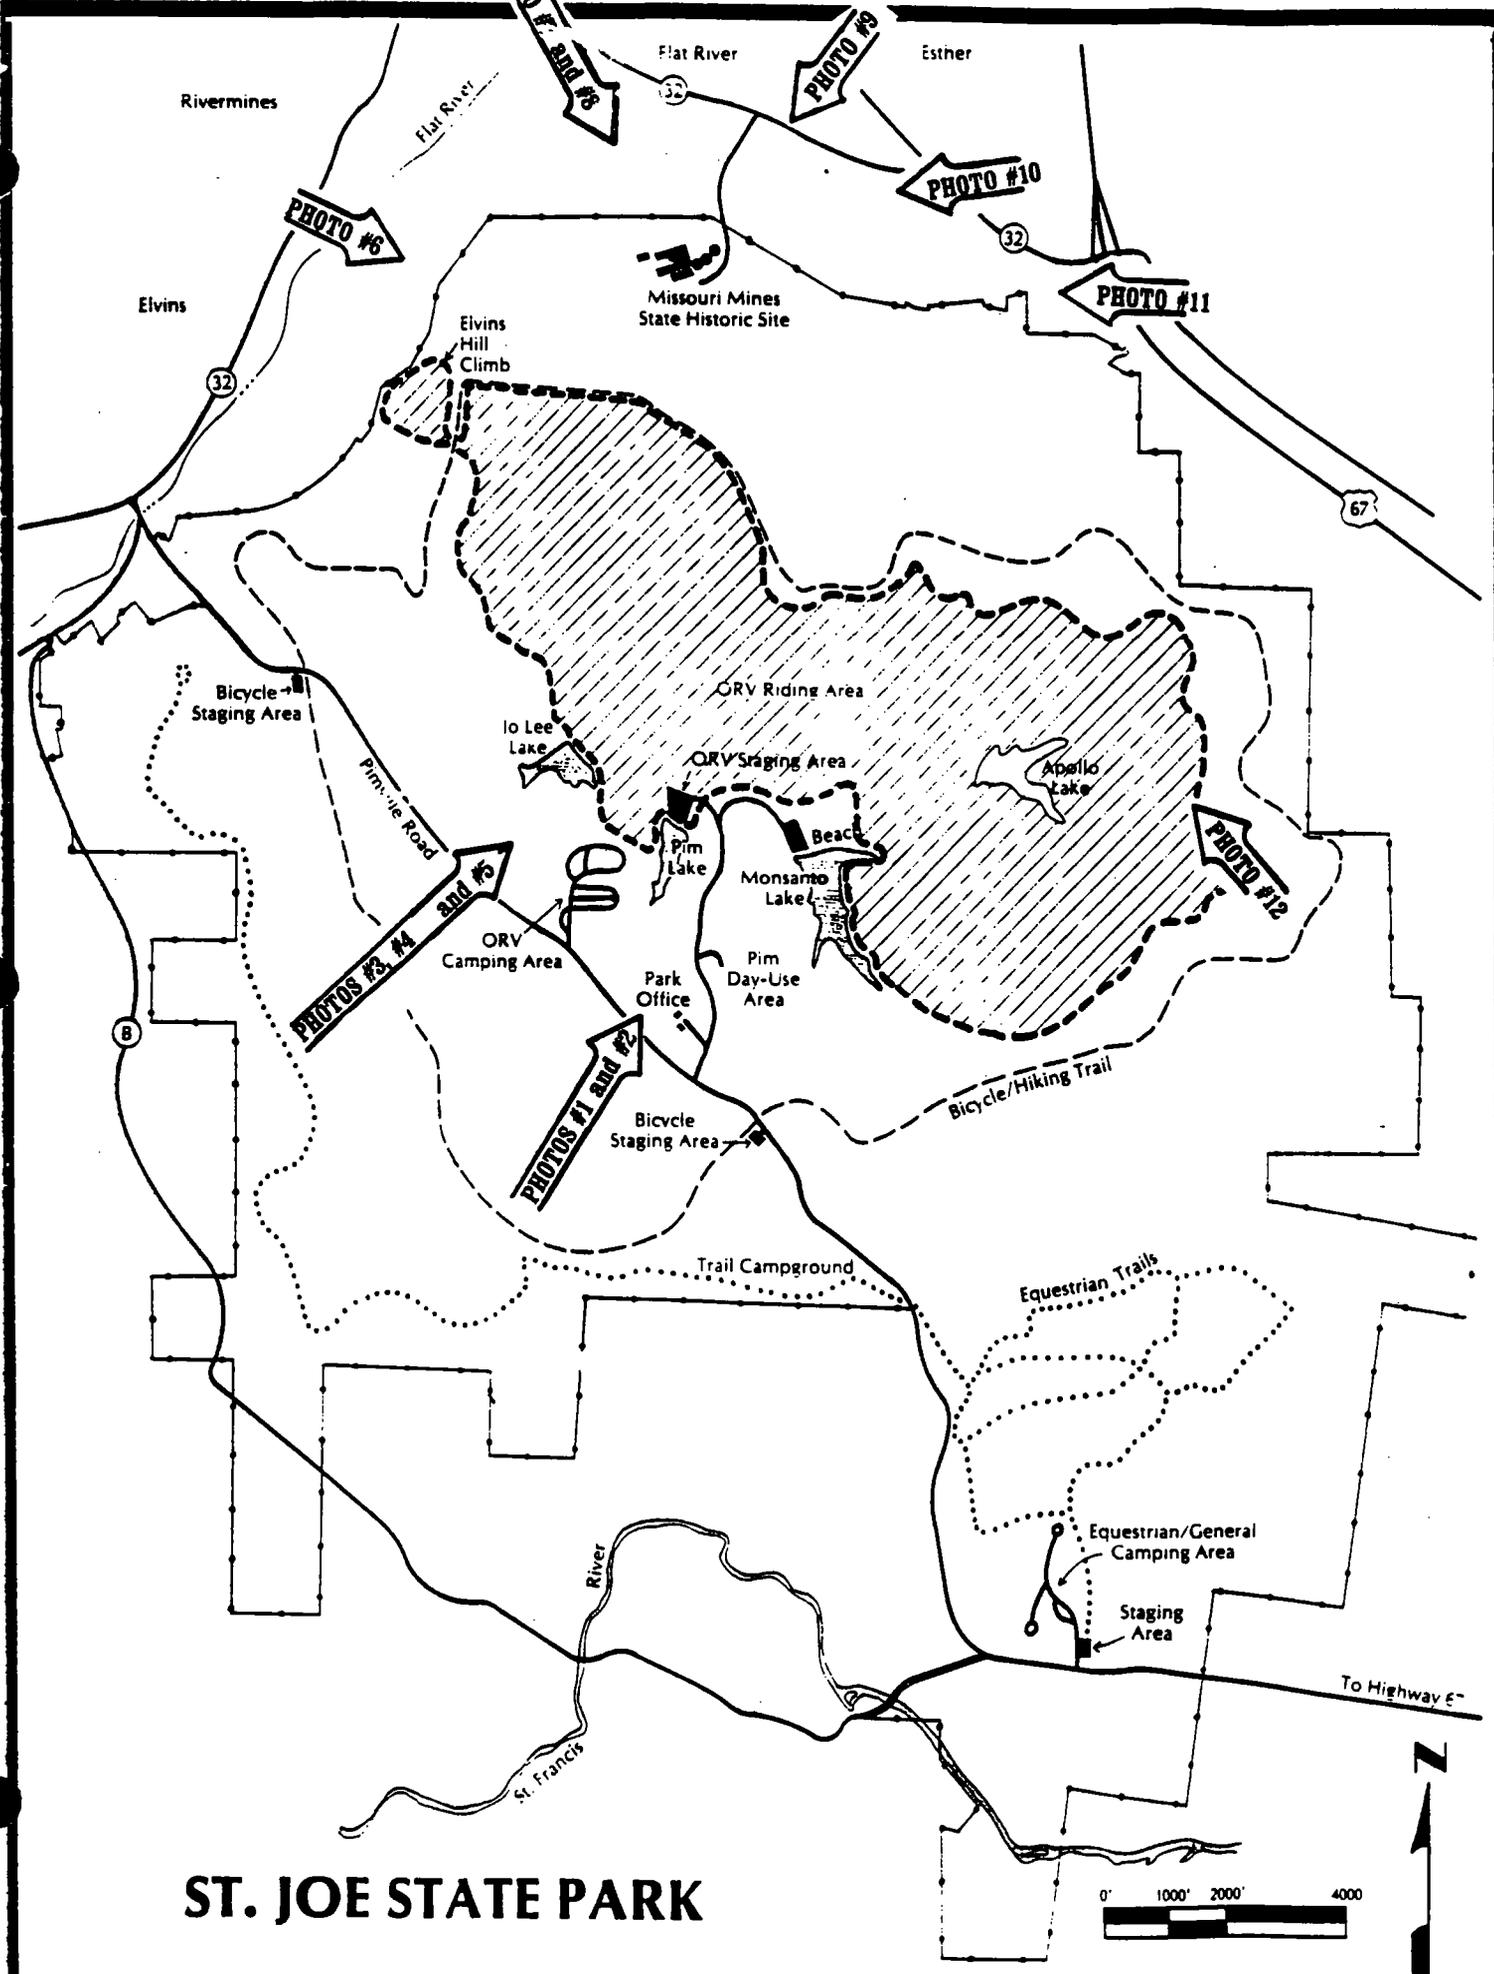
**AERIAL PHOTOGRAPHS
OF THE
ST. JOE STATE PARK SITE
FLAT RIVER, MISSOURI**

MAY 13, 1994
