ADMINISTRATIVE RECORD COVER SHEET

SUBJECT: Final Fifth Five-Year Review Report, former Mather Air Force Base (AFB),

**FIFTH FIVE-YEAR REVIEW REPORT
FORMER MATHER AIR FORCE BASE
SACRAMENTO COUNTY, CALIFORNIA**

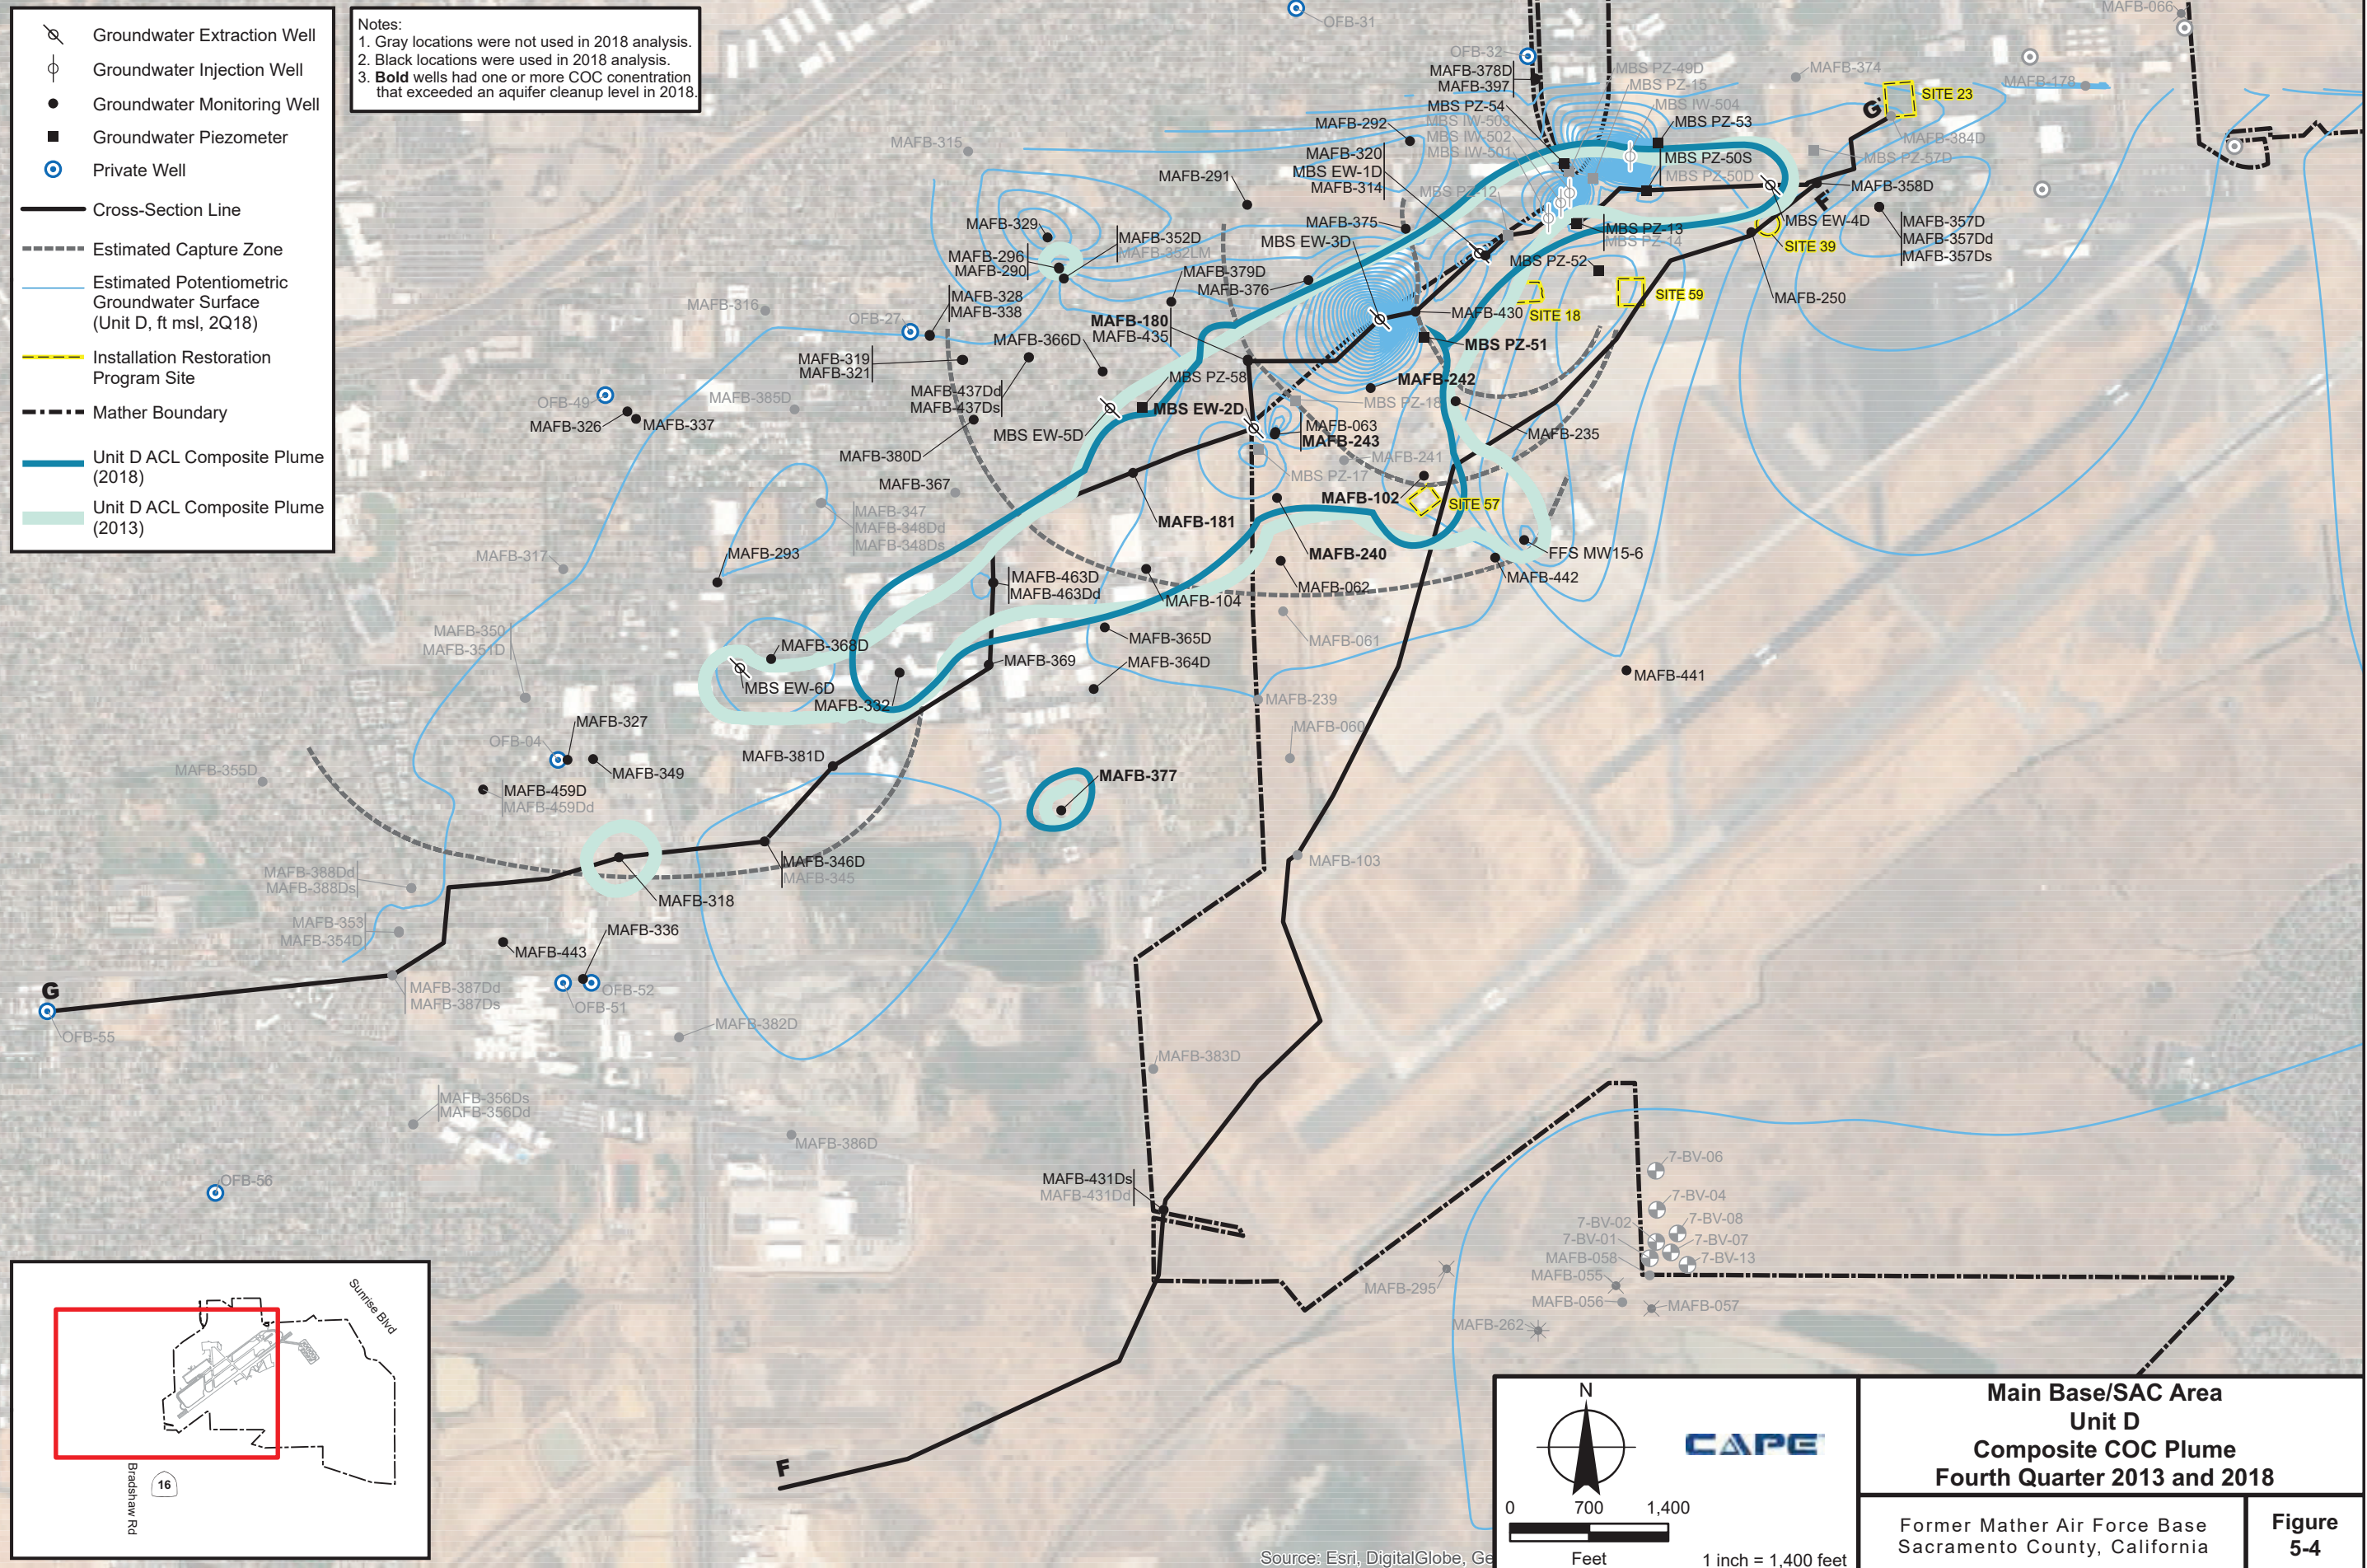
Figure 5-4

Notes:
 1. Gray locations were not used in 2018 analysis.
 2. Black locations were used in 2018 analysis.
 3. **Bold** wells had one or more COC concentration that exceeded an aquifer cleanup level in 2018.

- Groundwater Extraction Well
- Groundwater Injection Well
- Groundwater Monitoring Well
- Groundwater Piezometer
- Private Well
- Cross-Section Line
- Estimated Capture Zone
- Estimated Potentiometric Groundwater Surface (Unit D, ft msl, 2Q18)
- Installation Restoration Program Site
- Mather Boundary
- Unit D ACL Composite Plume (2018)
- Unit D ACL Composite Plume (2013)

During the time period of this five-year review, the extent of the COC plume in the Main Base/SAC Area decreased as a result of continued removal of COCs by the groundwater extraction system. Figures 5-2, 5-3, and 5-4 show a comparison of the plume boundaries in 4Q13 and 4Q18 in each hydrostratigraphic unit: Unit A/Water Table, Unit B, and Unit D, respectively. The water table plume area has decreased from 183 acres in 2013 to 114 acres in 2018 (a decrease of 38 percent). The B unit plume area has decreased from 723 acres in 2013 to 469 acres in 2018 (a decrease of 35 percent). The D unit plume area has

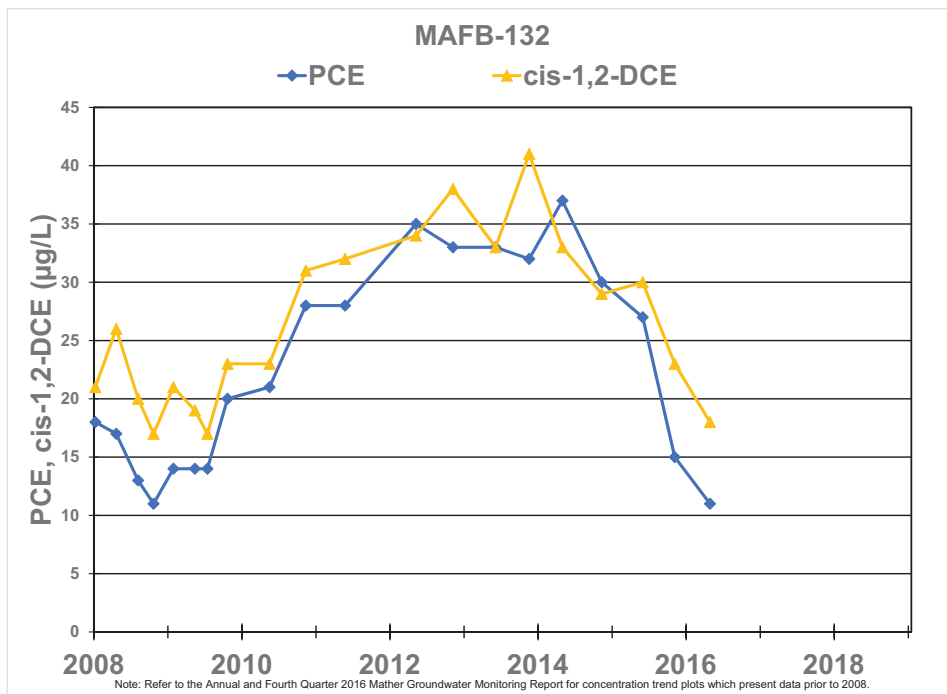
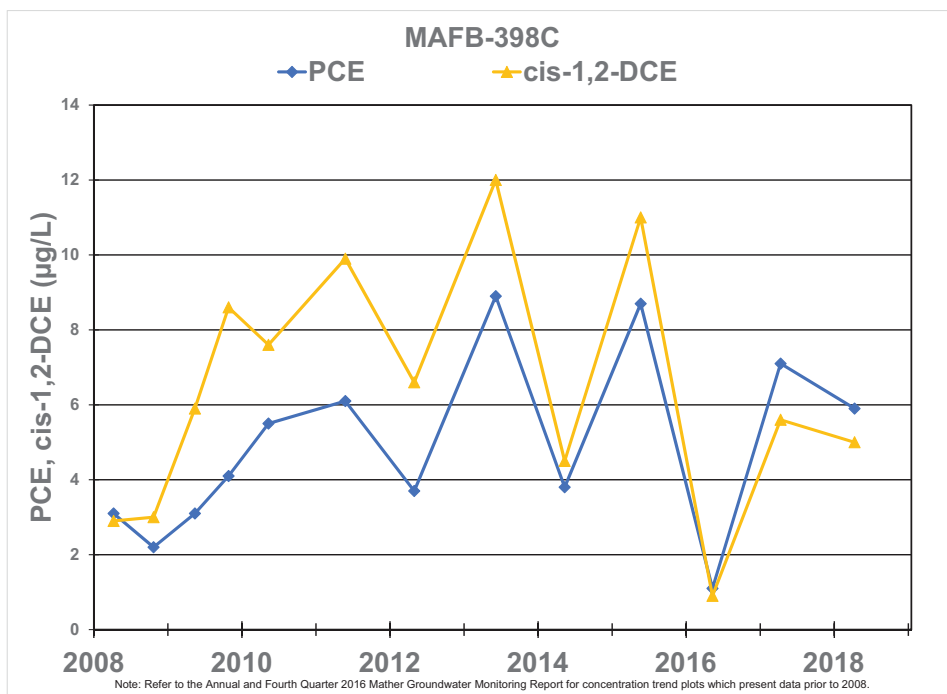
Figure 5-7. Concentration Trend Graphs for PCE and cis-1,2-DCE at MAFB-132 and MAFB-398C

Due to declining groundwater levels, MAFB-132 in the central portion of the plume contained insufficient water for sampling from 2017 through 2019. In July 2019, a new groundwater monitoring well, MAFB-467, was installed near MAFB-132 to monitor this area of the northeast plume. The well was constructed with a deeper screen interval and will allow continued monitoring of concentration trends and plume containment.

trend line). While COC concentrations (specifically, PCE and cis-1,2-DCE) at most Northeast Plume wells have continued to decrease since 2009, there is no real trend at MAFB-398C and MAFB-132 has contained insufficient water for sampling 2017 through 2019; therefore, an updated prediction of when ACLs may be achieved based on trend analysis cannot be made at this time (Figure 5-7). Once there are sufficient data points obtained from the replacement well, MAFB-467, the statistical trend will be evaluated and a prediction of when ACLs may be achieved will be presented in the annual monitoring report.
