**Former Pease Air Force Base
Portsmouth, New Hampshire**

5 Year Review Report (1999 to 2004)

**FORMER PEASE AIR FORCE BASE
FIVE-YEAR REVIEW REPORT (1999-2004)**

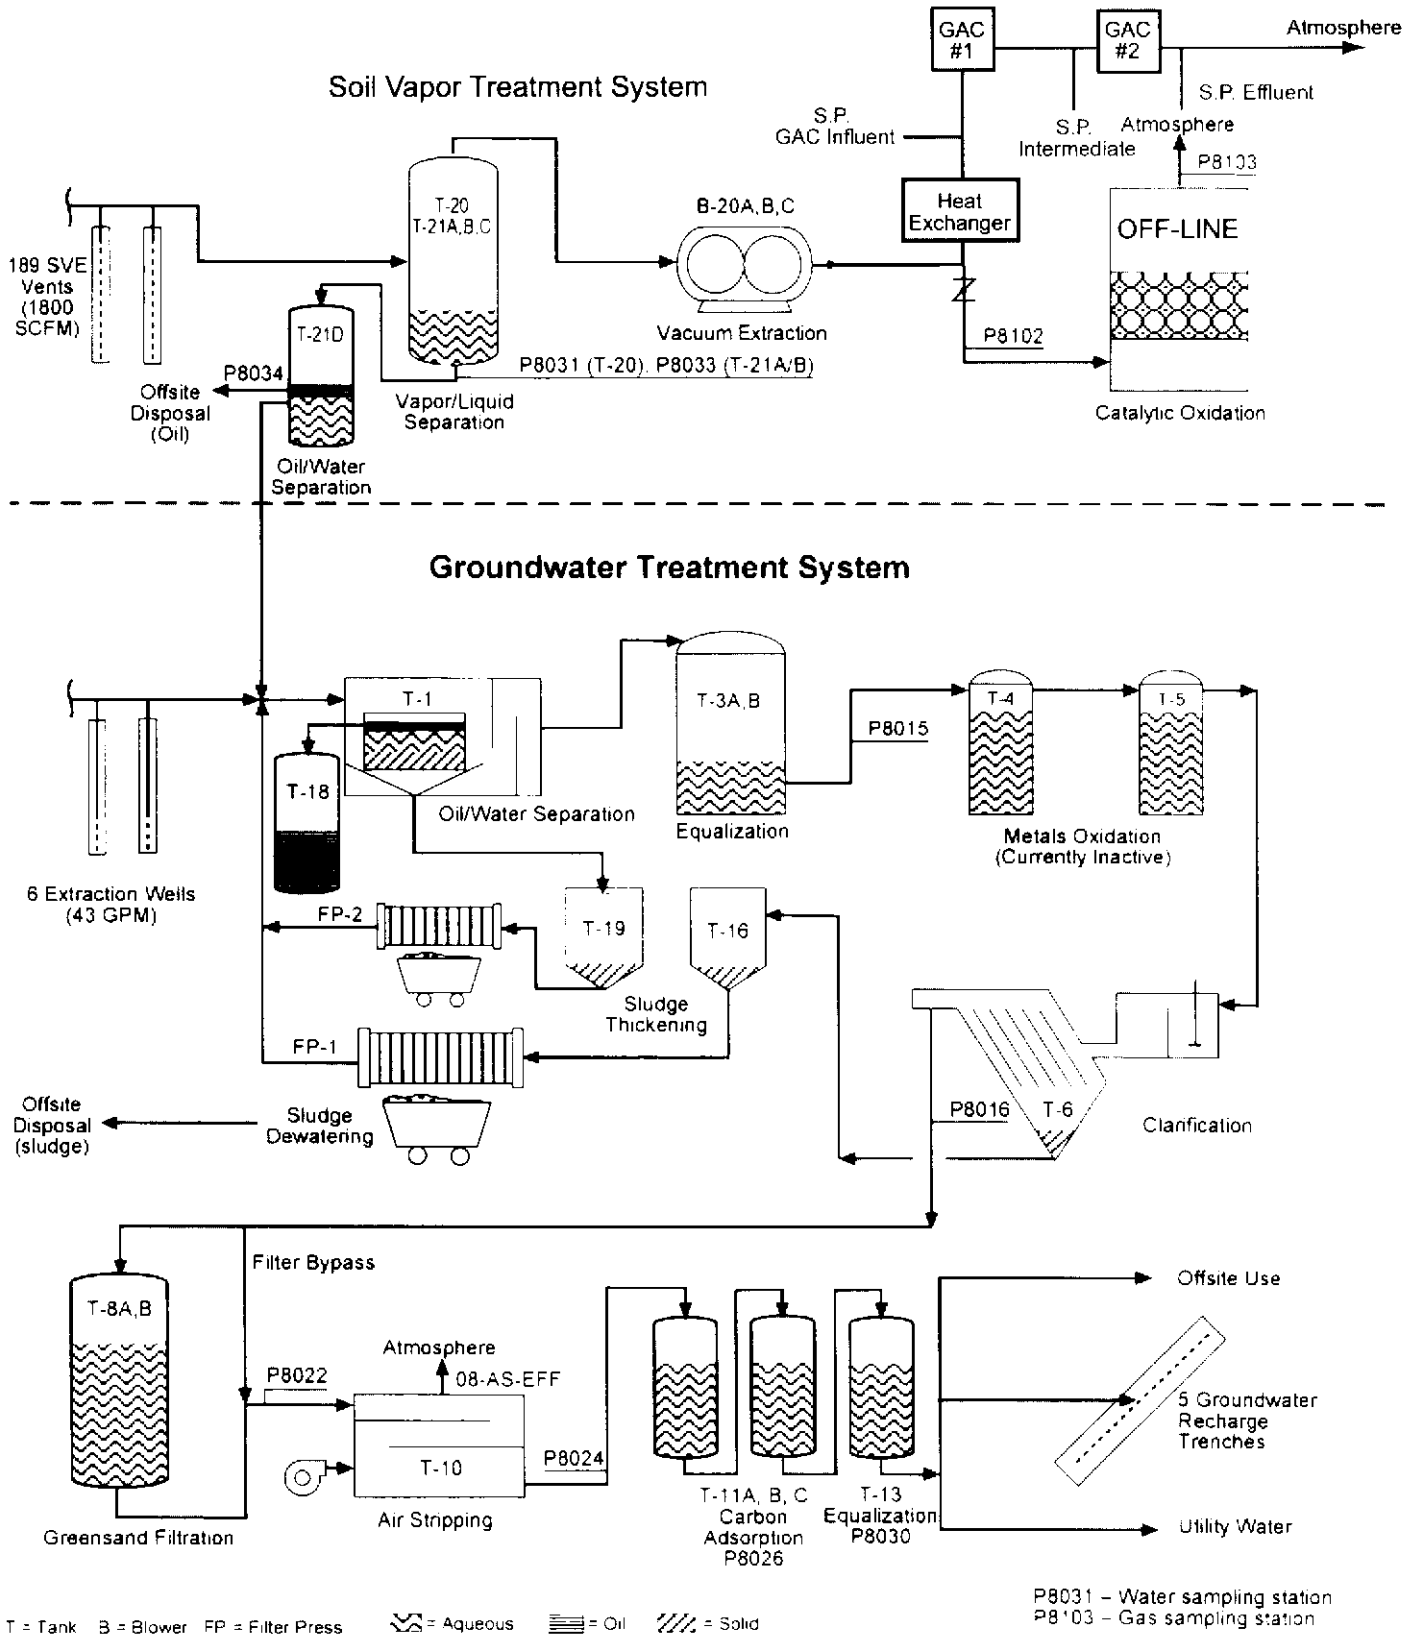
FIGURE 7.9-3

Site 8 Process Flow and Sampling Locations

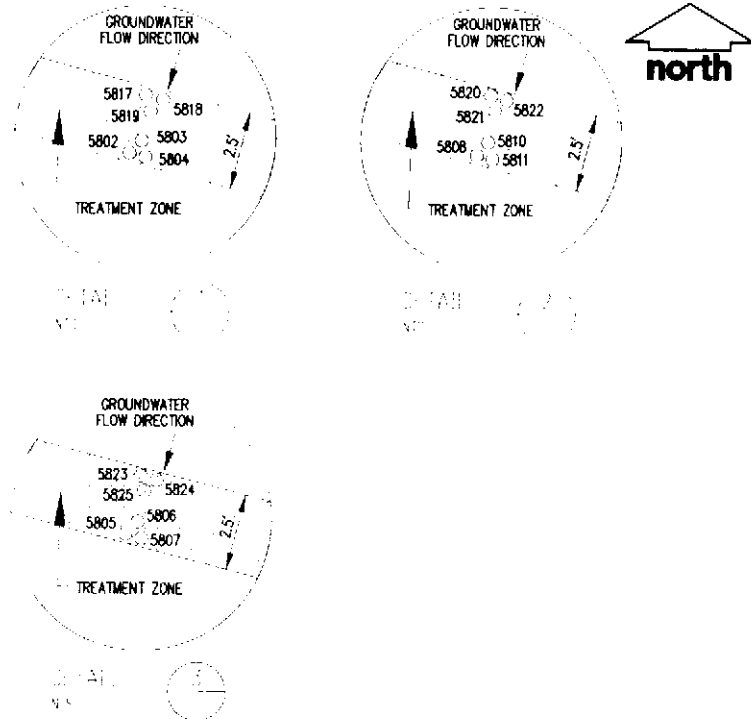
FIGURE 7.11-7

- NOTES:**
1. -- IN RESULT BOX INDICATE ANALYTE WAS NOT DETECTED.
 2. J -- DENOTES QUANTITY IS ESTIMATED.
 3. ALL CONCENTRATIONS ARE REPORTED IN MICROGRAMS PER LITER (µg/L).
 4. PRB -- PERMEABLE REACTIVE BARRIER.
