# *Five-Year Review Report*

## 2008 Five-Year Review for Hill Air Force Base

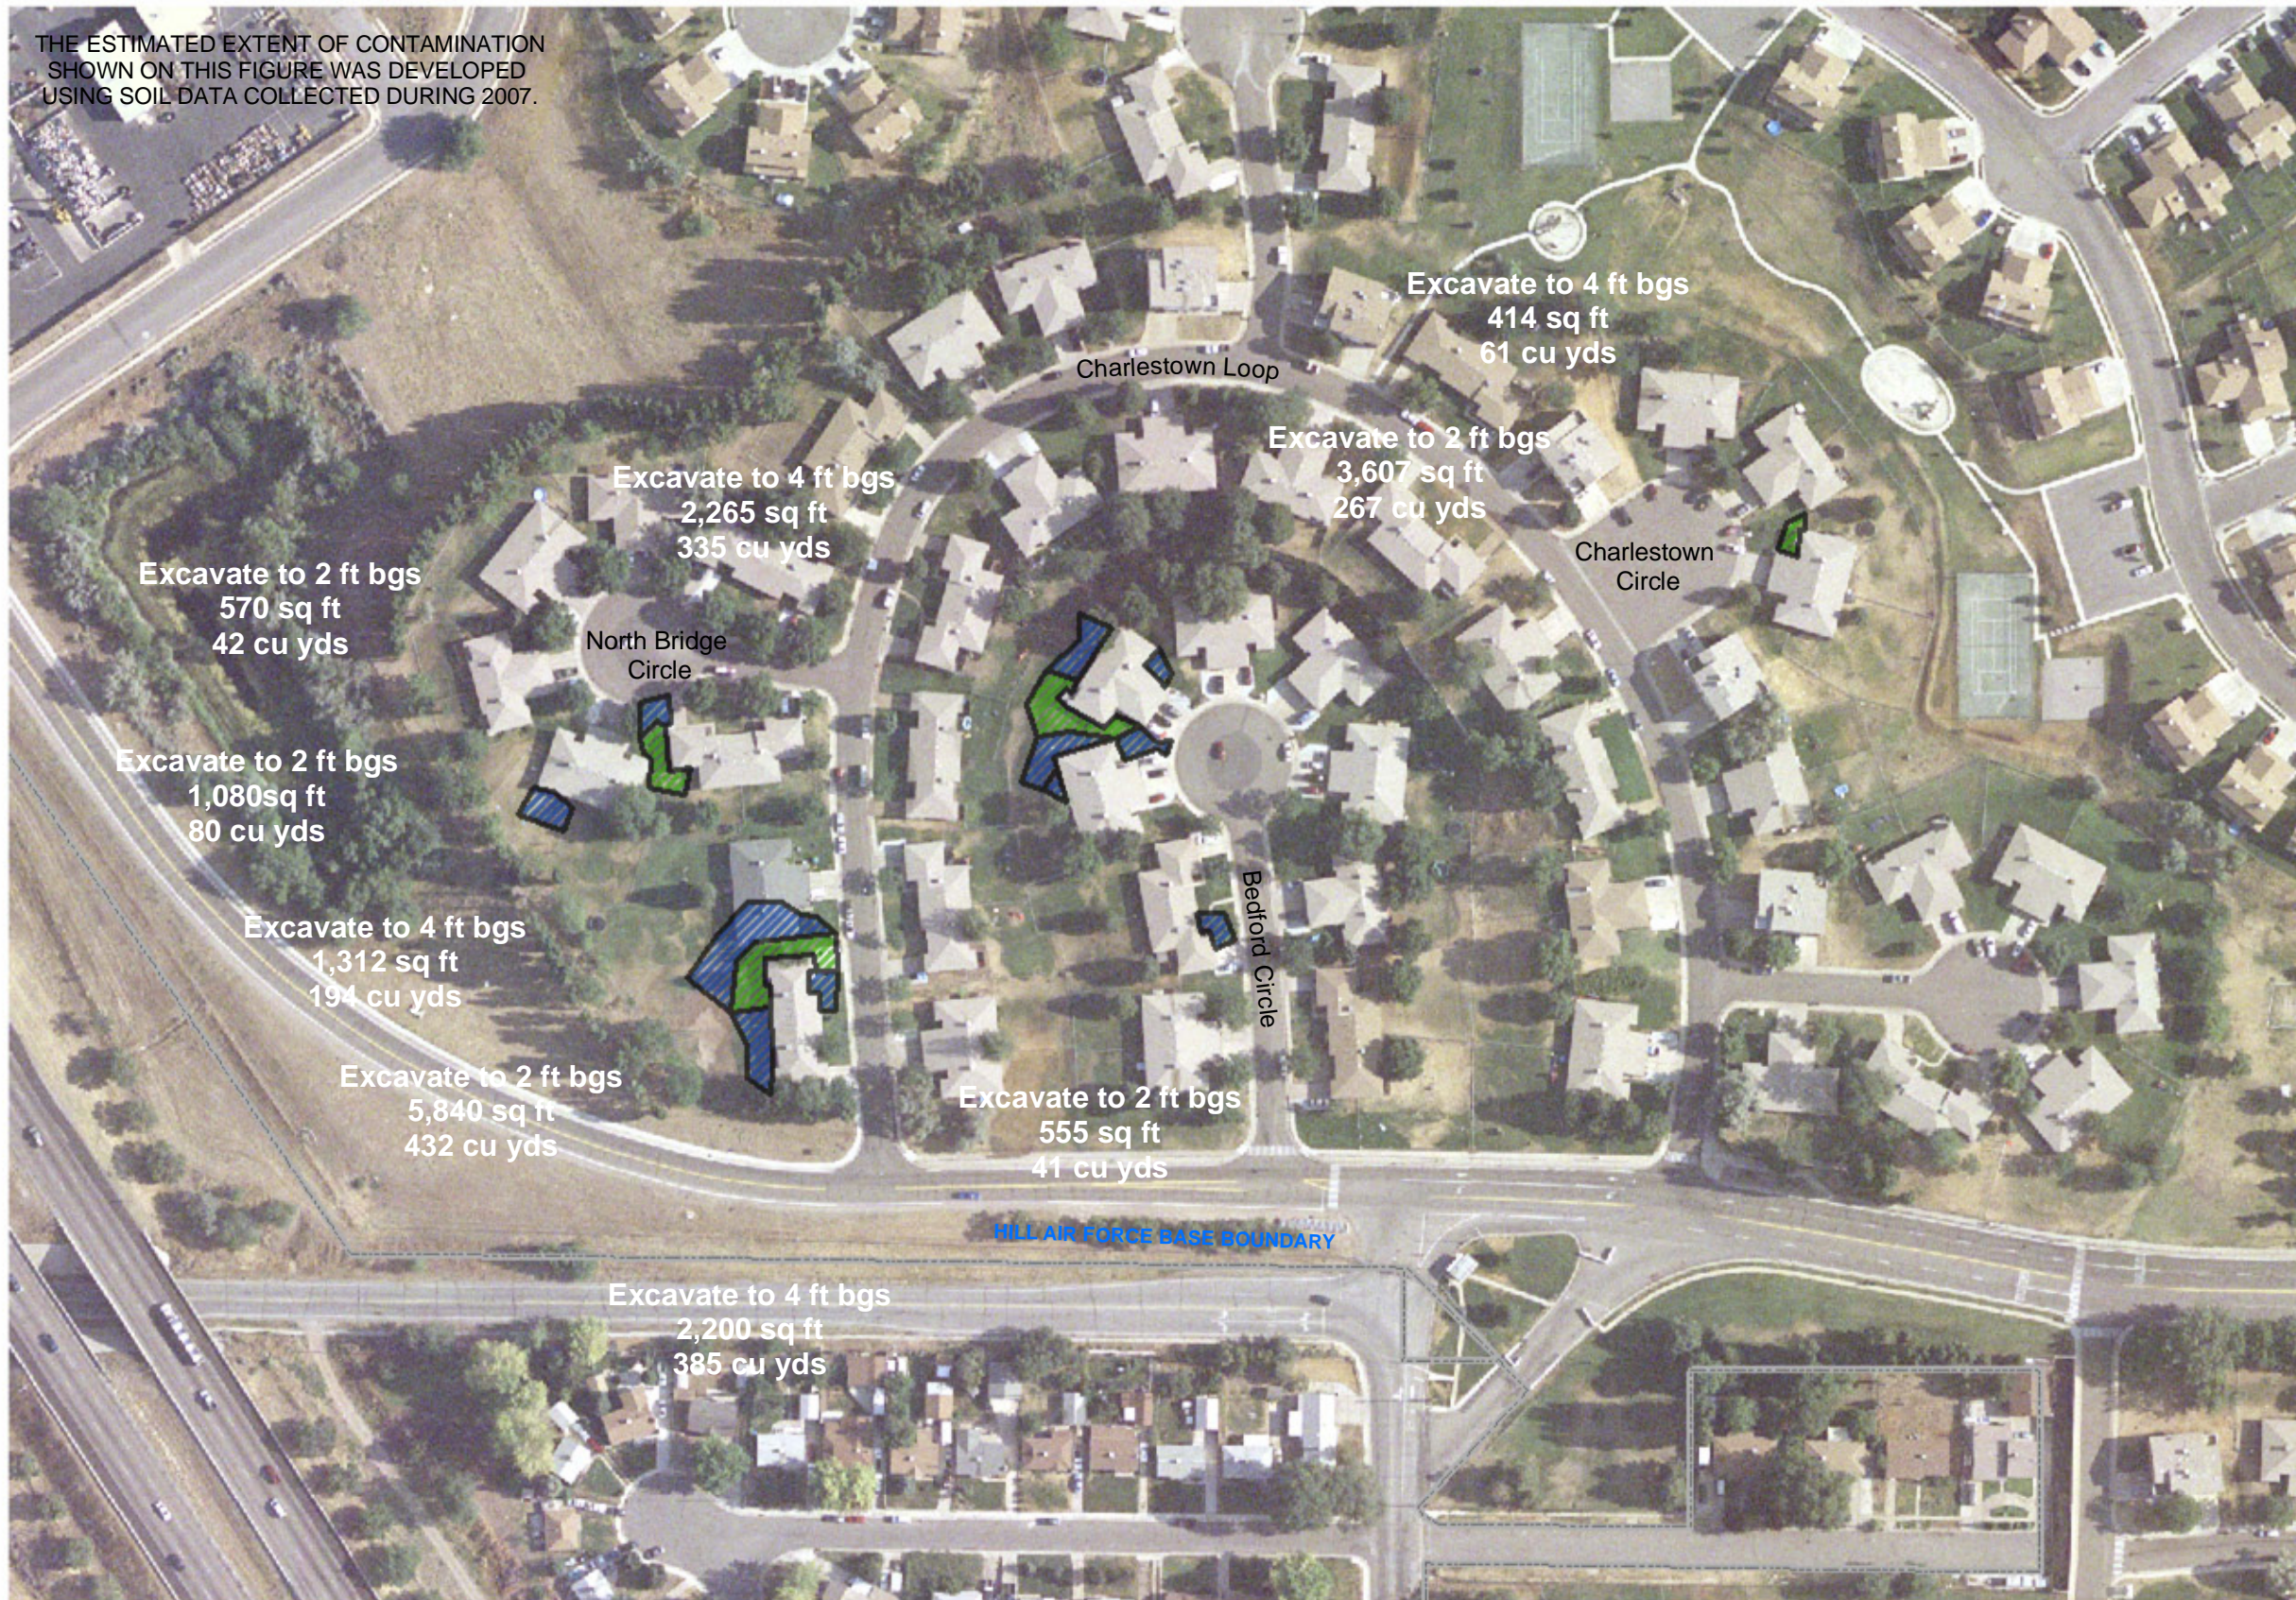
**FIGURE OU 13 - 1**  
**SITE FEATURES OF OPERABLE UNIT 13**  
2008 FIVE-YEAR REVIEW  
IRP SITE: SS112  
HILL AIR FORCE BASE, UTAH

THE ESTIMATED EXTENT OF CONTAMINATION SHOWN ON THIS FIGURE WAS DEVELOPED USING SOIL DATA COLLECTED DURING 2007.

- PCBs > 10 ppm
  - PCBs 1 ppm to 10 ppm
  - PCBs < 1 ppm
  - PCBs not detected
  - Excavate to 2 ft bgs
  - Excavate to 4 ft bgs
- DRMO Defense Reutilization Marketing Office
- bgs Below ground surface
- ppm Parts per million
- PCB Polychlorinated biphenyl
