New Bedford Harbor Superfund Site

U.S. Army Corps of Engineers New England District

Draft Final Intertidal Work Plan for West Zone 4 Revision 1

October 2020

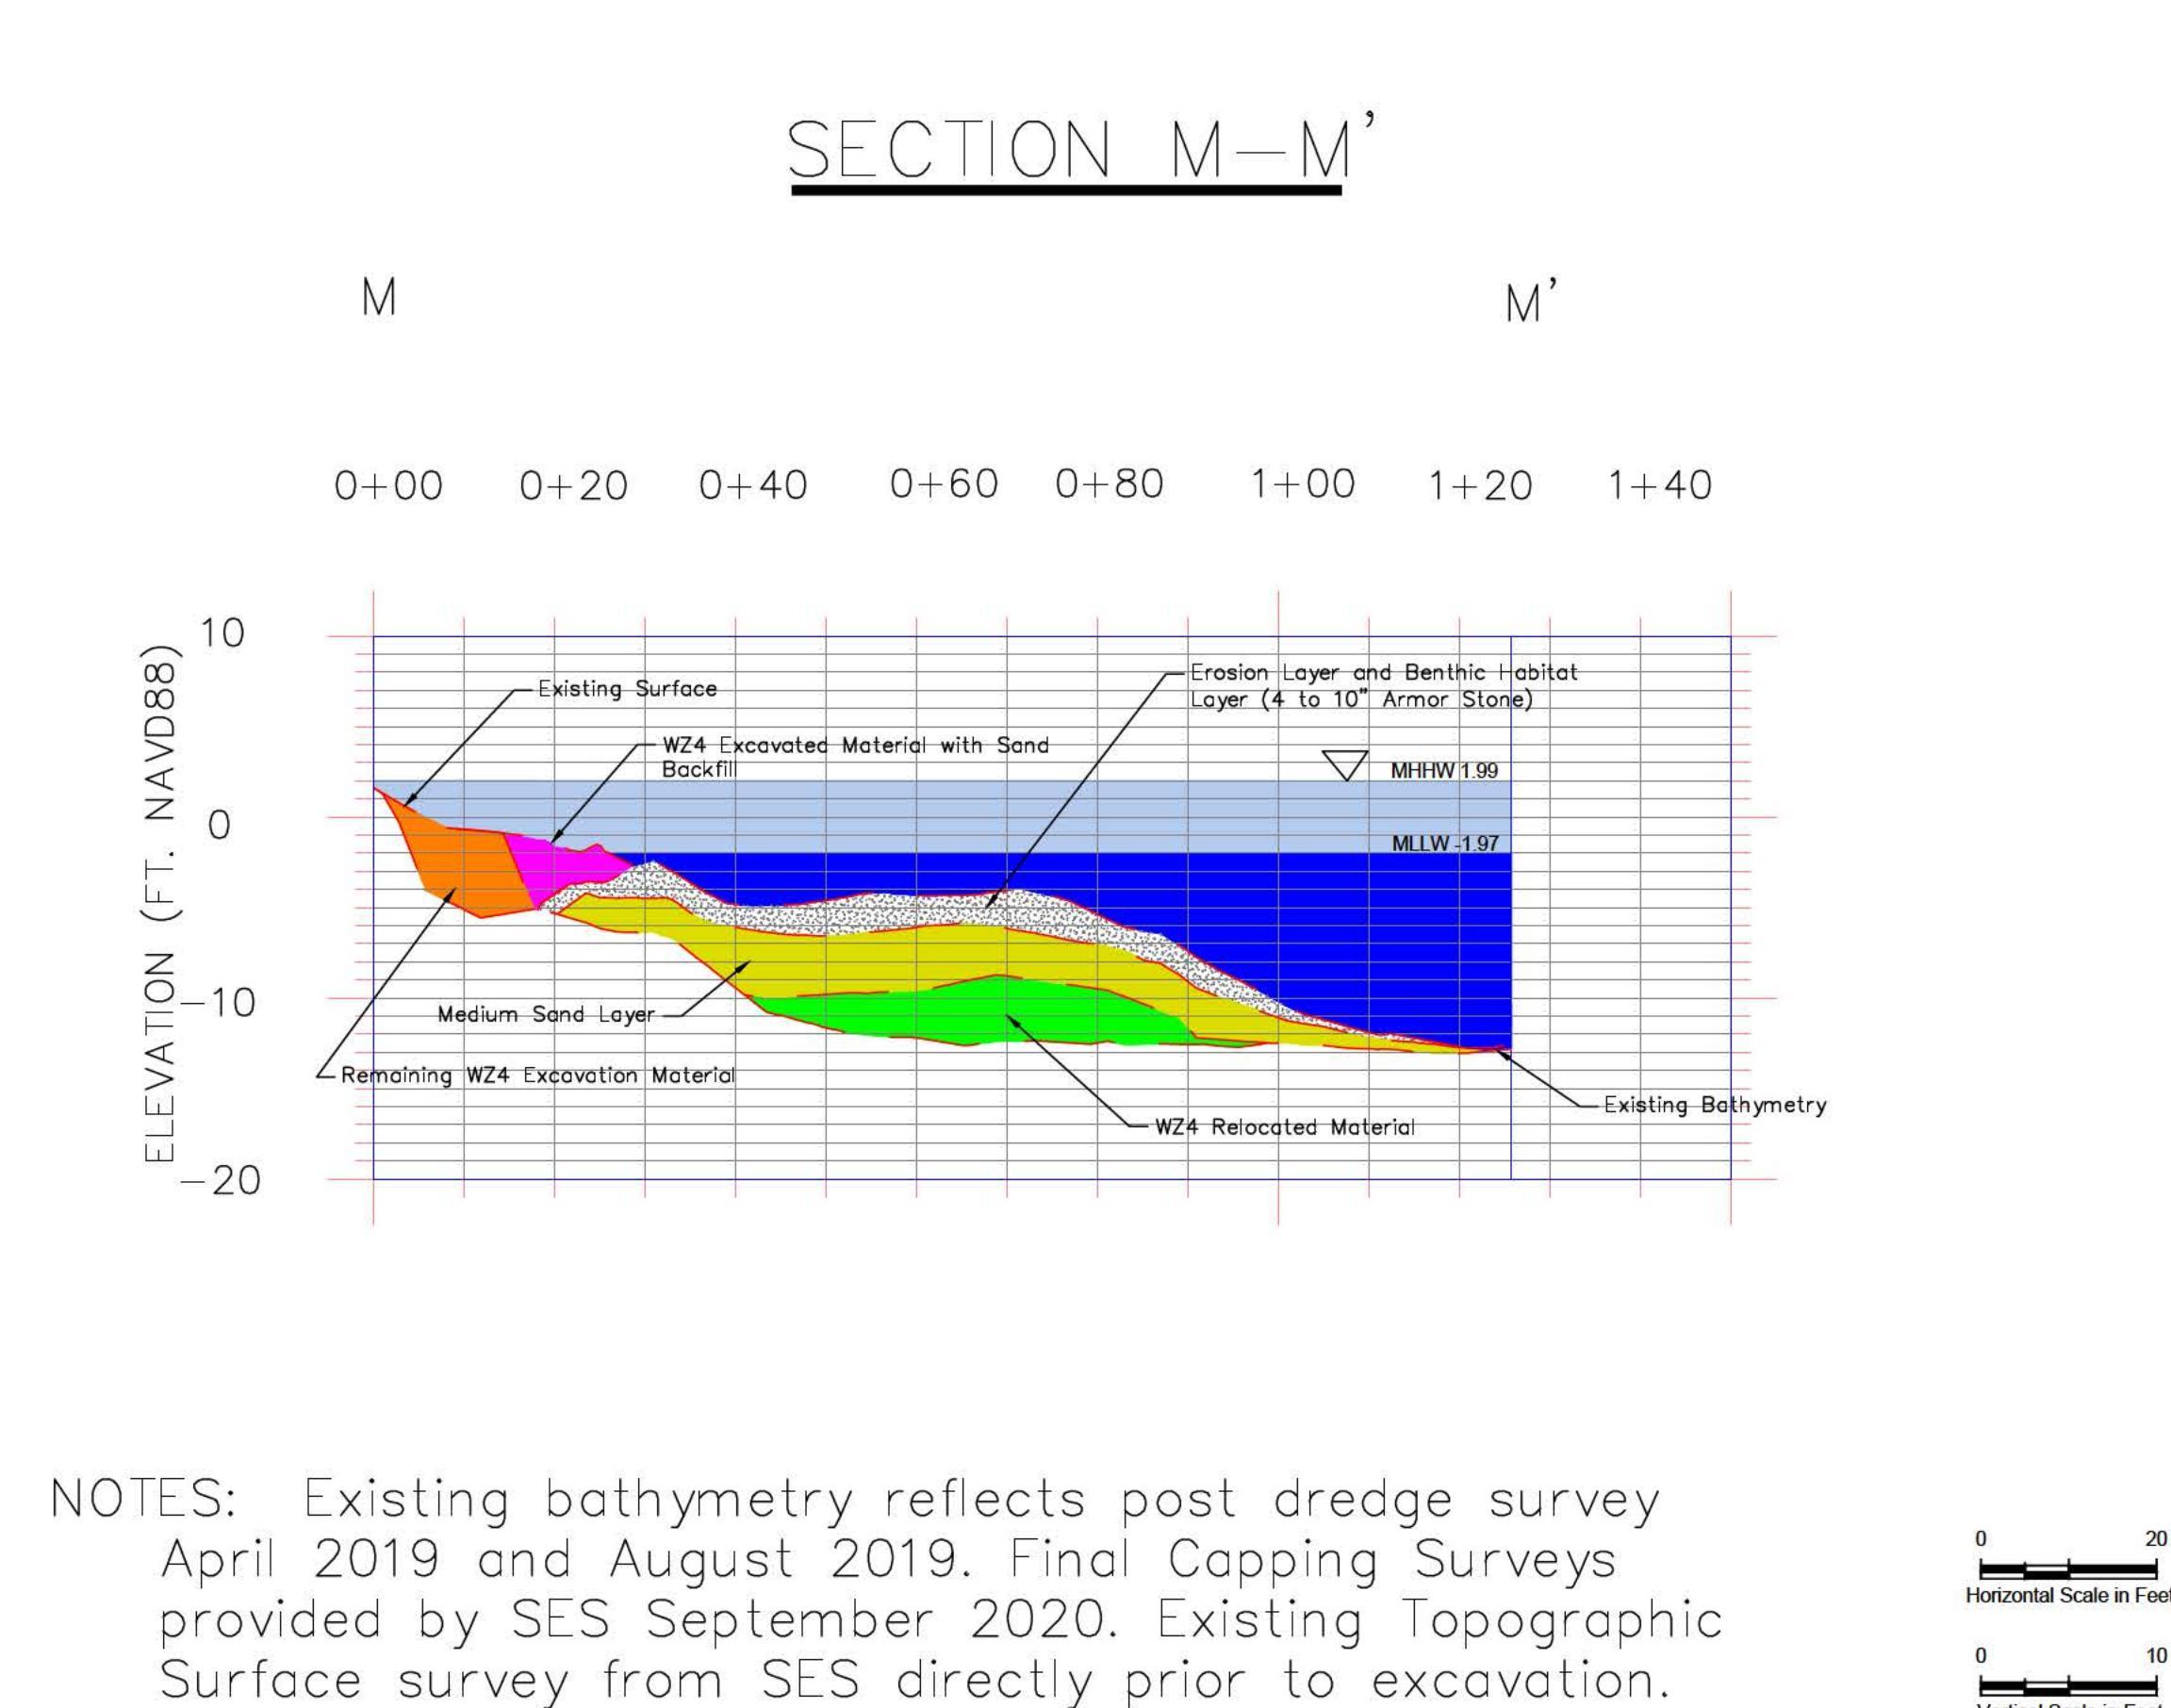
-
		1
2		
No. Revision	Date	App.
Client/Owner:		
Issued for:		
Drawing Title:		
Cross Section	NA_NA'	
L114 Final Asb	built	
	Date: 10-	19-2020
	Scale:	
	Designed By:	
	Drawn by:	SAT
	Checked by:	
	Project Number:	
	Sheet of	
	Drawing Number:	
	Figure 2	-4b

Two subtidal caps abutting West Zone 4 were constructed in September 2020 (Figure 2-1). Prior to cap construction, portions of the West Zone 4 excavation area along the landward cap design boundaries were excavated and the material relocated to within the cap design footprints (Figures 2-4a and 2-4b). The excavated areas were backfilled with clean sand at 3H:1V to serve as a buffer between the remaining West Zone material and the caps. The sand buffer will protect the caps during future intertidal remedial excavation by minimizing sloughing of cap material and providing a clean interface. Some removal of backfill sand is anticipated in the buffer zone during the future West Zone 4 remediation. The relocated West Zone 4 material was isolated within the cap with approximately 2 ft of clean sand, containing high levels of Total Organic Carbon (TOC), and 1 ft of armor stone.

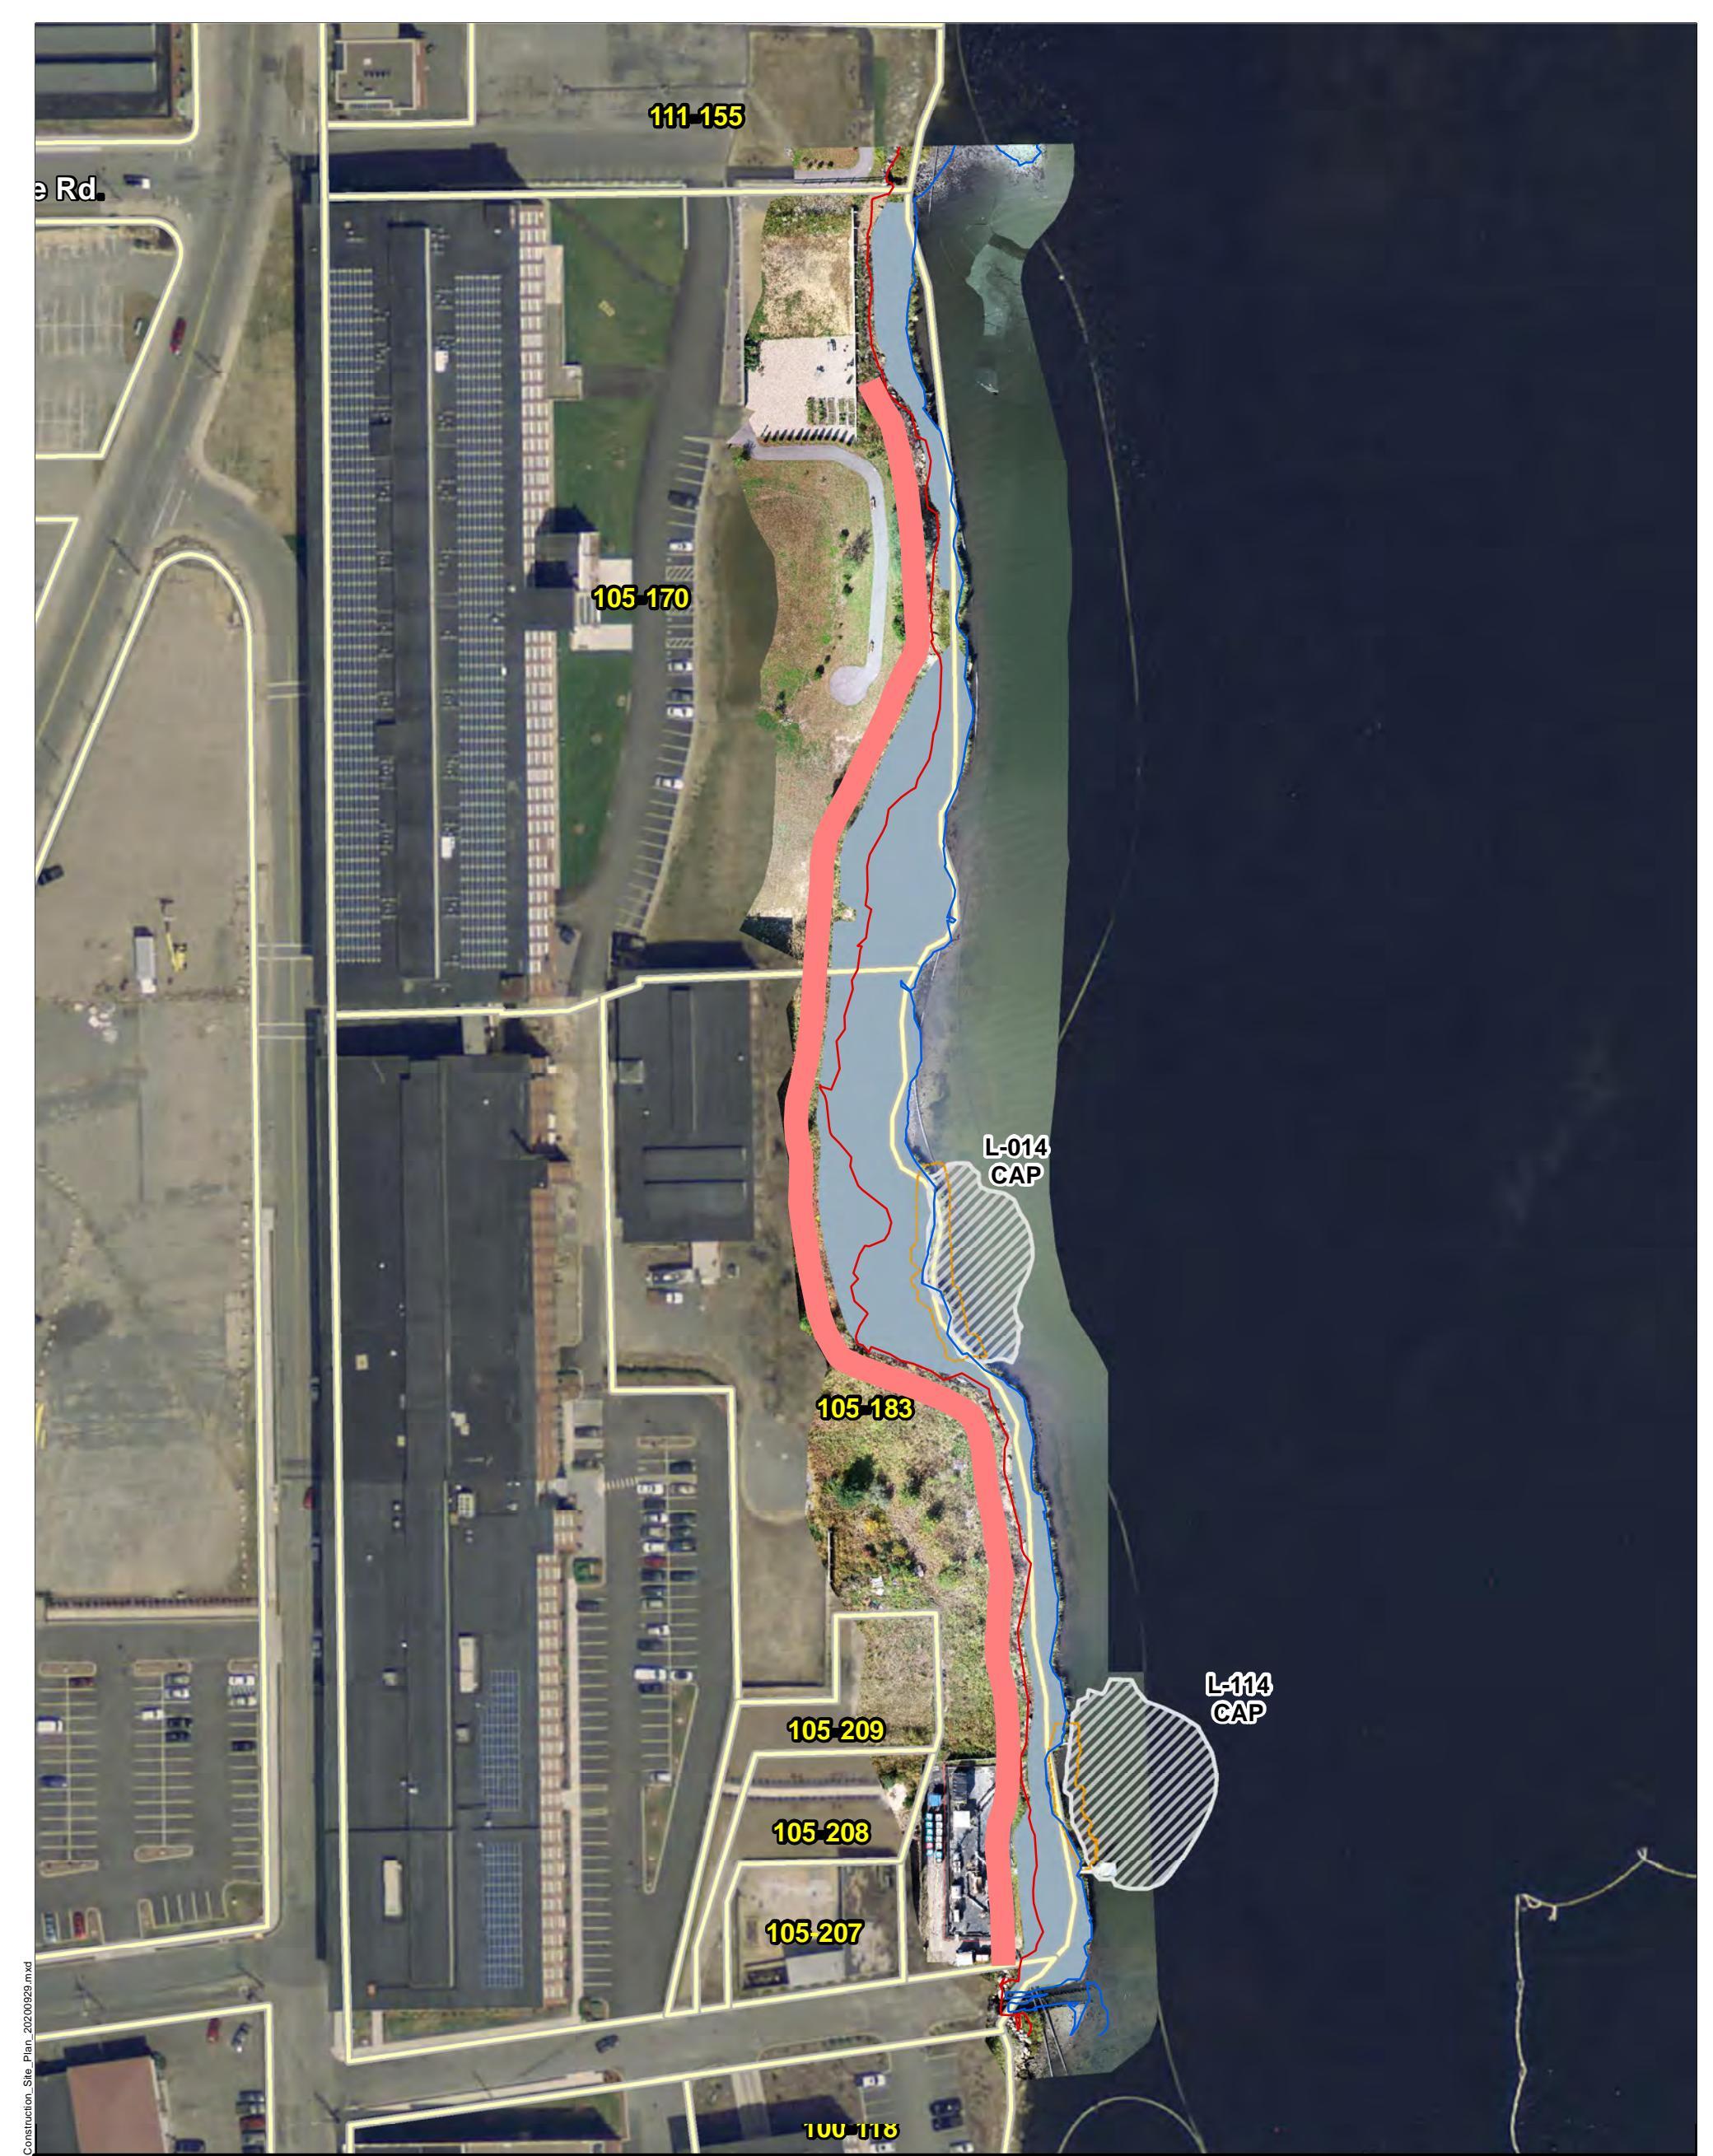
Final Extent Engineered Cap Aerial Photography Green Seal 2018 and MassGIS 2014 0 50 100 Feet 1:1,200 **JACOBSS Intertidal West Zone 4 Construction Site Plan** New Bedford Harbor Superfund Site October 2020 Figure 3-1

Access to the portions of Parcels 105-170 and 105-183 requiring remediation will be through private property that is currently under access agreements obtained by EPA. Temporary roads will be built to create equipment access to the remediation areas. Approximately 1,100 linear ft of temporary access roads will be constructed. The roads will be approximately 15 ft wide. A construction site plan showing the excavation areas and temporary access roads is provided as Figure 3-1. The temporary access road in the northern portion of Parcel 105-183 will traverse a patch of *Phragmites*. As described in the Generic Work Plan, the access road will be constructed using a layer of geotextile fabric covered by either 12 inches of dense-grade aggregate or construction mats, which will prevent contact between the construction vehicles using the road and the *Phragmites*. The use of aggregate or mats will be determined in the field when the roads are cleared.

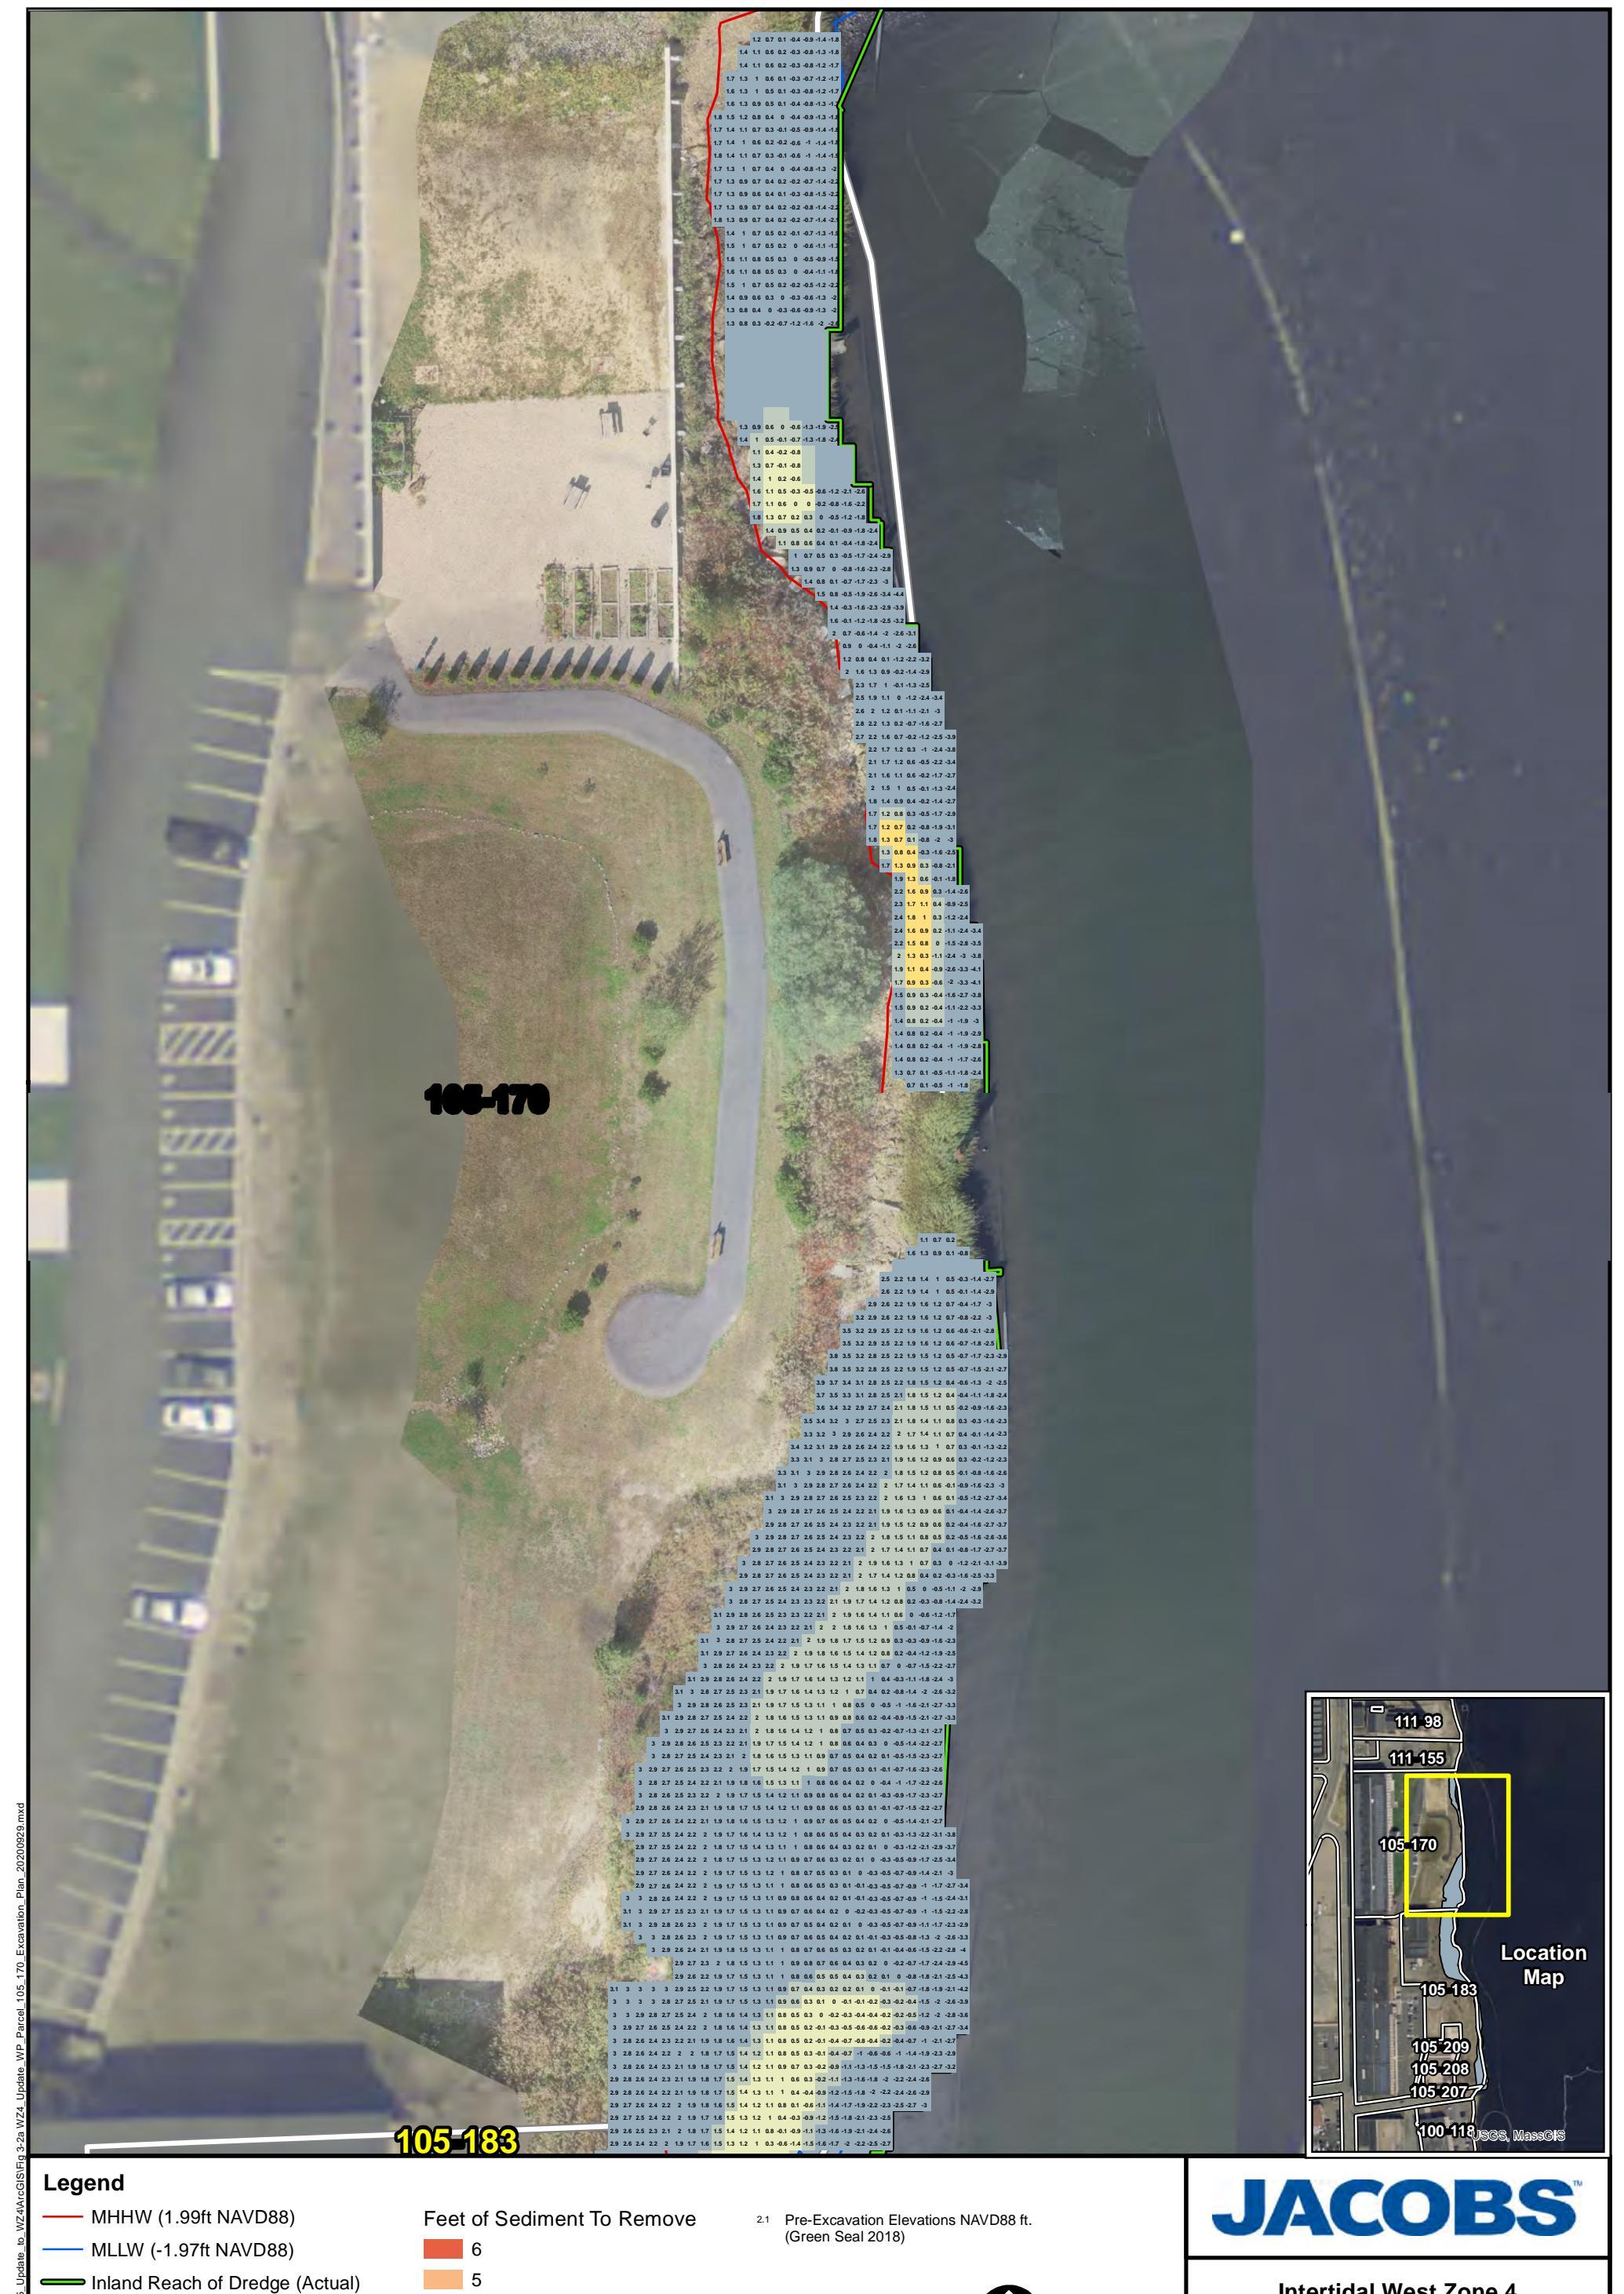
The cut depth, areal extent of contamination and pre-excavation surface elevations for the excavation areas are shown on Figure 3-2a for Parcel 105-170 and on Figures 3-2b and 3-2c for Parcel 105-183. Following WZ4 material relocation during cap construction, the total area to be excavated is approximately 45,000 square feet (sf) and has a corresponding volume of 3,200 cubic yards (cy). The eastern (seaward) edge of the excavation areas have been adjusted to match the landward extent of subtidal dredging and capping. As represented in Figures 3-2b and 3-2c, the final cap areas for L-014 and L-114 increased from the design due to the presence of unanticipated debris in the excavated West Zone 4 material. The presence of debris resulted in a greater volume of relocated material. The L-014 and L-114 cap footprints were enlarged during construction to cover the relocated contaminated material and meet the cap layer design thickness and slope requirements. The southern end of the L-014 cap and the northern and southern ends of the L-114 cap now interface with contaminated material to be removed during West Zone 4 remedial action. The excavation along this interface is not anticipated to be greater than a 1.0 ft. cut; therefore, careful excavation along this unbuffered boundary should minimally impact the cap.

Intertidal West Zone 4 Parcel 105-170 Excavation Plan Showing Cut Depths and Pre-Excavation Elevations New Bedford Harbor Superfund Site

Using PCB data collected through multiple rounds of sampling, a 3-dimensional excavation model was developed as depicted in the West Zone 4 excavation plans in Figures 3-2a, 3-2b, and 3-2c. The horizontal and vertical extents of the excavations include all sample locations with total PCB concentrations exceeding TCLs (for non-mudflat locations), and mudflat locations with PCB concentrations exceeding the subtidal/mudflat remedial action level (RAL) of 30 mg/kg.¹ All of the 0-1 ft samples outside of the excavation areas have total PCB concentrations below 25 mg/kg except for WS408 in Parcel 105-170 (Figure 2-3a). The After-Action Report for WZ4 will include

the calculated 95UCL for these parcels and document that it complies with the ROD's TCL. The vertical extent of contamination was not delineated at four locations on Parcel 105-183 as follows:

- INT239, INT240, and INT243: the maximum coring depth was 5 ft at these locations; the excavation depths will extend to 6 ft.
- S-3849: the maximum coring depth was 3 ft at this location; the excavation depth will extend to 4 ft.

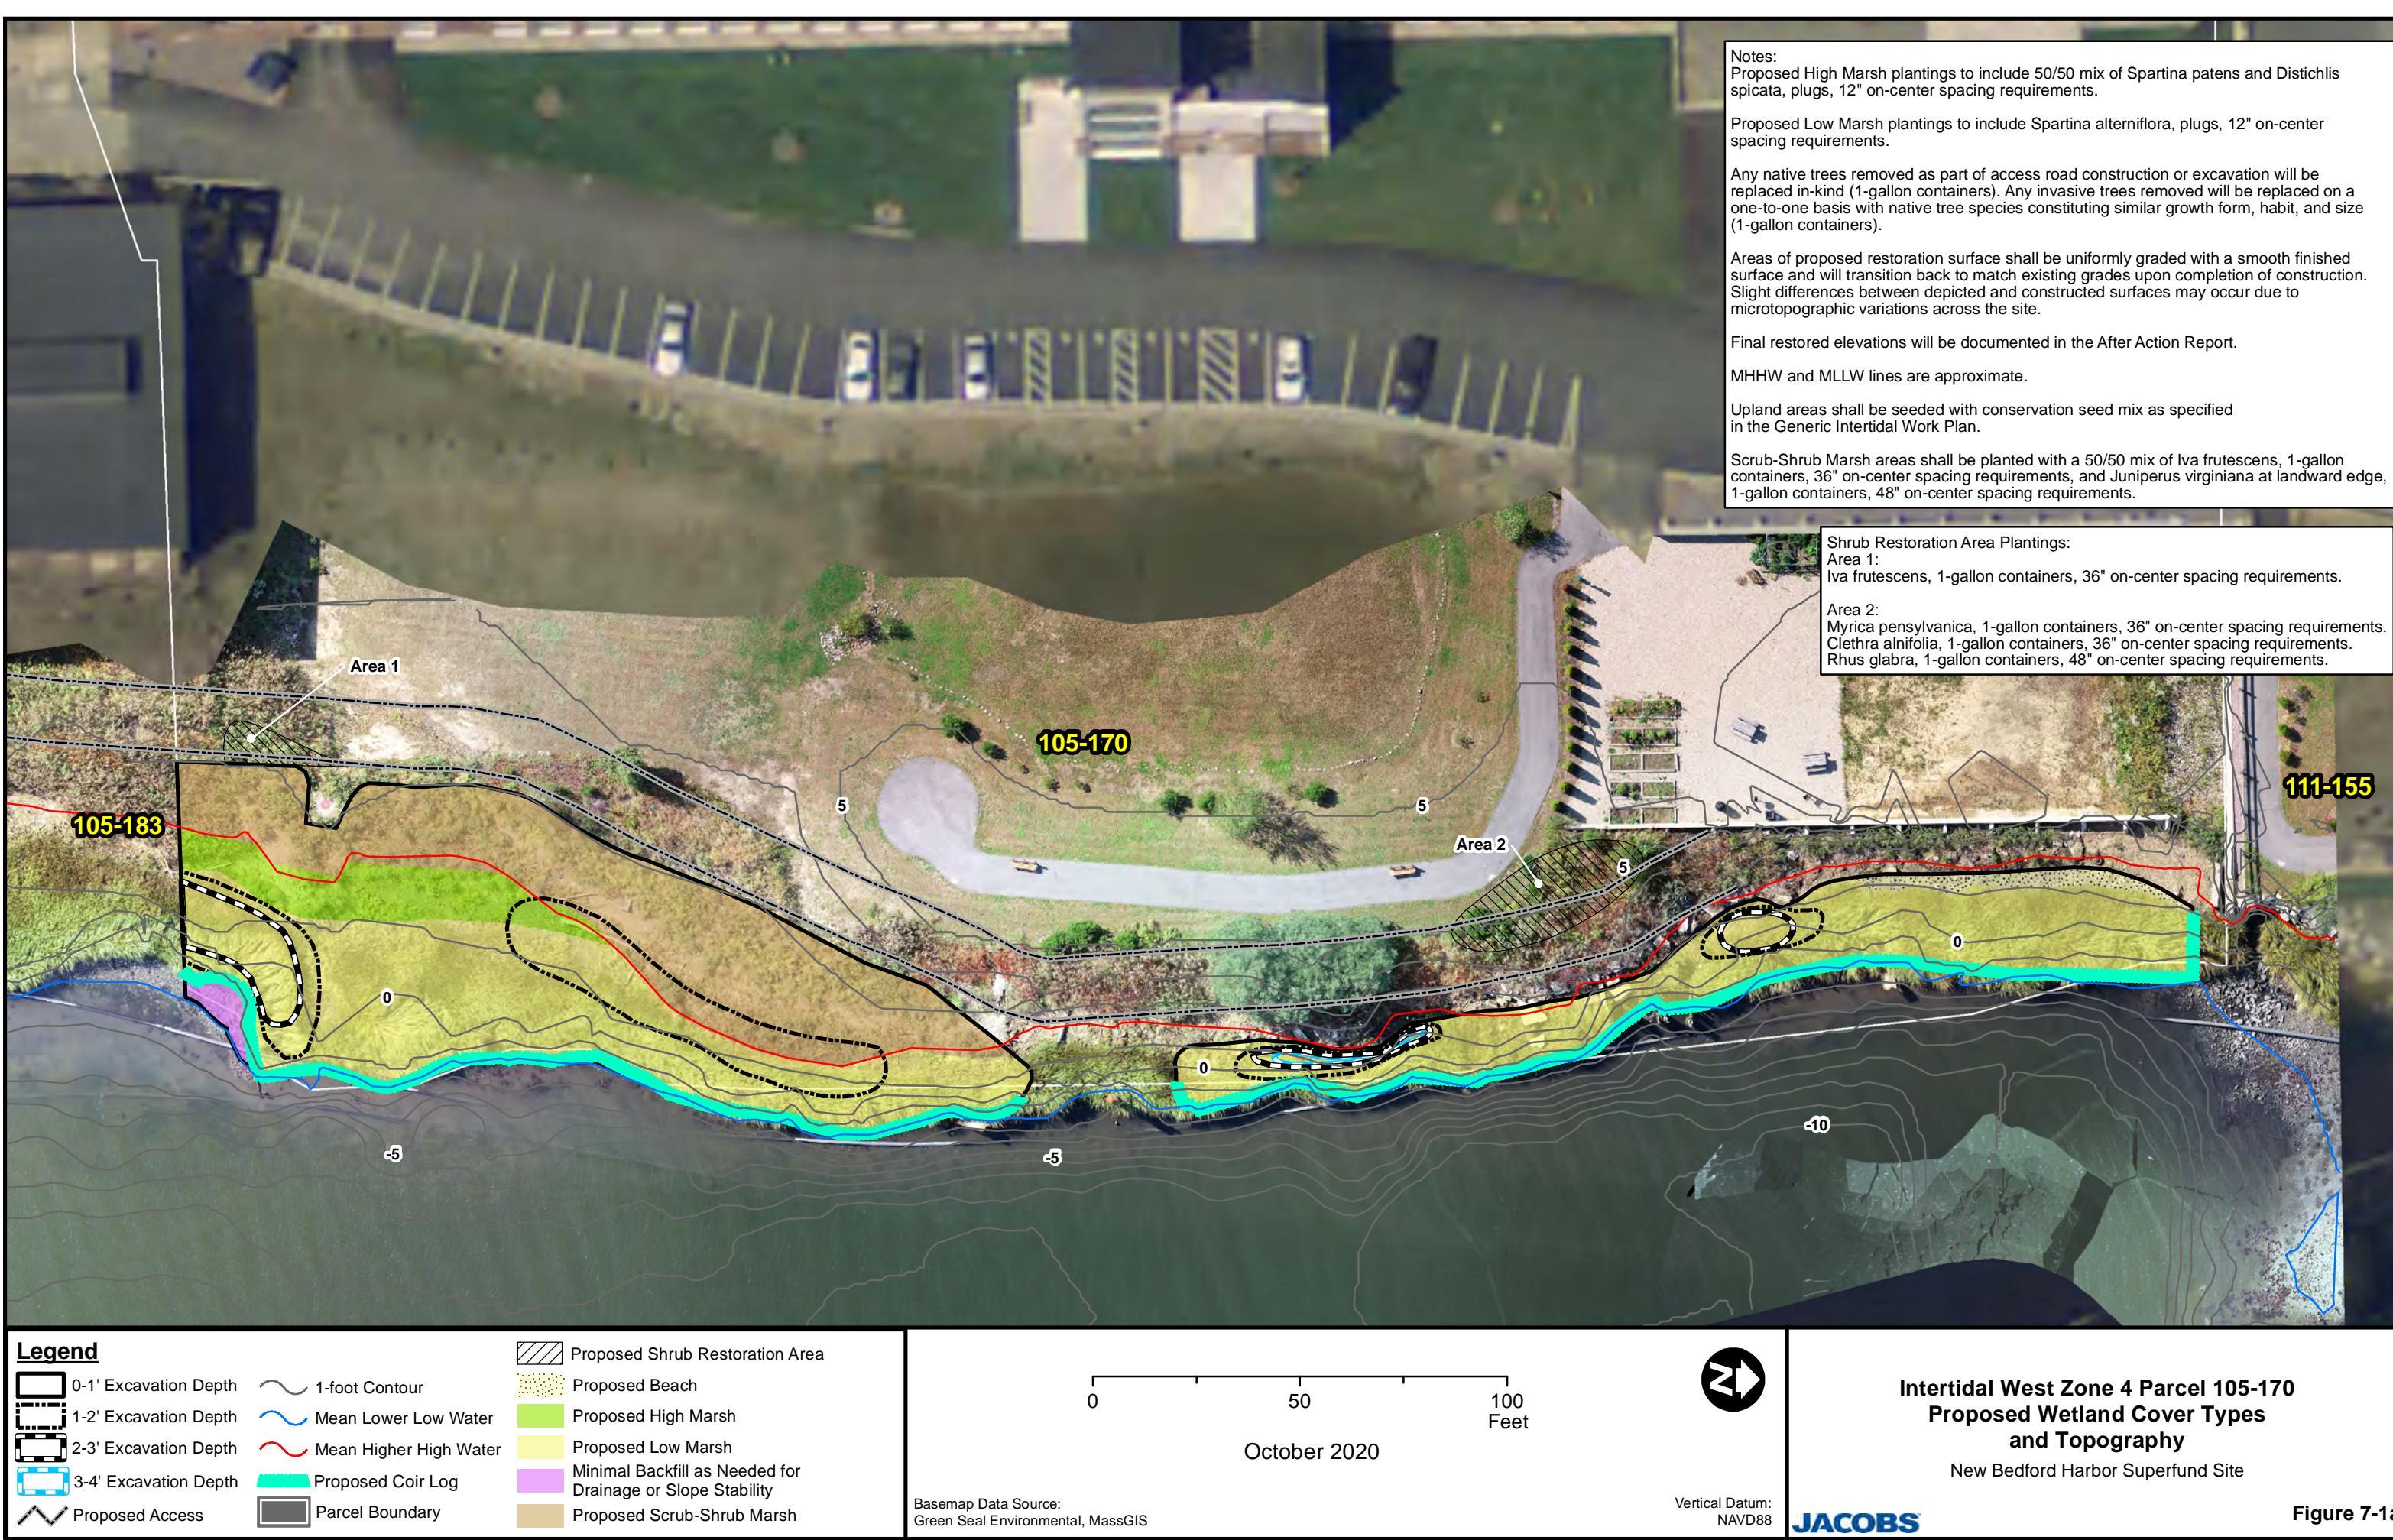
Proposed restored vegetation types within the remediation areas are shown in plan view in Figure 7-1a and Figure 7-1b. A conceptual cross section is provided in Figure 7-2 and construction cross sections are provided in Appendix B. Tree and shrub species identified for restoration are included in the planting notes included in Figures 7-1a and 7-1b. The existing and proposed post-restoration acreages of each cover type are included in Tables 7-1a and 7-1b and shrub restoration area summaries are provided in Tables 7-2a and 7-2b. Areas to be restored as upland within the backfilled excavations on Parcel 105-183 will be seeded with the coastal salt-tolerant seed mix shown in Table 7-3. As depicted in Figures 7-1a and 7-1b, coir logs will run the entire length of the excavated areas on the seaward edge of the restored low marsh along both Parcels 105-170 and 105-183.

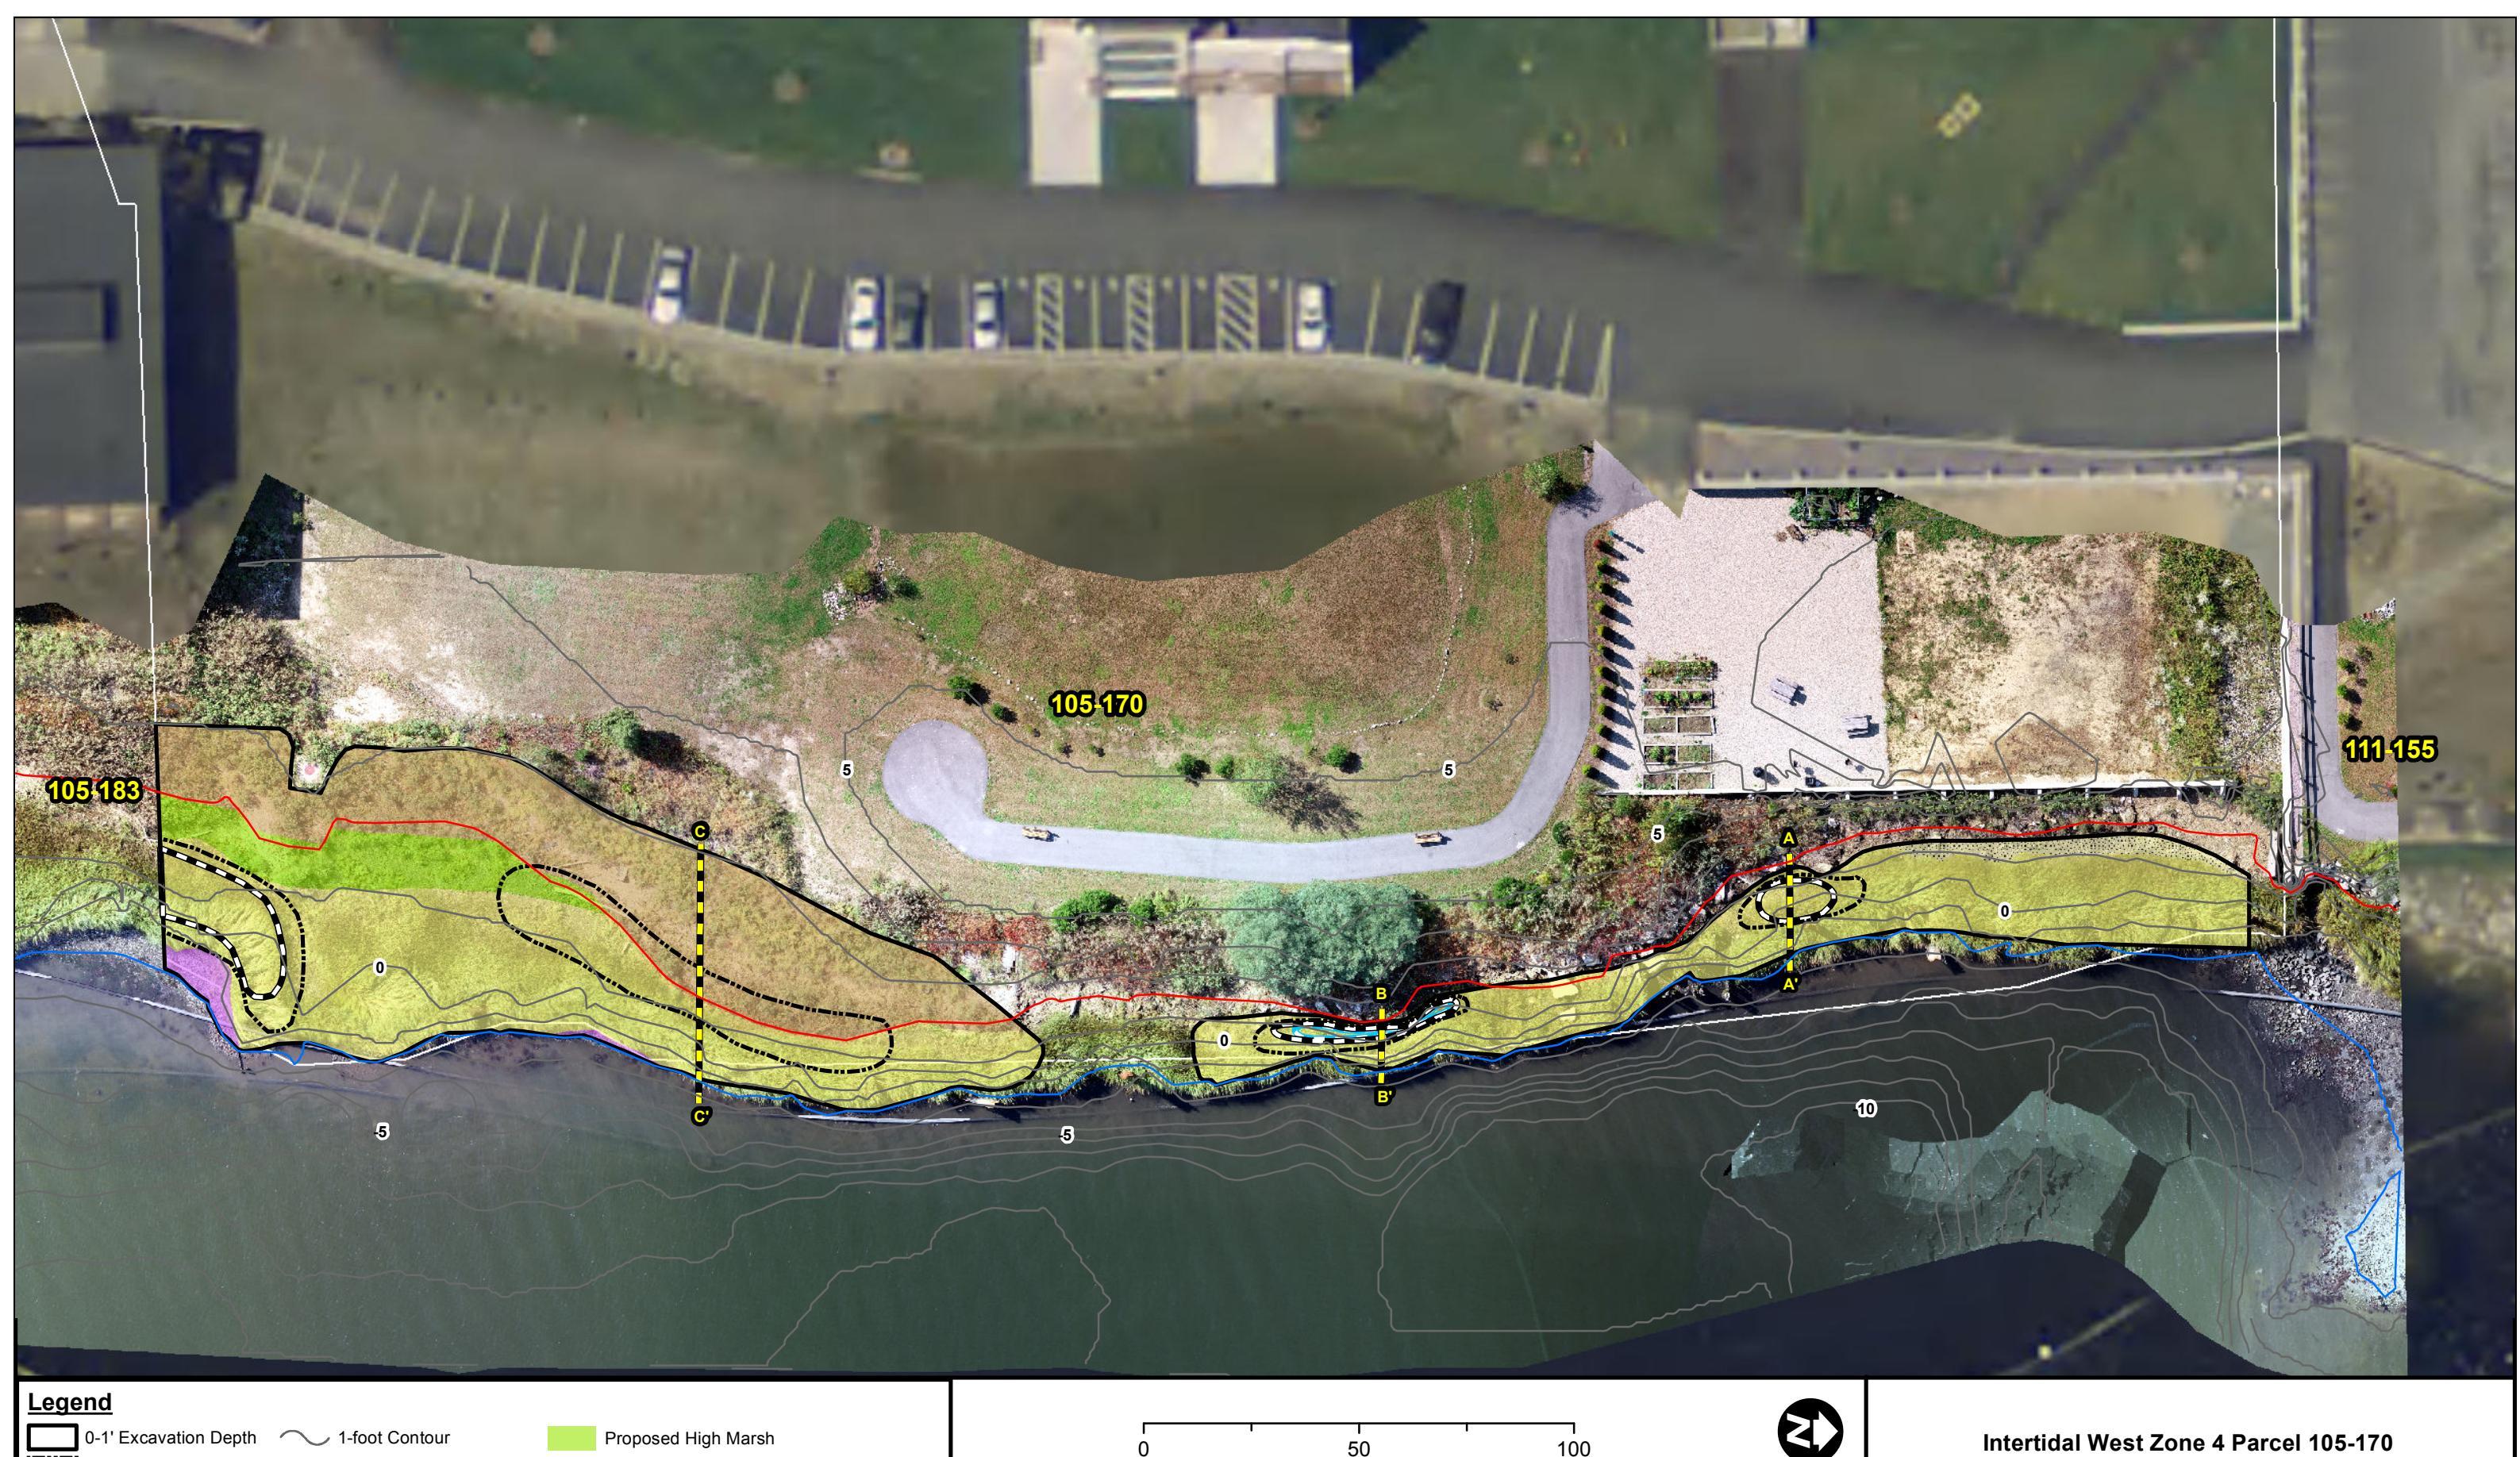
Intertidal West Zone 4 Parcel 105-170 **Cross Section Locations** New Bedford Harbor Superfund Site
