FOURTH FIVE-YEAR REVIEW REPORT

Avtex Fibers Superfund Site Front Royal, Warren County, Virginia

U.S. Environmental Protection Agency

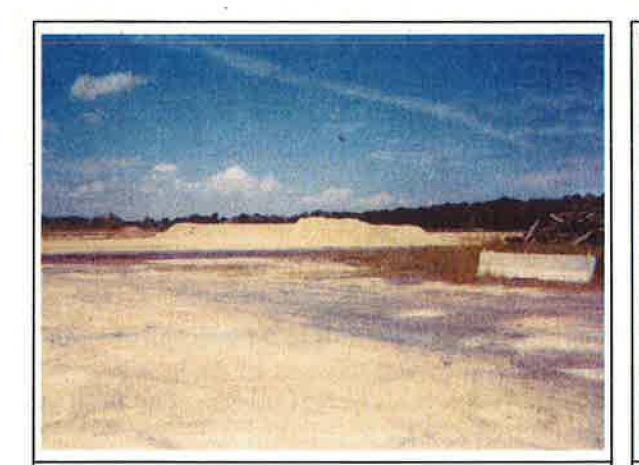
Photo 1: Plant Area (09-05-12) Latitude: not available Longitude: not available Description: Ponded Water (background left)

No action required.

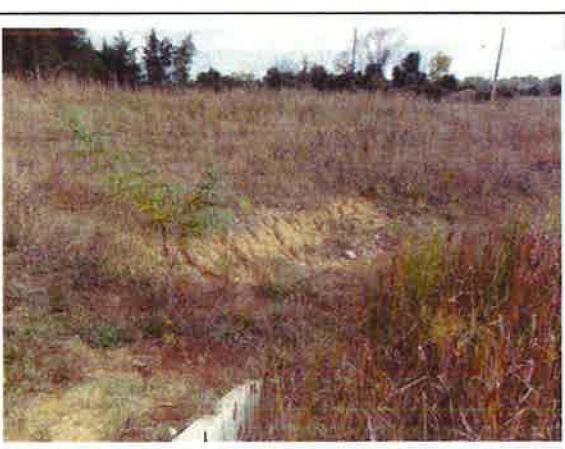
Photo 2: Storm Water Basin West (10-24-12) Latitude: 38.9221 Longitude: -78.21004 Description: Erosion Gullies North Side of Basin

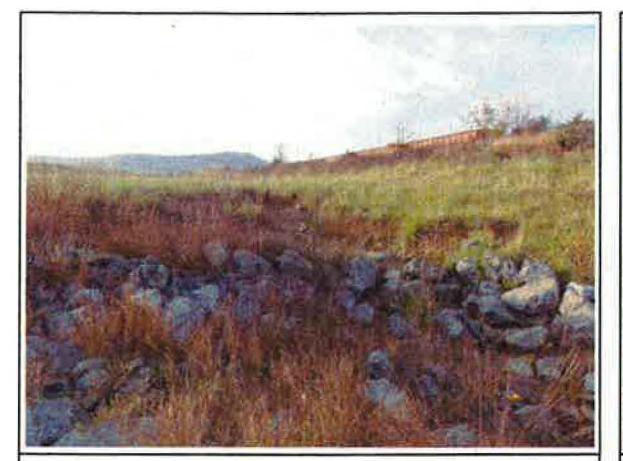
The **Storm Water Basin East** drains approximately 50 acres in the adjacent area east of the railroad tracks. Moderate bank erosion was occurring along the basin inlet, and erosion gullies approximately 1 to 2 feet in depth were present northeast of basin (**Photos 3 & 4**). The erosion is being addressed under the O&M Plan.

Photo 3: Storm Water Basin East (10-23-12) Latitude: 38.9221 Longitude: -78.21543 Description: Bank Erosion along Basin Inlet

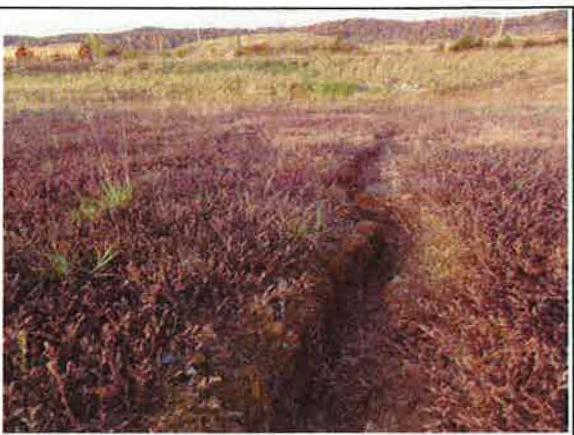
Photo 4: Storm Water Basin East (10-23-12) Latitude: 38.9221 Longitude: -78.21543 Description: Erosion Gullies North of Basin

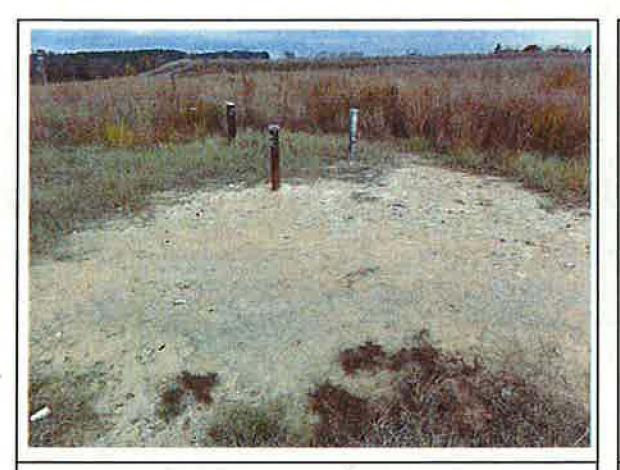
Viscous Basin 1 (VB-1) is located to the west of Viscous Basins 2 & 3, just east of the historical wastewater treatment plant. VB-1 is predominantly well vegetated, but warm season grasses are less dense than VB 2 and 3. The north slope has small areas of unstable soils that are sparsely vegetated. A 40 foot by 40 foot area adjacent to monitoring wells MW-11 and 135 is void of vegetation with an adjacent area of stressed vegetation; white residue (assumed to be salts) are evident (**Photos 5 & 6**). The soils and vegetation are being addressed under the O&M Plan. All gas vents were inspected visually and appeared to be in good condition. Some were slightly out of vertical.

Photo 5: VB-1 (10-23-12) Latitude: 38.92883 Longitude: -78.21479 Description: Bare ground / Stressed Vegetation

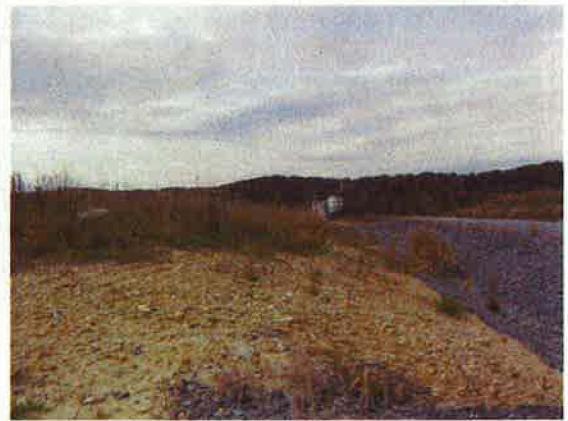
Photo 6: VB-1 (10-23-12) Latitude: 38.92968 Longitude: -78.21398 Description: North slope with sparse to no vegetation

• No action required. -

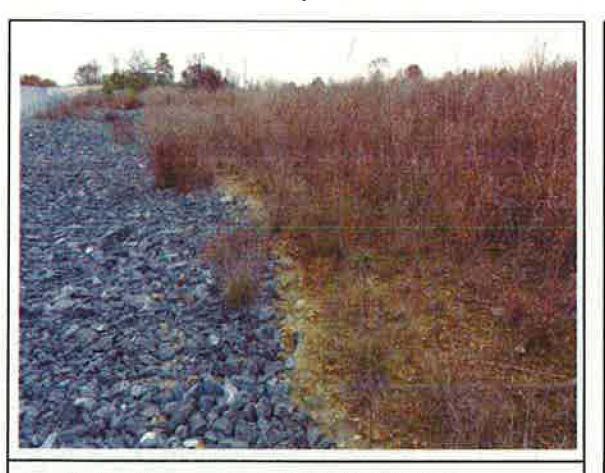
Viscous Basins 2 and 3 (VB-2 & VB-3) are located to the east of Viscous Basins 1. VB-2 and VB-3 are predominantly well vegetated, however, the north facing slopes and north west corner show evidence of unstable soils with sparse to no vegetation along the rip rap channel (Photos 7 and 8). The unstable soils and vegetation are being addressed under the O&M Plan. All gas vents were inspected visually and appeared to be in good condition. Some wells were slightly out of vertical and some were not labeled.

Photo 7: Viscous Basin 2 & 3 (10-23-12) Latitude: 38.92993 Longitude: -78.213 Description: Unstable soils with sparse to bare vegetation

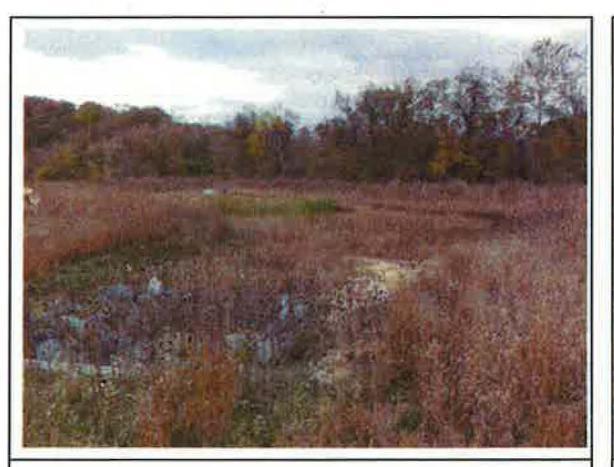
Photo 9: Viscous Basin 4, 5 & 6 (10-23-12) Latitude: 38.92944 Longitude: -78.21538 Description: NW corner Storm water pond. Assumed to be salt

No action required.

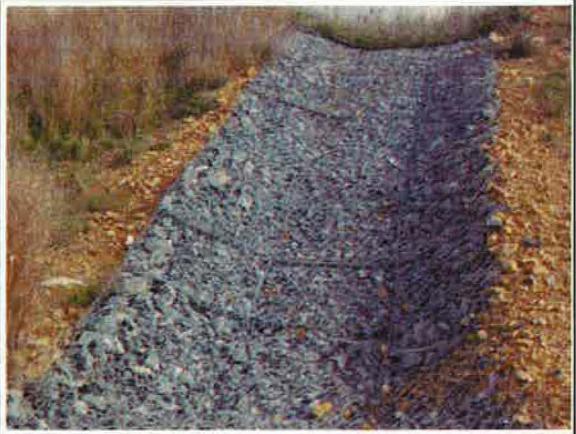
Photo 10: Viscous Basin 4, 5, and 6 (10-23-12) Latitude: 38.92959 Longitude: -78.21513 Description: Flume #3. Unstable soil

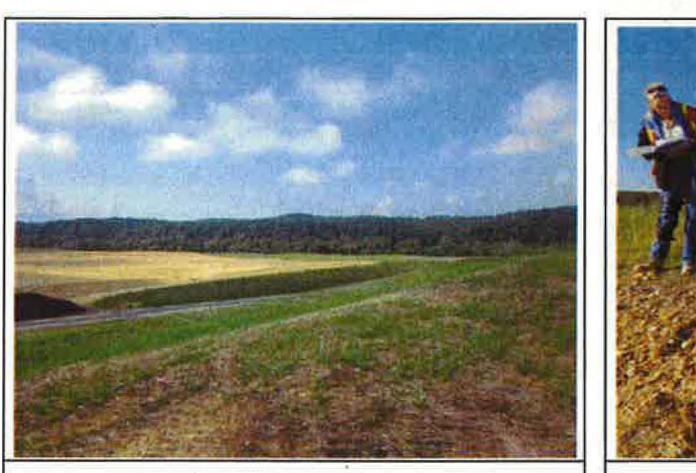
The New Landfill and Sediment Basin #2 are located to the east of Viscous Basins 7 & 8 and north of Ditch #10. The New Landfill was recently capped in May 2012 and seeded in June 2012. Vegetation is being established (Photo 11), although there are some areas of unstable soils contributing to minor rill erosion (Photo 12). Routine erosion monitoring and closure care maintenance including soil amendment/stabilization, erosion repair and reseeding as necessary is being performed under the O&M Plan. All gas vents were inspected visually and appeared to be in good condition. Some were slightly out of vertical. Sediment Basin #2 is well vegetated with wetland plants and in good condition.

Photo 11: New Landfill (8-21-12) Latitude: not available Longitude: not available Description: Vegetation being established on New

Landfill

No action required.

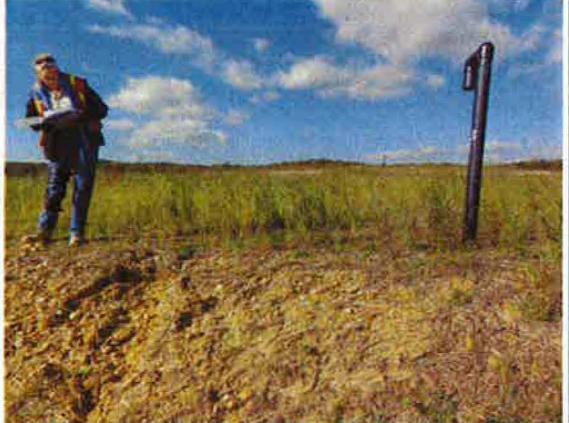
Photo 12: New Landfill (10-17-12) Latitude: not available Longitude: not available Description: Minor unstable soil & rill erosion on slopes

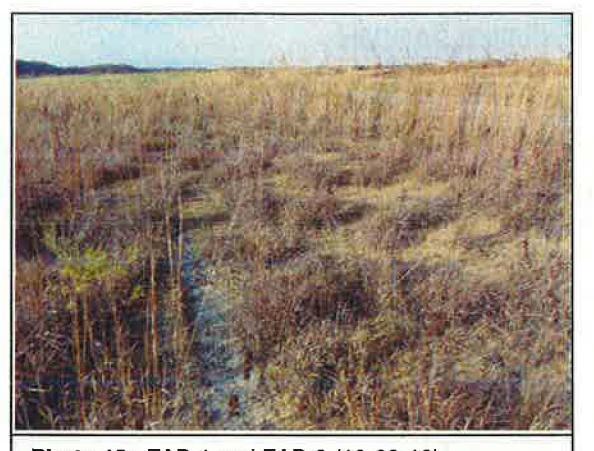
Photo 13: FAB-1 and FAB-2 (10-23-12) Latitude: 38.92272 Longitude: -78.21169 Description: Area of sparse vegetation along road.

No action required.

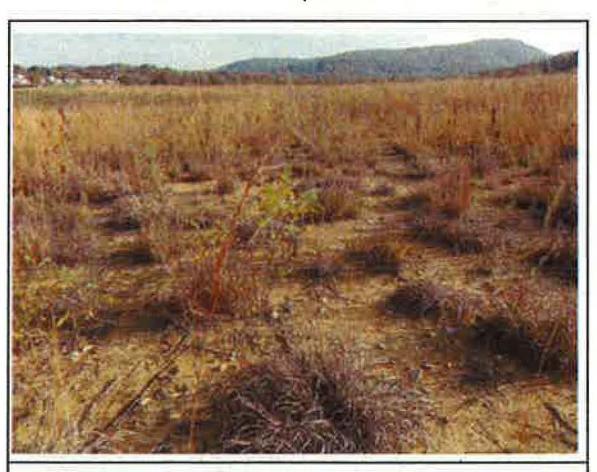
Fly Ash Basin 3 (FAB-3) is located to the west of the former Fly Ash Stockpile and south of Viscose Basin 9. The basin has generally sparse vegetation (**Photos 14 and 15**), and a small ponded depression area (**Photos 16 and 17**) was observed; these will be addressed under the O&M Plan. Sump SB-3-1 was located but not opened; no visual evidence of problems.

Photo 14: FAB-3 (10-23-12) Latitude: 38.92363 Longitude: -78.21277 Description: Sparse Vegetation

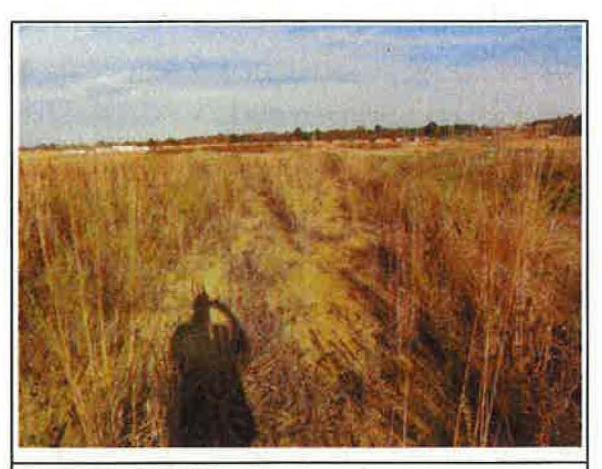
Photo 15: FAB-3 (10-23-12) Latitude: 38.92307 Longitude: -78.21281 Description: Sparse Vegetation

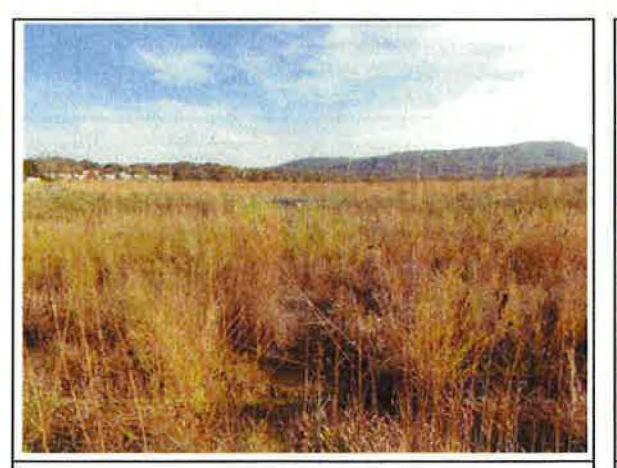
Photo 16: FAB-3 (10-23-12) Latitude: 38.92325 Longitude: -78.21267 Description: Small ponded area

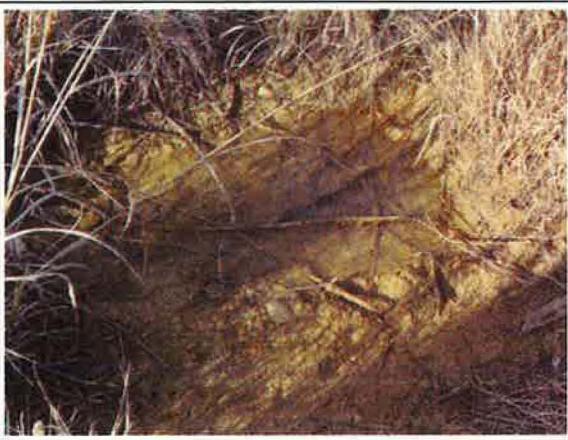
Photo 17: FAB-3 (10-23-12) Latitude: 38.92321 Longitude: -78.21262 Description: Close-up of ponded depression area

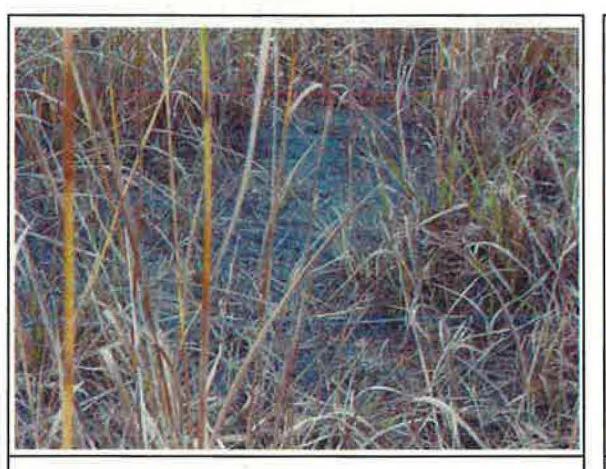
Photo 18: FAB-6 (10-23-12) Latitude: 38.91957 Longitude: -78.21115 Description: Sparse vegetation & exposed TRM matting along ditch

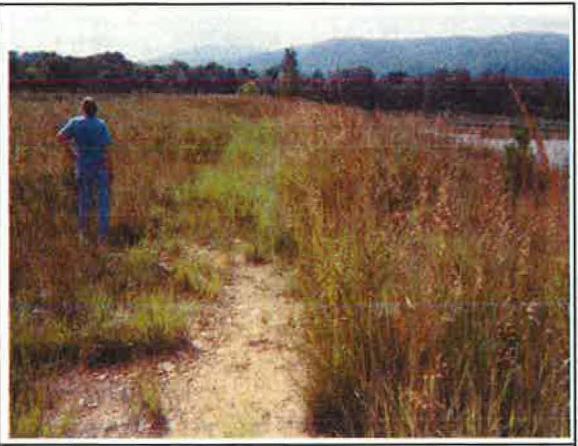
Photo 19: FAB-6 (09-05-12) Latitude: not available Longitude: not available Description: Sparse to bare vegetation along access road

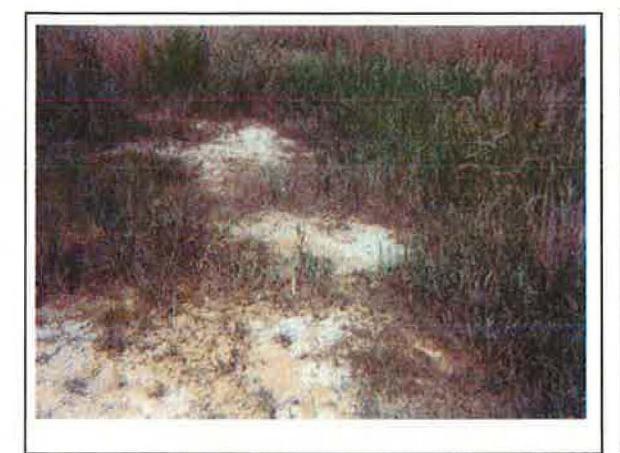
Photo 20: FAS (09-05-12) Latitude: not available Longitude: not available Description: Salt in salt impacted area

• No action required.

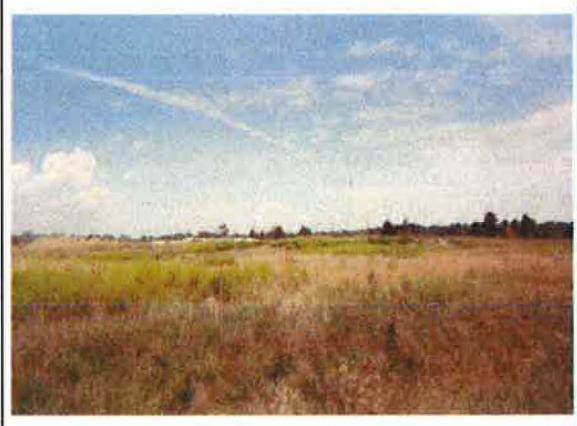
Photo 21: FAS (09-05-12) Latitude: not available Longitude: not available Description: Vegetation in salt impacted area.

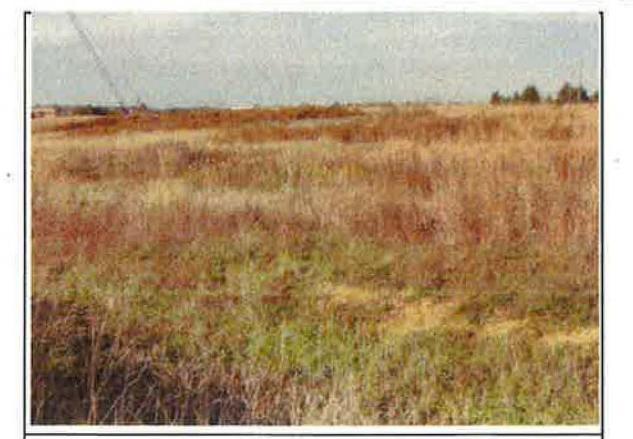
Photo 22: FAB-3 (10-23-12) (DSC00159) Latitude: 38.92268 Longitude: -78.21148 Description: Sparse vegetation along ditch.

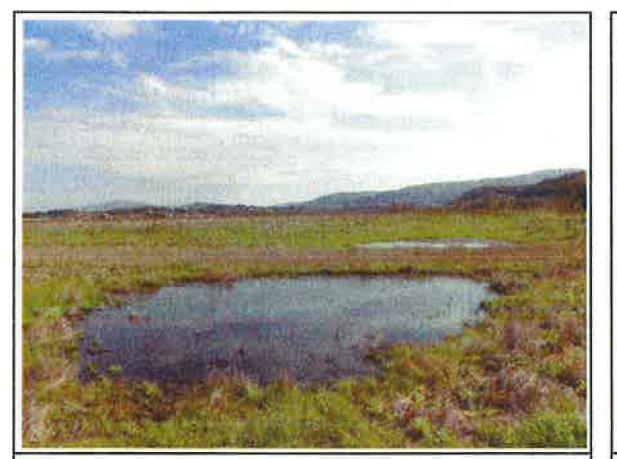
It is also noted that portions of the covers installed on SB 1, SB 3 and SB 4 have experienced differential settlement to a degree that will require significant repairs. These cover repairs are expected to be performed in 2013.

Photo 23: SB-1, Cell 3 Latitude: 38.92618 Longitude: -78.21802 Description: Surface water ponding. Settlement

- 1. Closure of Polishing Basin 1 and 2, which is scheduled for 2013.
- 2. Closure of the Emergency Lagoon, which is scheduled for 2013.
- 3. Repair of the covers on SB1, 3, and 4, which is scheduled for 2013.

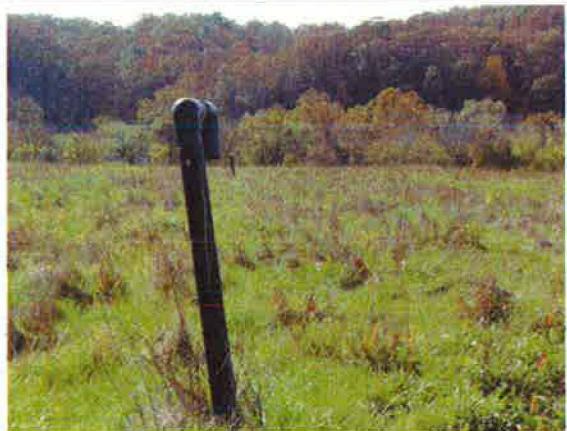
Photo 24: SB-1, Cell 4 Latitude: 38.92699 Longitude: -78.21604 Description: Gas Vent (GV25) tilting south

• No further action required.
