Draft Final Institutional Control Implementation and Assurance Plan Operable Unit 6 Libby Asbestos Superfund Site Libby, Montana

March 2021

#### BNSF Railway Company 800 North Last Chance Gulch

KJ Project No. 2149206.00

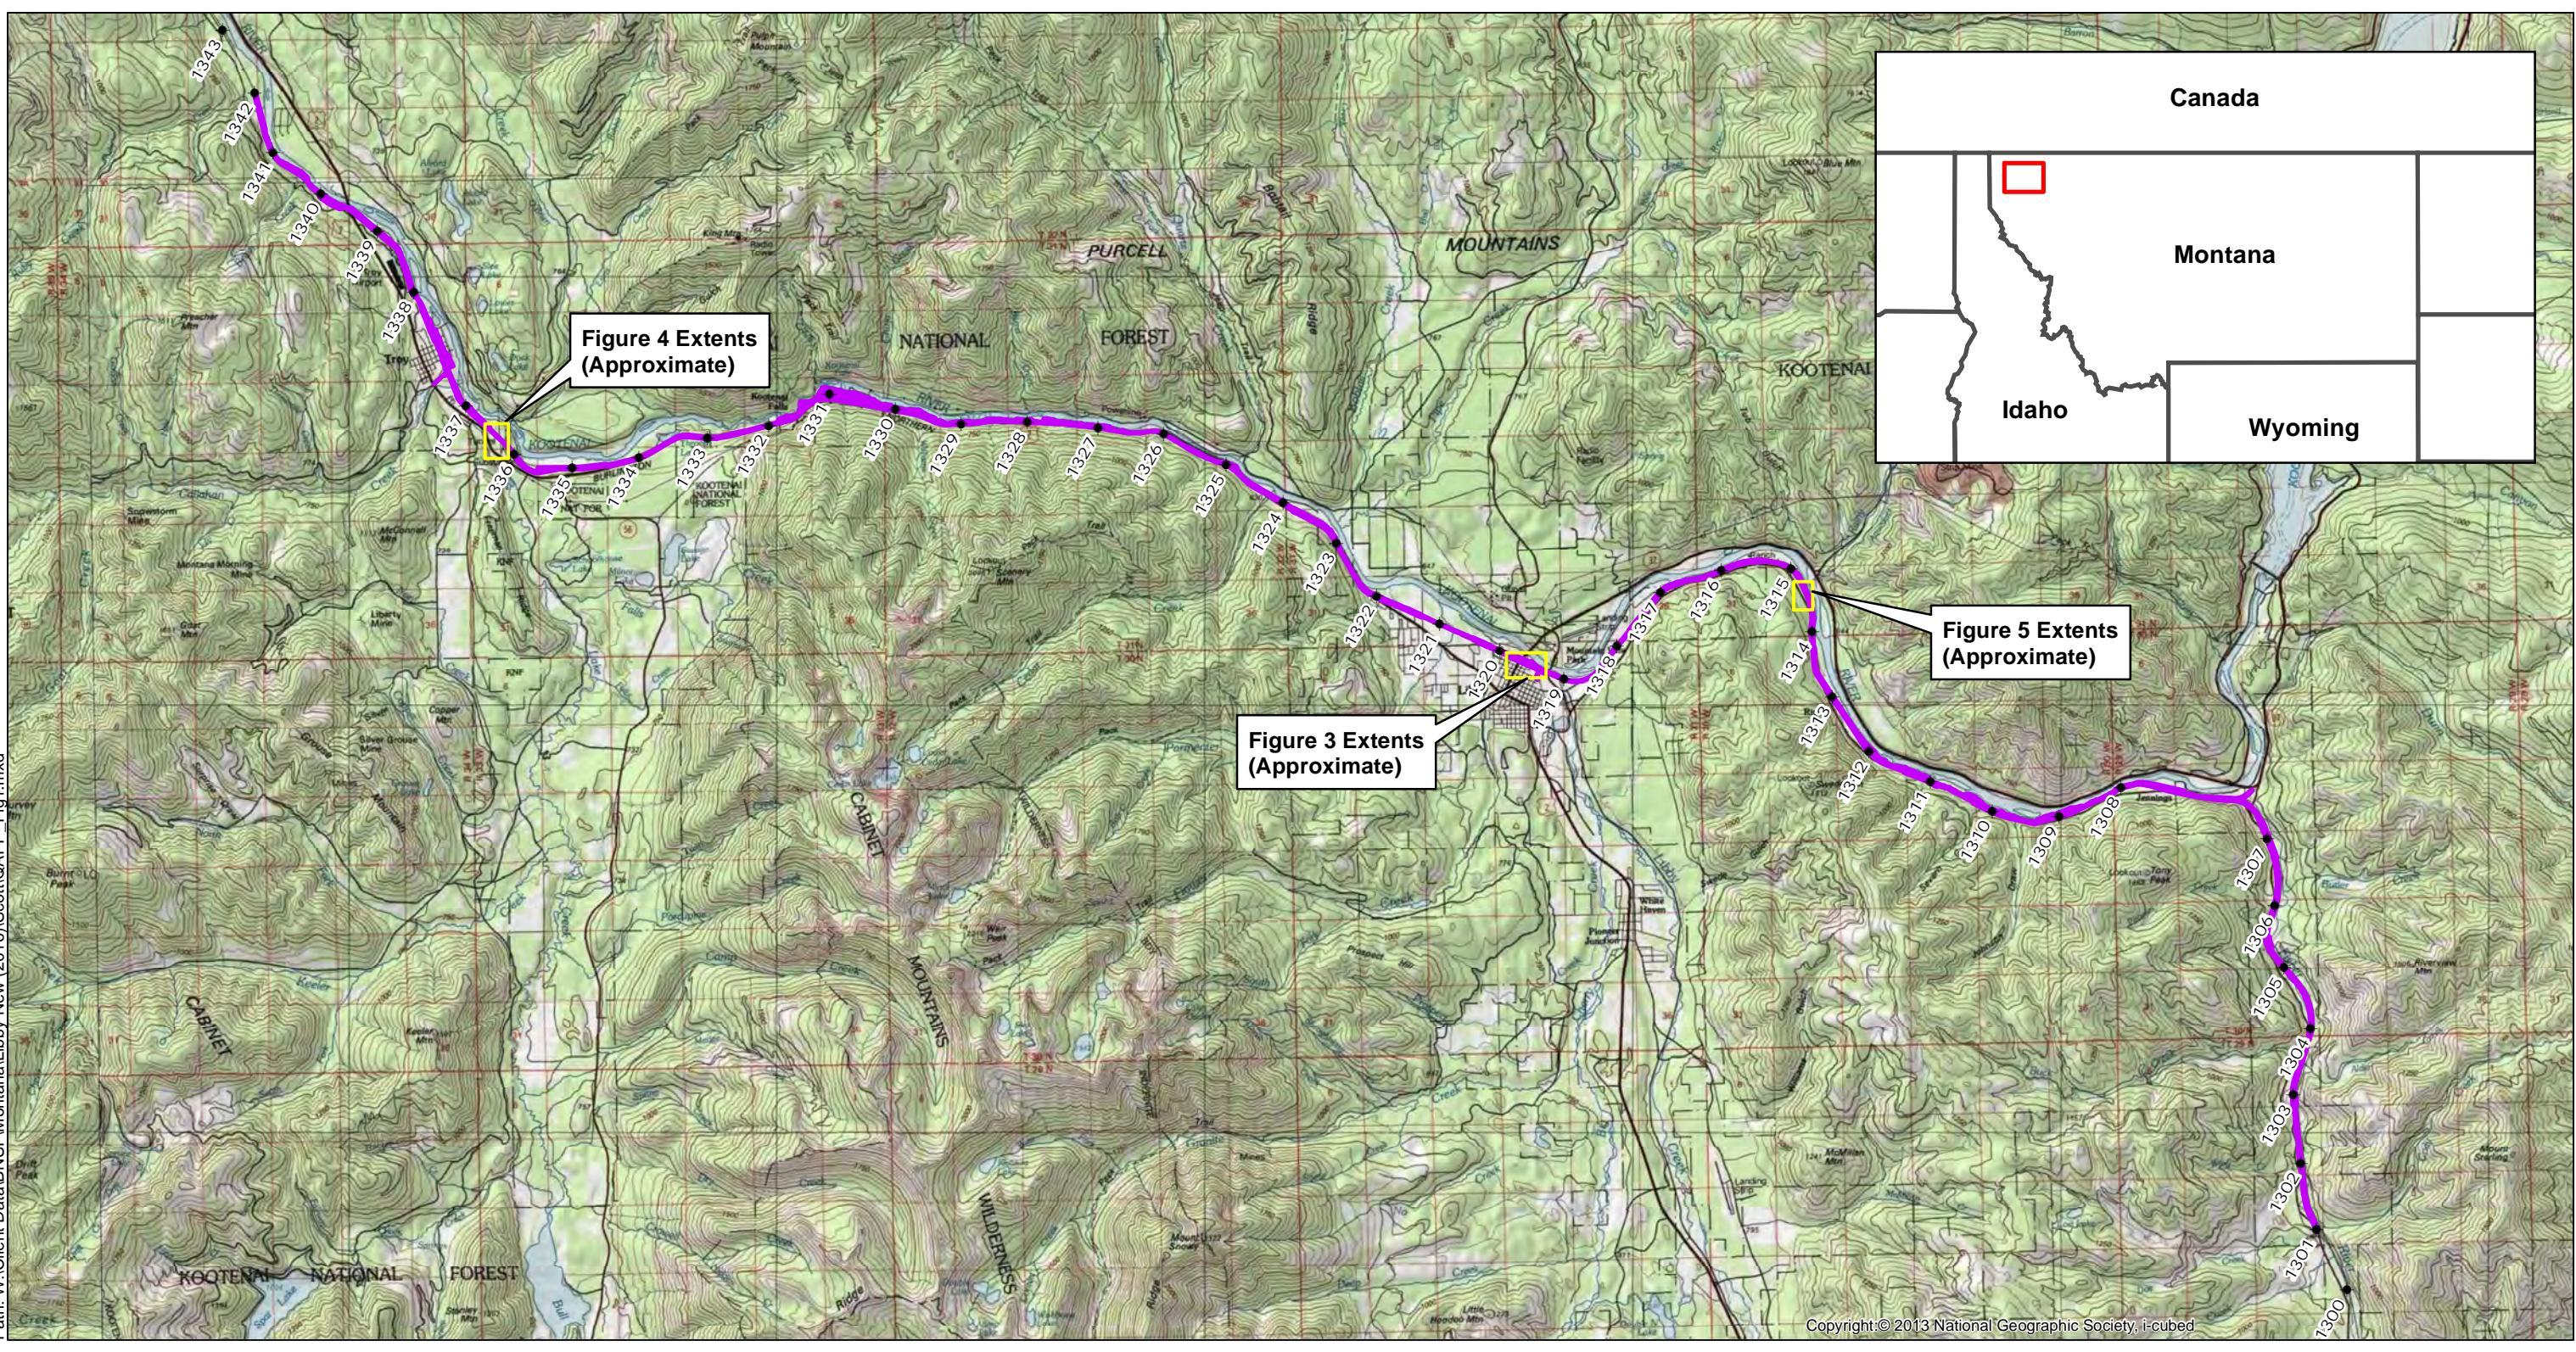
Figure 1

The Libby Asbestos Superfund Site (Superfund Enterprise Management System #MT0009083840) (Libby Asbestos Site) is located within and around the City of Libby and Town of Troy, Montana. Libby is the county seat of Lincoln County and lies in the northwestern corner of Montana, approximately 35 miles east of Idaho and 65 miles south of Canada. Libby and Troy lie in a valley carved by the Kootenai River and framed by the Cabinet Mountains to the south. The site location is shown on Figure 1.

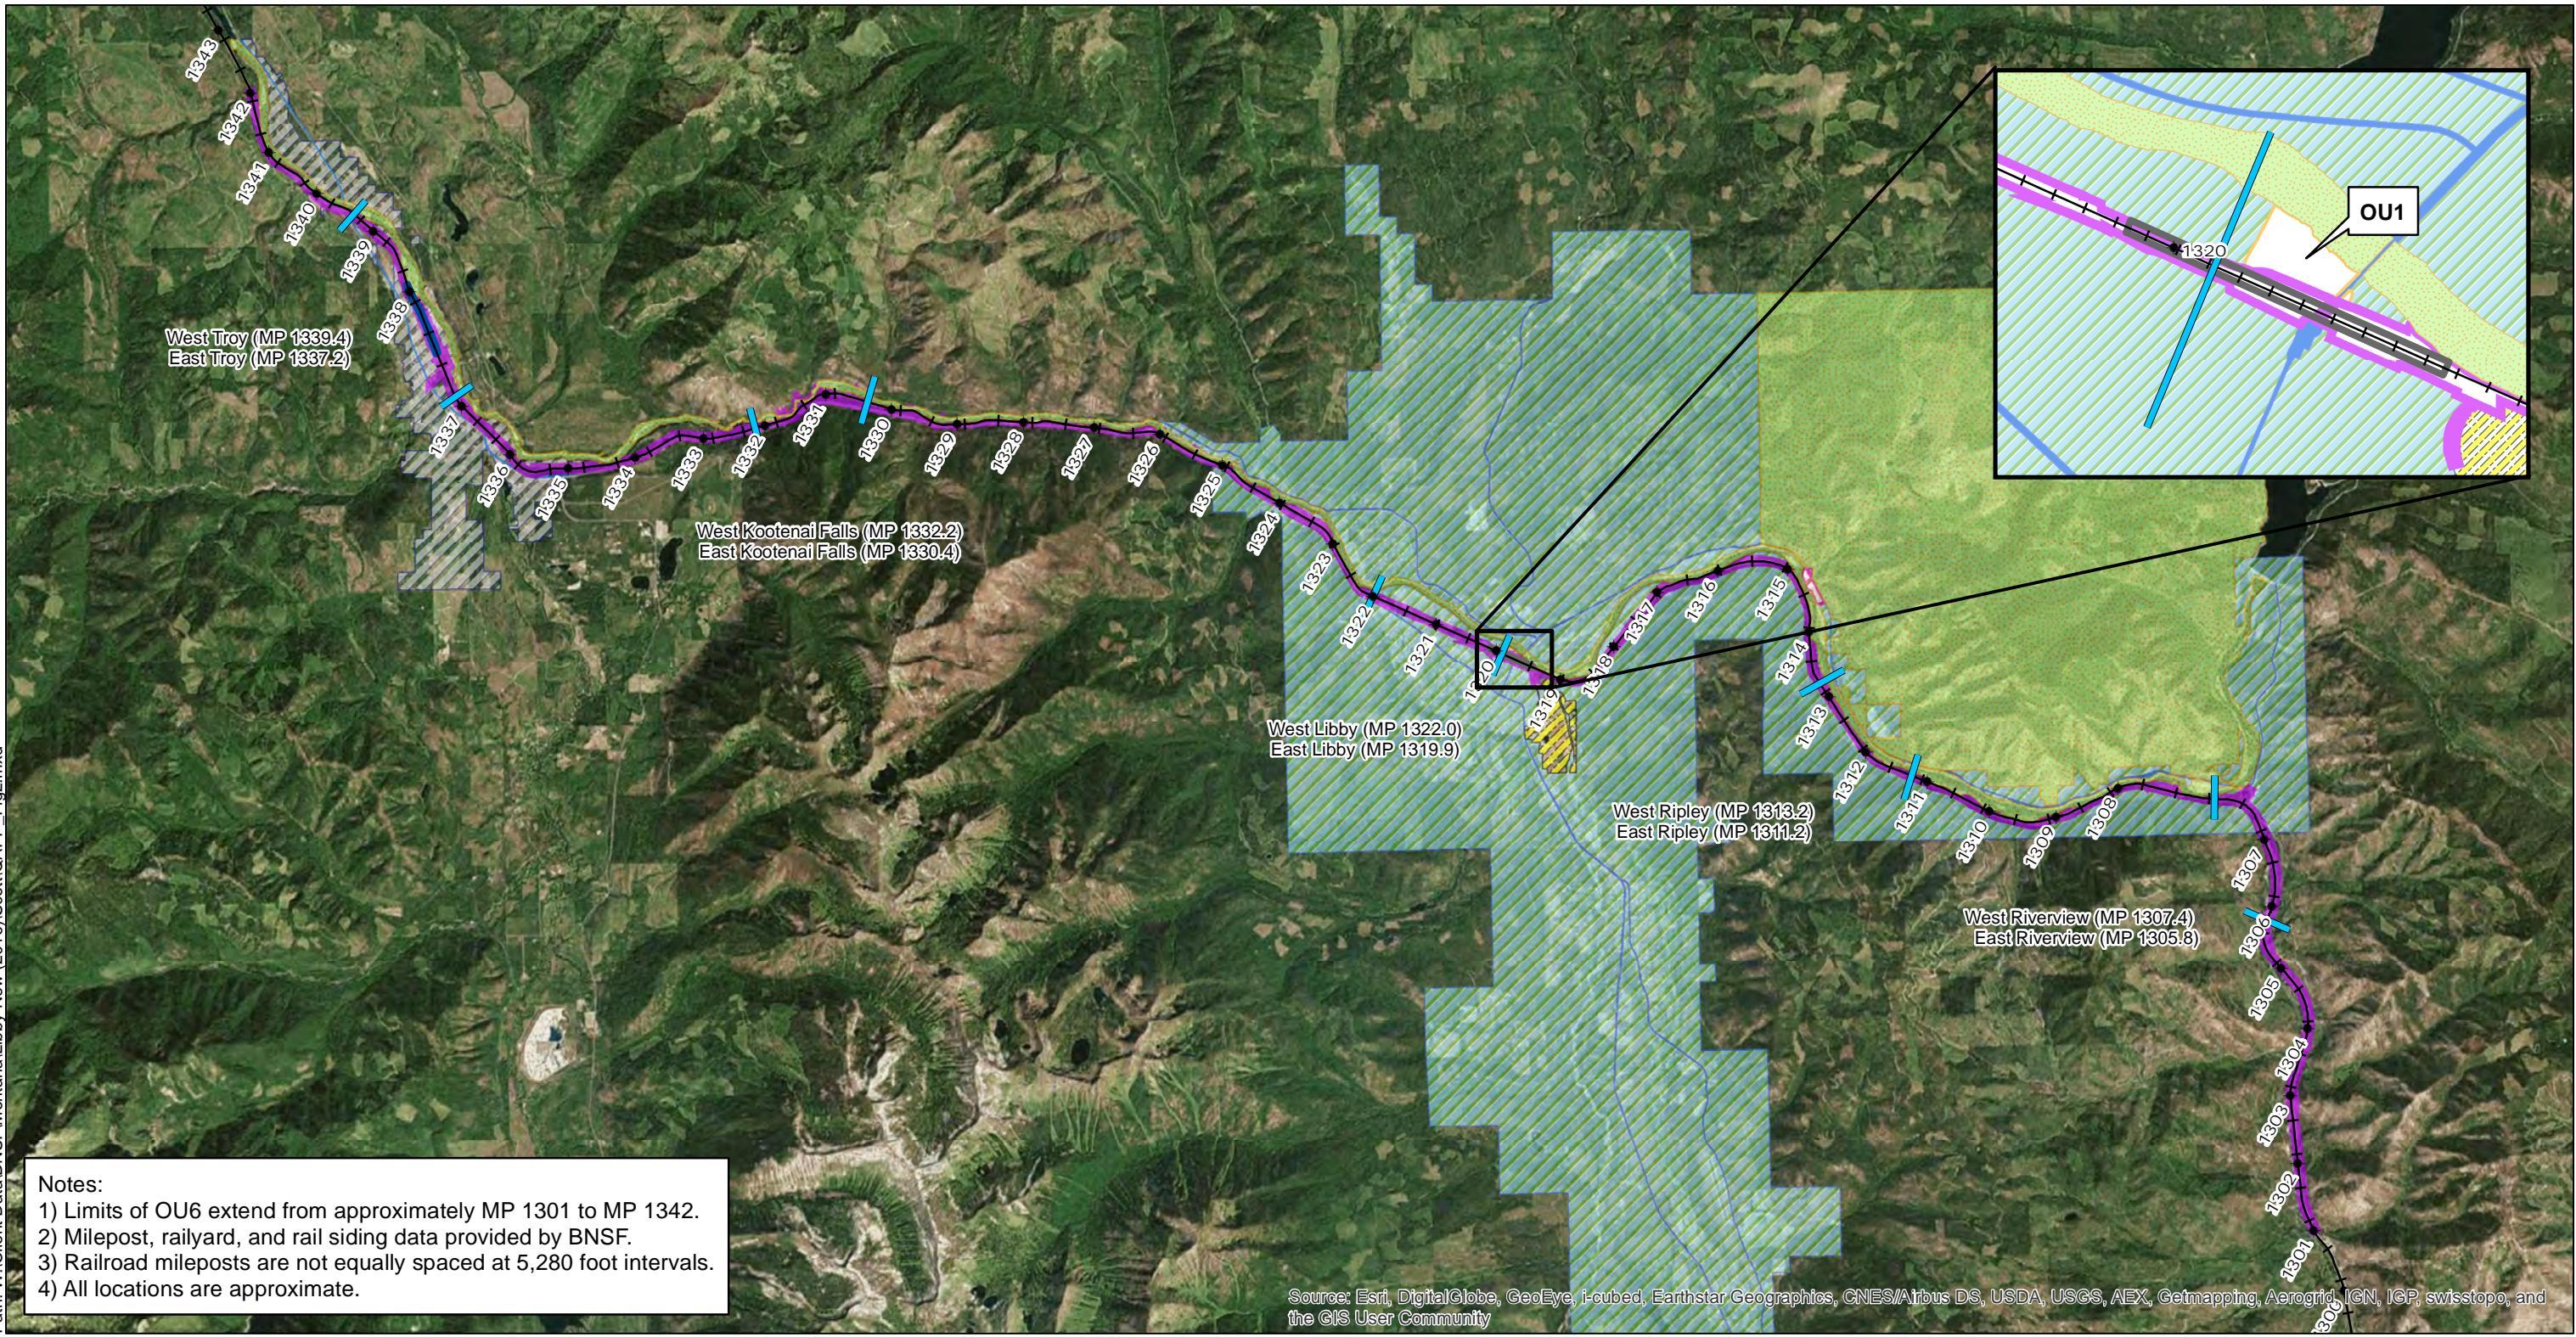
The EPA initiated an emergency response action in November 1999 to address questions and concerns raised by citizens of the City of Libby regarding possible exposures to asbestos fibers as a result of historical mining, processing, and exportation of asbestos-containing vermiculite. To facilitate a multi-phase approach to remediation of the Libby Asbestos Site, eight separate OUs were established. These OUs are shown on Figure 2 and are described by the EPA as follows (EPA 2016a):

As discussed in Section 2.1, OU6 extends from the limits of OU4 on the east to the limits of OU7 on the west. In railroad terms, OU6 extends from BNSF milepost (MP) 1301 (east) to MP 1342 (west) of BNSF's Kootenai River Subdivision. The extent of OU6, and its relationship to other OUs, are shown on Figure 2.

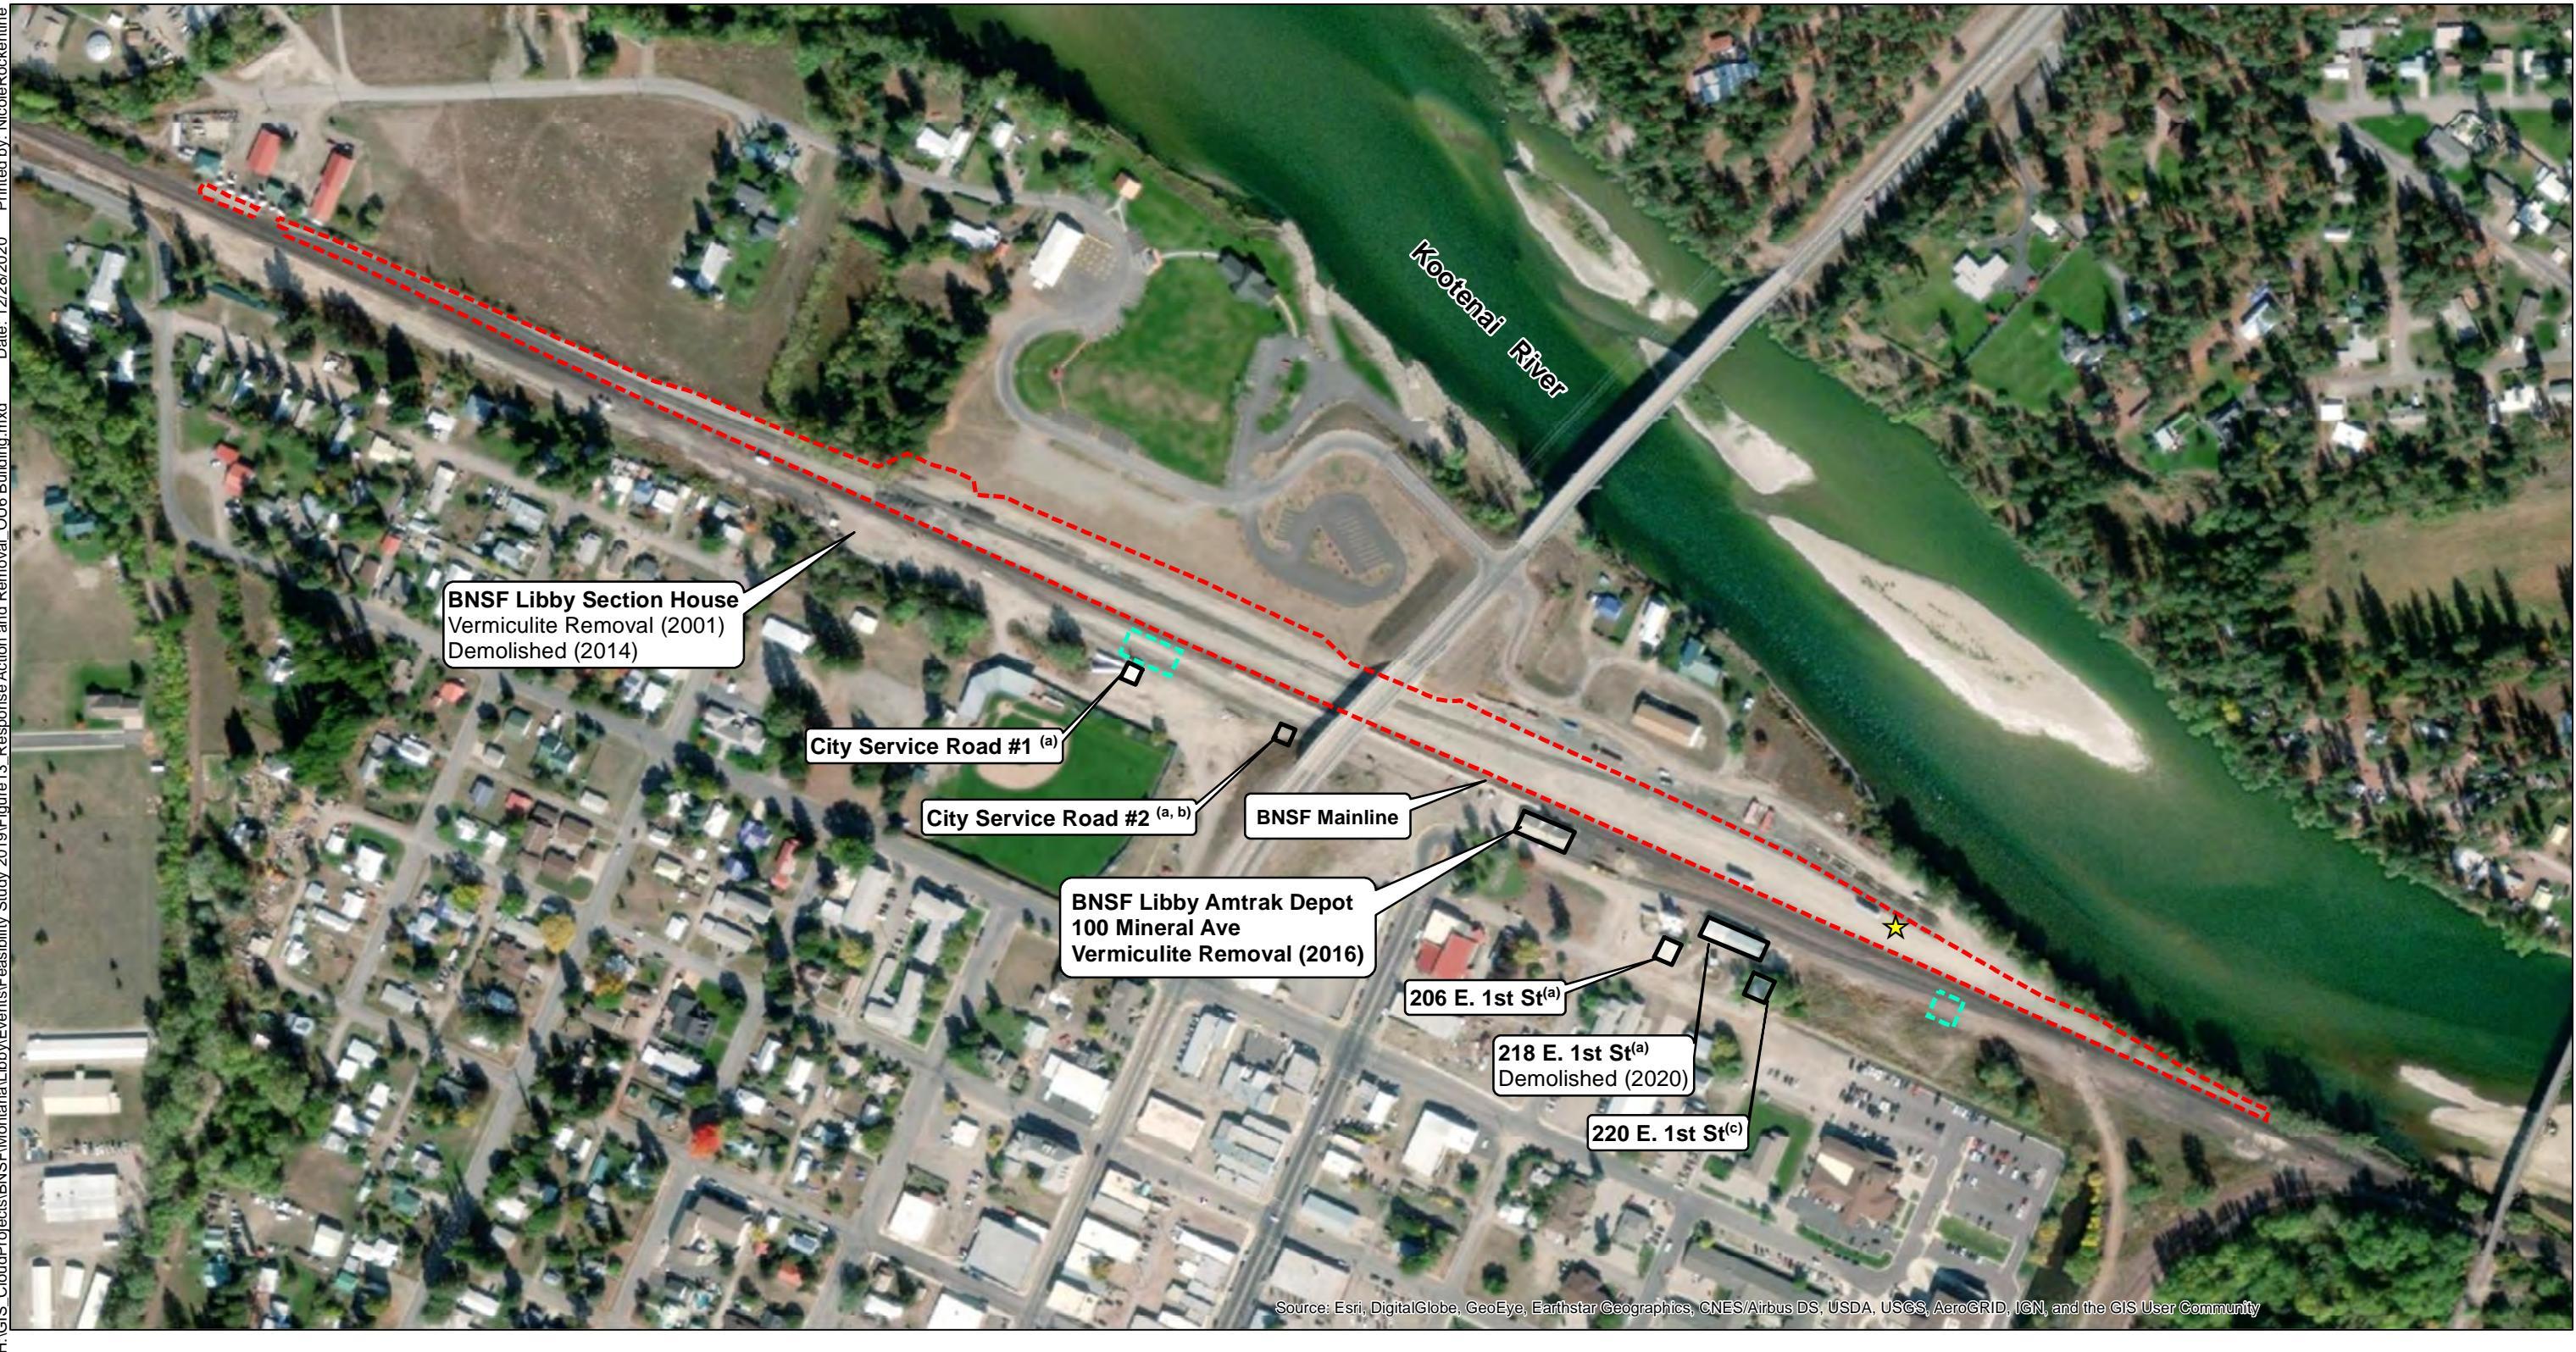
> > Figure 3

Note: Location and extent of institutional control boundary areas are approximate.

- <sup>(a)</sup>EPA conducted contaminant screening study in 2002.
- <sup>(b)</sup>Building has since been removed
- <sup>(c)</sup>Contaminant screening non conducted by EPA. BNSF completed survey in 2020.

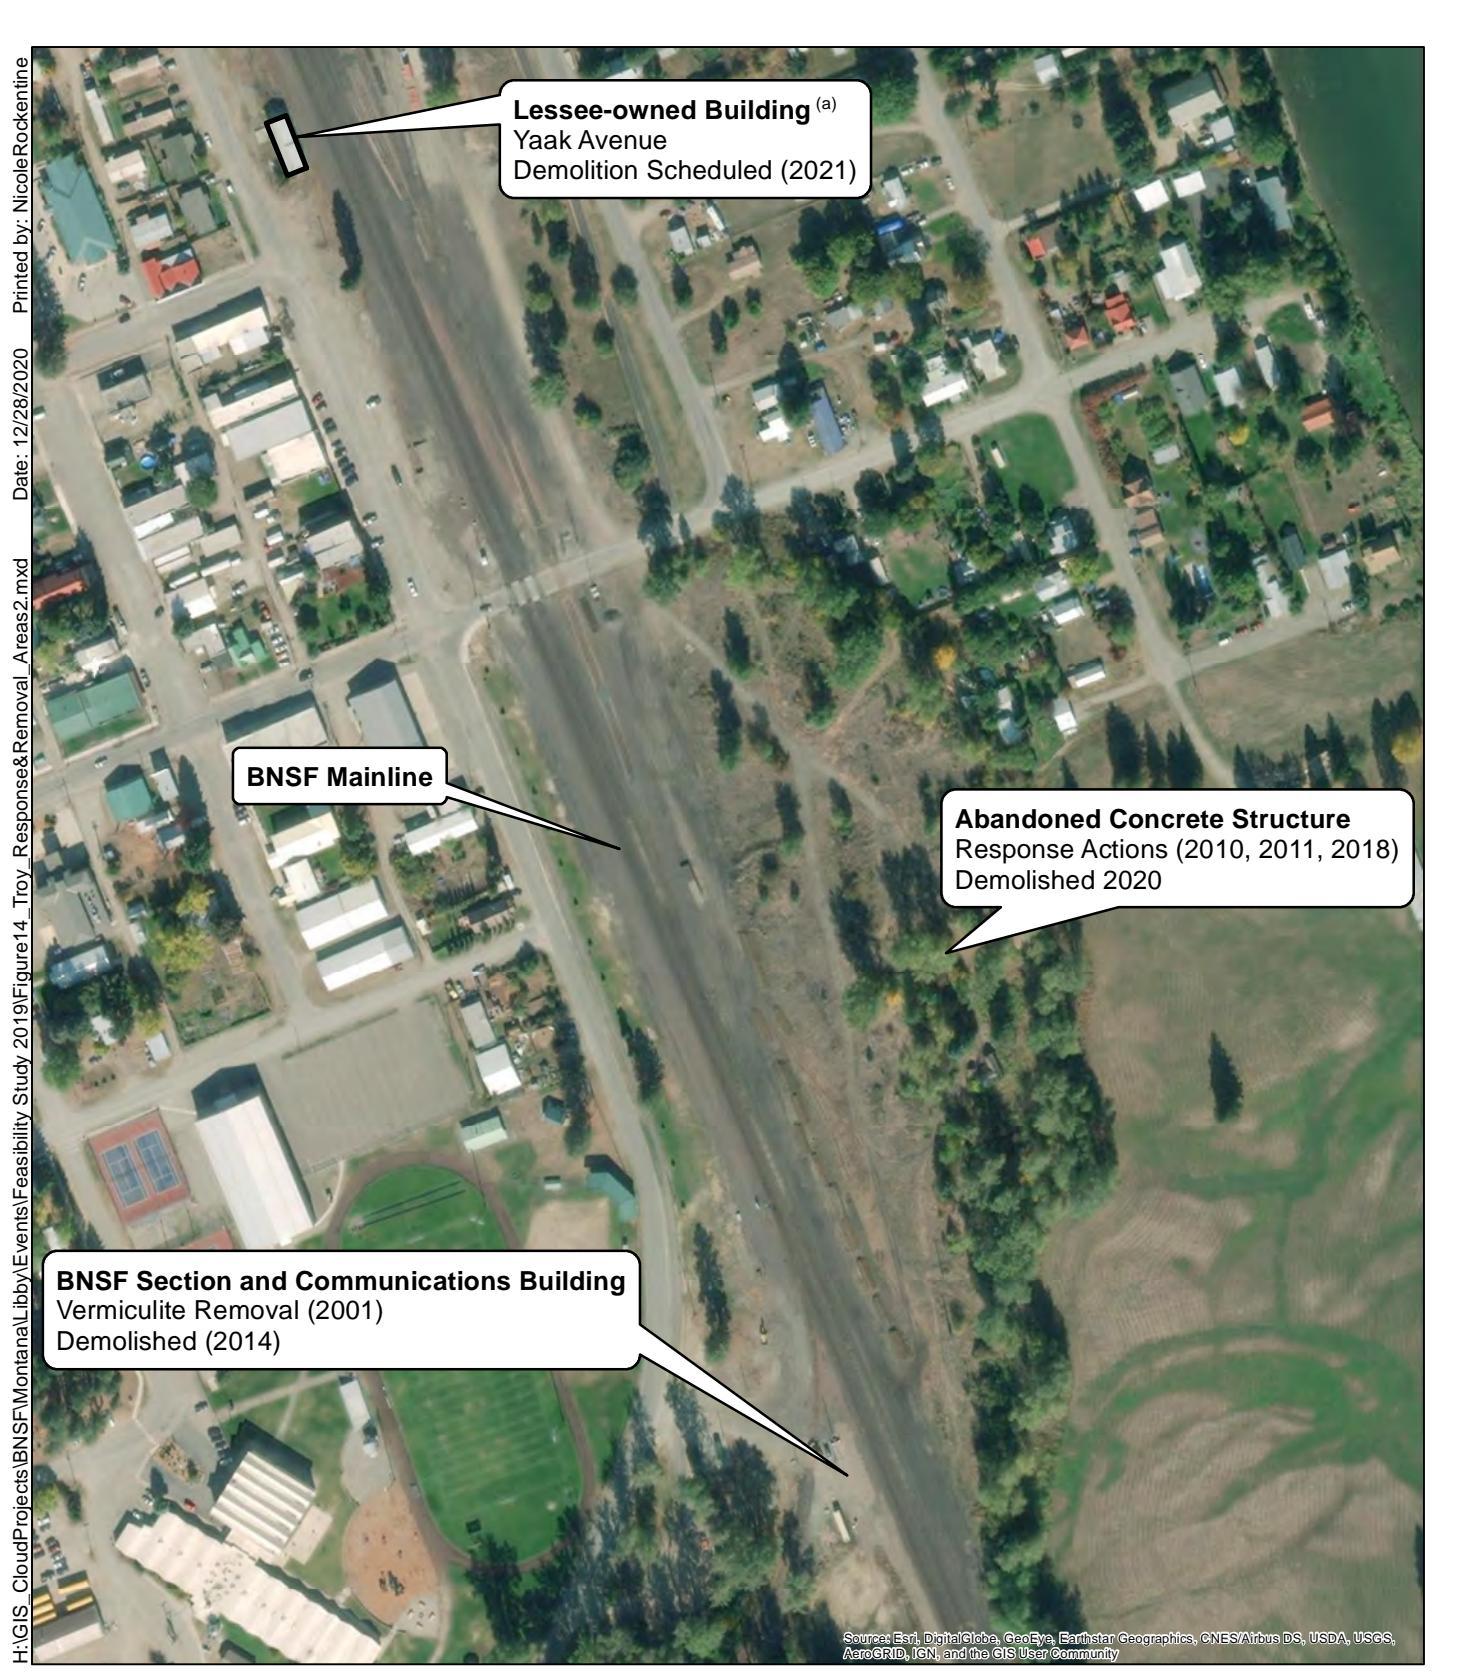
**BNSF Troy Response Action** and OU6 Building Locations

Note: Location and extent of depicted response action areas are approximate.

<sup>(a)</sup> DEQ conducted a Troy asbestos property evaluation in 2009.

During the Site Walkthrough/Final Inspection with DEQ and EPA in May 2018, a new opening was observed beneath the steel plates previously installed on the Troy concrete structure. In September 2018, BNSF personnel took additional measures to secure new opening in the Troy concrete structure. In 2020, BNSF demolished the Troy concrete structure. Additional details are provided in the *OU6 RA Report* (Kennedy Jenks 2021).

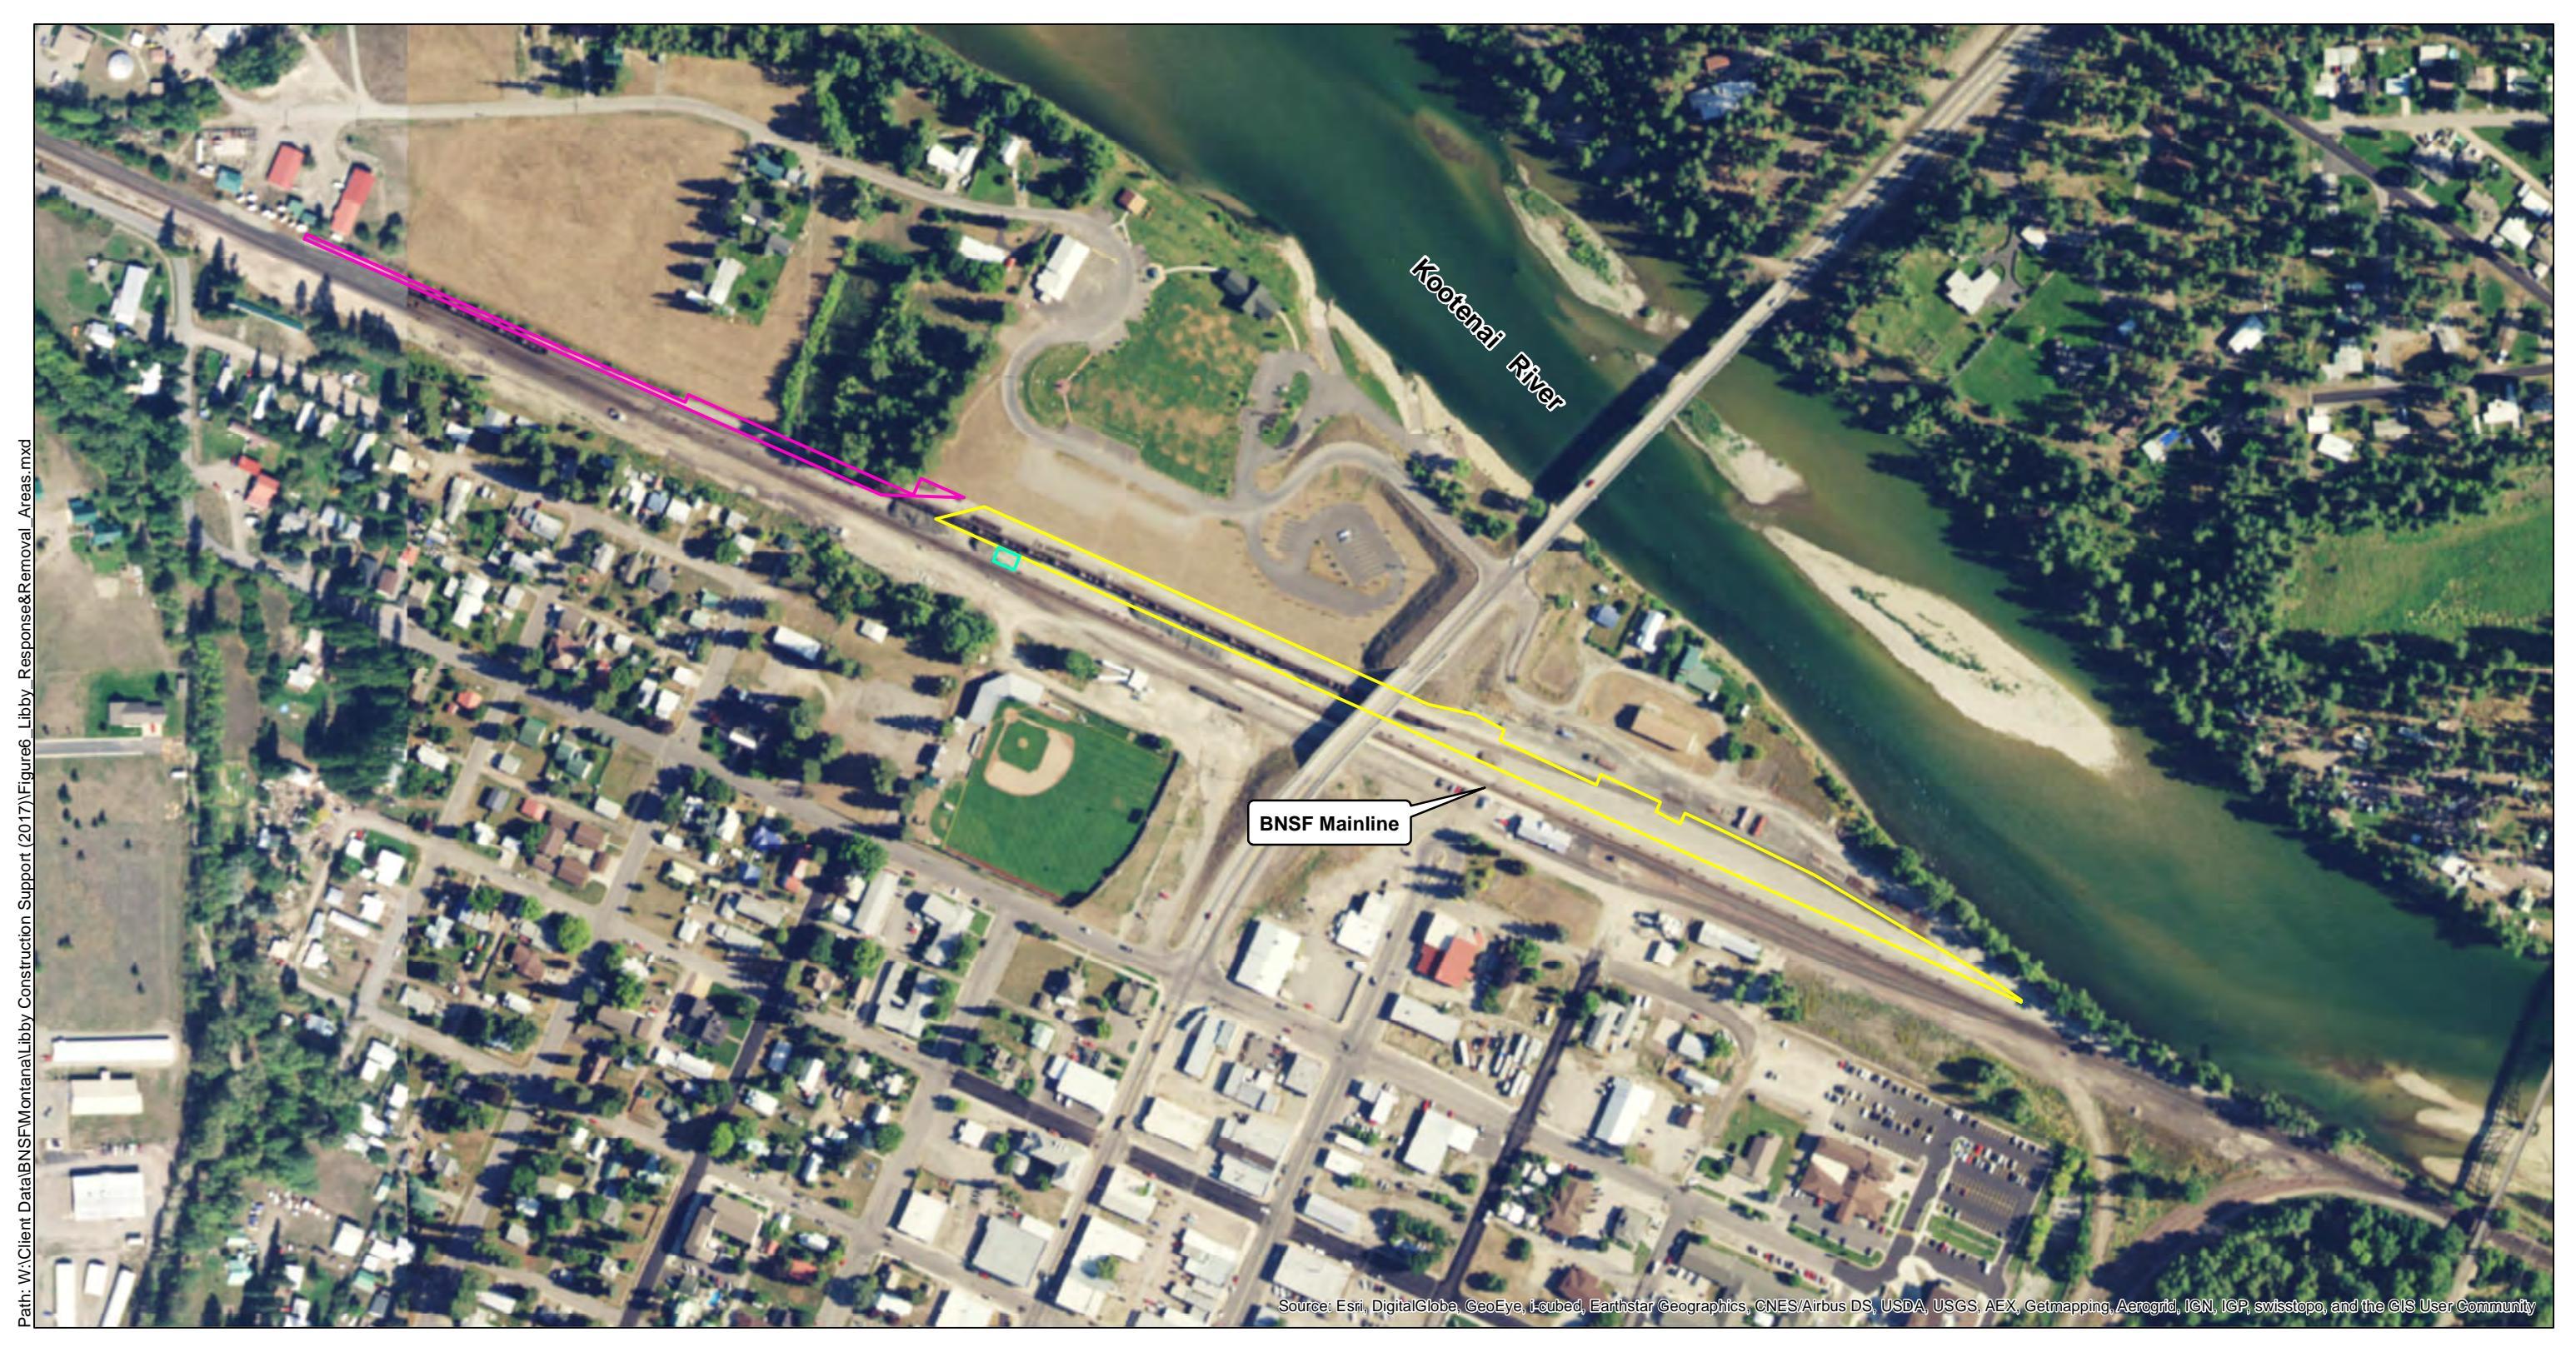
BNSF Libby Railyard - Areas with Tremolite/Actinolite in Soil

Zone 1/2/3 - Area Containing Tremolite/Actinolite

Zone 4/7 East Tract - Area Containing Tremolite/Actinolite

Zone 4/7 West Tract - Area Containing Tremolite/Actinolite

Note: Location and extent of institutional control boundary areas are approximate.

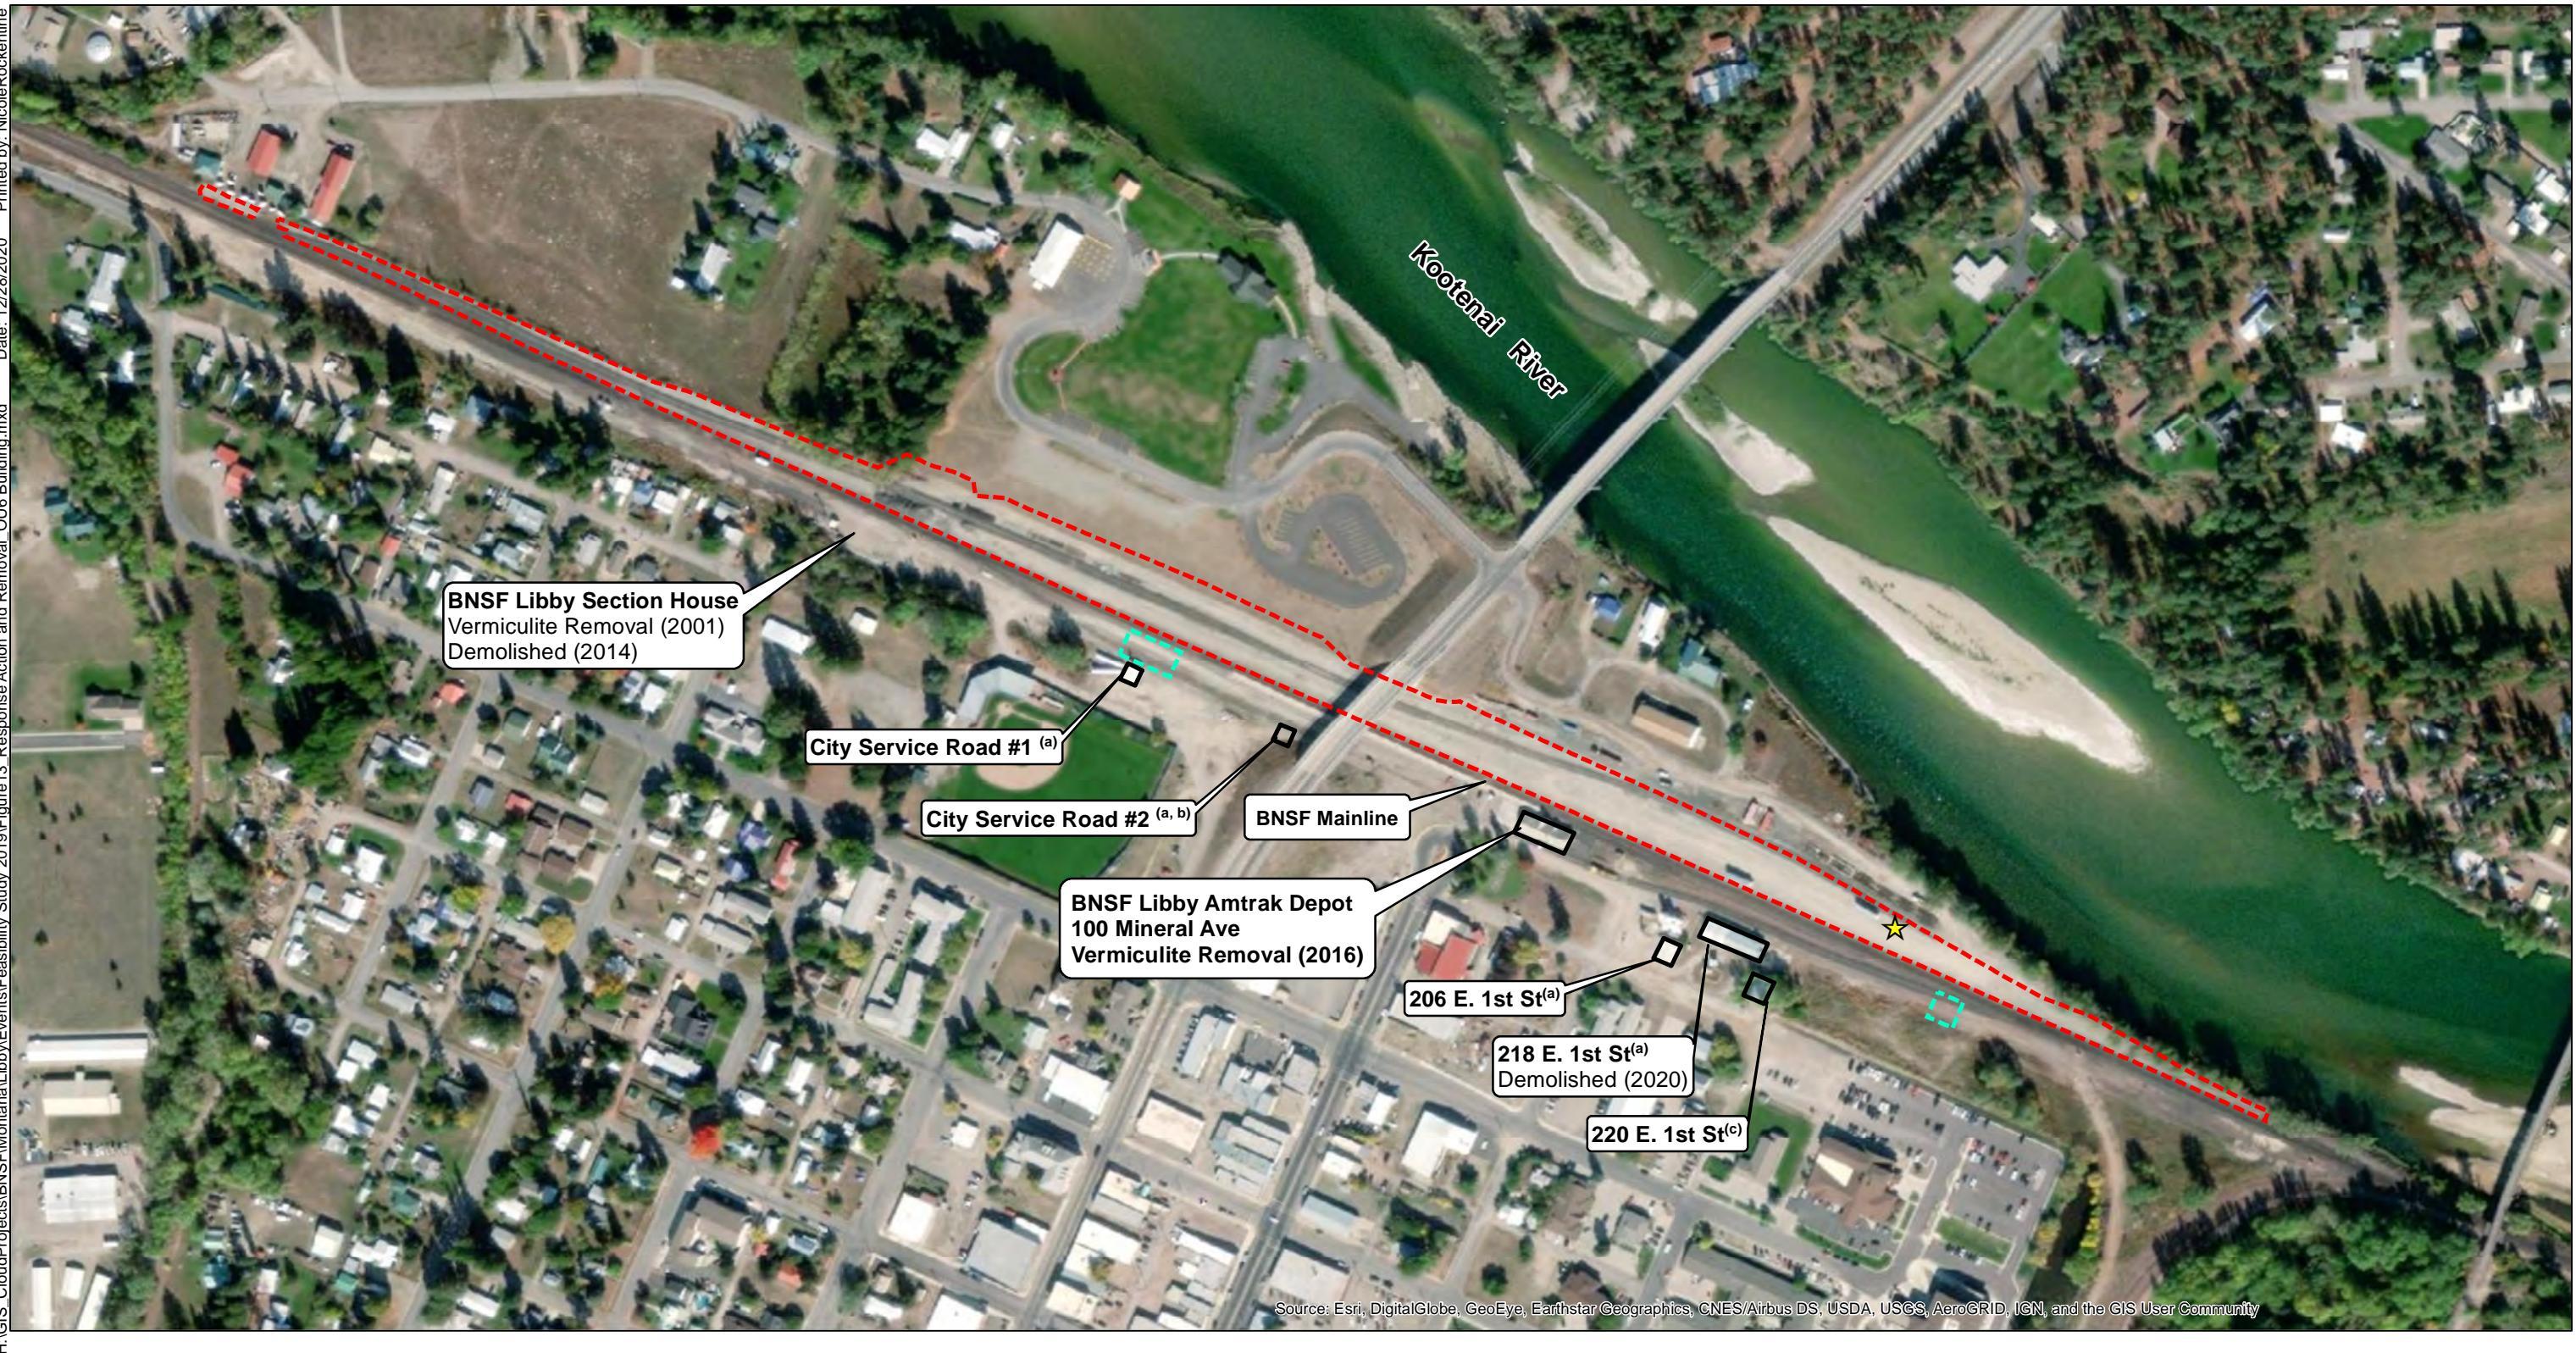
BNSF Libby Response Action, Removal Areas, and OU6 Building Locations

Note: Location and extent of institutional control boundary areas are approximate.

- <sup>(a)</sup>EPA conducted contaminant screening study in 2002.
- <sup>(b)</sup>Building has since been removed
- <sup>(c)</sup>Contaminant screening non conducted by EPA. BNSF completed survey in 2020.

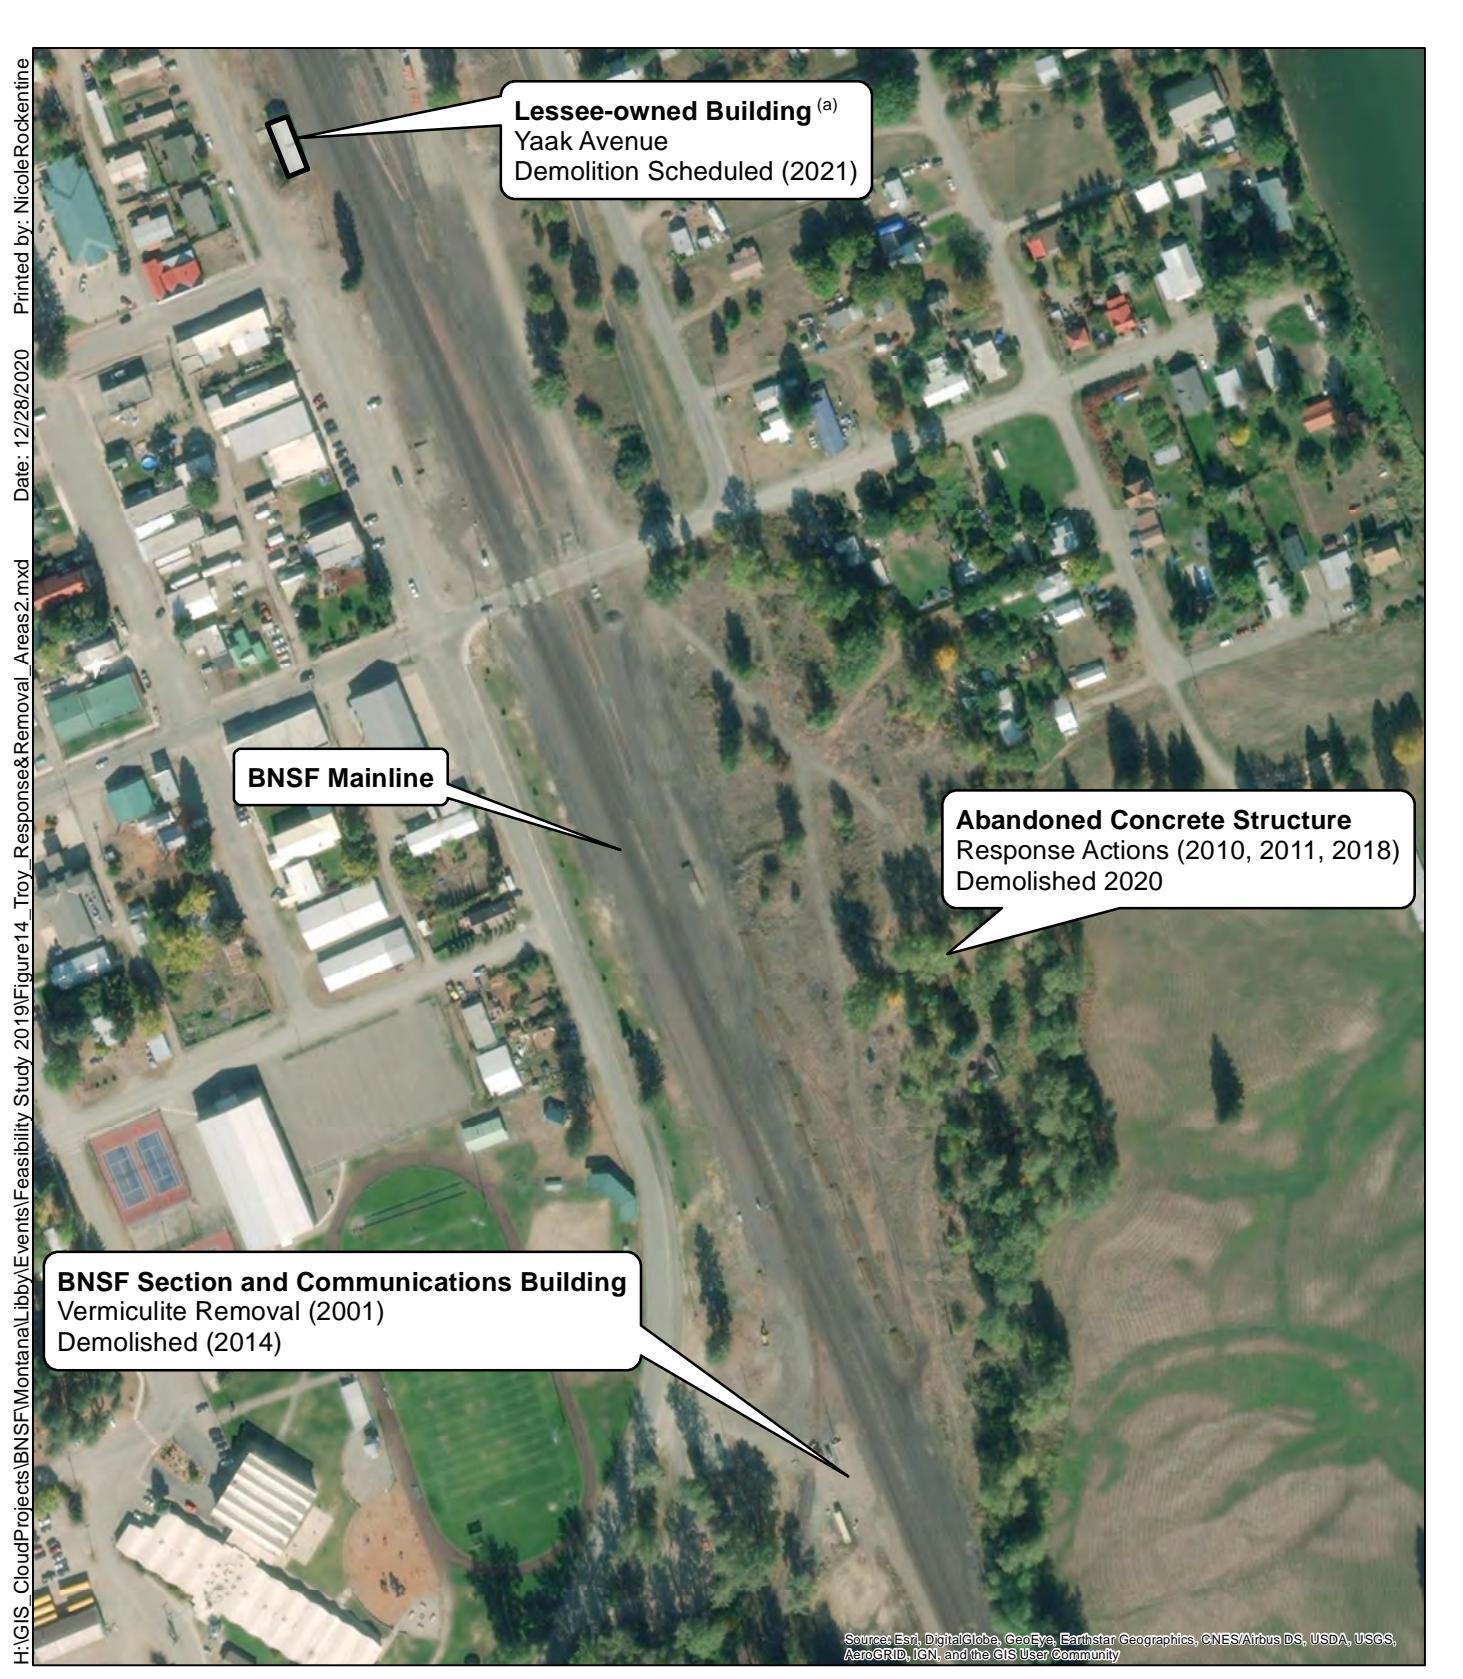
BNSF Troy Response Action and OU6 Building Locations

Note: Location and extent of depicted response action areas are approximate.

<sup>(a)</sup> DEQ conducted a Troy asbestos property evaluation in 2009.
