Draft Final Institutional Control Implementation and Assurance Plan Operable Unit 6 Libby Asbestos Superfund Site Libby, Montana

March 2021

#### BNSF Railway Company 800 North Last Chance Gulch

KJ Project No. 2149206.00

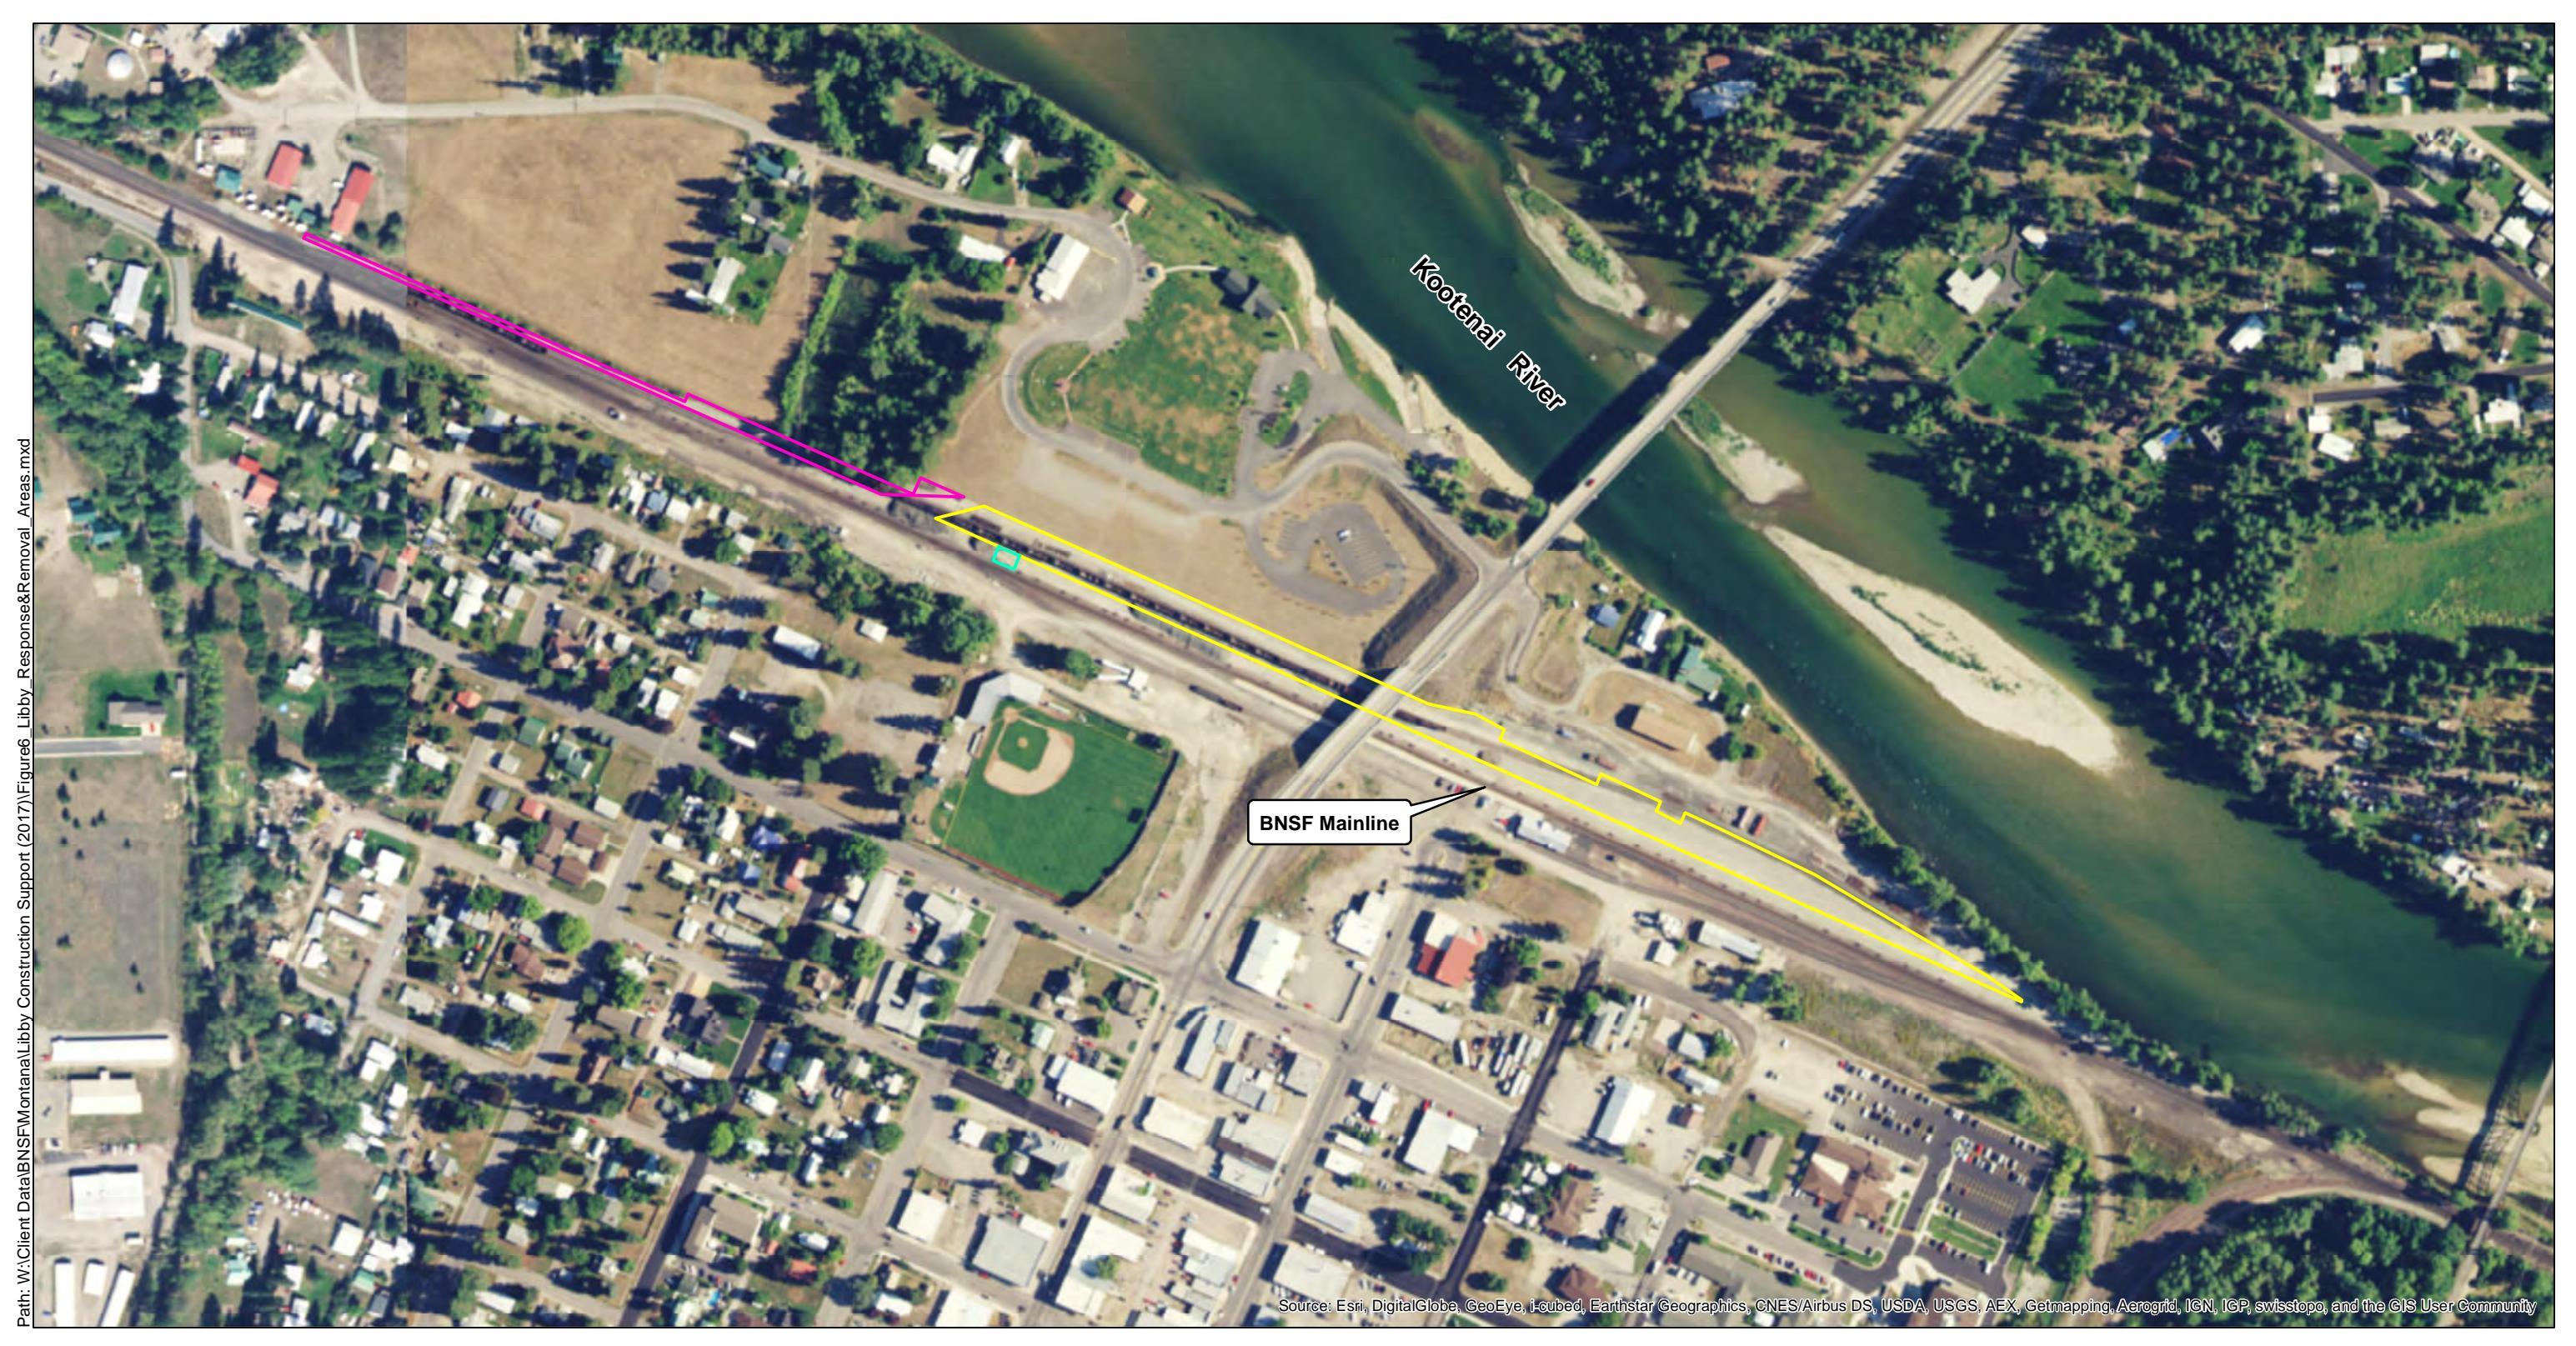
BNSF Libby Railyard - Areas with Tremolite/Actinolite in Soil

Zone 1/2/3 - Area Containing Tremolite/Actinolite

Zone 4/7 East Tract - Area Containing Tremolite/Actinolite

Zone 4/7 West Tract - Area Containing Tremolite/Actinolite

Note: Location and extent of institutional control boundary areas are approximate.
