# BORIT SUPERFUND SITE COMMUNITY UPDATE

AMBLER BOROUGH, UPPER DUBLIN & WHITPAIN TOWNSHIPS, PA

**July 2012**

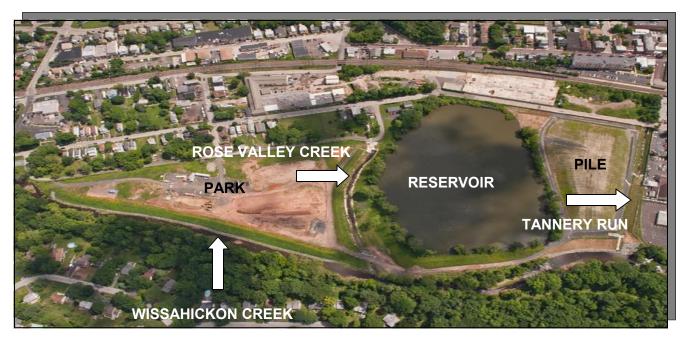
Aerial view of BoRit Asbestos Superfund Site
