## New Bedford Harbor Superfund Site

Final Pierce Mill Cove After Action Report

ACE-J23-35BG1001-M17-0040 | C

April 2018

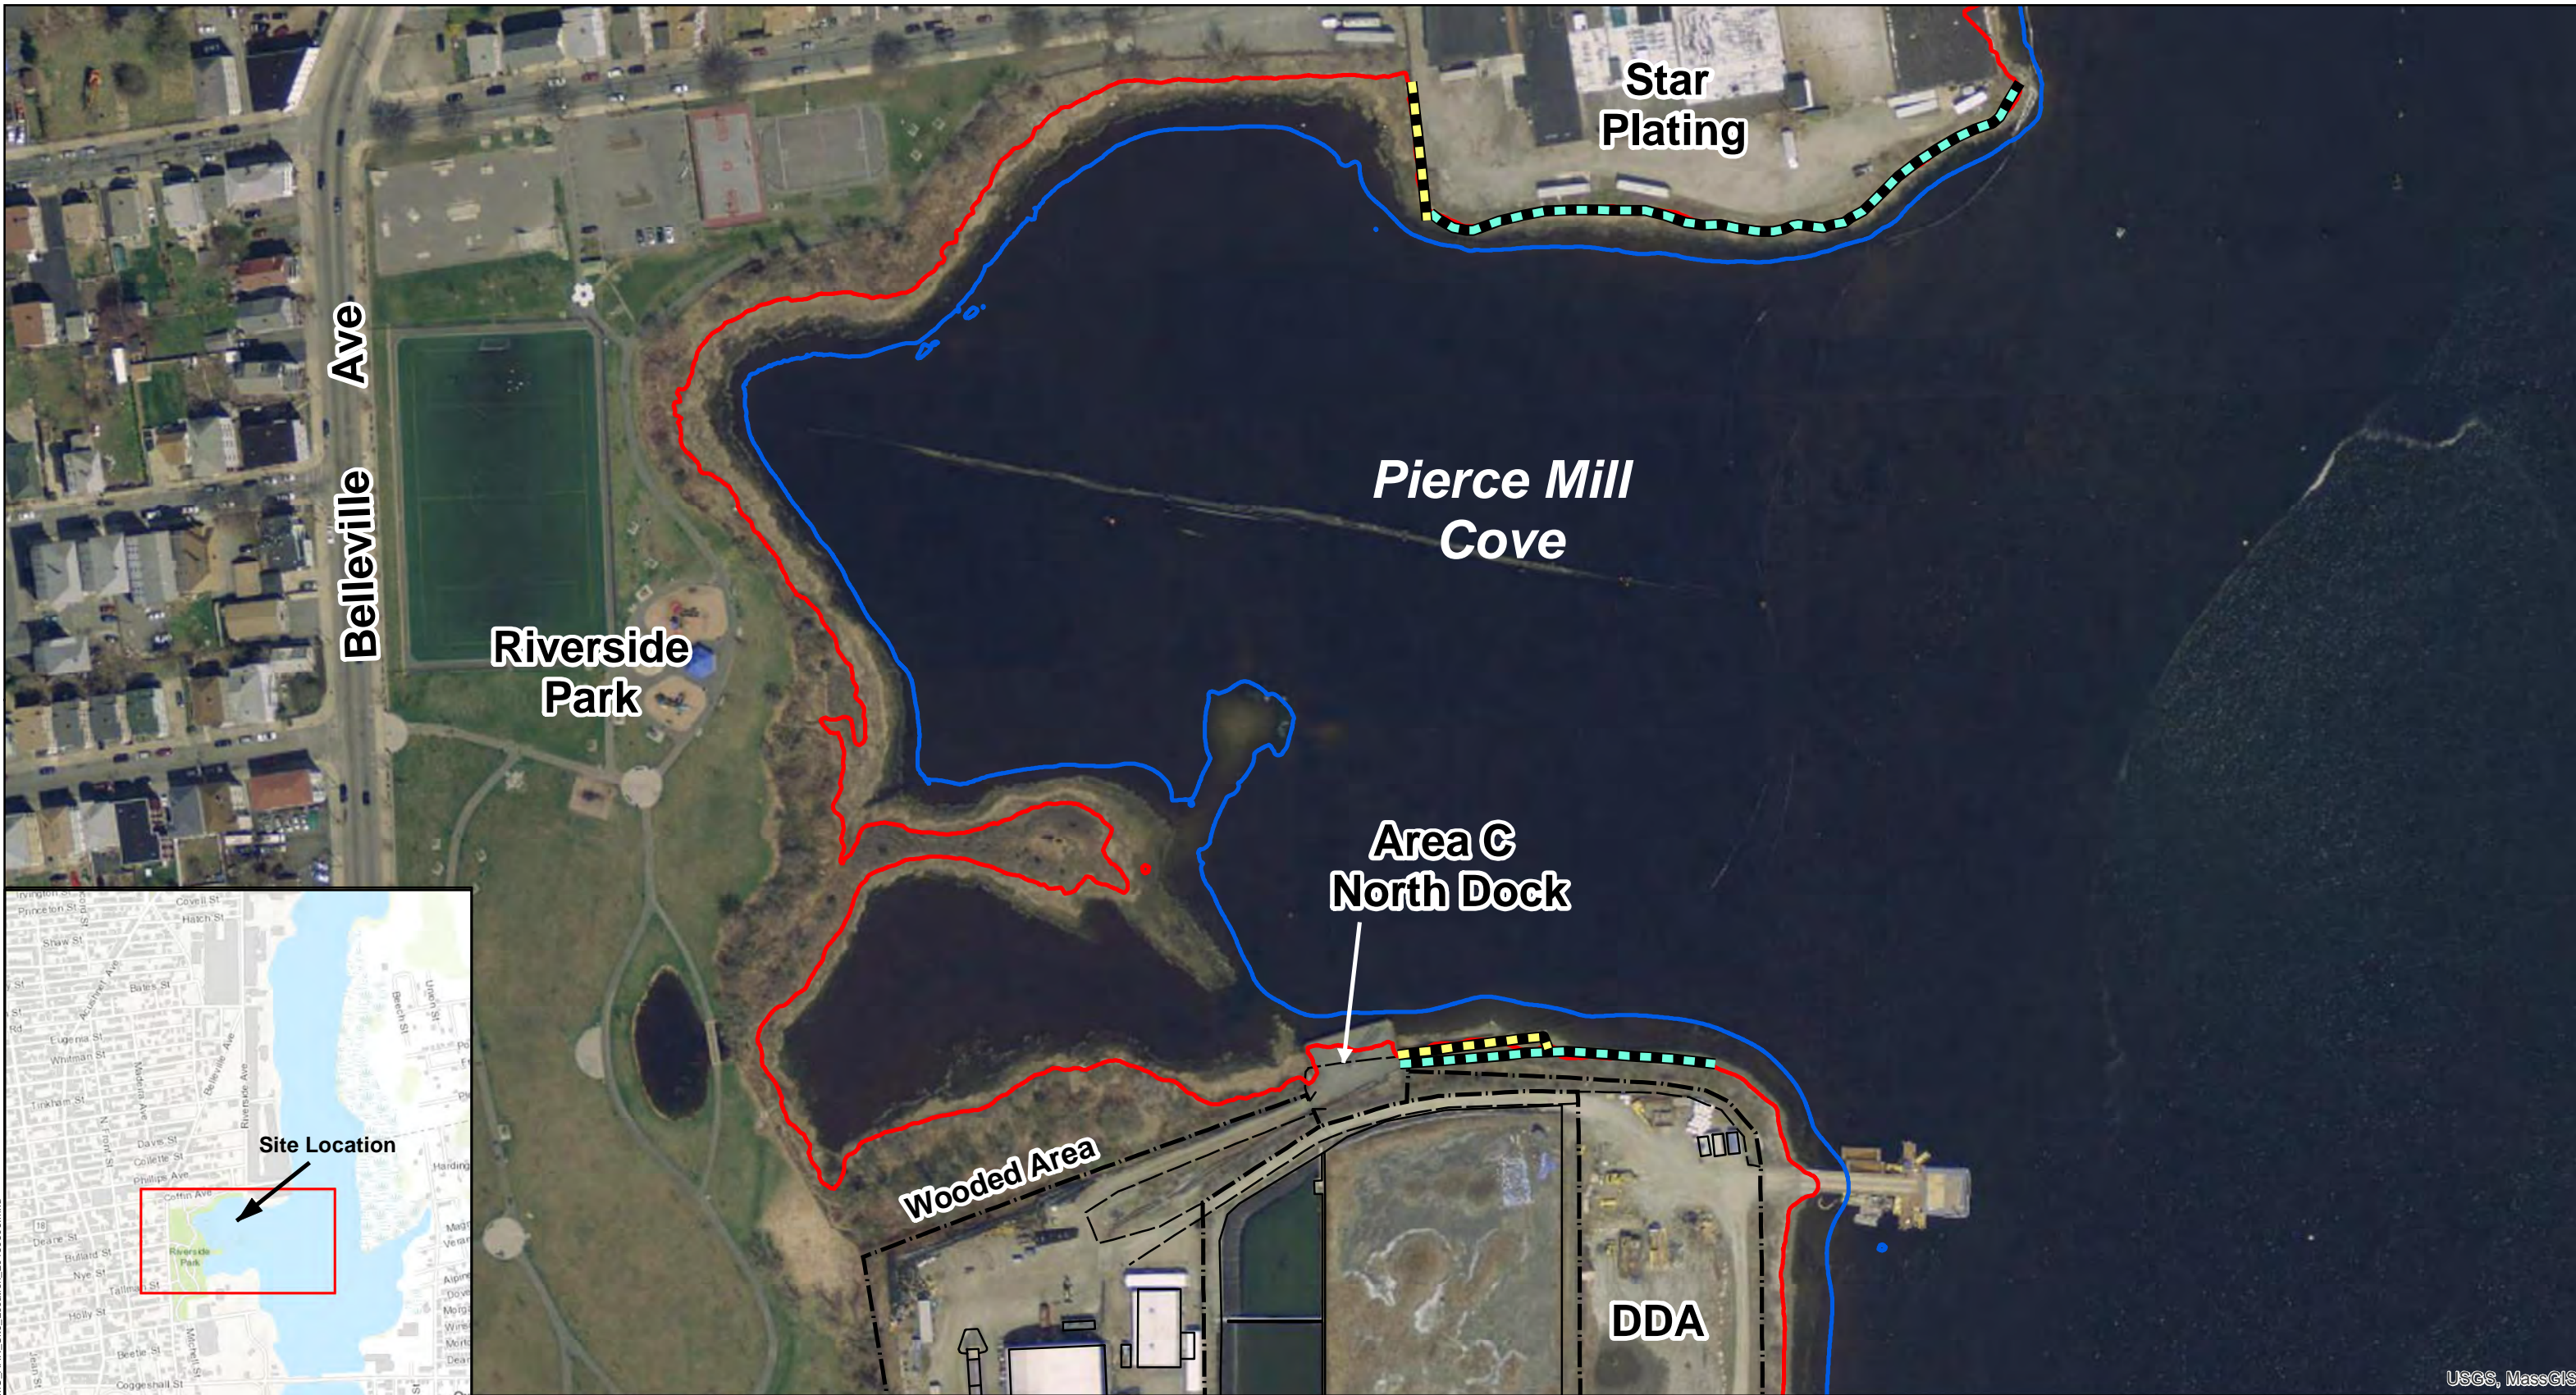
NAME: jpiculto Date: 3/27/2018 Figure 1-1

**Pierce Mill Cove  
Site Location and  
Pre-Excavation Features**

Remediation and restoration of the Pierce Mill Cove (PMC) intertidal zone were conducted by Jacobs Engineering Group (Jacobs) under U.S. Army Corps of Engineers – New England District (NAE) Interim Remediation Action Contract No. W912WJ-14-D-0002 between October 24, 2016 and December 19, 2017. The primary objective of remedial action at PMC was to remove soil and sediment with polychlorinated biphenyl (PCB) levels greater than the site-specific target cleanup levels (TCLs) as established in the *1998 Record of Decision for the New Bedford Harbor Superfund Site* (EPA, 1998), and to restore the site to baseline or comparable conditions. TCLs established for the PMC Site are 10 milligrams per kilogram (mg/kg) for mudflats/subtidal areas (regardless of depth), 25 mg/kg for soil and sediment one foot (ft.) deep or less in vegetated marsh areas for recreational users, and 50 mg/kg for soil and sediment deeper than 1 ft. in vegetated marsh areas. A 95% upper confidence level (UCL) compliance calculation was performed on the final remediated and restored condition of the top foot of the entire PMC intertidal zone to ensure PCB concentrations were below the recreational TCL of 25 mg/kg. PMC is located on the western side of New Bedford Harbor extending from the northern end of the EPA/USACE Sawyer Street facility to the southeastern corner of the Star Plating property (Figure 1-1).

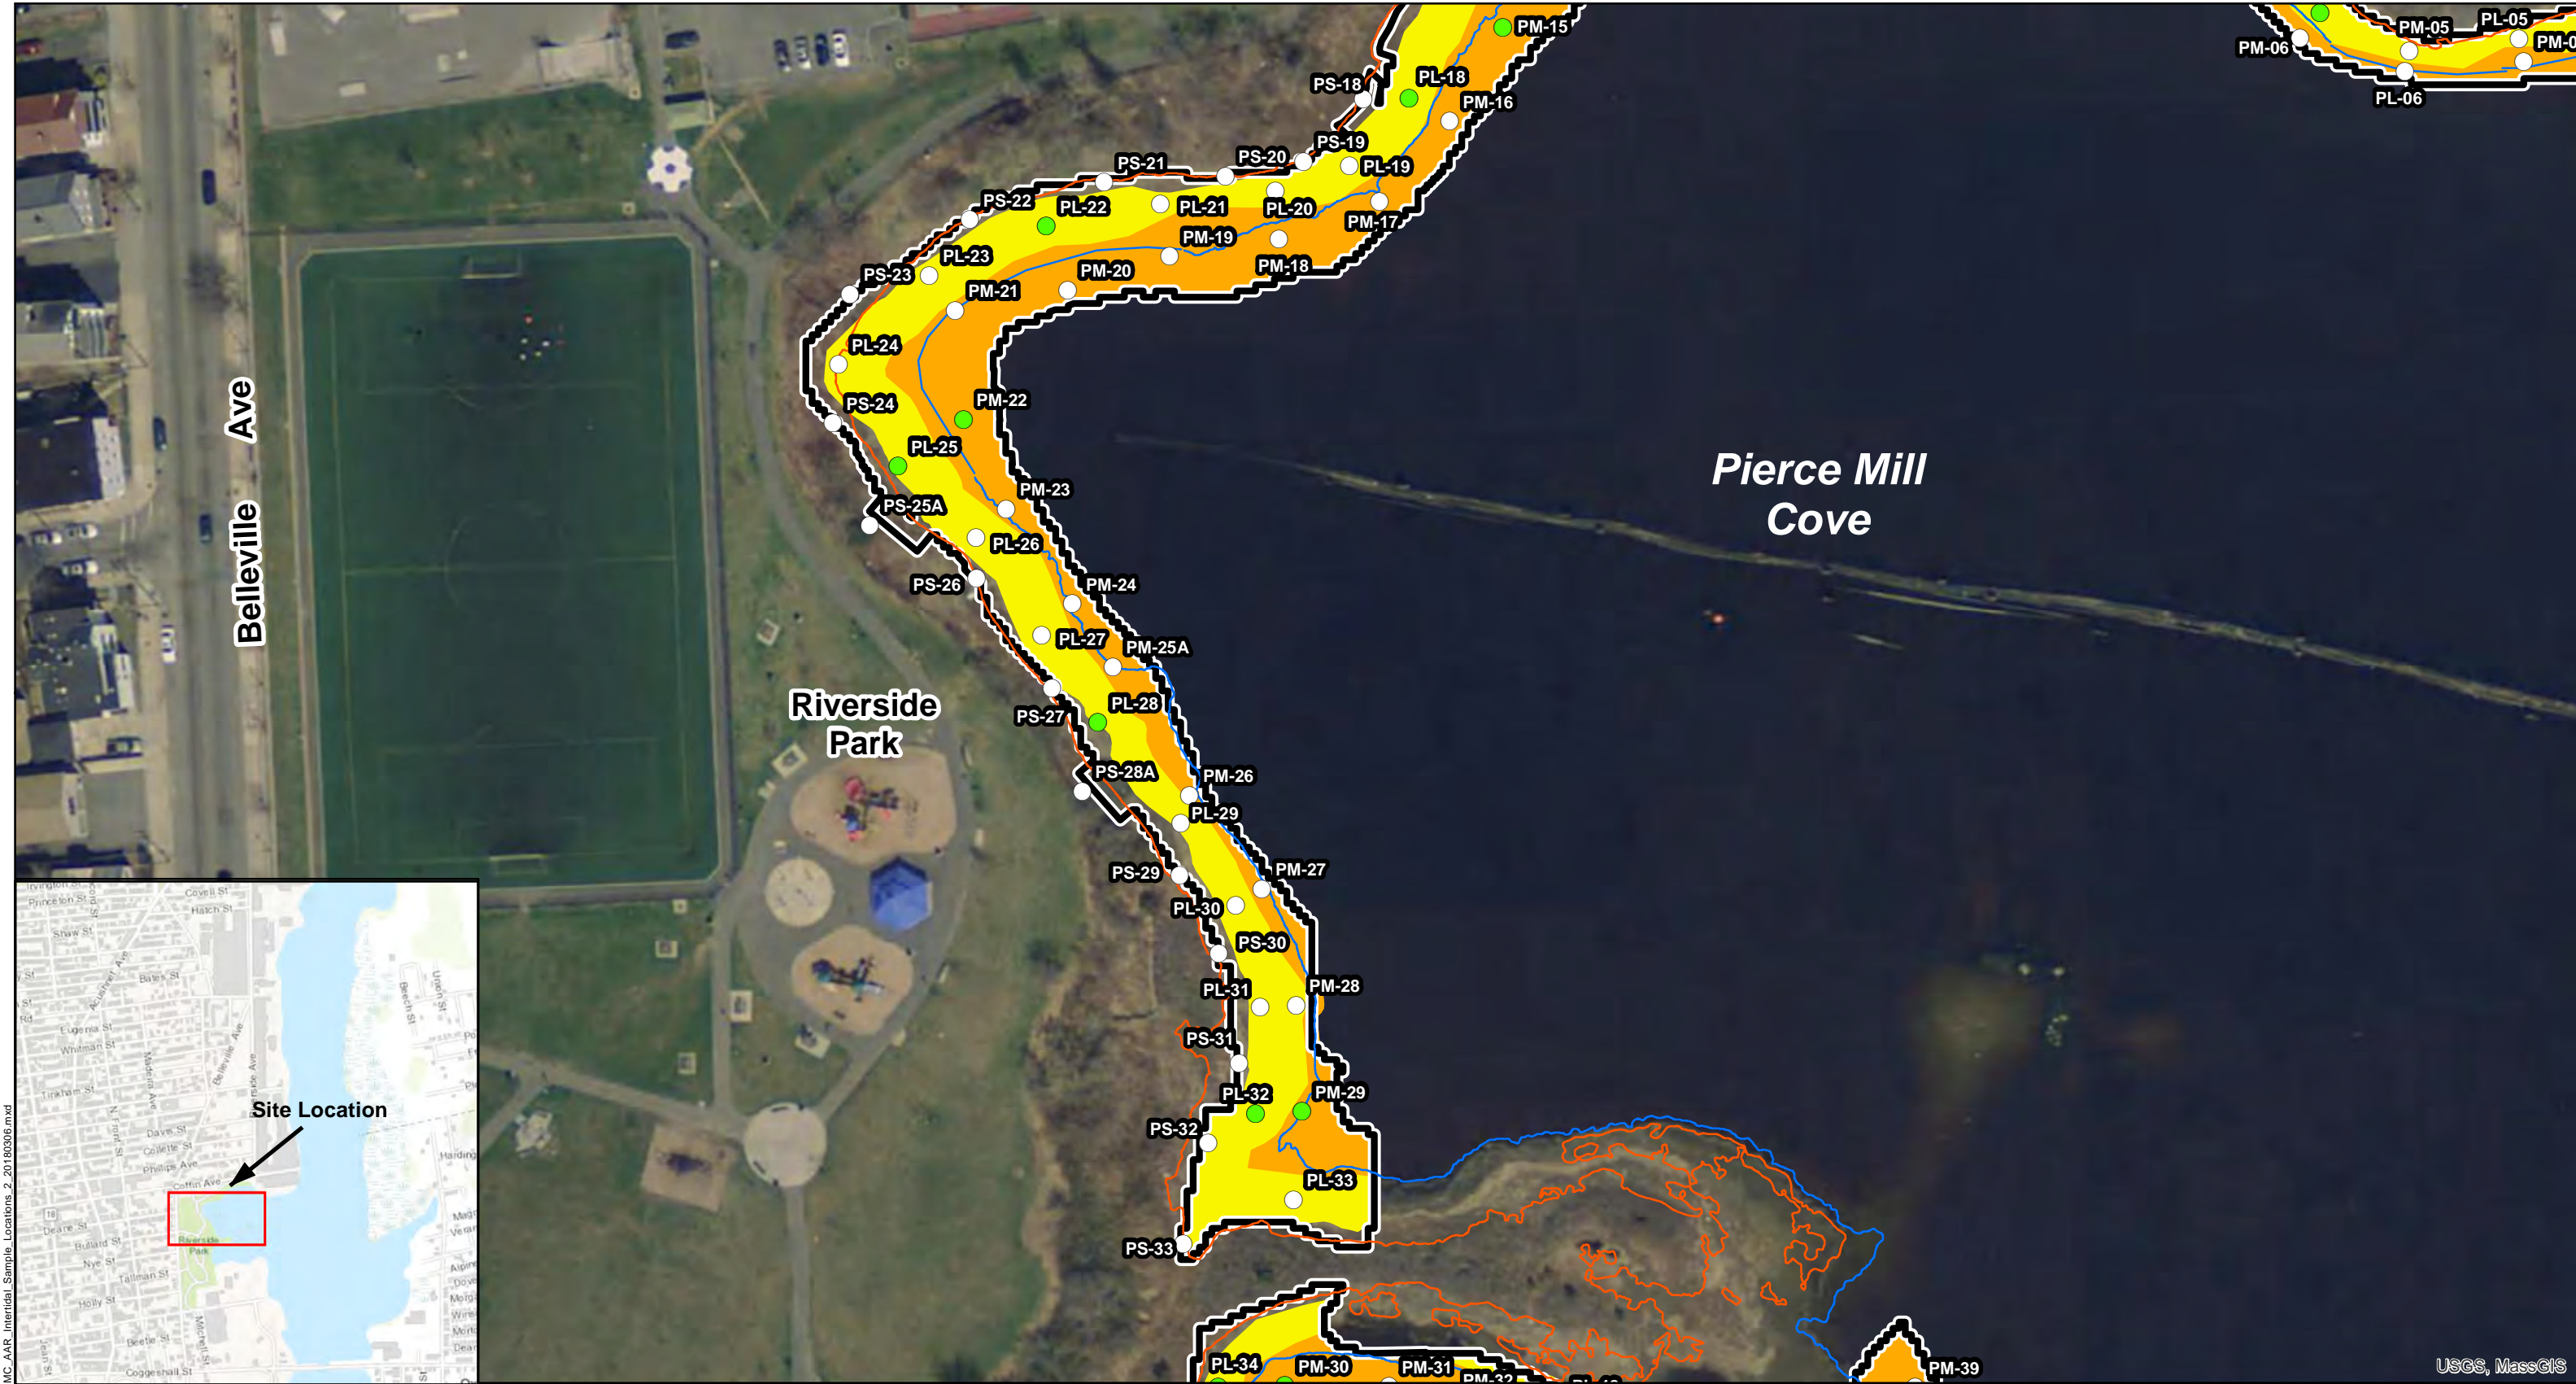
NAME: jpiccolto Date: 3/27/2018 Figure 2-5

Intertidal Verification and Confirmation Sample Locations, West

Post-excavation verification sampling was conducted by an independent party in accordance with the Field Sampling Plan Addendum #1 to the *Revised Draft Final Confirmatory Sampling Field Sampling Plan, Lower Harbor Winter 2016 Dredge Areas and Parcel 265* (Battelle 2016a) [Confirmatory Sampling FSP] as well as the *Uniform Federal Policy- Quality Assurance Project Plan (QAPP) Addendum* (Battelle 2016b). Verification samples were collected on a 50-ft. grid from a pre-defined mudflat/subtidal compliance demonstration area (CDA) and a saltmarsh CDA. Jacobs screened the verification samples using immunoassay analysis to evaluate whether any further removal of contaminated sediment was required (Figure 2-4, Figure 2-5 and Figure 2-6).

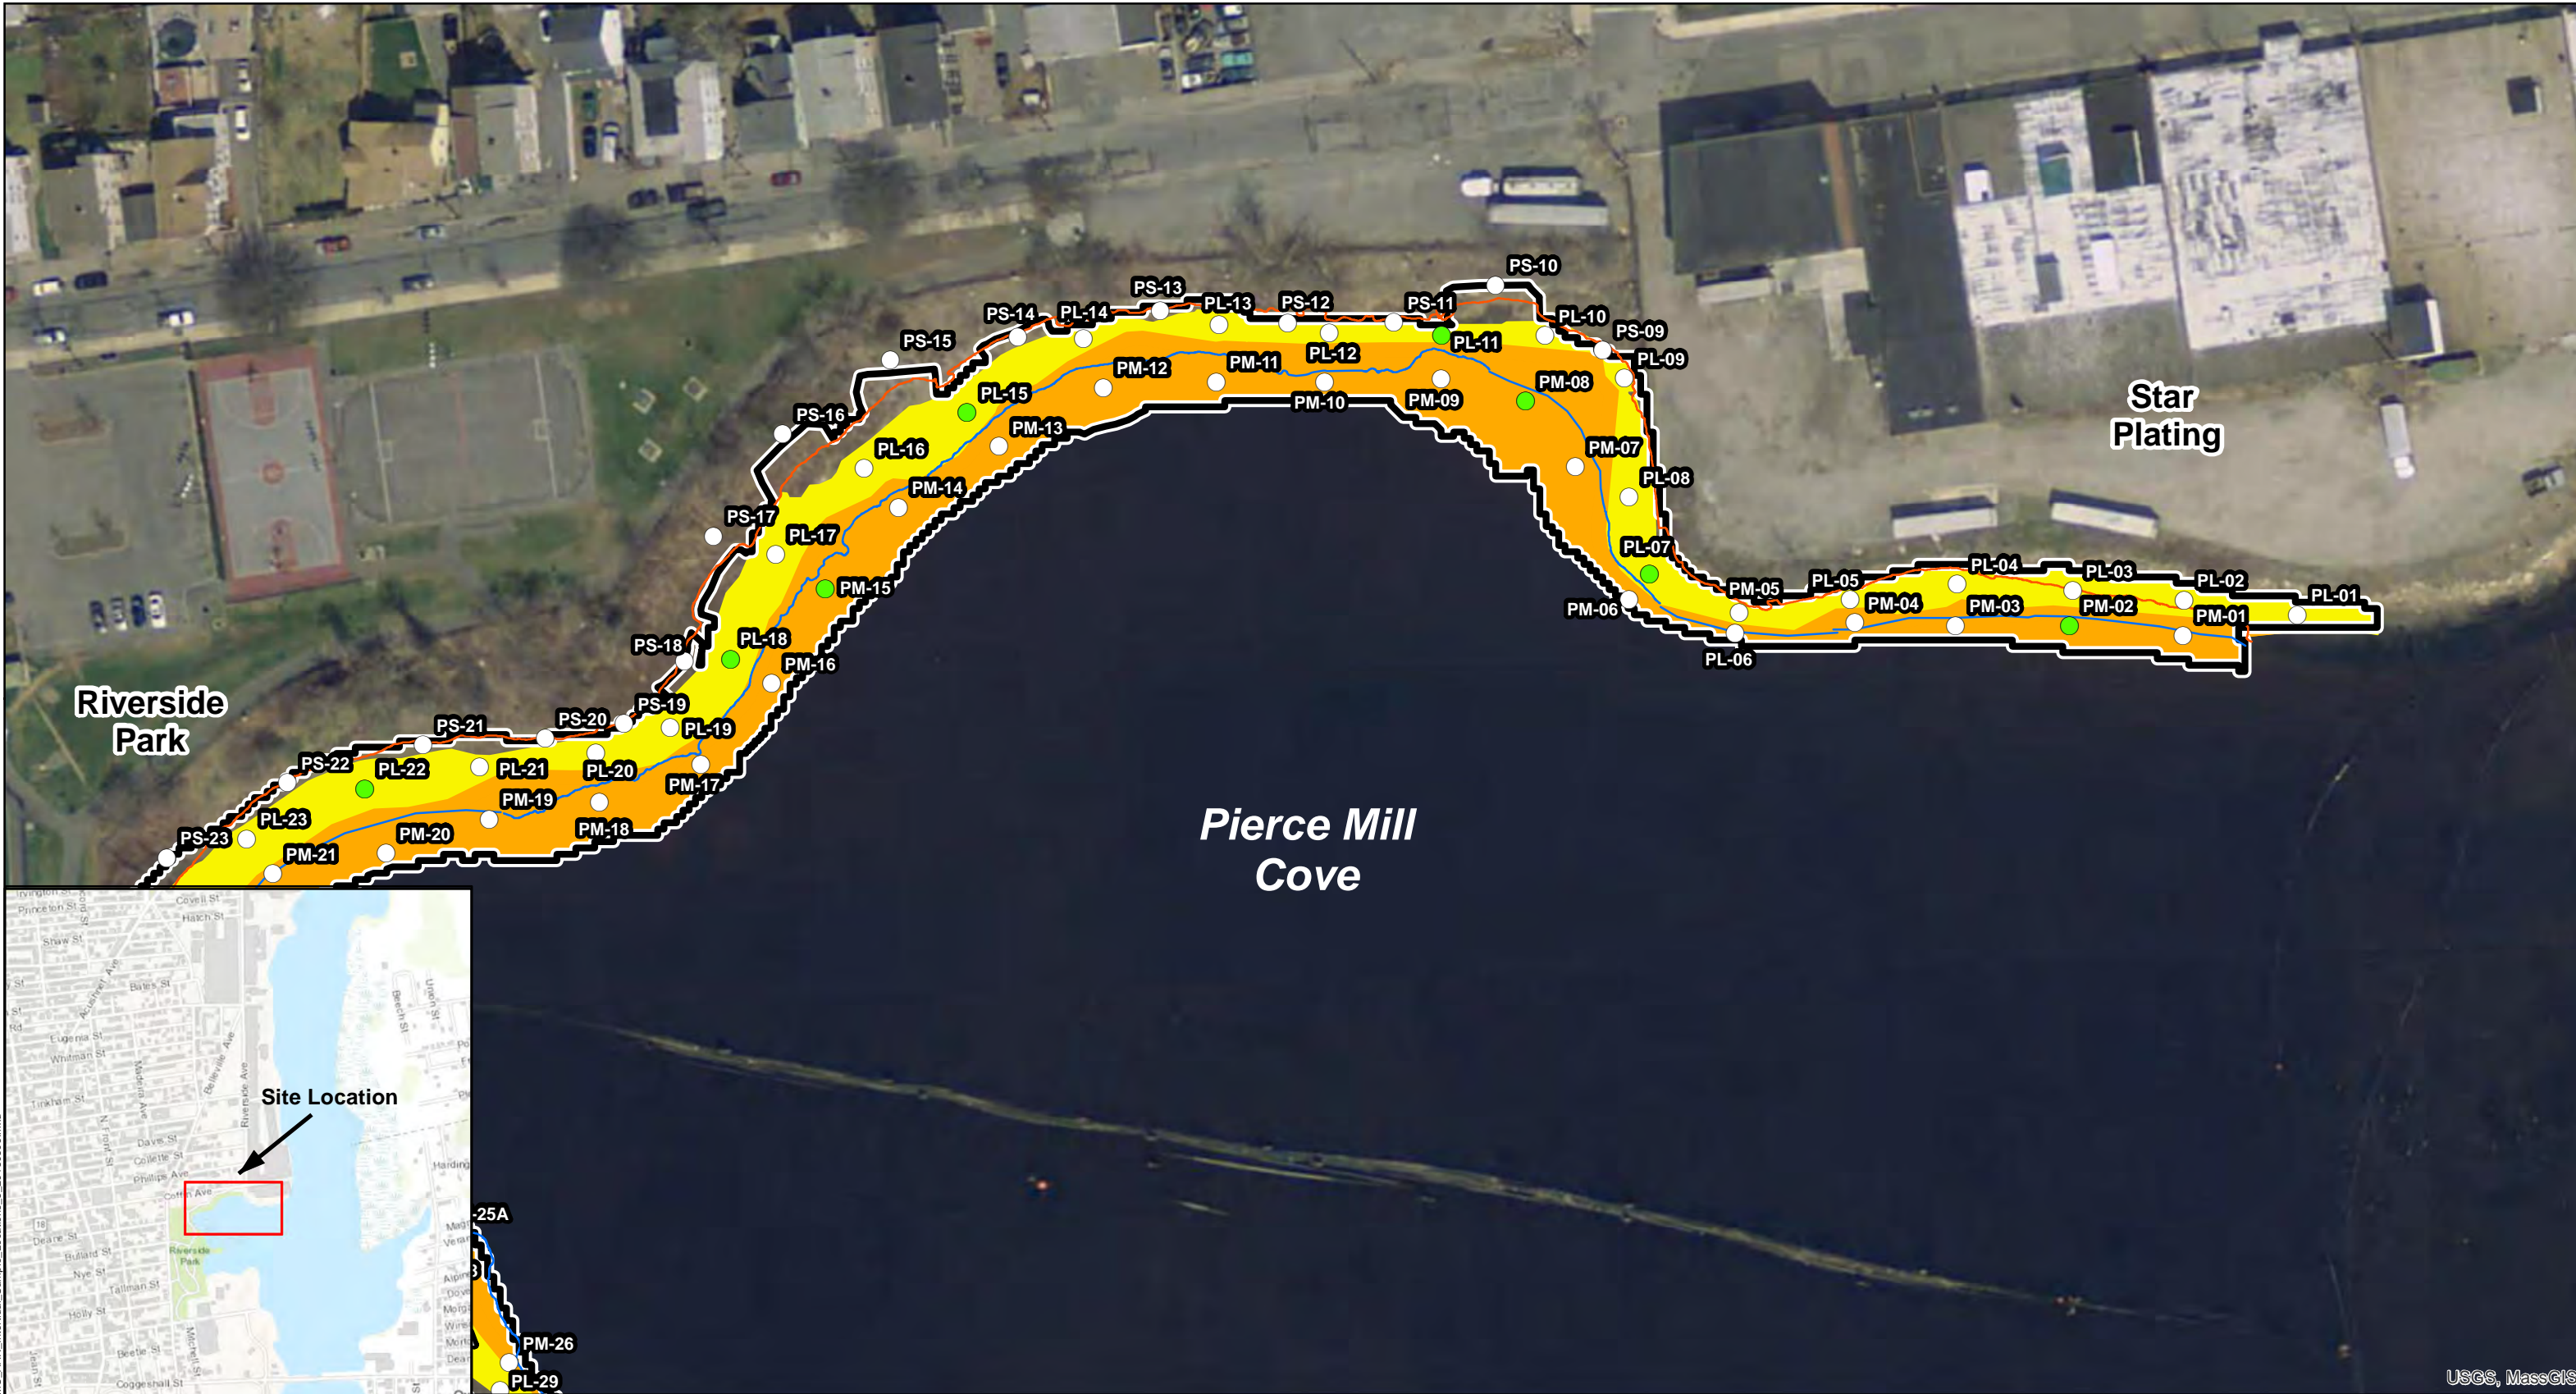
NAME: jpiccolto Date: 3/27/2018 Figure 2-6

Intertidal Verification and Confirmation Sample Locations, North

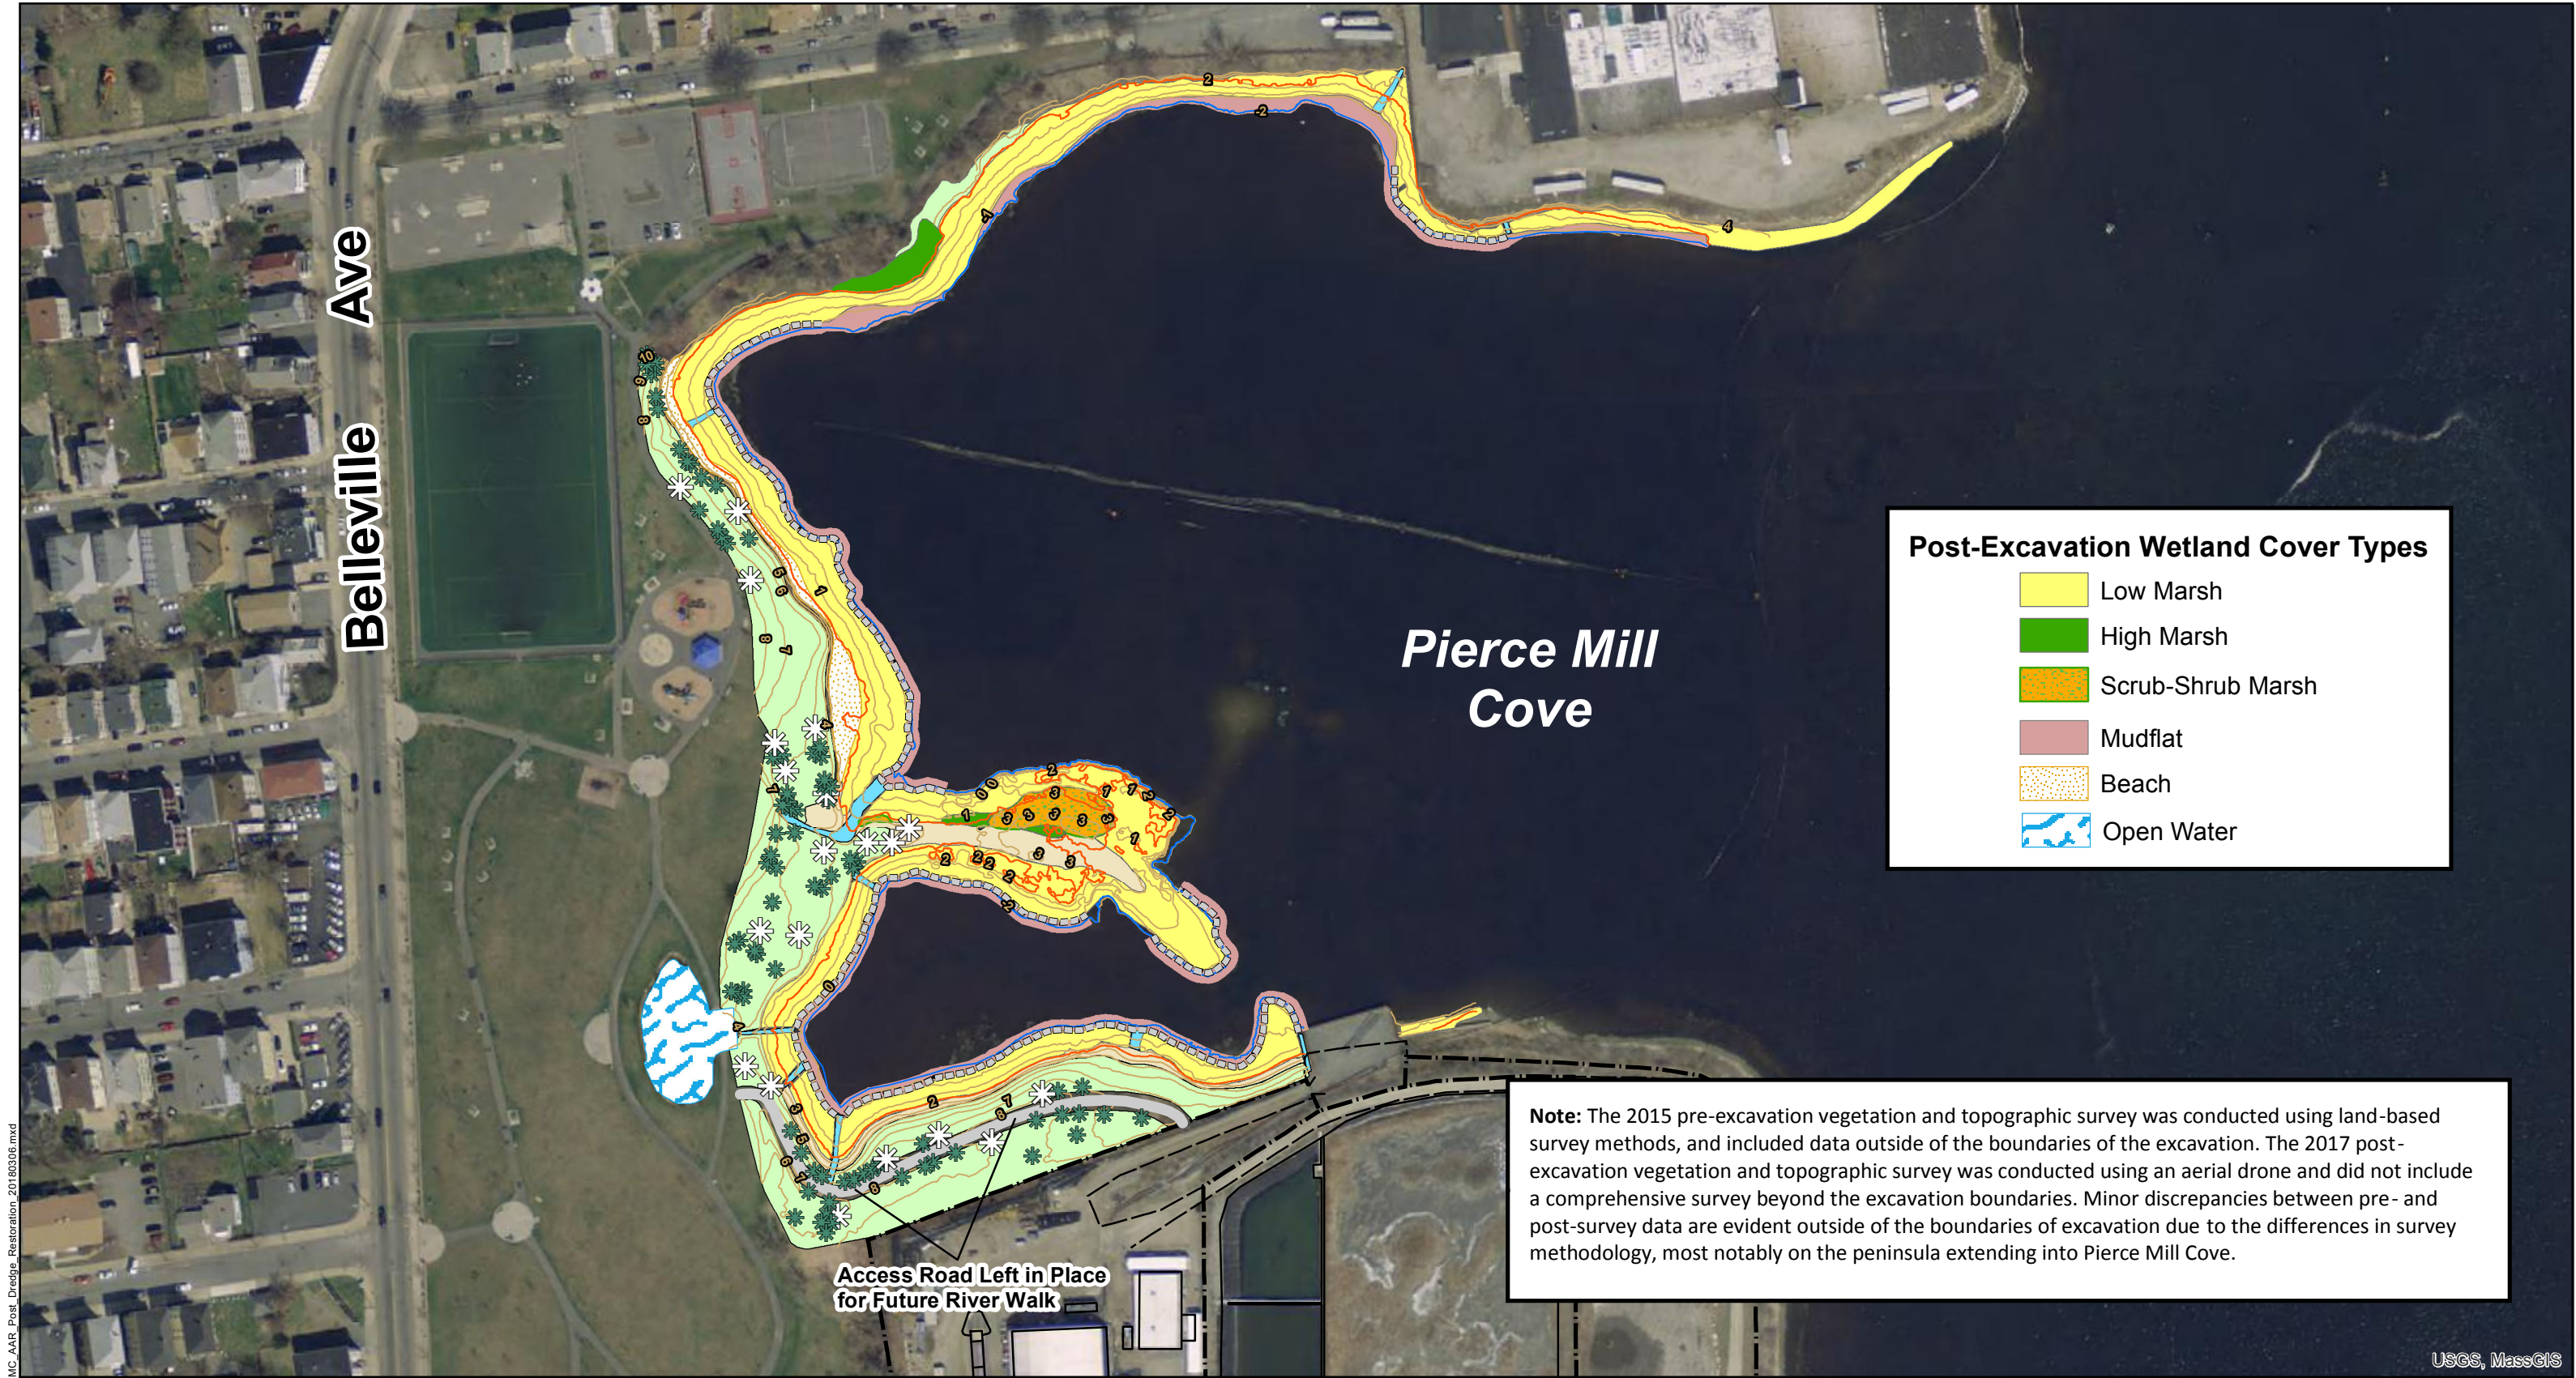
NAME: jpiccullo Date: 4/13/2018 **Figure 2-7**

**Note:** The 2015 pre-excavation vegetation and topographic survey was conducted using land-based survey methods, and included data outside of the boundaries of the excavation. The 2017 post-excavation vegetation and topographic survey was conducted using an aerial drone and did not include a comprehensive survey beyond the excavation boundaries. Minor discrepancies between pre- and post-survey data are evident outside of the boundaries of excavation due to the differences in survey methodology, most notably on the peninsula extending into Pierce Mill Cove.

**Pierce Mill Cove Post-Excavation Restoration**

The plant community composition at the Site was restored on an approximate 1:1 basis, as compared to the *Wetland Delineation* (AECOM 2015). The exception to this restoration ratio is mudflat, where the pre-excavation survey (5.52 acres in 2002) and the post-excavation survey (2.2 acres in 2018) differ. The difference is the excavated mudflat areas were not restored, except to establish a stable slope near the low marsh border. Also the growth of vegetation into the mudflats from 2002 to 2017 reduced the final mudflat footprint. A post-excavation wetlands cover map is presented in [Figure 2-7](#).

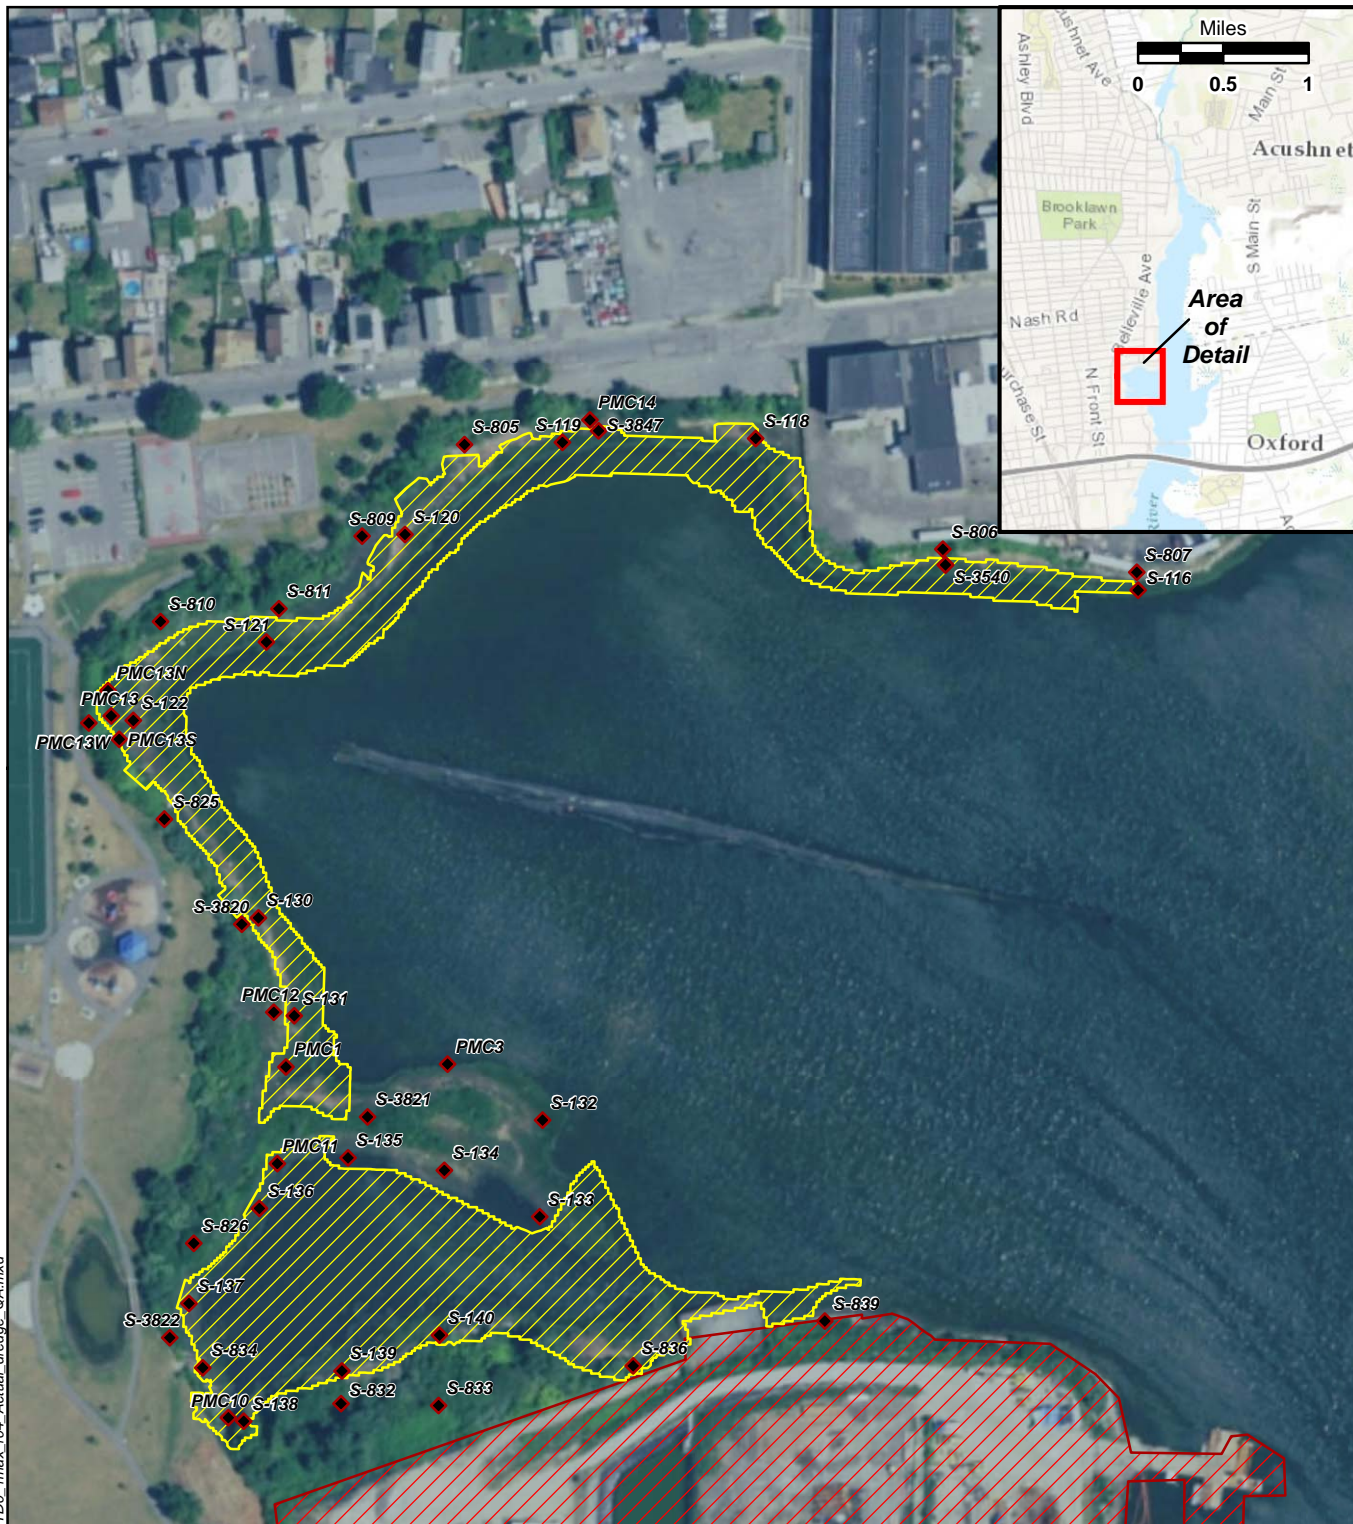
Pierce Mill Cove  
Intertidal Sampling Locations
