**FINAL REPORT
FOR
LOWER NEPONSET RIVER PCBS
SITE INSPECTION
BOSTON/MILTON, MASSACHUSETTS**

Submitted by:
Weston Solutions, Inc.
Region I
Superfund Technical Assessment and Response Team IV (START)
101 Billerica Avenue, Building 5, Suite 103
North Billerica, Massachusetts 01862
April 2019

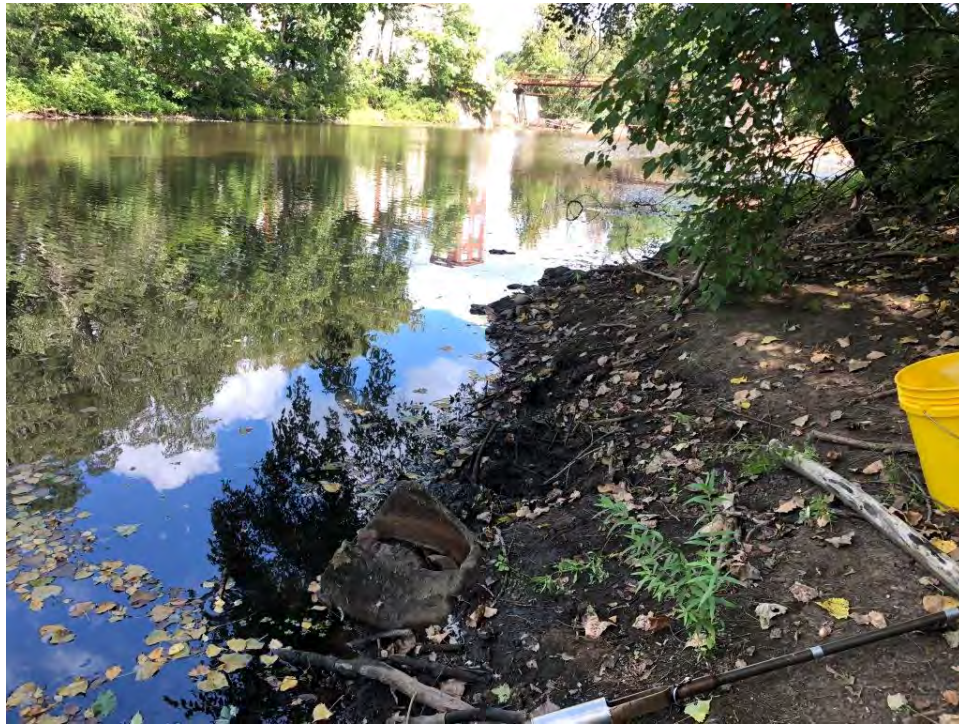
SCENE: View of sediment sample location THD-C3, with the Tileston and Hollingsworth Dam (THD) in the background. Photograph taken facing northeast.

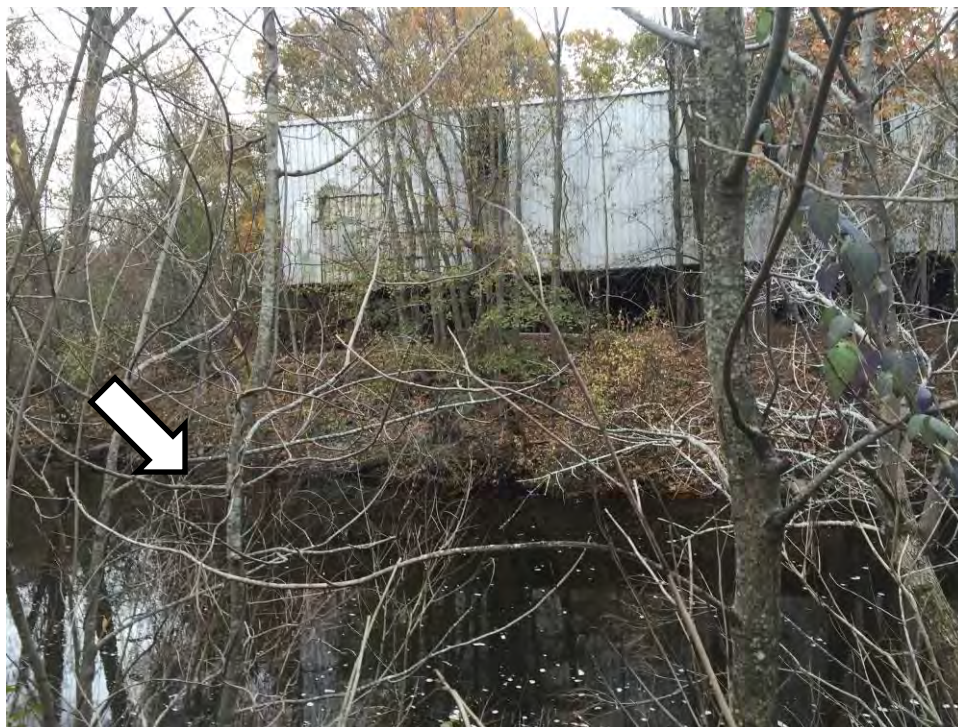
SCENE: View of sample location SD-42 located off the northeast corner of the former tannery/paper mill building, downstream from the Tileston & Hollingsworth (T&H) Dam. Photograph taken facing south.

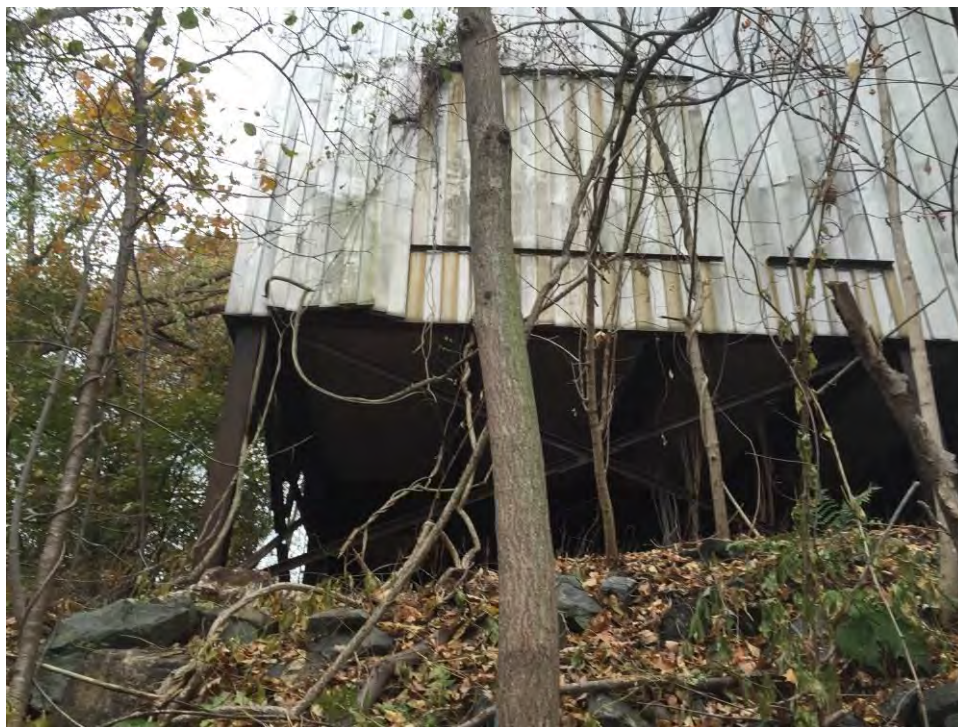
SCENE: Close-up view of the northeast corner of the former tannery/paper mill building. Photograph taken facing south.

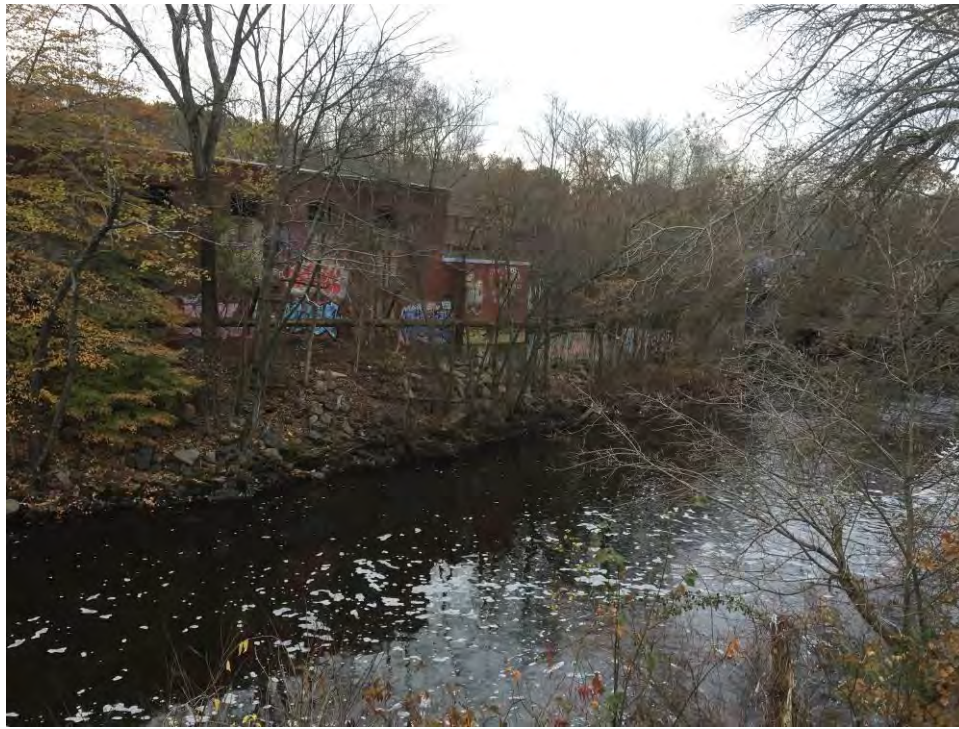
SCENE: View of pipes (raceway) along former tannery/paper mill building; note the T&H Dam on the right. Photograph taken facing southwest.

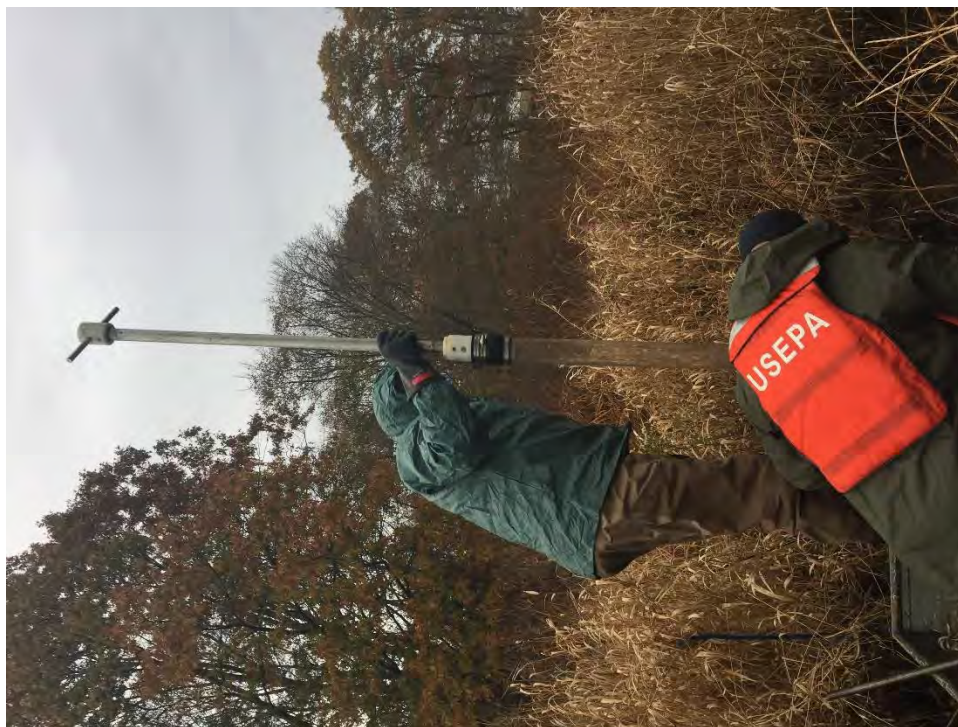
SCENE: View of using the percussion corer at sample location SD-30 on Mill Pond on Mother Brook, upstream of the Westinghouse Dam. Photograph taken facing north.

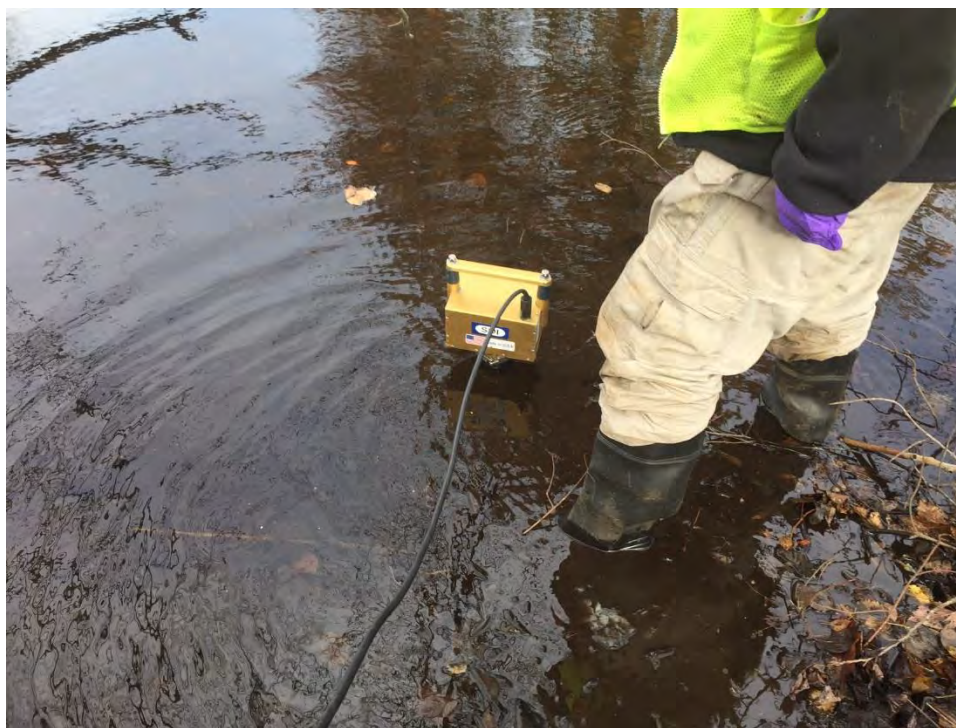
SCENE: View of using the Vibecore Mini to collect sample SD-25. Photograph taken facing northeast.
