**SIXTH FIVE-YEAR REVIEW REPORT FOR  
W.R. GRACE & CO., INC. (ACTON PLANT) SUPERFUND SITE  
MIDDLESEX COUNTY, MASSACHUSETTS**

**U.S. Environmental Protection Agency  
Region 1  
Boston, Massachusetts**

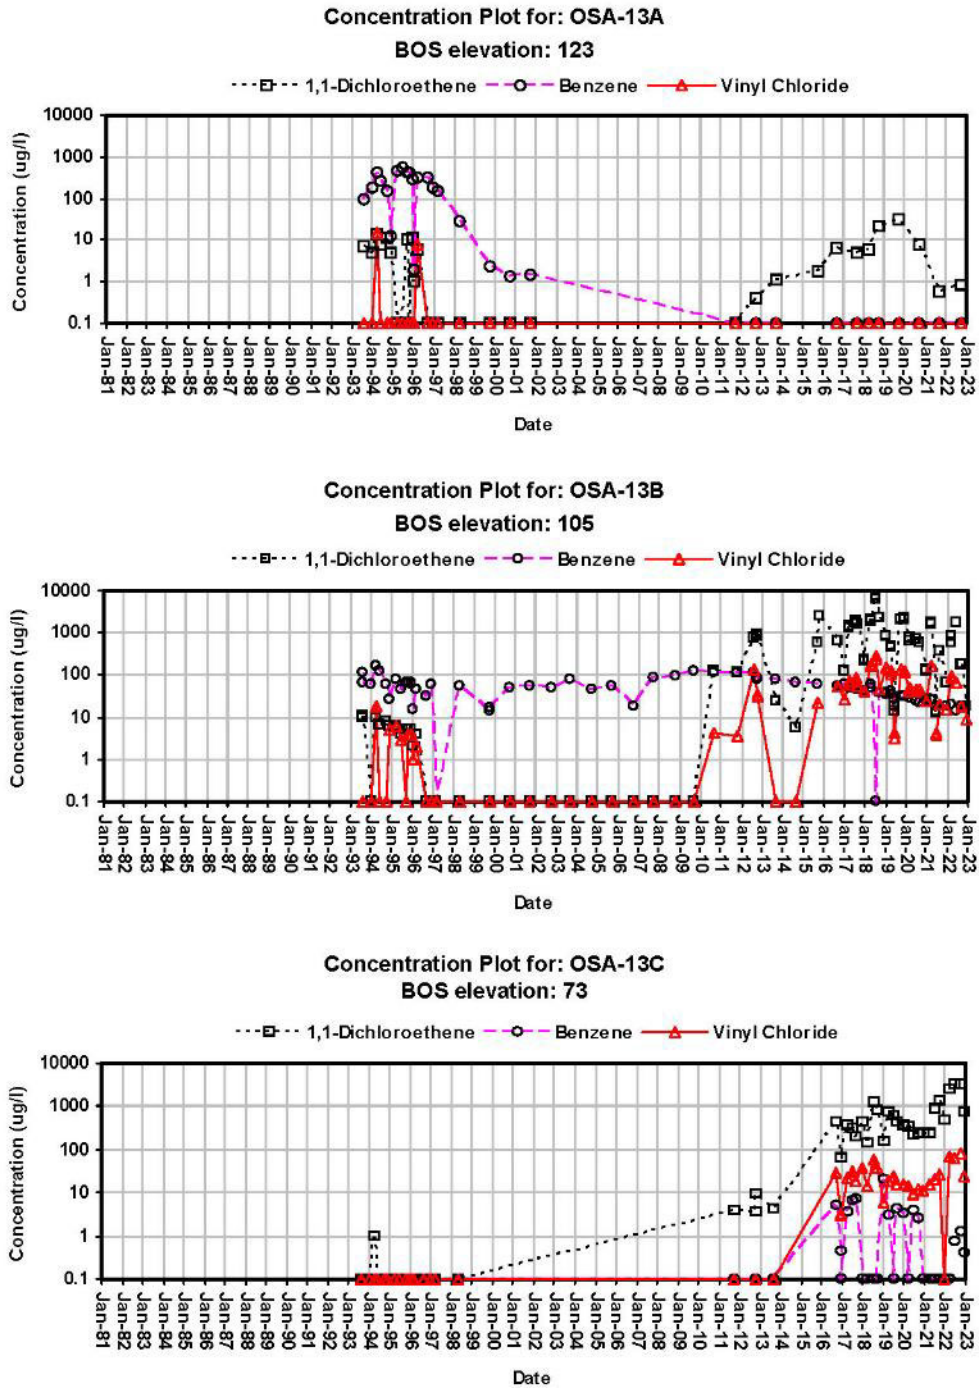
**Figure E-12: Concentration Plots for OSA Cluster**

Maximum concentrations of VDC and vinyl chloride were observed in the OSA-13 well cluster in 2022 with trends either increasing or stable. There has been variability in VDC concentrations detected in samples collected from OSA-13B and OSA-13C during the past 10 years. Quarterly sampling for VOCs at OSA-13B and OSA-13C, along with annual sampling for VOCs at select nearby wells was initiated in 2016. For the past several years

Not detected plotted as 0.1 ug/l.

<b>OU(s): OU-3</b>	<b>Issue Category: Monitoring</b>			
	<b>Issue:</b> Increasing concentrations of VOCs in the OSA-13 well cluster area have been observed during and prior to this FYR.			
	<b>Recommendation:</b> Continue investigating the increasing concentrations of VOCs observed in the OSA-13 well cluster area and identify the source of that contamination.			
<b>Affect Current Protectiveness</b>	<b>Affect Future Protectiveness</b>	<b>Party Responsible</b>	<b>Oversight Party</b>	<b>Milestone Date</b>
No	Yes	PRP	EPA	12/31/2025

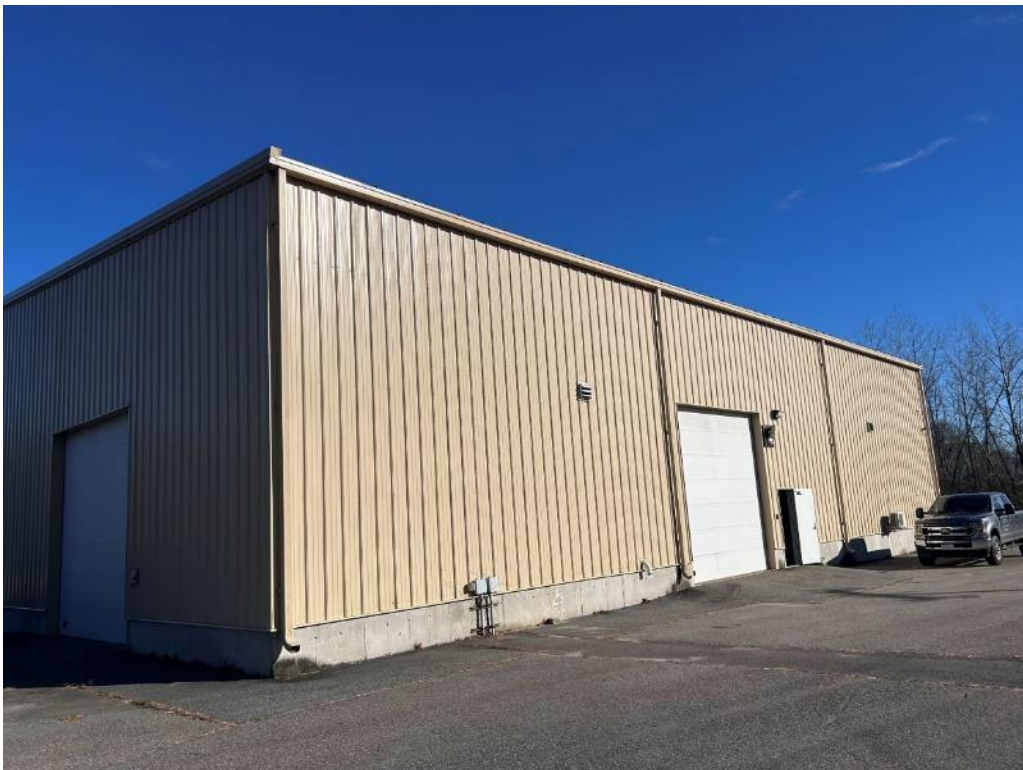
Site inspection participants toured the LATS and the LATS building. The building and system were in excellent condition. Participants discussed the treatment process that currently targets metals removal as VOC concentrations in the influent are relatively low. The system no longer treats 1,4-dioxane because the influent is below 3 µg/L. Site inspection participants also viewed the Industrial Landfill cap and drainage. The cap had been recently mowed and was well vegetated. The drainages were mostly clear of vegetation. Along the northern boundary, the drainage has some standing water, which results in more vegetative growth. The growth did not appear to impede flow. From the top of the landfill, participants viewed the solar array on the Town of Concord owned parcel.

LATS

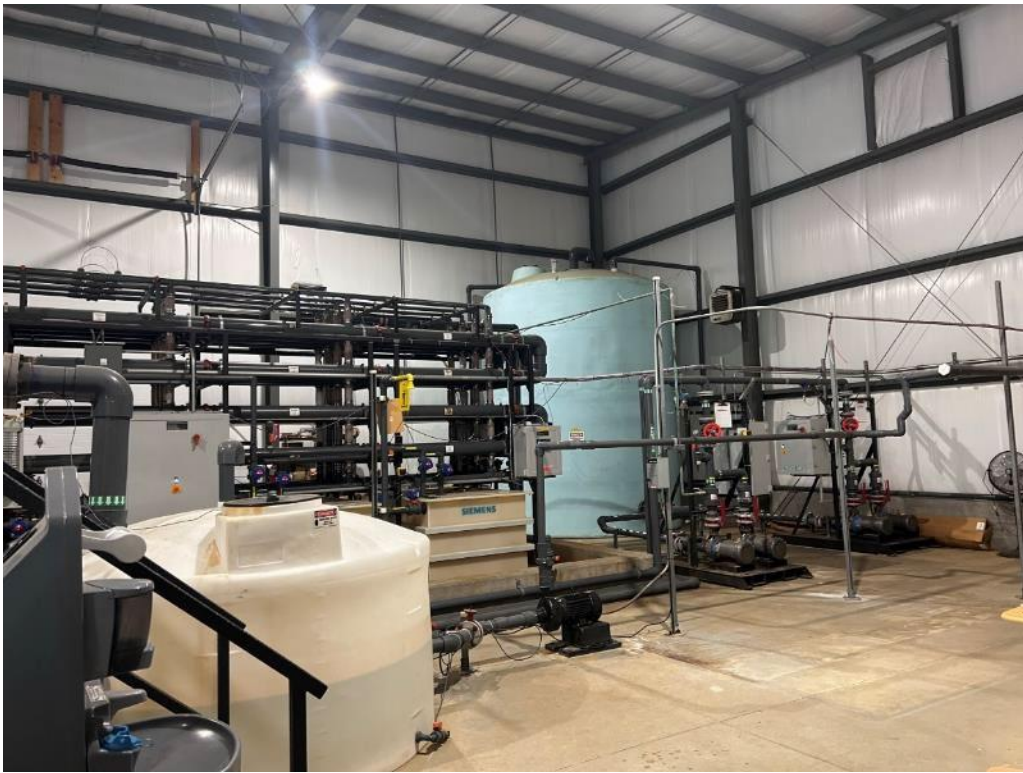
Interior of the LATS building

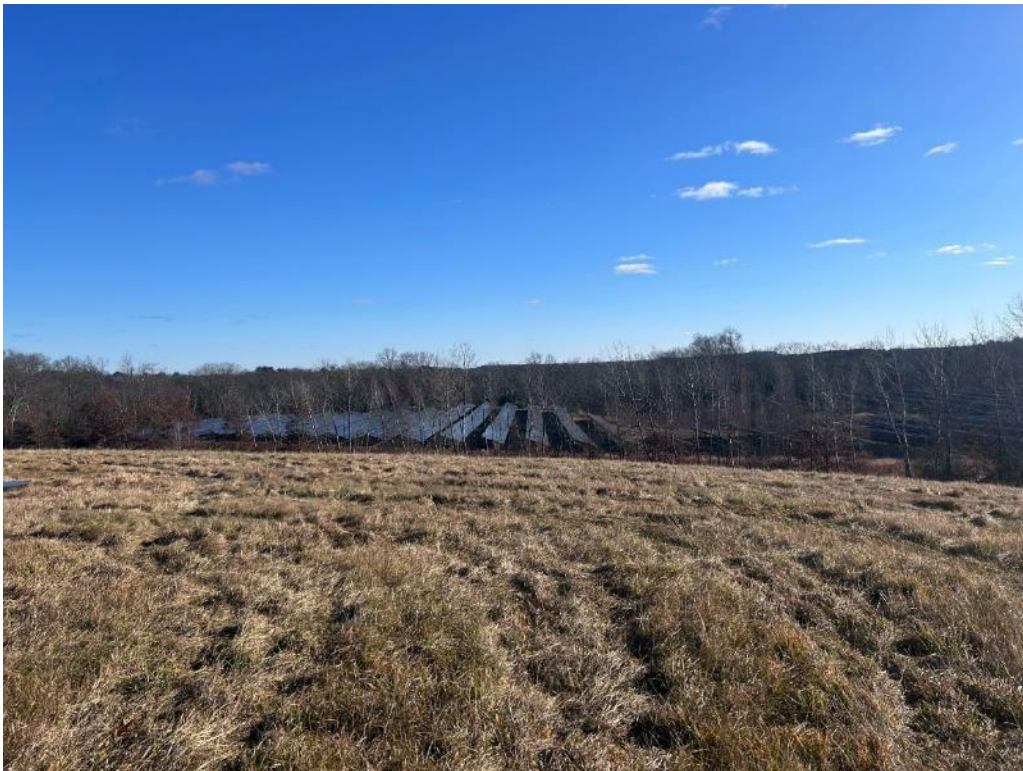
Landfill cap with the solar facility in background

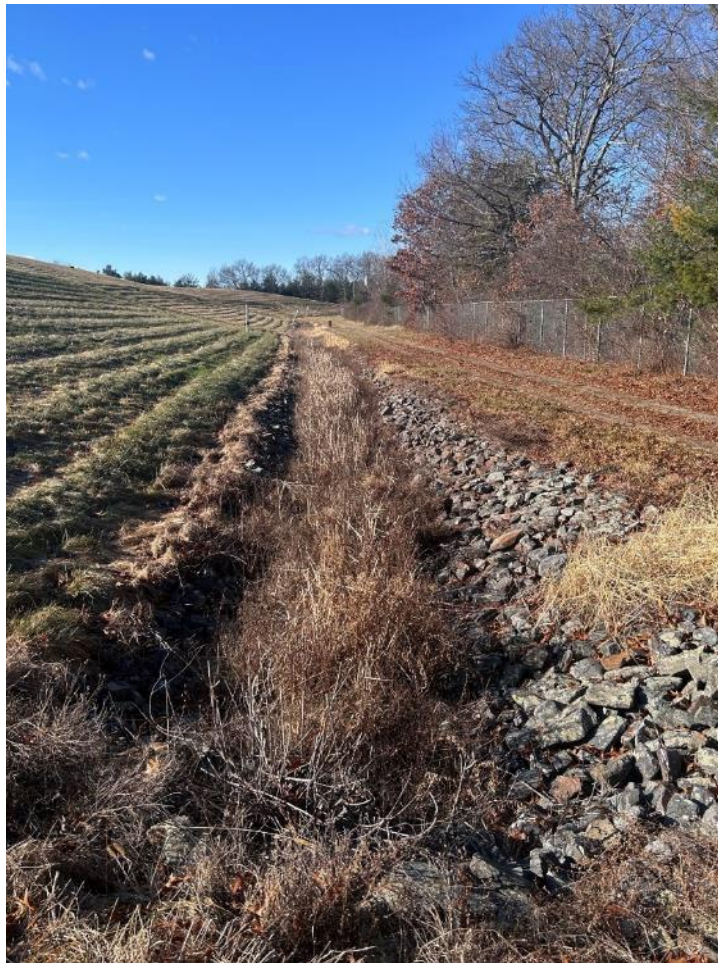
The Industrial Landfill is maintained and monitored in accordance with the Site's 1996 Draft Post-Closure Operation and Maintenance Plan. Drainage swales and culverts are checked twice per year and following large storm events. The landfill cover is inspected for evidence of erosion, vegetation (deterioration or excessive growth), ponded water, animal burrows, cracks, odors, and damage to site facilities. Grass on the landfill is mowed bi-annually down to 4 to 5 inches.

Stormwater drainage with some vegetative growth

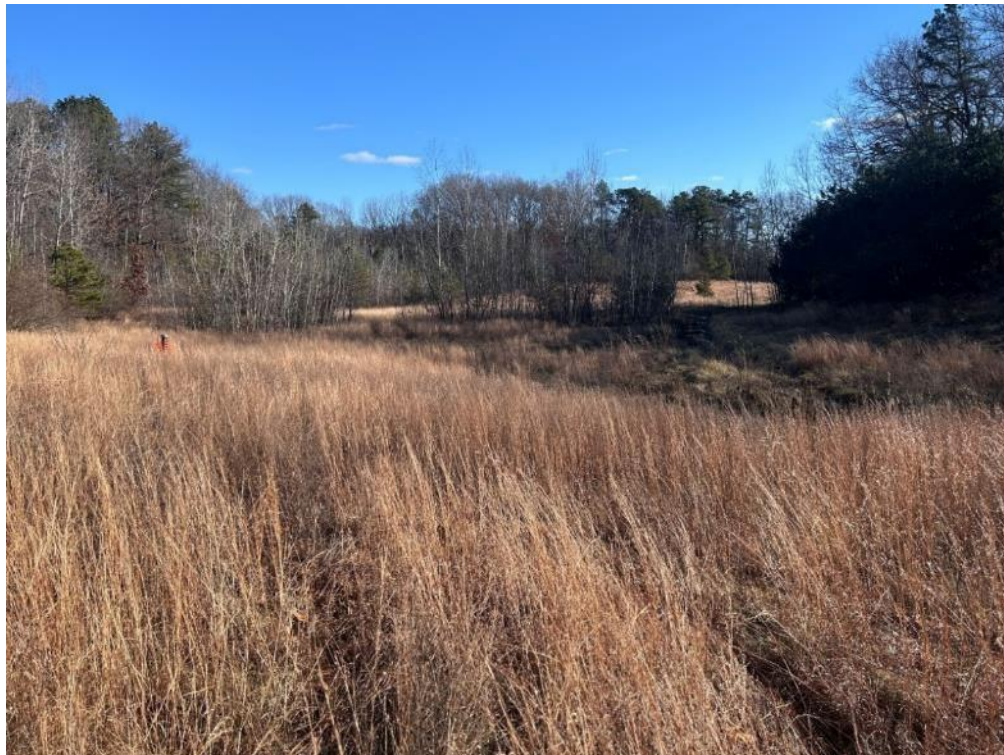
Site inspection participants proceeded to observe the Former Lagoon Area, several locked monitoring wells, the area with remaining building foundations and pavement and concrete slabs, and the MTBA commuter rail line. Across the rail line, participants observed the North Lagoon wetland area and the area being considered for future residential development. Lastly, participants observed Sinking Pond and the water treatment outfall. The pond water level was high due to recent precipitation. There was little evidence of trespassing. Overall, participants did not observe anything that calls into question the current protectiveness of the remedy.

Former Lagoon Area

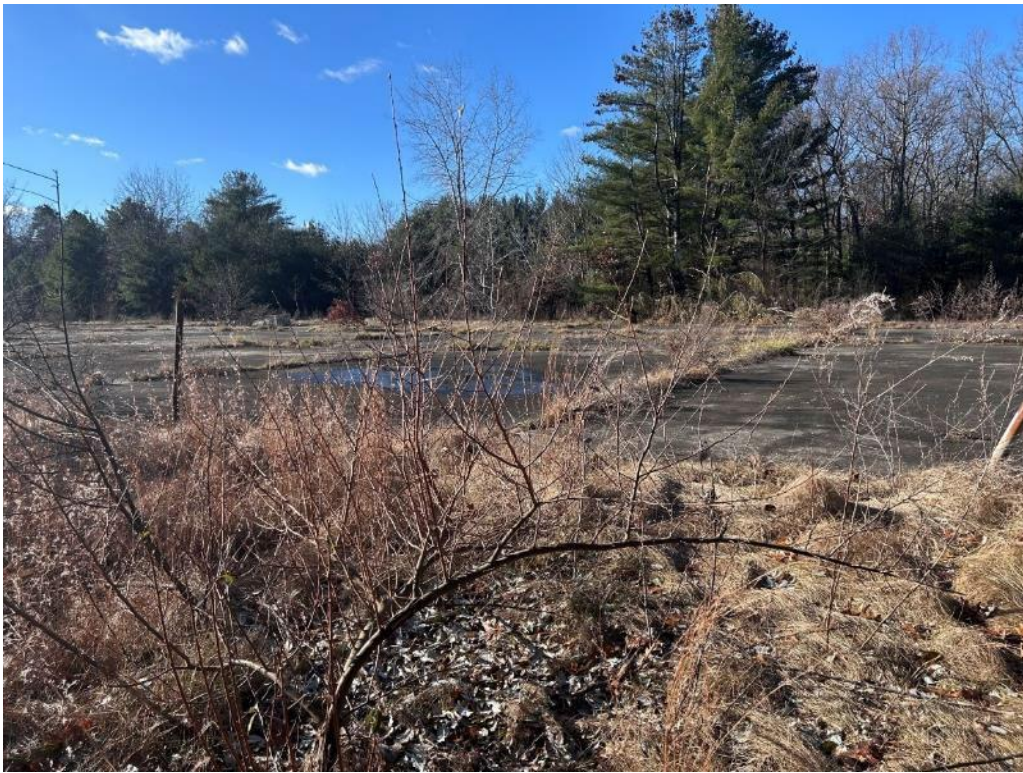
Former building area with remaining pavement and slabs

<b>OU(s): OU-1</b>	<b>Issue Category: Changed Site Conditions</b>			
	<b>Issue:</b> Current status of soil is unknown in non-source areas. Given the increased interest in redevelopment at the Site, in order to ensure future protectiveness, additional institutional controls may be appropriate.			
	<b>Recommendation:</b> Consider an institutional control to require soil characterization or soil management plan to ensure site-related contamination is not present in soils, and if present, is appropriately addressed by a soil management plan.			
<b>Affect Current Protectiveness</b>	<b>Affect Future Protectiveness</b>	<b>Party Responsible</b>	<b>Oversight Party</b>	<b>Milestone Date</b>
No	Yes	PRP	EPA	6/30/2026

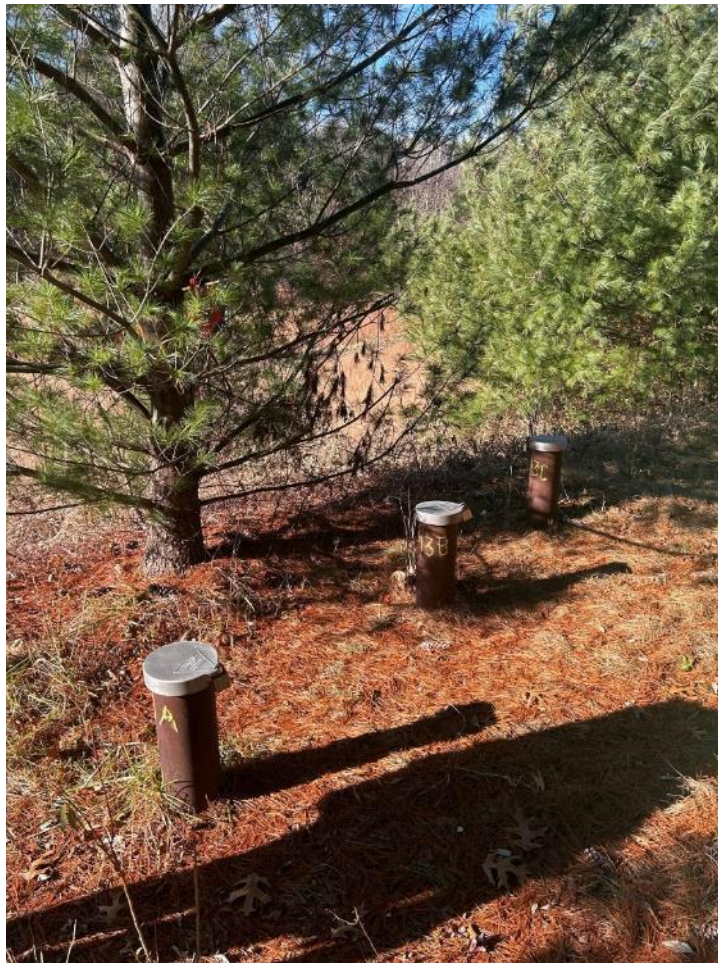
- VOC plumes are contained. In 2022, the maximum concentrations of VDC and vinyl chloride were observed in the OSA-13 well cluster, located in the Former Lagoon Area. Due to variability observed at this well cluster (an anomalous spike in 2010 to 2012, when VDC was detected at a maximum concentration of 900 µg/L), Grace initiated quarterly sampling in 2016 for VOCs at OSA-13B and OSA-13C, along with annual sampling for VOCs at select nearby wells. For the past several years, Grace has been collecting more data and doing additional analysis to determine the source of contamination causing the increase in VOC concentrations in the OSA-13 well cluster. As of 2022, concentrations in OSA-13C are increasing. Grace plans to submit an investigation plan designed to identify the location of the source of that contamination to EPA in 2024.

Monitoring wells OSA-13 A, B and C

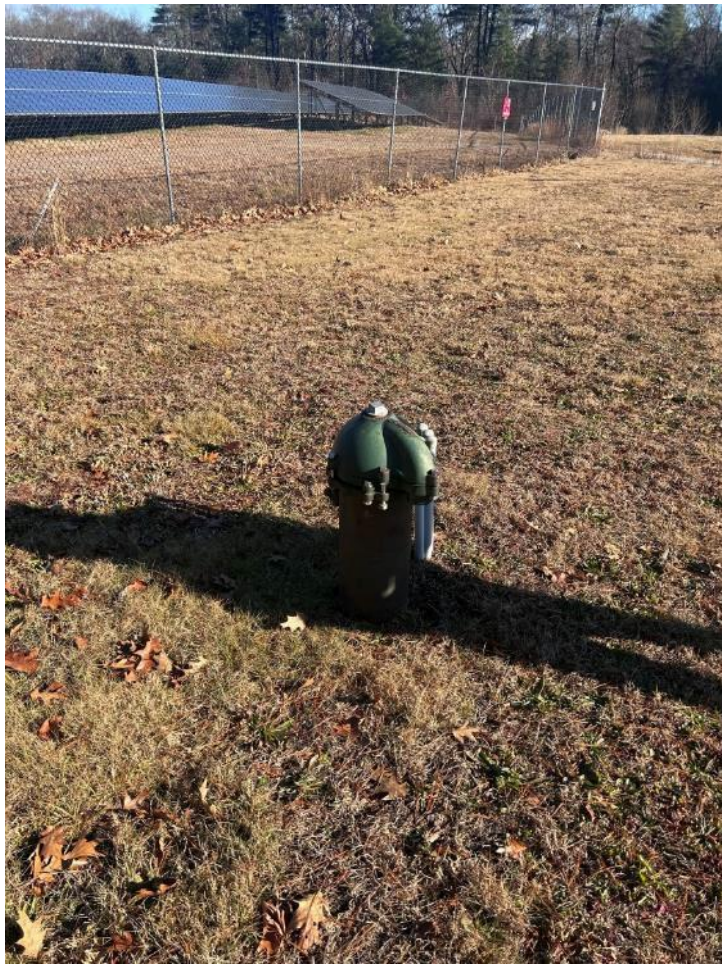
In 2017, without notifying or consulting either EPA or MassDEP, the town of Concord installed a groundwater extraction well intended to provide non-potable water to clean buses at the bus maintenance facility. This 8-inch diameter well was advanced to a depth of about 500 feet in bedrock. EPA became aware of the well after personnel repairing the monitoring wells damaged during construction of the solar array discovered it. EPA issued a letter on March 21, 2024 restricting the use of this well out of concern that it may draw contaminated groundwater from the Site, with potential to pose a risk to human health and adversely affect the groundwater remedy. Concord responded to EPA's letter on April 9, 2024 and stated that the well has never been used and will be decommissioned in Spring/Summer 2024.

Inactive pumping well on Concord Bus Facility

<b>OU(s): OU-3</b>	<b>Issue Category: Changed Site Conditions</b>			
	<b>Issue:</b> The town of Concord installed a groundwater extraction well south of the Site for use at the bus facility.			
	<b>Recommendation:</b> Properly abandon the groundwater extraction well at the bus facility.			
<b>Affect Current Protectiveness</b>	<b>Affect Future Protectiveness</b>	<b>Party Responsible</b>	<b>Oversight Party</b>	<b>Milestone Date</b>
No	Yes	Other	EPA	12/31/2024
