# Weekly Field Report

Week: 11-17-13 through 11-23-13  
New Bedford Harbor Lower Harbor CAD Cell (LHCC)

This Weekly Field Report was prepared to serve as a summary of field activities conducted throughout the week for Phase I dredging of the New Bedford Harbor Lower Harbor CAD Cell (LHCC) in New Bedford, Massachusetts.

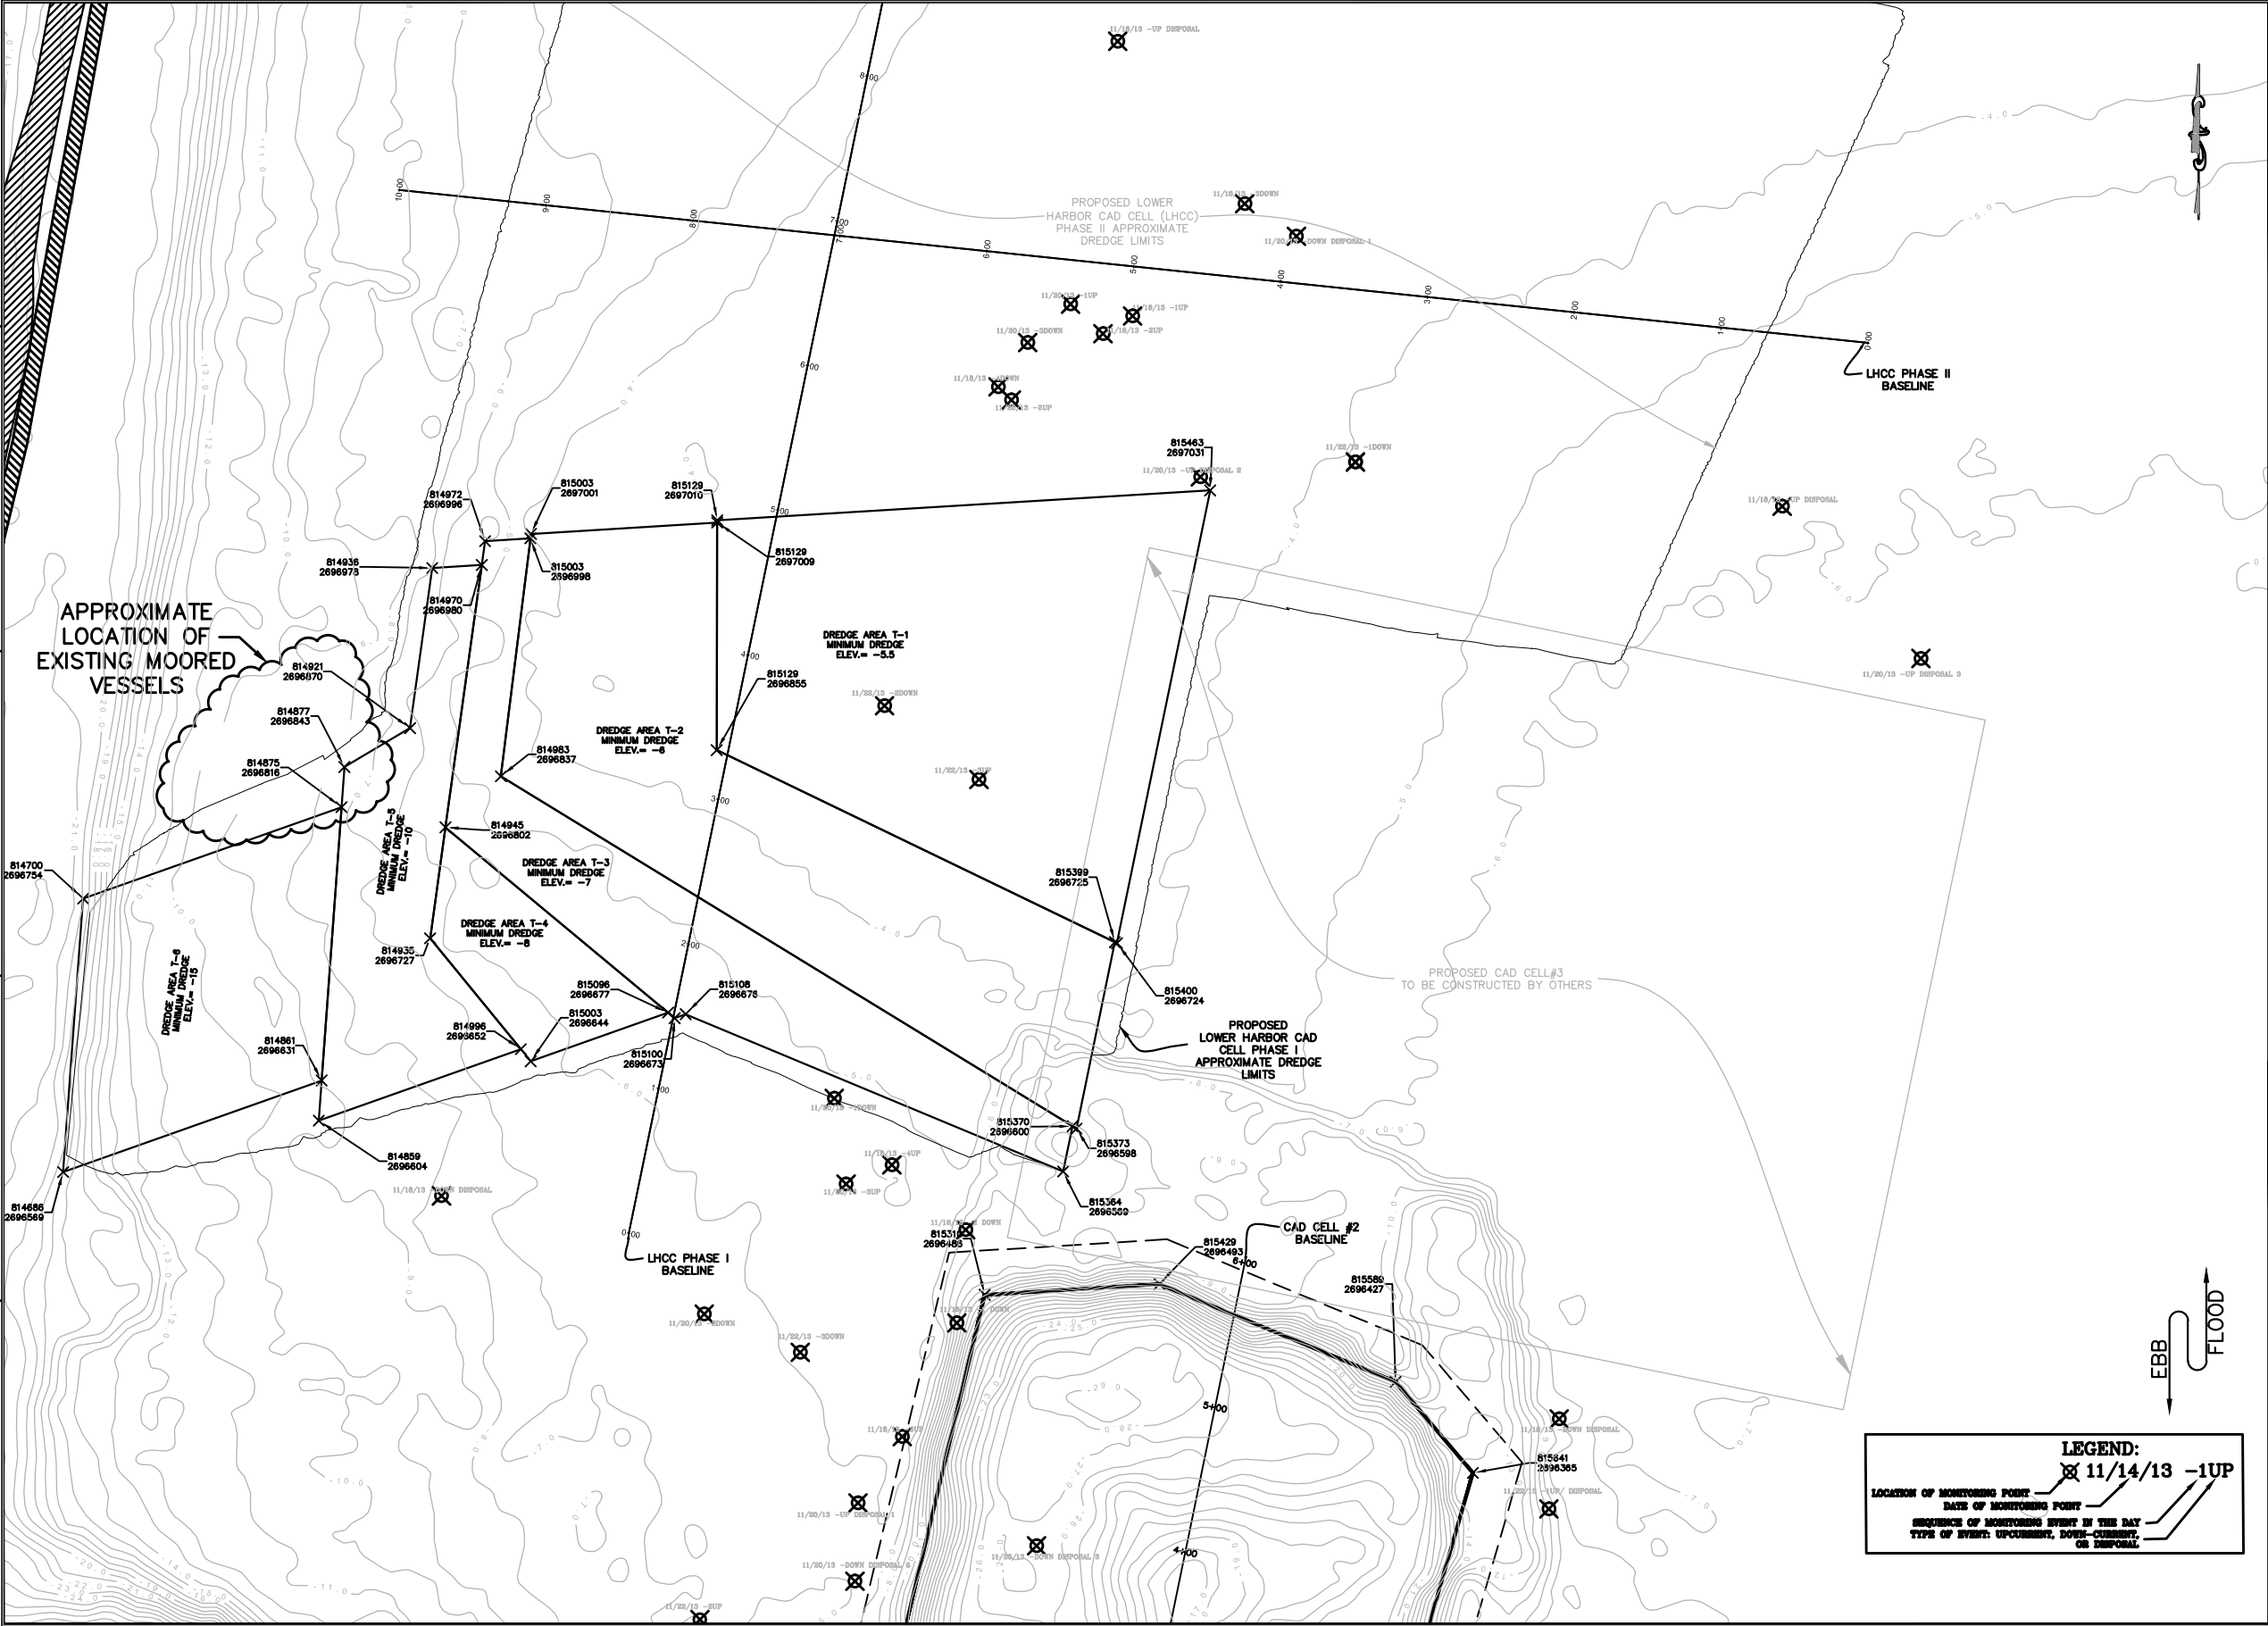
Figure 1  
Lower Harbor CAD Cell Phase I – Water Quality Monitoring

- Water Quality Monitoring Forms completed for the week of November 17<sup>th</sup> through November 23<sup>rd</sup> are attached (Attachment 2). Included with the attached forms is Figure 1 *Lower Harbor CAD Cell Phase I Water Quality Monitoring Plan*, which shows the locations of the water quality monitoring events conducted during this reporting period. Per the approved Water Quality Monitoring Plan and associated performance standards for this dredging effort Apex will;

LOWER HARBOR  
CAD CELL  
PHASE I  
WATER QUALITY  
MONITORING
