**FOURTH FIVE-YEAR REVIEW REPORT FOR  
BARCELONETA LANDFILL SUPERFUND SITE  
BARCELONETA, PUERTO RICO**

**U.S. Environmental Protection Agency  
Region 2  
Guaynabo, Puerto Rico**

**May 2020**

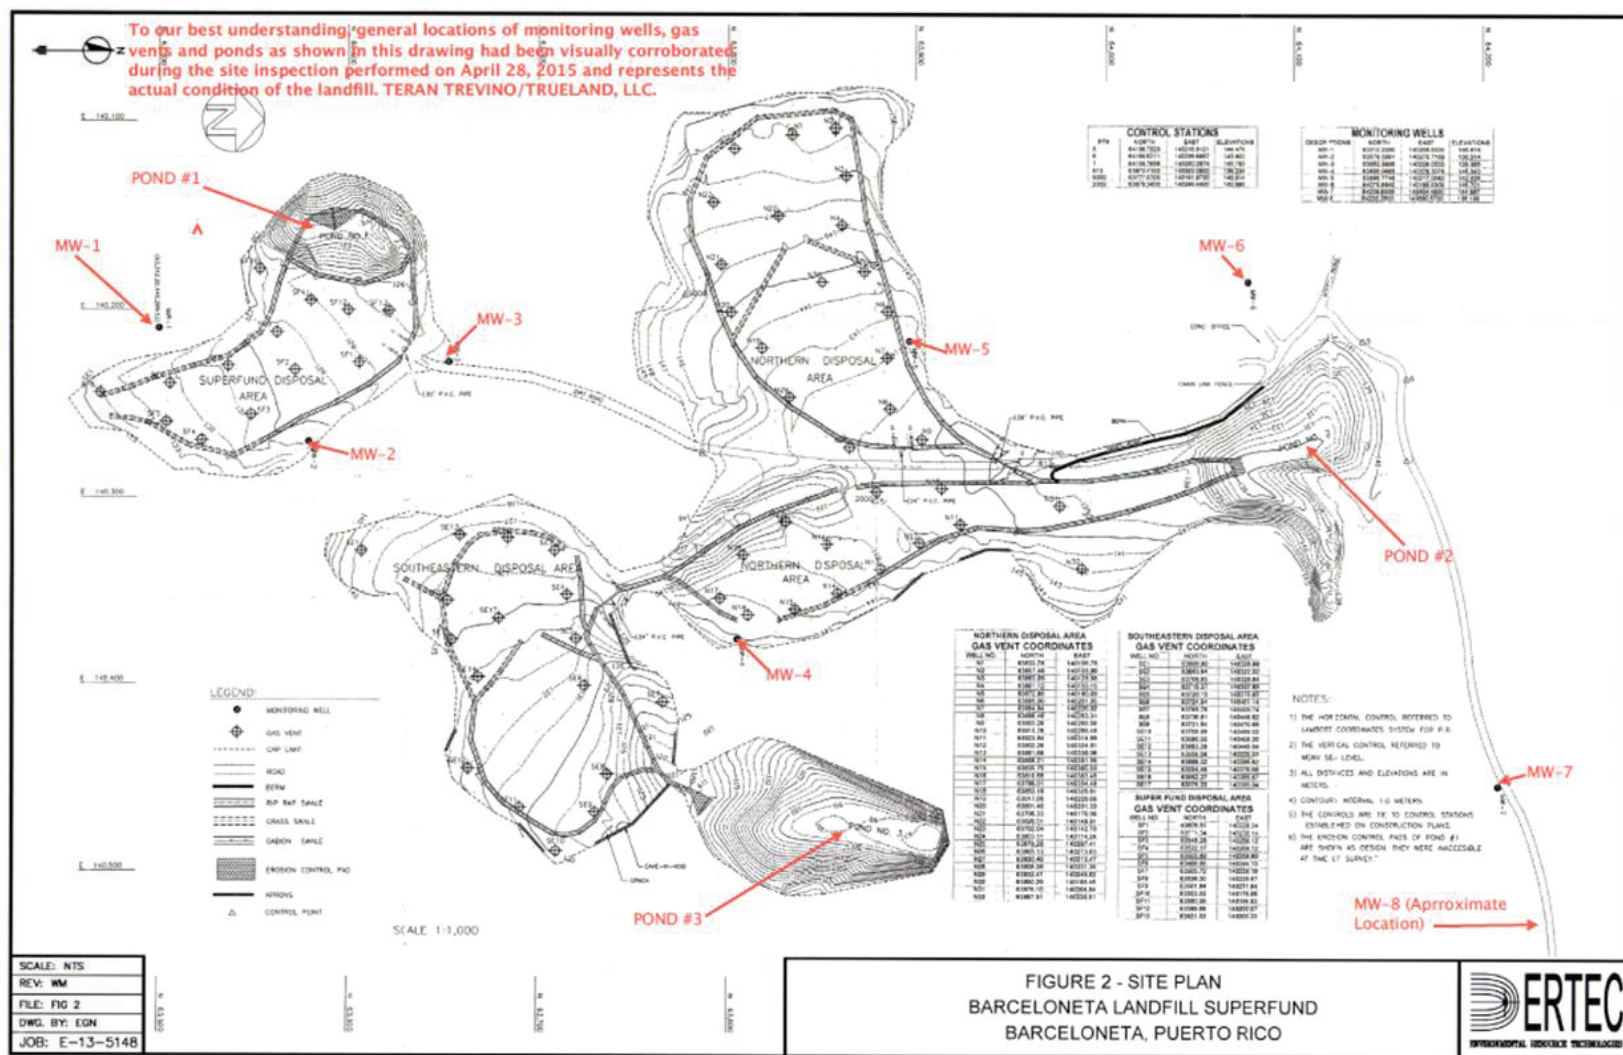
Attachment 1: Figure: Site Wells Location

Now, consistent with the, September 2000 O&M Plan five monitoring wells (MW-1, MW-4, MW-6, MW-7 and MW-8) are being sampled on an annual basis. Groundwater samples are analyzed for the following parameters: TSS; TDS; manganese; mercury; nickel; aluminum; chromium; and iron.
