**FOURTH FIVE-YEAR REVIEW REPORT FOR  
ABEX CORP. SUPERFUND SITE  
PORTSMOUTH, VIRGINIA**

**MAY 2017**

**U.S. Environmental Protection Agency  
Region 3  
Philadelphia, Pennsylvania**

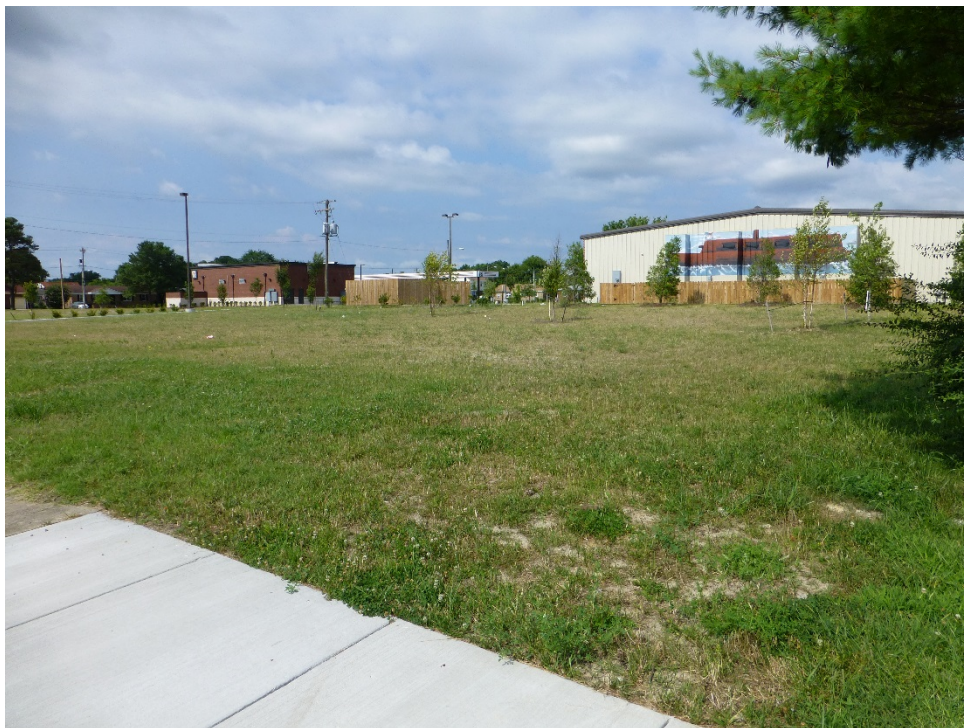
During the site inspection, participants discussed the recent construction of a 7-Eleven gas station on the property bounded by Lincoln Street to the south and Effingham Street to the west. Site inspection participants discussed how the excavation efforts followed property use restrictions and the permitting process; the warning liner displaced during construction efforts was not replaced. As a result, there are areas of the property without a liner and where soil contamination is mixed with non-contaminated soils. The property owner and any future purchaser would need to check with appropriate city personnel before building on the property; the property is covered by City Ordinance 1996-15. Additionally, with a new commercial owner, soil sampling would likely take place as part of Phase 2 environmental assessment though it would not be required. EPA and VADEQ will consider and implement an approved protocol for on-site areas where excavation is approved and warning liners are damaged or removed.

Back of Dollar General and 7-Eleven properties, viewed from Green Street

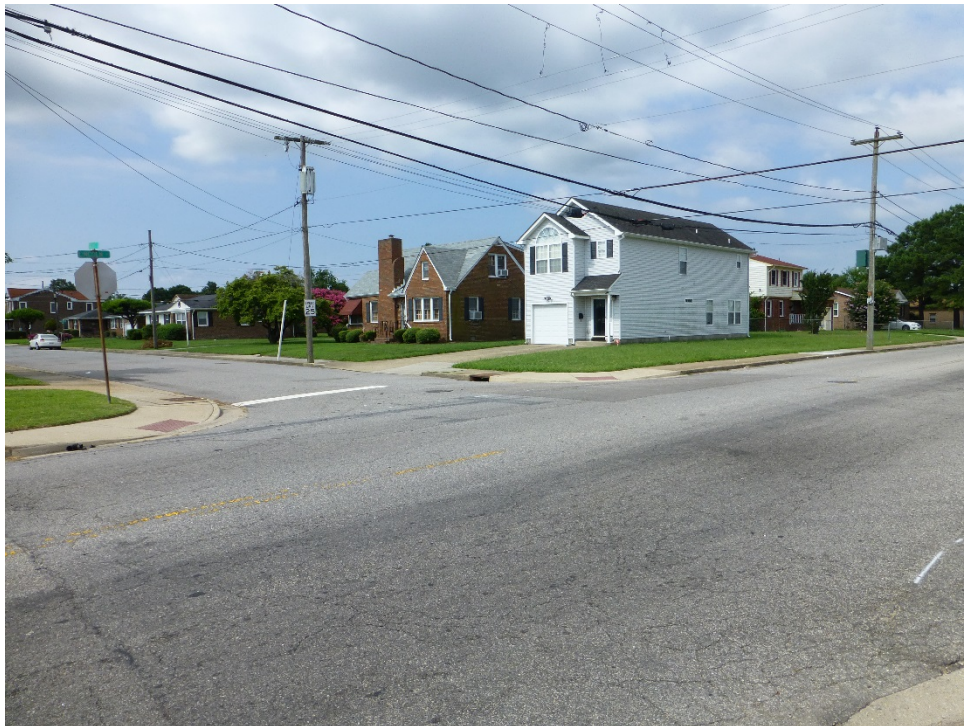
The Lincoln Street block was remediated to residential standards during the OU1 remedial action, but the contamination was not related to the foundry and EPA did not require institutional controls for the area. However, on-site buildings were left in place during excavation efforts. If the buildings or homes were demolished in the future, exposure to lead-contaminated soil could be possible. The City and property owners may want to consider whether institutional controls or other use restrictions are appropriate on those properties. A combination of excavation and institutional controls prevents exposure to lead and would not likely result in site exposure above the 200 mg/kg exposure limit.

Looking south from Lincoln Street, to Lincoln Street residential cleanup block

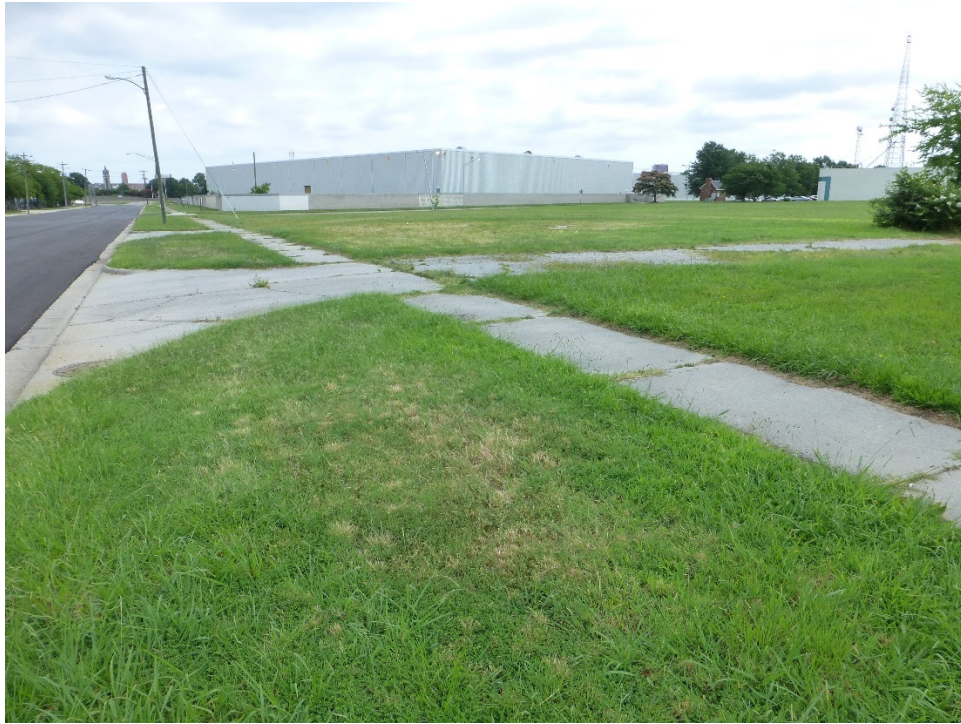
Remarks: Participants noted cracking sidewalks and pavement throughout the Site with weeds growing. These could require minor repairs in the future but did not see any holes or excavated areas in permanent covers.

Minor cracks along sidewalks bordering Seventh Street
