**2015 ANNUAL GROUNDWATER MONITORING REPORT**  
**(JULY 2015 - JUNE 2016)**

**HAVERTOWN PCP SUPERFUND SITE  
HAVERTOWN, HAVERTOWN TOWNSHIP,  
DELAWARE COUNTY, PENNSYLVANIA**

**JULY 2016**

**Tetra Tech, Inc.  
240 Continental Drive, Suite 200  
Newark, Delaware 19713**

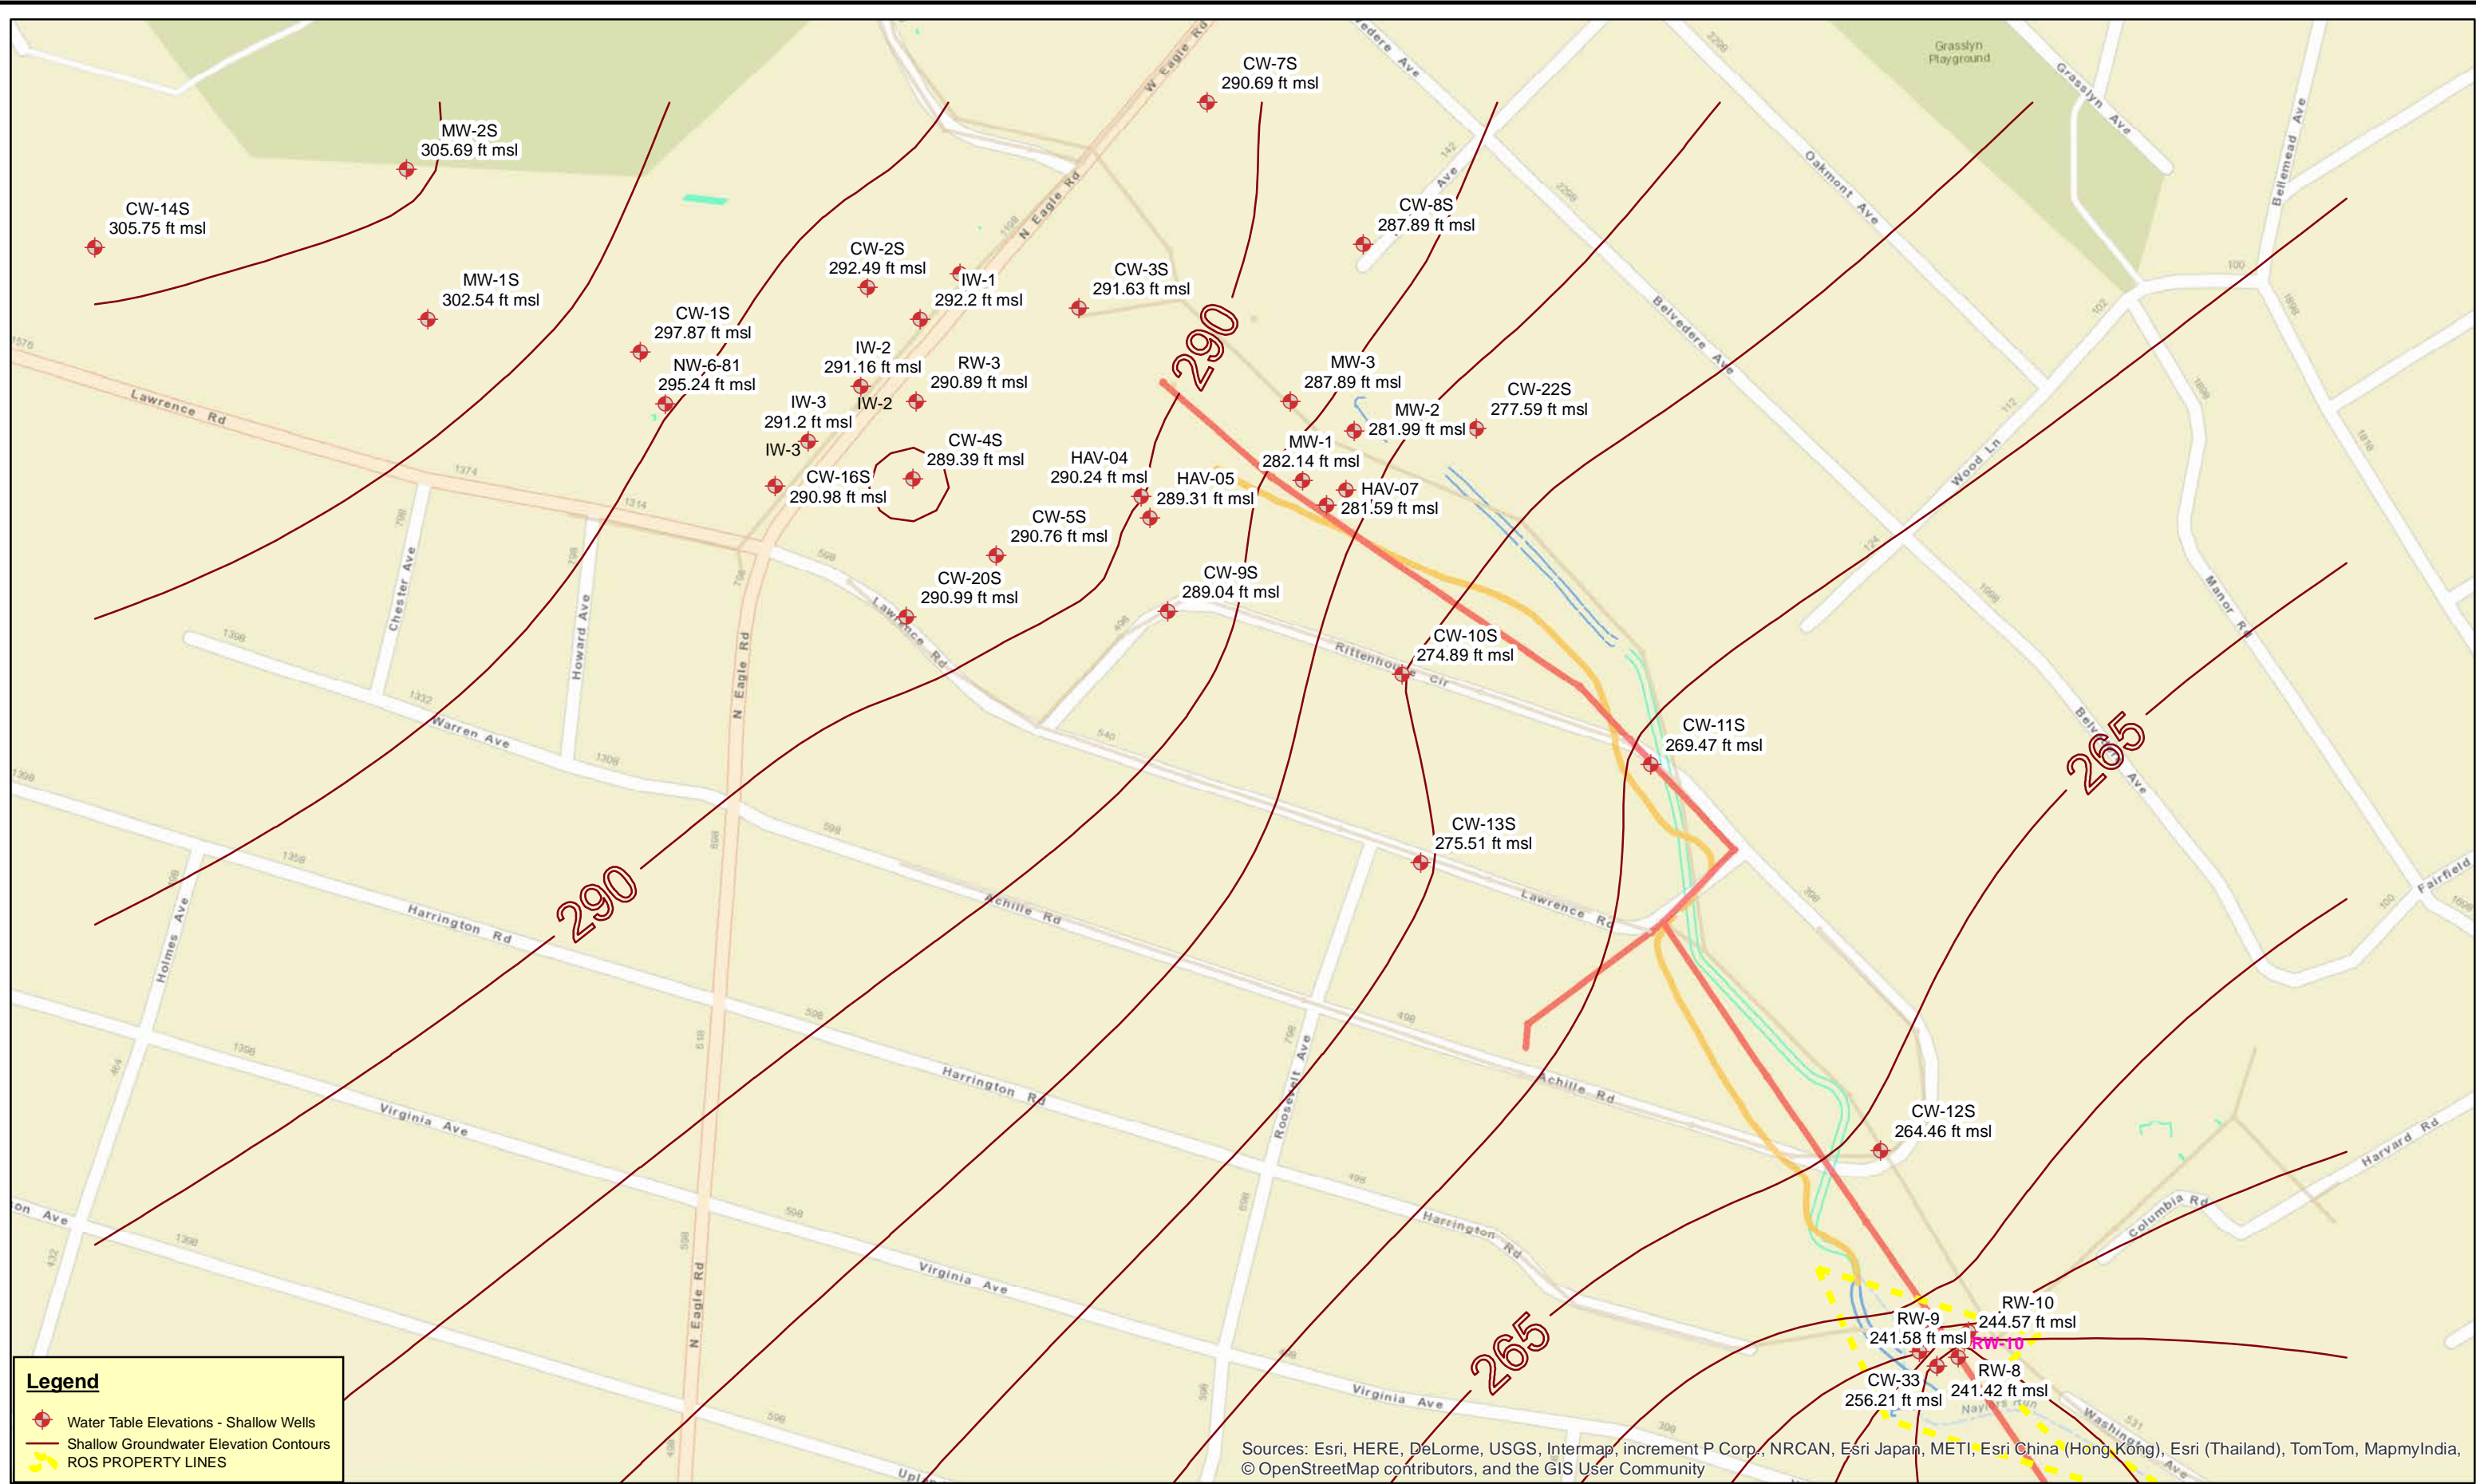
**FIGURE 3 - SHALLOW WATER TABLE ELEVATION**  
**MARCH 2016**  
**HAVERTWON PCP SUPERFUND SITE**  
**DELAWARE COUNTY**  
**HAVERTOWN, PENNSYLVANIA**

Figure 3 shows groundwater contours for the shallow zone/overburden while the system was operational. Figure 4 displays groundwater contours for the deep zone/bedrock while the system was operational.

Table 3 presents water-level data. Figures 3 and 4 indicate a measurable drawdown near the RW wells and CTR. Pumping at recovery well RW-5 screened at 36 to 46 ft bgs continued to draw down water levels in surrounding deep wells CW-24, CW-26 and CW-16 S/I/D, and to impact the water level in downgradient wells CW-27D, and CW-4S/I/D. Pumping at RW-7 (screened from 90 to 120 ft bgs) draws down the water tables in surrounding wells CW-28, NW-1, CW-4S/I/D, and CW-17D, and impacts water levels in downgradient wells CW-3S/I/D, CW-5S/I/D, CW-18D, and CW-19D.

The pumping systems at the CTR (8 to 18 ft bgs) and RW-6 (screened from 25 to 35 ft bgs) continued to draw down water levels in nearby monitoring wells MW-1, MW-2, CW-9S/D, and downgradient wells HAV-07 and CW-21S/D. These two pumping systems also influenced water levels in upgradient wells HAV-04, HAV-05, and MW-3. The ROS Area recovery wells RW-8, RW-9, and RW-10 (all three screened from 7 to 18 ft bgs) drew down water levels in upgradient wells CW-32, CW-33, and CW-34.

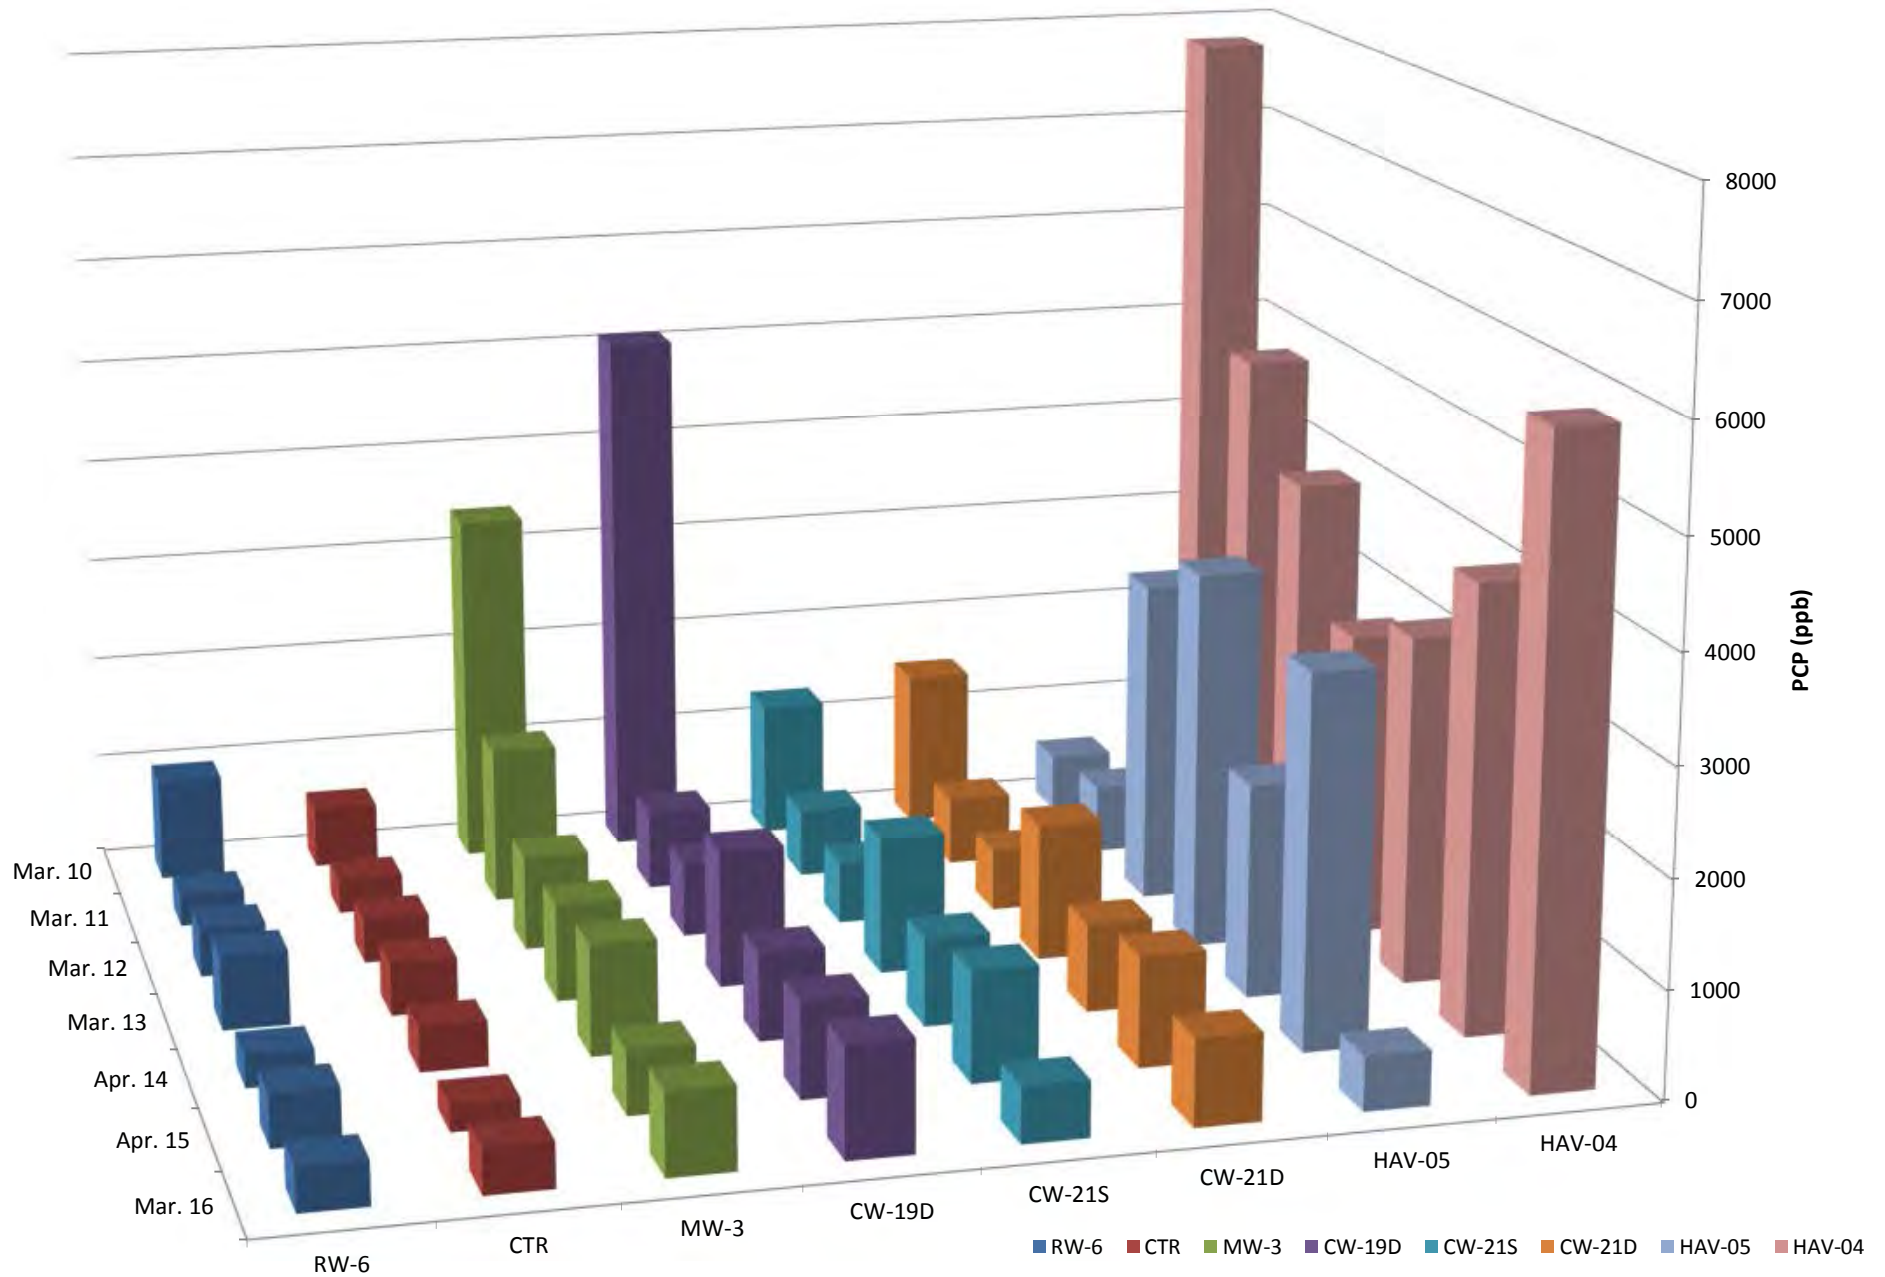
**Figure 9**  
**PCP Concentration Graph - Collection Trench Area Wells**  
**2010 - 2016**

For CTR samples, PCP concentrations varied from 500 µg/L (March 2013) to 415 µg/L (April 2014) to 255 µg/L (April 2015) to 430 µg/L (March 2016). More detailed information may be found in Table 5.

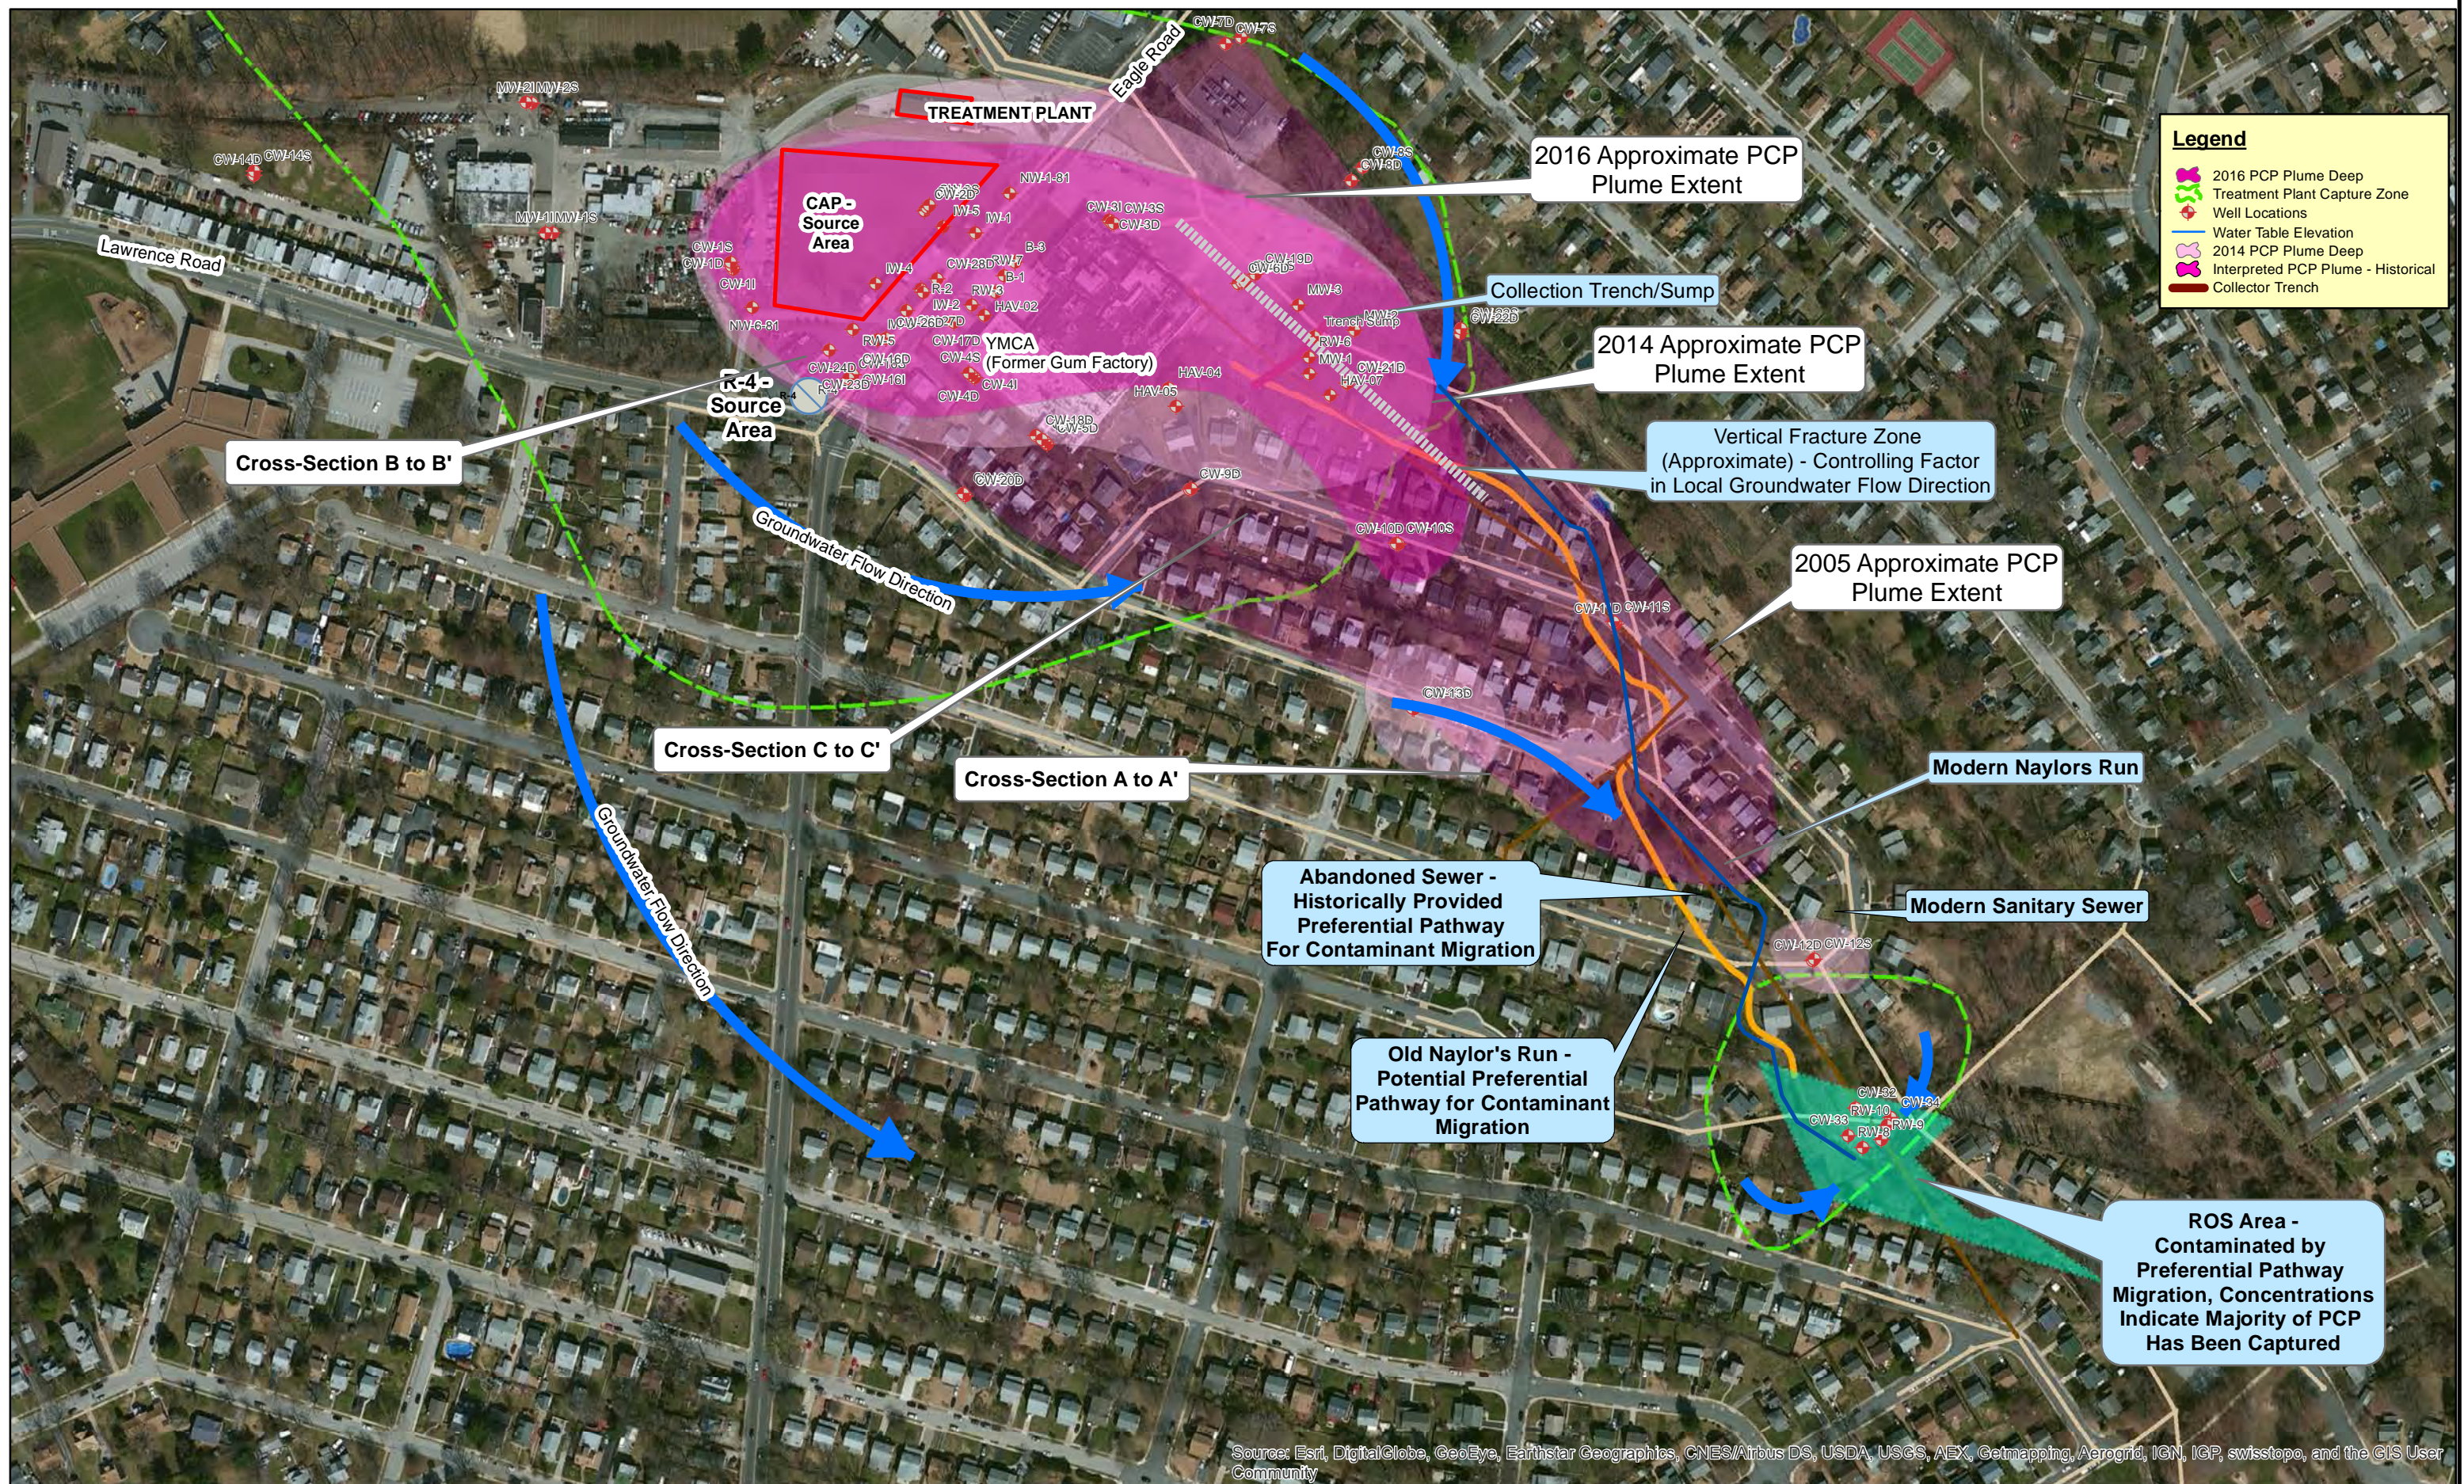
The three cross-section alignments generated during the 2014 update were updated with the March 2016 data as well. The alignment locations are shown on **Figure 12**. These cross-sections were generated in AutoCAD to depict the subsurface conditions at key locations and include the following:

Review of pump test and boring log data at RW-5, RW-6, and RW-7 indicated a zone of vertical fracturing near the area shown on **Figure 12**. At this time, the fracture zone has not been fully delineated, and the approximate alignment shown on the map is the area estimated to have an impact on the wells currently included in the O&M monitoring. Based on the alignment of Naylor's Run, the rocks observed in the creek, and the approximate alignment of the fractures on the historic Naylor's Run stream channel, it is probable that the fracture zone extends further north and south away from the approximate alignment shown on the map.

A review of the updated CSM indicates that the vast majority of the plume is currently being captured by the existing remediation system. While 100% capture may not always occur due to abnormal conditions (such as an excessively rainy season, or technical issues) the remediation system has reduced the overall size of the plume from the 2005 extent and appears to contain it. However, since the 2014 CSM update, there does not appear to have been a significant change in plume volume, though there has been a change in morphology, as seen by the extent of the 2016 plume when compared to the 2014 plume. At the time sampling was performed, the plume appears to have extend outside the capture zone. The cause for this is currently unknown.
